ATSB TRANSPORT SAFETY REPORT
Aviation Occurrence Investigation AO-2008-072
Final

Missing aircraft
Buckingham Bay, Northern Territory
16 October 2008
VH-WRT, GA-8 Airvan

Report No.	Publication date	No. of pages	ISBN
AO-2008-072	July 2010	50	978-1-74251-078-1

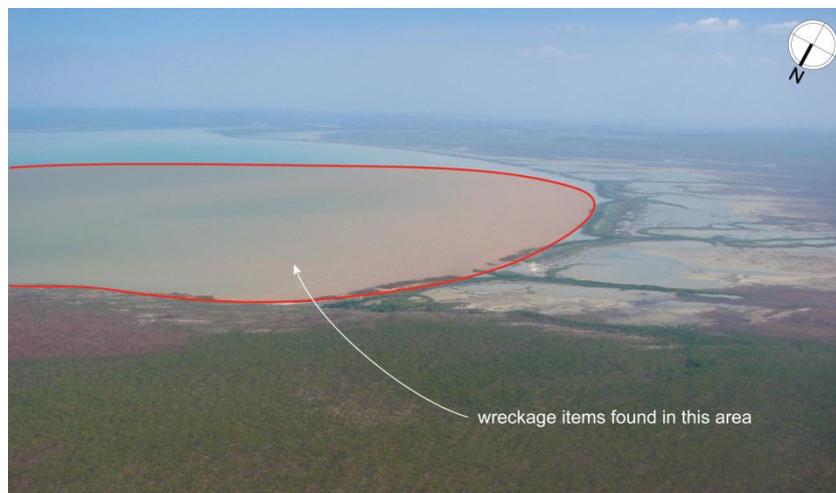
Figure 3: Aerial view of the south-western part of Buckingham Bay

The following day, items of wreckage (cargo and a number of aircraft parts) were found floating or beached in the south-western part of Buckingham Bay (Figures 3 and 4).

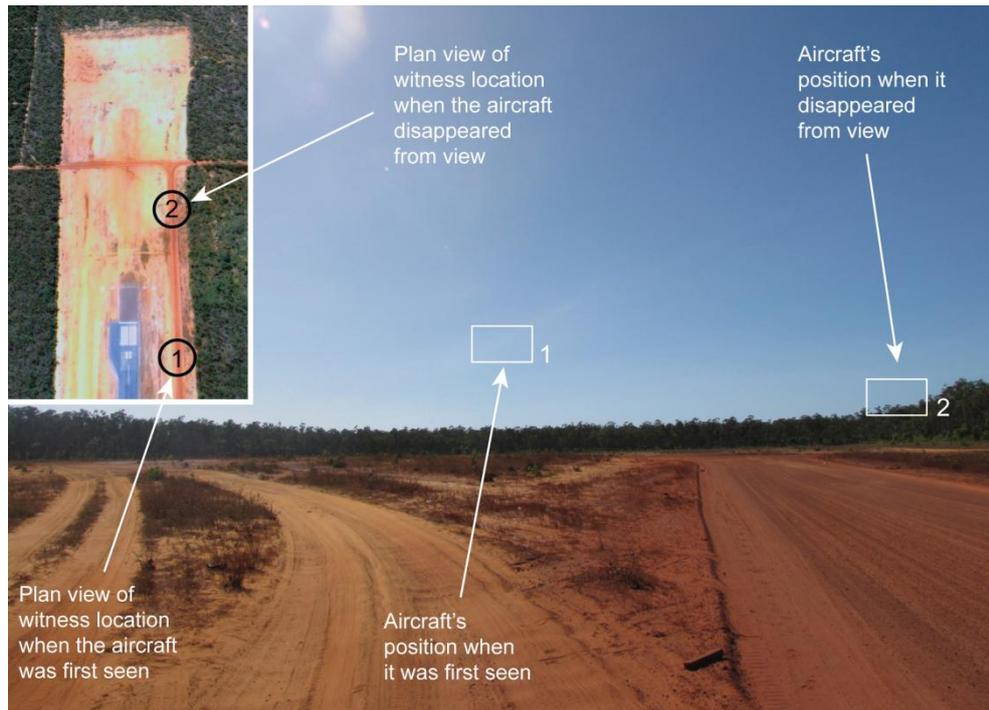
Figure 5: Second witness's view from the aerodrome

The second account is from a member of the Galiwinku community who reported that he was driving east with two companions along the dirt road on the airfield shortly after the pilot took off. The road ran parallel to and to the south of the runway. The witness reported getting out of the vehicle to watch the aircraft's departure (Figure 5). The second witness's information was provided to the ATSB several months after the accident, after knowledge of the accident, the accident flight's intended destination, and the location of wreckage was well known in the local community.

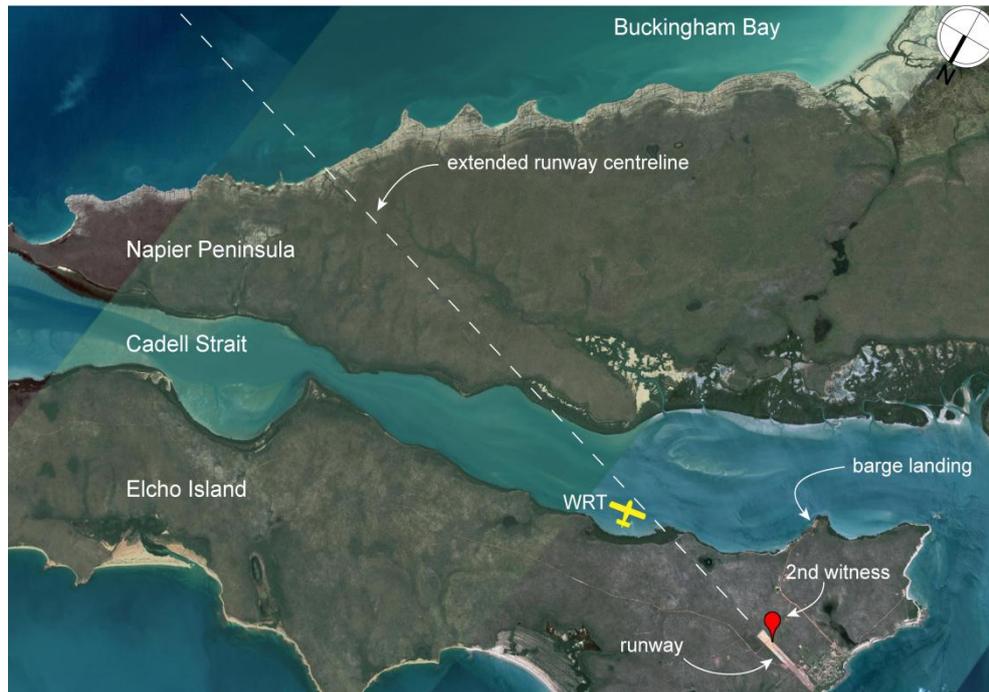
Figure 6: Location of the second witness on the aerodrome and of the aircraft when it turned right and began to descend³

The second witness recalled watching the aircraft fly away from him as it climbed, before turning to the right (Figure 6), with an angle of bank sufficient for him to see the left wing above the fuselage. It then descended quite steeply until it disappeared behind the trees at the eastern end of the airfield. The witness reported being concerned by an apparent lack of engine noise, and thinking that the aircraft was not operating normally.

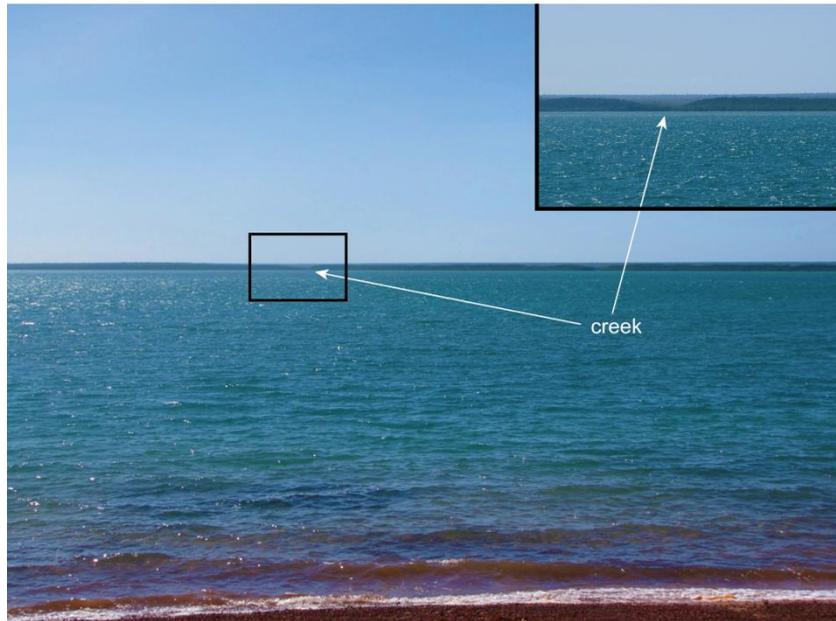
Figure 7: The second witness's view east across Cadell Strait showing the creek above which he saw the plume of smoke

Once the second witness could no longer see the aircraft from the airfield, he drove quickly to the Elcho Island barge landing from where he had an unobstructed view to the east. He reported that he saw a plume of ‘dark black’ smoke on the eastern side of the Napier Peninsula⁴, and described the plume as ‘thin [with a] big round ... top’. Although he was unable to estimate the height of the plume, he said that it ‘kept climbing and then disappeared into the sky’.

The accuracy of the second witness’s estimate of the position of the smoke was aided by the location of a number of creeks on the north-western side of the Napier Peninsula: his line-of-sight crossed the second most northerly of the creeks (Figures 7 and 8).

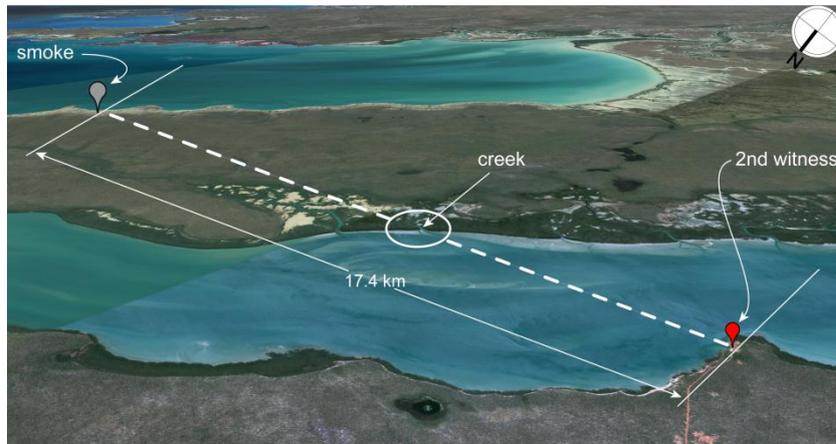
Figure 8: Location of the second witness at the barge landing and his line of sight to the smoke he recalled seeing

NOTE: The distance from the Elcho Island barge landing to the south-eastern side of the Napier Peninsula is 17.4 km, measured along the witness's line of sight. The exact distance from the witness to the smoke is not known.

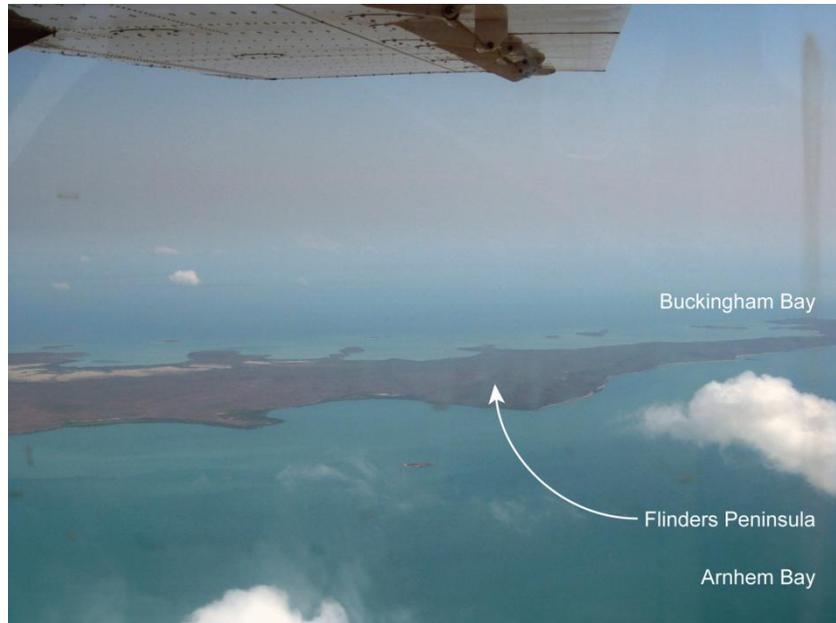
Figure 9: Photograph taken at about the time of the accident from the aircraft flying between Gove and Milingimbi

Visual satellite imagery indicated nearly clear conditions in the vicinity of Elcho Island and Buckingham Bay at around 0930. That was corroborated by the fine conditions reported by a pilot flying an aircraft between Gove and Milingimbi that morning. At about the time of the accident, that aircraft was approaching the southern part of the Flinders Peninsula and a passenger took a photograph looking north-west across the Flinders Peninsula to the part of Buckingham Bay over which the Airvan was expected to track. That photograph indicated benign conditions (Figure 9).

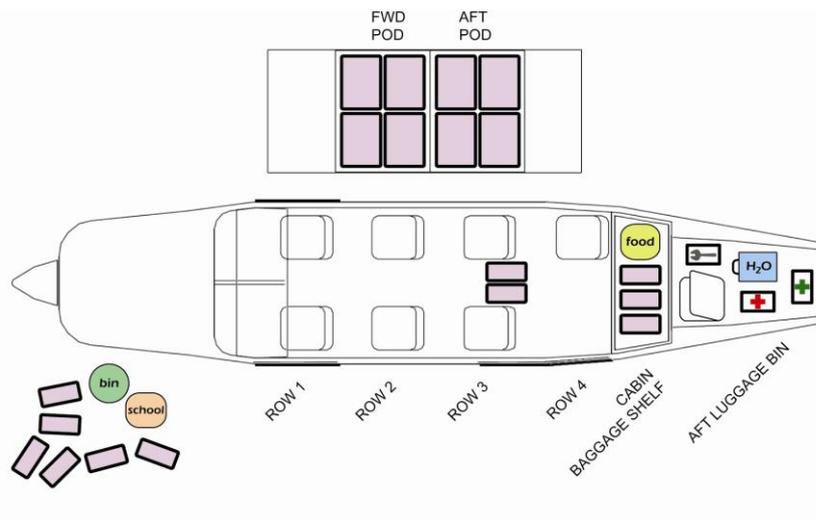
Figure 17: Reported distribution of the items of cargo

There is no information on where the remaining six fuel jerry cans, the green plastic rubbish bin, and the school stationery were placed within the aircraft. The reported distribution of the aircraft's load for the flight is illustrated in Figure 17, although the exact position of the two jerry cans reported to have been in the aisle is not known.

NOTE: The exact position of the two jerry cans reported to have been in the aisle is not known.

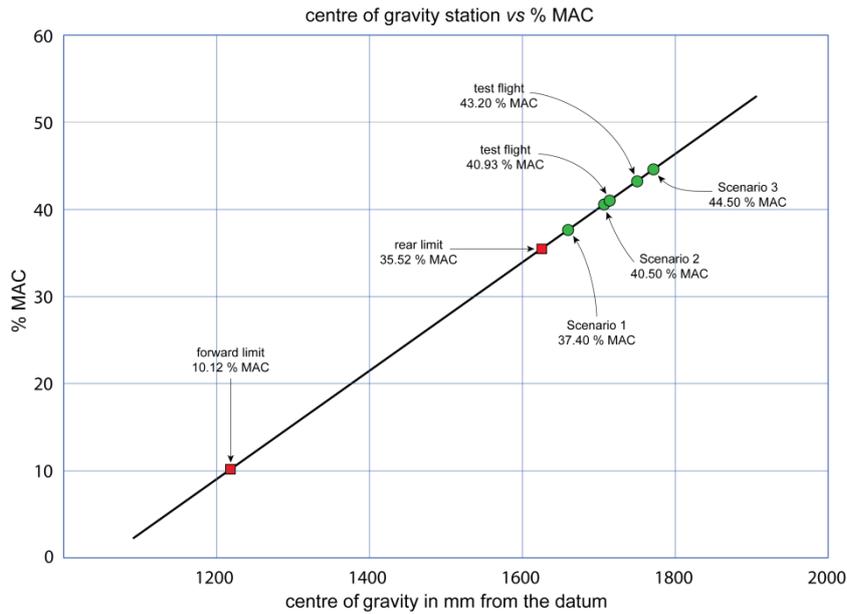
Figure 21: Airvan c.g vs % MAC

An aircraft's c.g may be expressed as a 'percentage of mean aerodynamic chord' (% MAC) by measuring the c.g in terms of the aerodynamic properties of the wing. The black diagonal line in Figure 21 shows the c.g for the Airvan in terms of the relationship between % MAC and the distance from the aircraft's datum¹⁹. The points plotted on the diagonal line represent the forward and rear c.g limits, the c.g in Scenarios 1 to 3, and the c.g on two flights conducted during the Airvan's certification program.

When the Airvan was test flown with the c.g as far to the rear as 43.20 % MAC, the aircraft was demonstrated to be controllable in all flight configurations. With that c.g, the aircraft was unstable in the take-off configuration, and unable to be trimmed in the landing configuration. It did not, however, require excessive force or exceptional piloting ability in that configuration, and responded at all times to conventional control inputs.

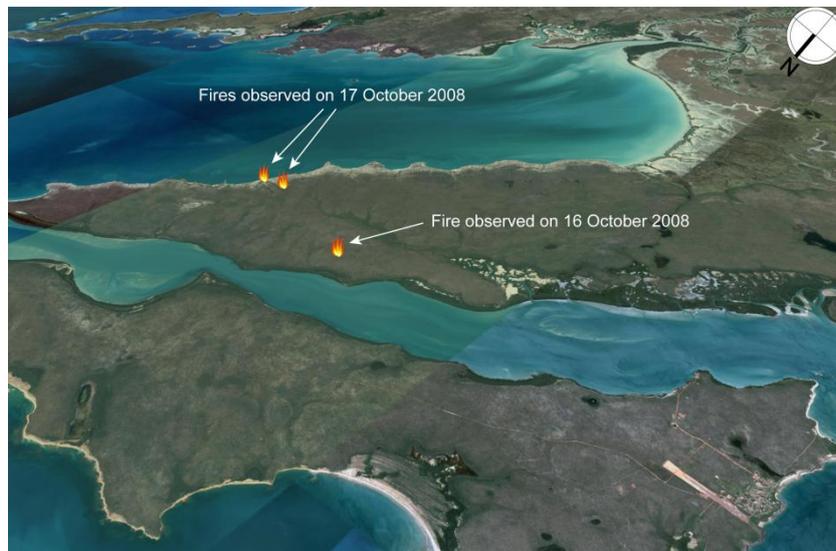
Figure 23: Location of fires on the Napier Peninsula seen from search aircraft after the accident

A number of bush fires on the Napier Peninsula were seen from aircraft involved in the search for WRT (Figure 23). Those fires were investigated on the ground by Northern Territory Police on 17 October 2008, and were judged to have been burning for more than 1 week.

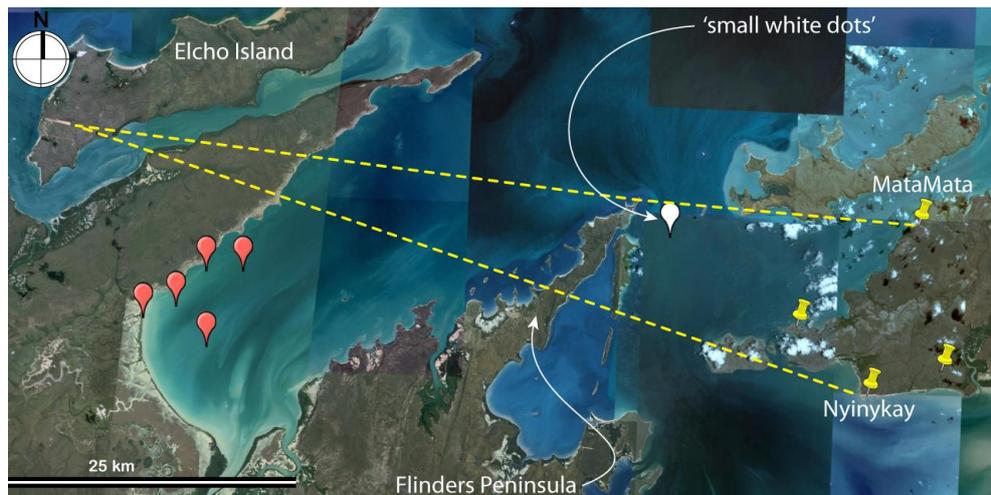
Figure A-1: Location of small white dots east of the Flinders Peninsula

In addition to the debris that was recovered from Buckingham Bay by the RCC-Australia search, and which was positively identified as coming from the aircraft, a number of 'small white dots' within a 1 NM (2 km) radius of position 12° 05.64' S 136° 04.27' E (Figure A-1, white balloon) were seen from a search aircraft at 0806 on 17 October 2008, almost 24 hours after the accident. It was possible that these may have been school whiteboards like those found in Buckingham Bay, although none were retrieved from the sea and positively identified. The following information was considered in order to conduct the search:

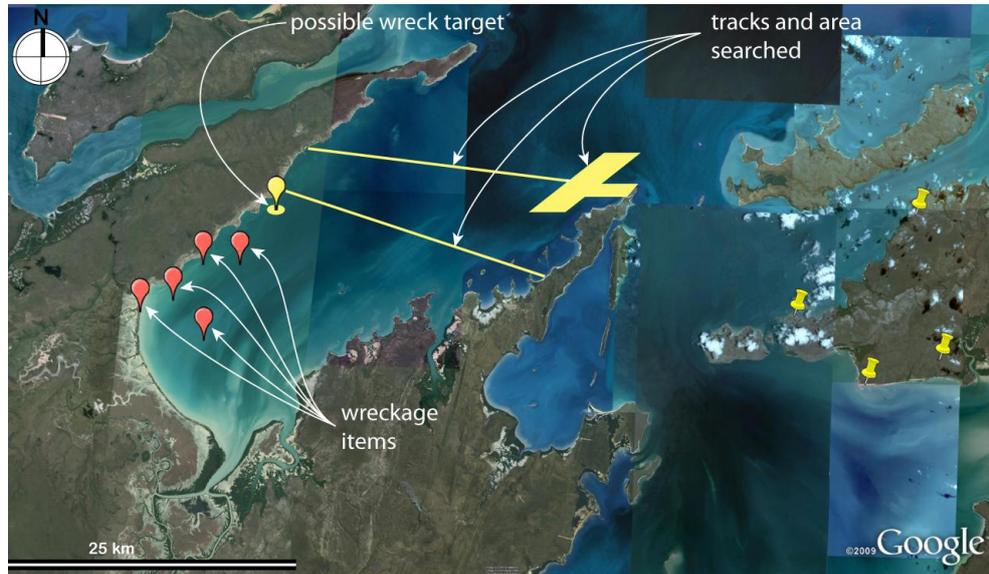
Figure A-2: Areas and tracks searched by the Northern Territory Police and ATSB and a possible wreck target on the western side of Buckingham Bay

The target on the sea bed on the western side of Buckingham Bay, which had been 'located' by parties from Elcho Island using a side-scan sonar, was interpreted and reported by those parties to be the aircraft. Northern Territory Police divers searched this location (marked by a white ellipse beneath a yellow balloon in Figure A-2) but found nothing.

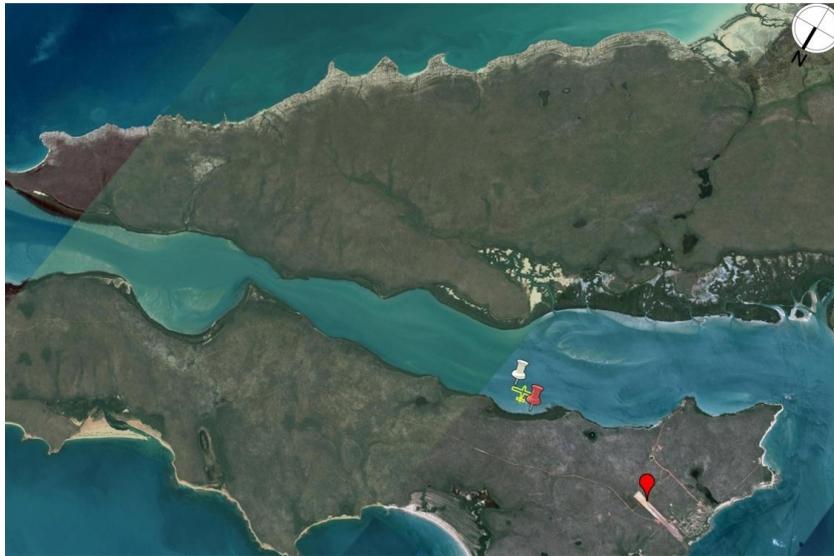
Figure B-1: Estimated position of the aircraft when the second witness saw it turn right

The positions at which the right turn commenced on the first and second reconstruction flights are marked on Figure B-1 by the red and white pins respectively.²² The yellow aircraft icon is the mid-point between them.
