FINAL ACCIDENT REPORT

AVIOARTE SERVIÇOS AÉREOS, Lda
Beechcraft 99

F-BTME

FINAL ACCIDENT REPORT Nr. 29/ACCID/2009

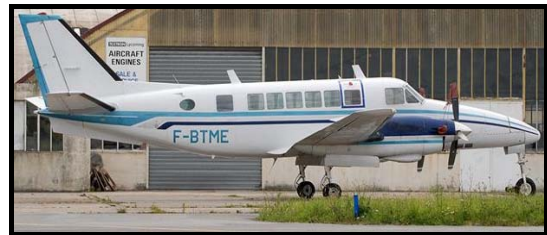
Picture Nr 3

It was a twin engine land aircraft, single low wing, metallic construction, retractable tricycle landing gear (*picture nr 3*), with a Maximum Take-Off Mass (MTOM) of 10400Lbs (4717kg) and seating 17 people, with following references (*table nr 2*):

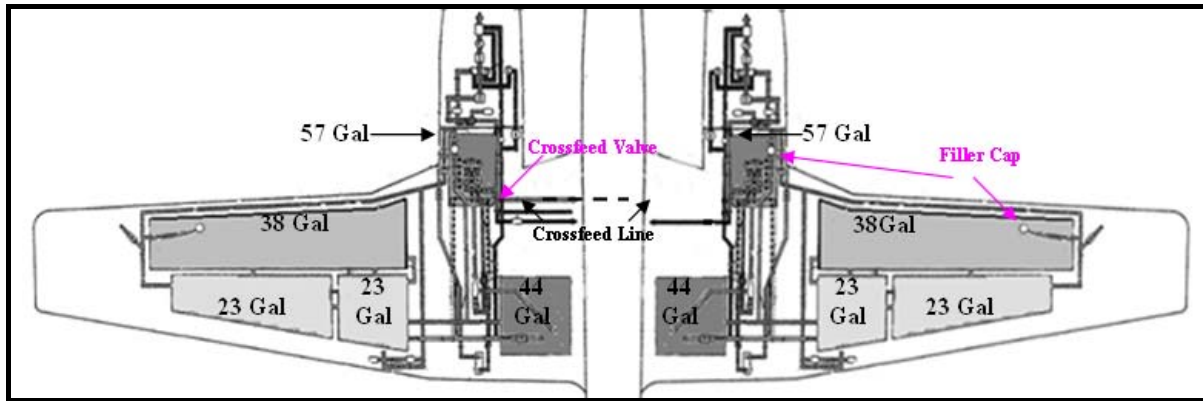
Picture Nr 4

Each fuel system was composed by five fuel cells, interconnected, being three in outer wing area, one in inner wing area, and the other in the engine nacelle (*picture nr 4*). All of them debited into nacelle tank, by gravity, which fed respective engine, directly, or the other engine, through crossfeed line, when crossfeed valve was opened. By design, there were 28USG in each wing that couldn't be used, as they couldn't flow to nacelle tank.

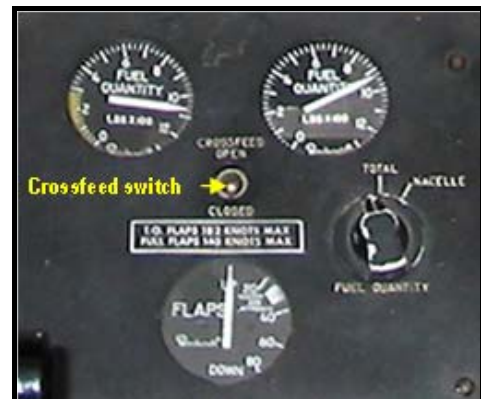
Figura Nº 5

Fuel quantity indication was provided by capacitance probes embedded in every cell and shown in two indicators, situated in cockpit forward pedestal, showing total usable fuel quantity in each wing (*picture nr 5*).

A crossfeed valve actuation switch, situated below quantity indicators (*picture nr 5*), allowed any engine to be fed with fuel from any wing tank, opening crossfeed valve, situated in left engine nacelle, and allowing fuel transfer from one wing to opposite engine.

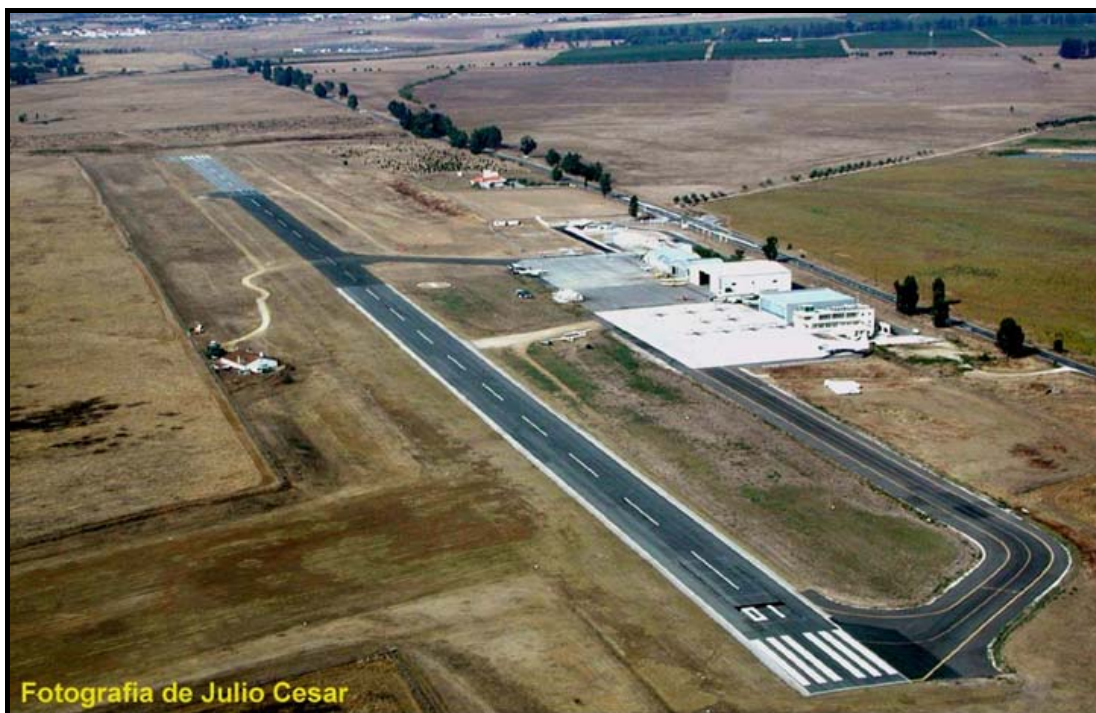
Picture Nr 6

Located at coordinates 38° 32' 49" N / 007° 53' 30" W and an altitude of 807ft (246m) Évora Municipal Aerodrome belonged to the Portuguese domestic aerodromes' network and it was available for VFR traffic of aircrafts with a MTOM ≤ 12500Lbs (5700kgs), during daytime or during the night by request. It was served by a tarmac main runway with 4265ft X 75ft (01/19) and a grass runway with 2100ft X 100ft (08/26). There was a 1500ft X 165ft aircraft parking area, with taxiways for runway access on both tops of the apron (*picture nr 6*).

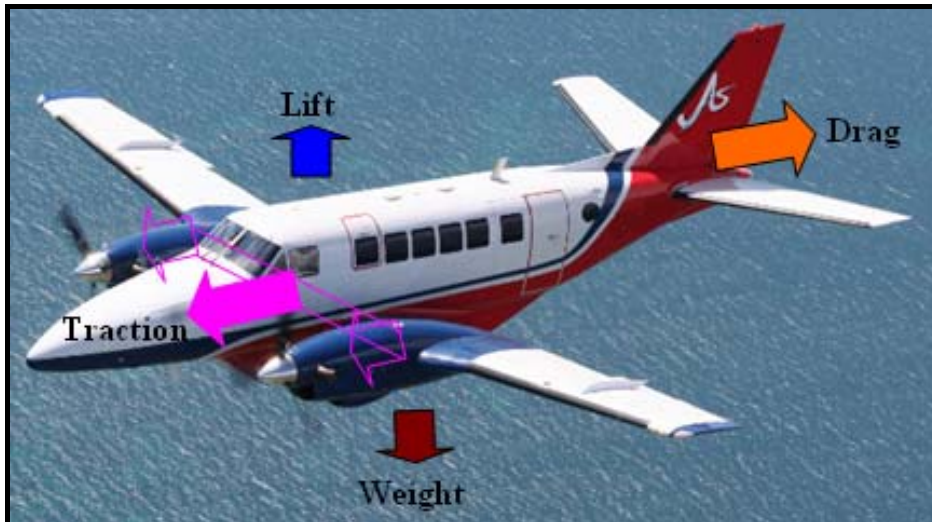
Picture Nr 13

Being traction force the result of two different forces applied at symmetrical points, regarding the aircraft longitudinal axis, it may be represented by one sole vector equal to the summation of both forces, situated on longitudinal plan and applied at the mean point (*picture nr 13*).

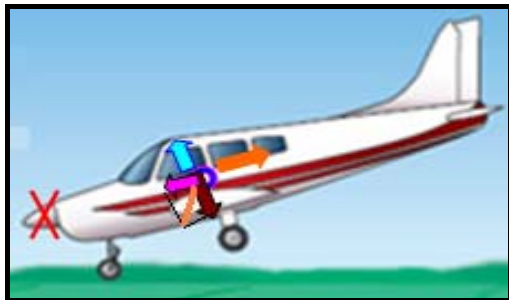
Picture Nr 14

When the engine fails, on a single-engine, all power (traction) is lost but there is no yaw movement, being the balance restored by decomposition of weight into two forces (*progress* - to counter-act drag and *weight* - opposing lift), keeping a minimum speed by exchange for altitude loss (*picture nr 14*).

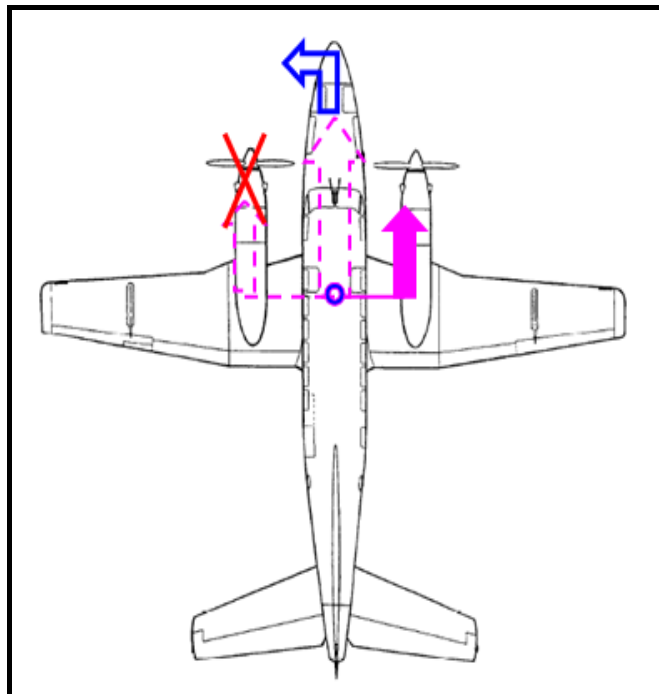
Picture Nr 15

By the contrary, when an engine fails on a twin-engine, an unbalance is created, which causes a yaw movement of the aircraft to the side of inoperative engine (*picture nr 15*).

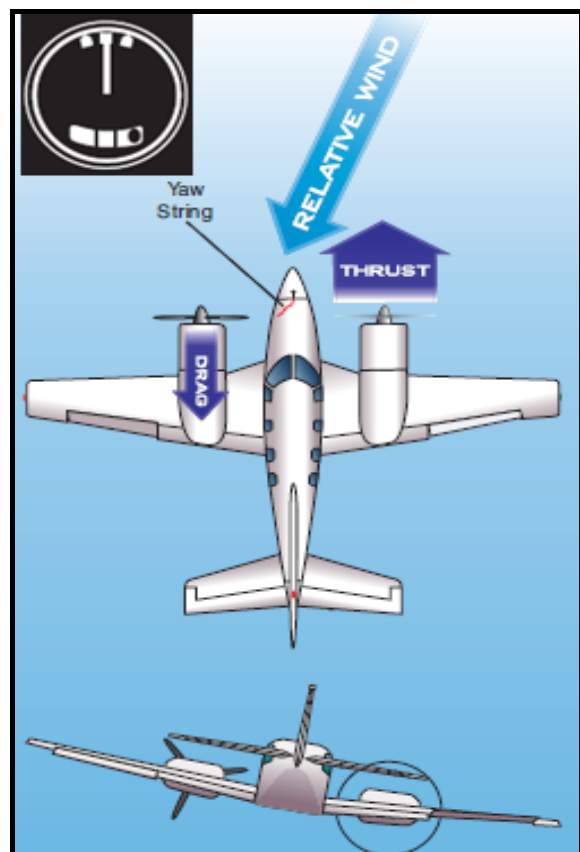
Picture Nr 17

If, by the contrary, rudder is kept in neutral and only aileron is used to keep straight flight, a great aileron deflection is required (8° to 10° bank) causing a substantial drag increase and a sliding of the airplane to operating engine side, resulting in a greatly reduced climb performance (picture nr 17).

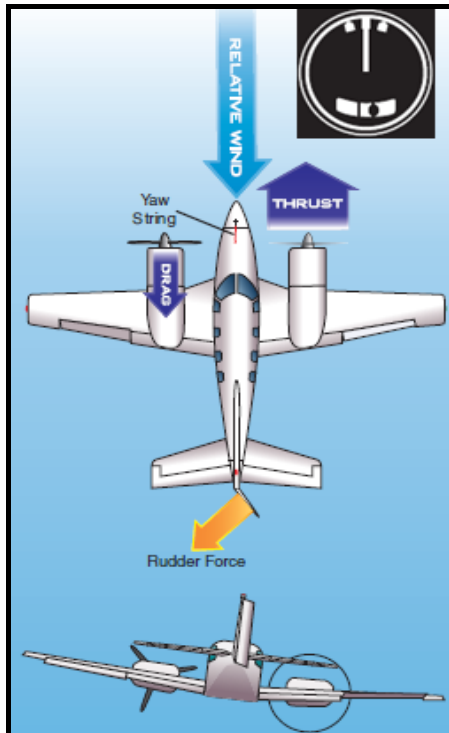
Figura N° 18

The best way to grant a straight & level flight, without side slipping, with a minimum drag and consequently with a better climb performance, is the coordinated application of both controls, aileron and ruder (picture nr 18).

Rudder and ailerons used together in the proper combination will result in a bank of approximately 2° towards the operative engine (maximum recommended 5°). The ball will be displaced approximately one-third to one-half towards the operative engine. The result is zero sideslip and maximum climb performance. When bank angle is plotted against climb performance for a hypothetical twin, zero sideslip results in the best (however marginal) climb performance or the least rate of descent.

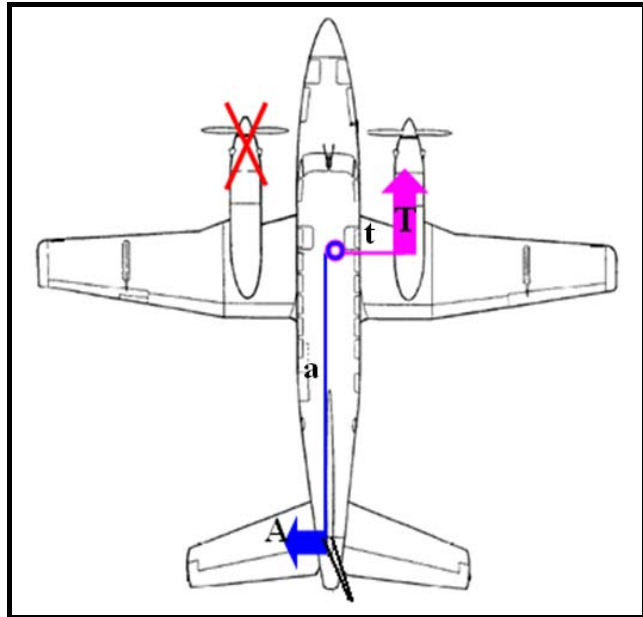
Picture Nr 19

To maintain straight flight, with one engine inoperative, aerodynamic force "A" multiplied by its arm "a" must counter-act engine power "T" multiplied by its arm "t" (picture nr 19), being force "A" dependent of vertical aerodynamic profile (fin and ruder) and aircraft airspeed.

Vertical aerodynamic profile is defined by design and attains its maximum efficiency at ruder full deflection. For the same ruder deflection aerodynamic force "A" varies directly with airspeed.

When airplane speed falls below V_{mc} , aerodynamic force ($A \times a$) can't balance engine force ($T \times t$) and the aircraft starts deviating to inoperative engine side, without the pilot having control, unless he increases speed (by altitude trading) or reduces engine power.

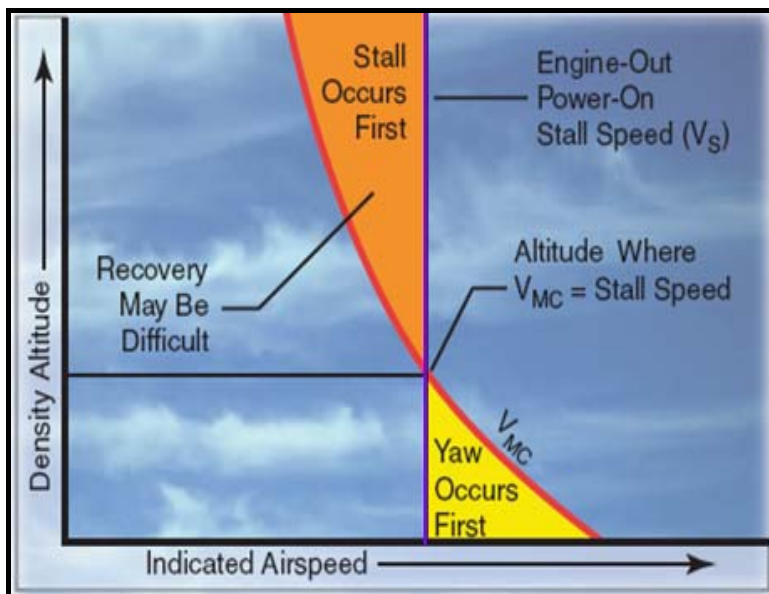
Picture Nr 20

The chart (picture nr 20) shows inter-relation between these two speeds and illustrates the critical flight conditions (stall & yaw) developed when the airplane speed enters overlapping areas, where one condition rapidly takes to the other.
