ACCIDENT INVESTIGATION FINAL REPORT

AN-26B, SP-FDO
Tallinn, Estonia
18. March 2010

Tallinn, 2012

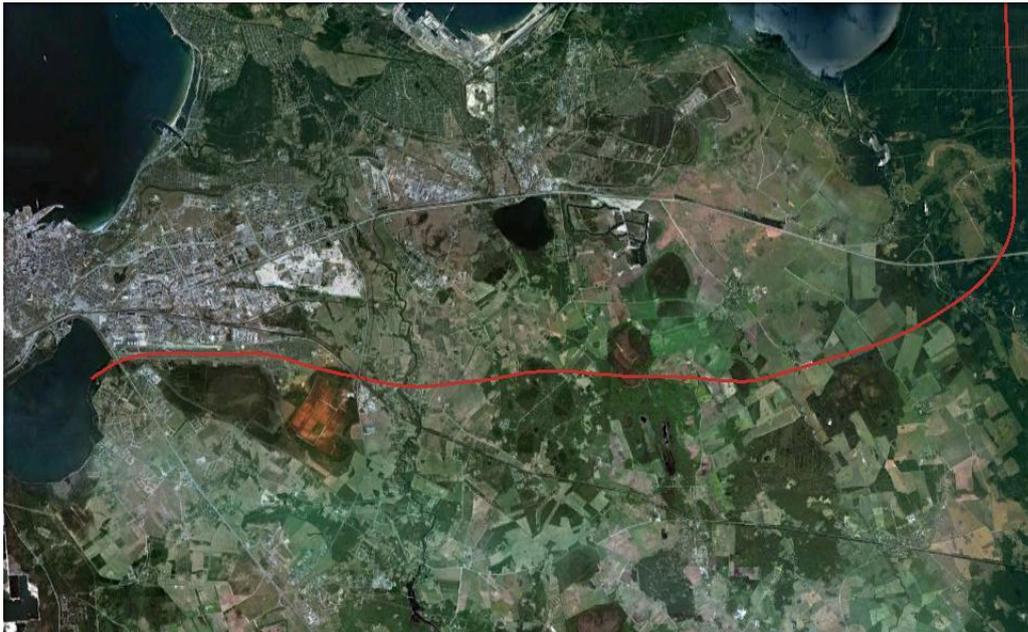
SP-FDO track on approach to EETN

During the approach the air traffic controller noticed the aircraft deviation from the approach path to the left and notified the crew. According to the FDR and CVR data the crew was unable to maintain a proper approach path both in lateral and vertical dimensions. The attempts to start RU19A-300 engine failed.

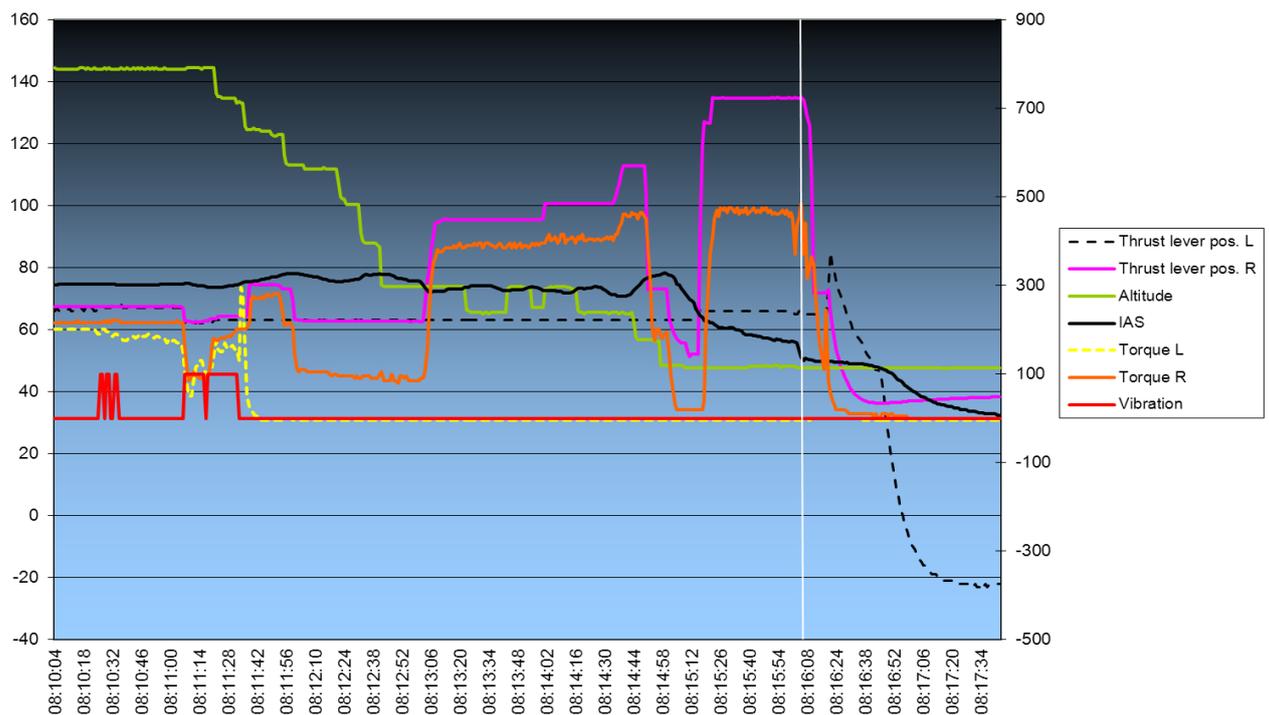
FDR selected parameters plot

08:15:14	Right engine thrust lever advanced to full power, landing gear travel down	
08:15:59	Landing gear travel down. Sudden loss of IAS from 174 to 137 km/h.	Contact with treetops
08:16:05	Right engine thrust lever retarded fully back	Crash landing on lake ice

CVR recordings are of good quality and provide information about chaotic decision making process in the cockpit. CVR transcripts are not part of this report.
