**GUYANA CIVIL AVIATION AUTHORITY  
AIRCRAFT ACCIDENT INVESTIGATION REPORT  
RUNWAY EXCURSION ON LANDING**

**CARIBBEAN AIRLINES**

**BOEING 737-800**

**REPORT # GCAA: 2/5/1/63**

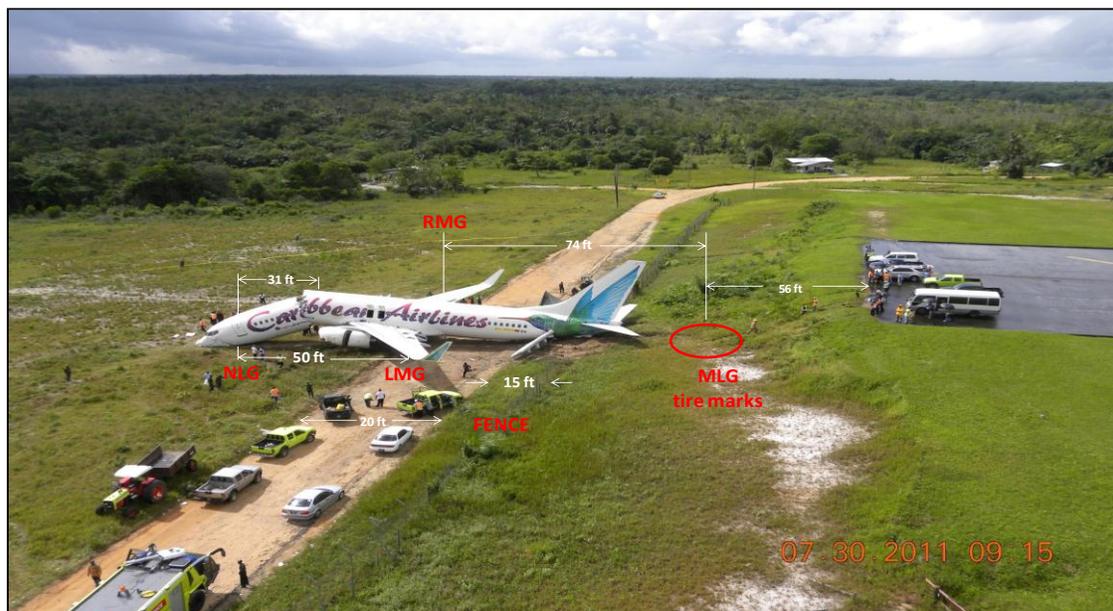
**Figure 14: Final Aircraft Location Relative to Runway**

The aircraft came to rest approximately 130ft off the runway paved surface and 64ft left of the extended runway center line. The final aircraft heading was approximately 10° left of RWY06 center line. (Figs.5&6.)

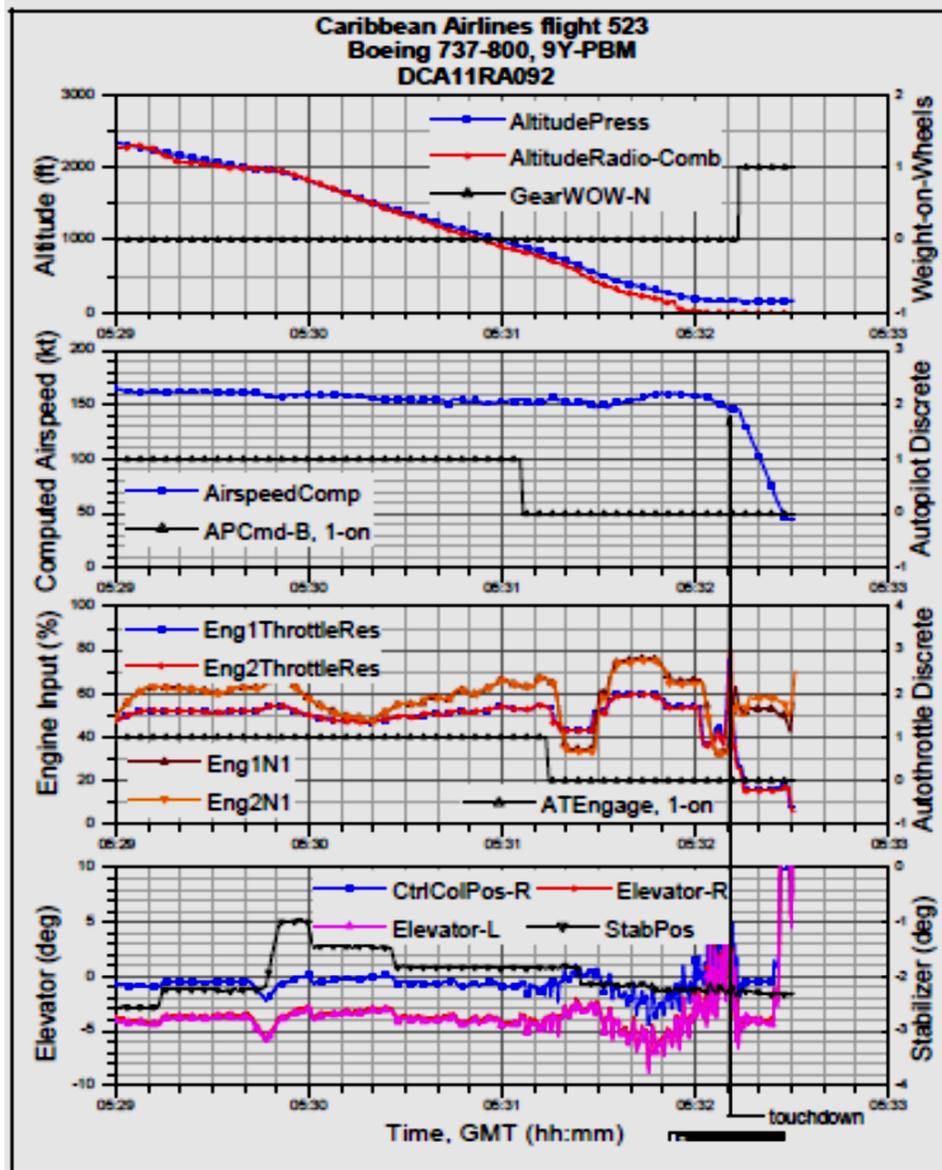
Right Gear Inboard Tire – 195psi

Figure 5a shows the airplane touching down at a computed airspeed of 146 kt (and a groundspeed of 151 kt as shown in Figure 5c.). The throttles were set to 75% N1 about 15 seconds prior to crossing the runway threshold and were transitioning from 75% N1 to 65% N1 as the airplane crossed the threshold at approximately 05:31:50. The throttles stayed at a 65% N1 level until 05:32:01 when they were reduced to a level that reached 33% N1 at 05:32:06, six seconds before touchdown. The throttles were advanced three seconds before touchdown and the average N1 reached about 59% near touchdown at 05:32:12<sup>3</sup>. The thrust

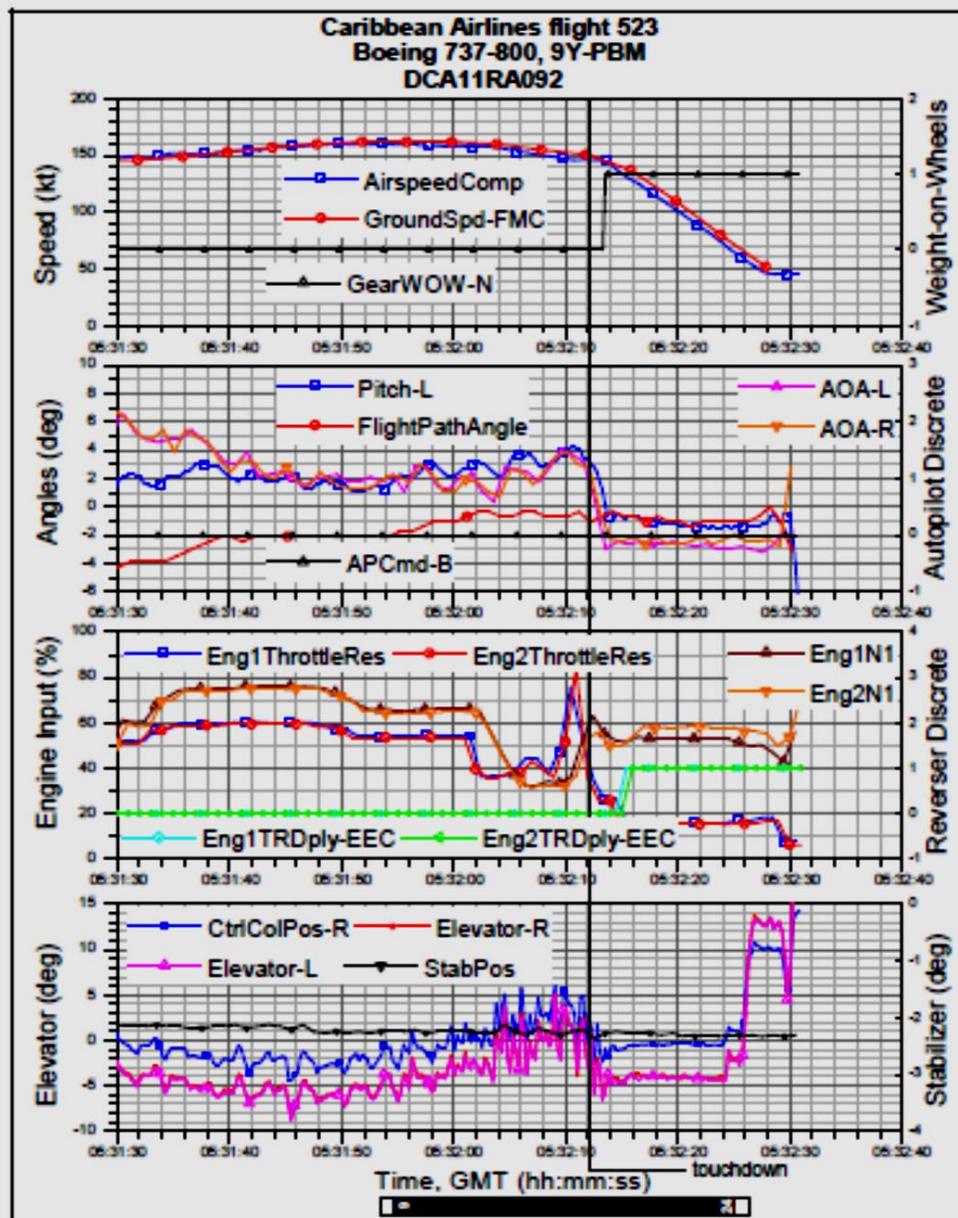
Figure 5c shows the parameters from Figures 5a and 5b but with a larger scale.

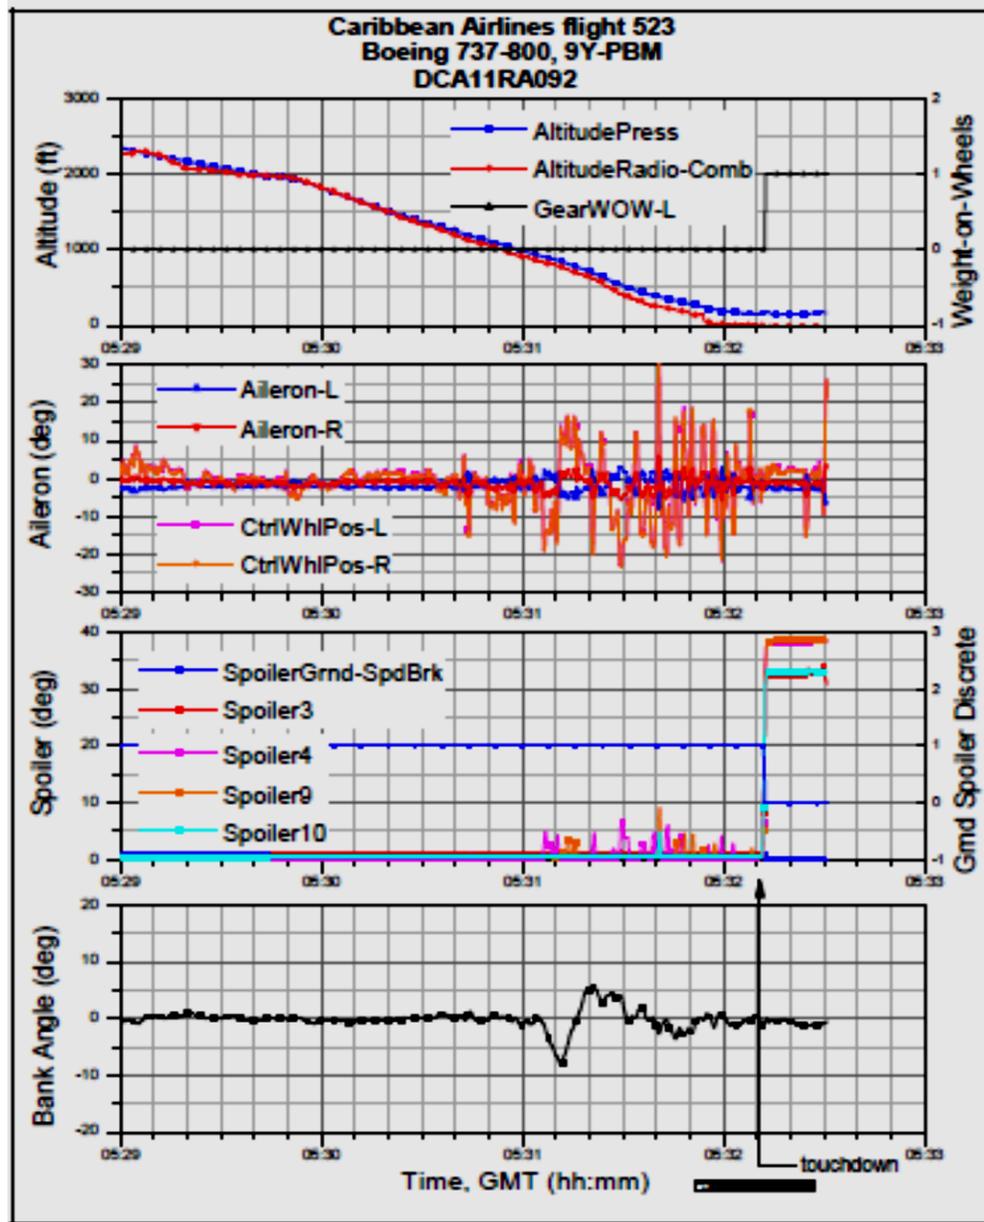
The lateral FDR parameters in Figure 6 show almost no control input until the autopilot was disconnected at 05:31:05. At this point there are small aileron and spoiler inputs (less than 5 degrees) all the way to the end of the FDR. The directional parameters in Figure 7 are similar except there are rudder inputs upwards of 5 degrees beginning at touchdown.

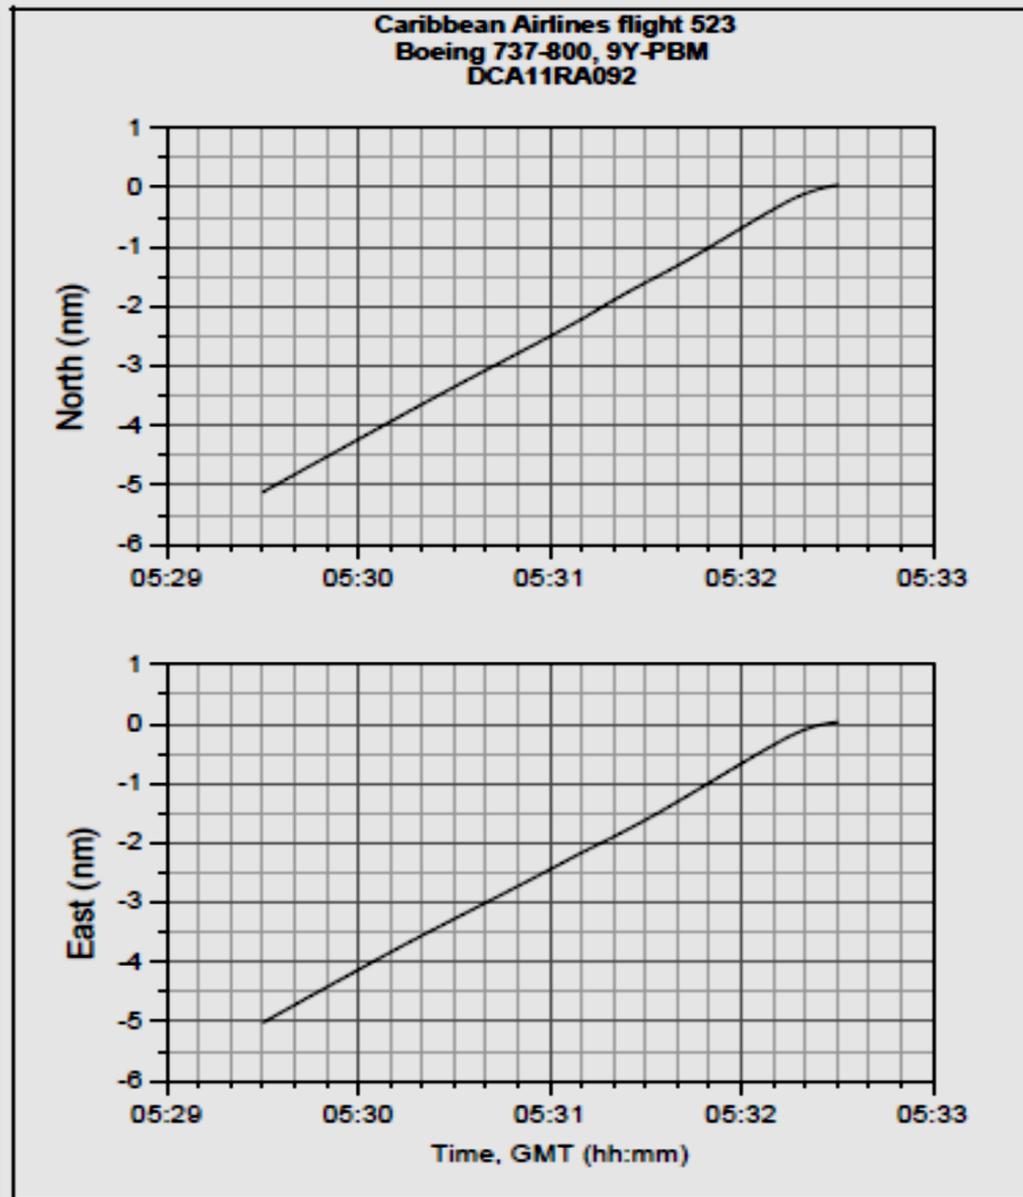
The wheels appeared to be intact and undamaged. Both wheels were P/N 3-1558. The serial numbers were not recorded due to limited access.

To examine the winds that were present during the landing and to view pertinent FDR and calculated parameters relative to the airplane's location on the runway, the FDR accelerometer data were integrated to obtain an inertial velocity and position. As previously mentioned, the NTSB did not have radar data for the accident. Instead, the accelerometer biases needed to perform the integration were calculated using position derived from FDR groundspeed and drift angle. The biases that were calculated and applied are listed in Figure 8. The true north and east positions relative to the airport origin<sup>4</sup> that resulted from the integration are shown in Figure 9.

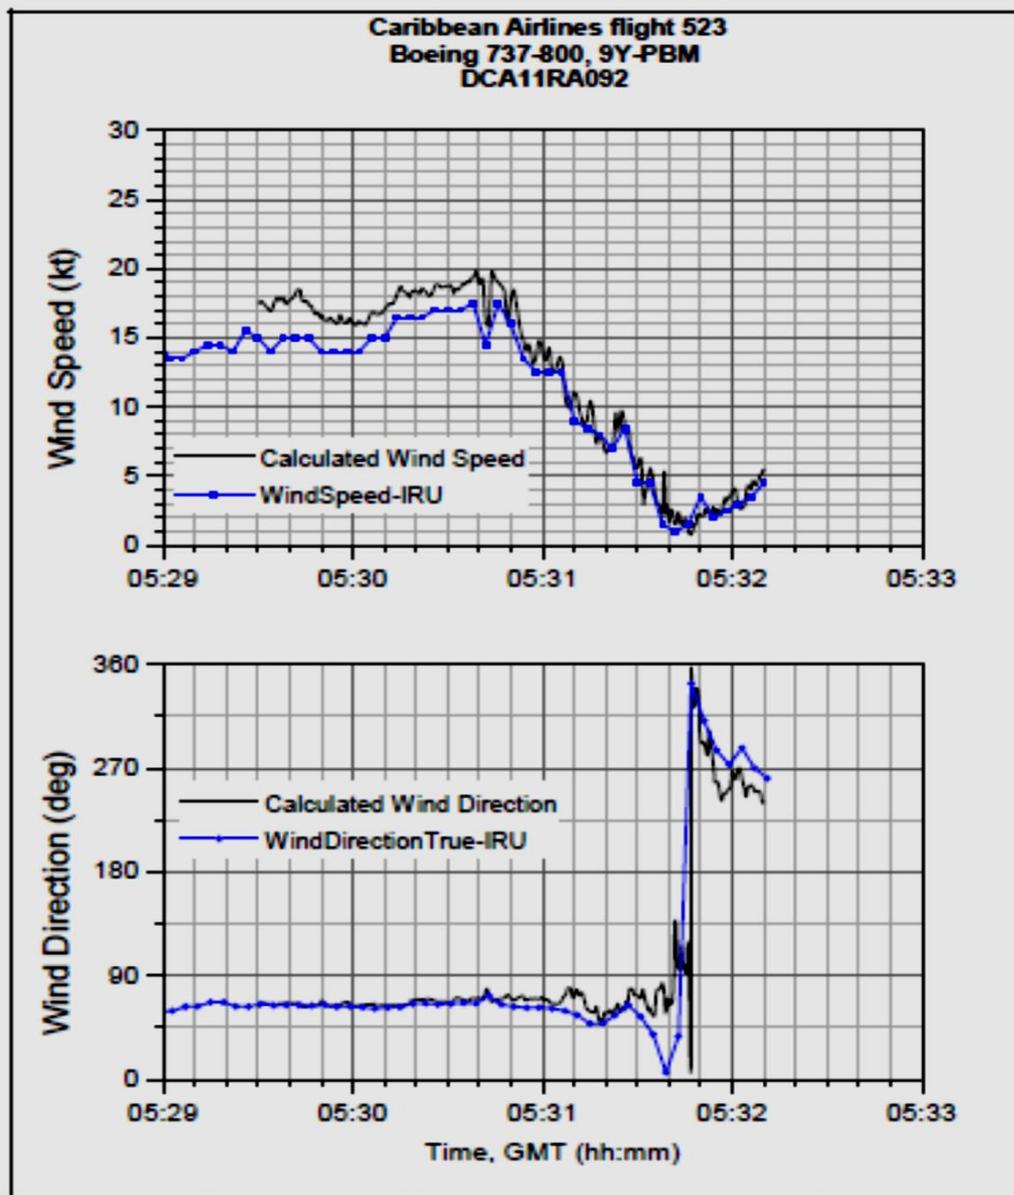
The winds are the difference between the inertial velocity determined from the accelerometer integration and the true airspeed which can be calculated from parameters recorded on the FDR. The calculated wind speed and direction, as well as those recorded on the FDR, are shown in Figure 10a as a time history. The calculated winds are also plotted in Figure 10b as a function of the height above the ground. Figure 10 indicates that the wind speed decreased below 5 kt and the wind direction shifted almost 180 degrees on short final. This corresponds to a point in the approach where the Caribbean crew reported seeing three red lights on the Precision Approach Path Indicator (PAPI)<sup>5</sup>. The shift may be explained by the rapidly increasing elevation of the terrain that exists approaching the threshold of runway 06. Other orographic changes (e.g., the transition from jungle to the airport environment) may have also contributed to the wind change. See Figure 11.

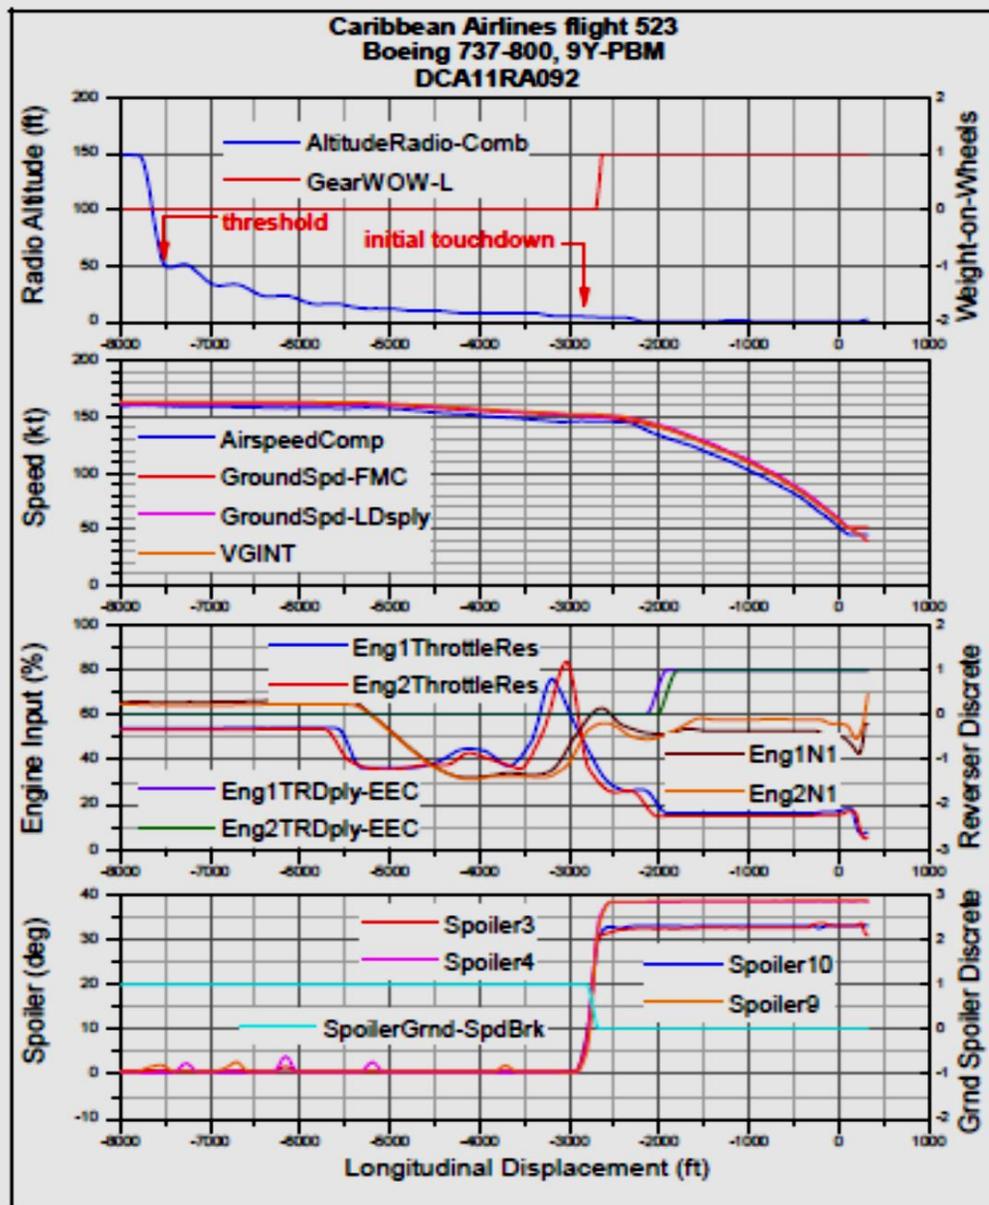
contaminated with sand, dirt and debris. There were no signs of hydraulic leakage.

The ground spoilers were armed and, as a result, deployed around the time of touchdown at 05:32:12 as shown in Figure 13a. The thrust reversers<sup>7</sup> deployed approximately two seconds later at 05:32:14 when the airplane was 2000 ft from the end of the runway or 2200 from the end of the pavement.

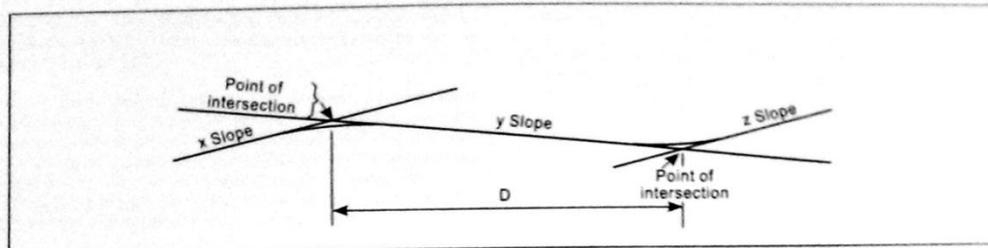
Figure A-2. Profile on centre line of runway

5.4 Deformation of the runway with time may also increase the possibility of the formation of water pools. Pools as shallow as approximately 3 mm in depth, particularly if they are located where they are likely to be encountered at high speed by landing aeroplanes, can induce aquaplaning, which can then be sustained on a wet runway by a much shallower depth of water. Improved guidance regarding the significant length and depth of pools relative to aquaplaning is the subject of further research. It is, of course, especially necessary to prevent pools from forming whenever there is a possibility that they might become frozen.
