**MINISTRY OF TRANSPORT,  
CONSTRUCTION AND MARITIME ECONOMY  
STATE COMMISSION ON AIRCRAFT ACCIDENT INVESTIGATION**

**FINAL REPORT**

**Occurrence No: 835/2011**

**Aircraft: ATR-72 airplane, registration marks: SP-LFH**

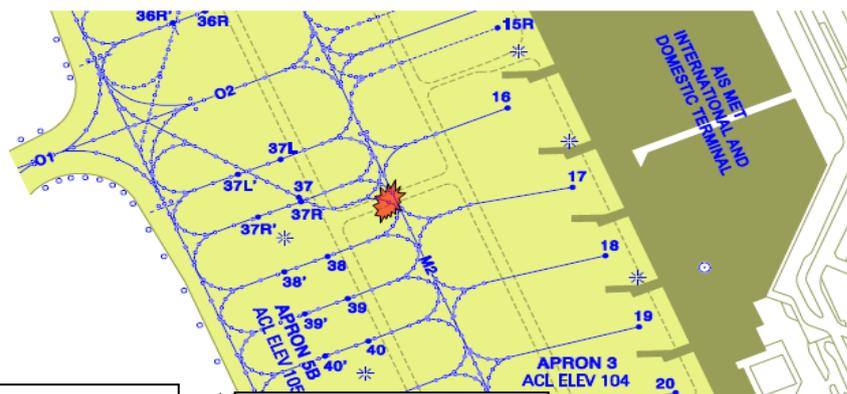
The event took place on the ground movement area of the Warsaw Chopin Airport at the intersection of taxiway "M2" with a service road (see diagram and Photo No1 below).

Collision site

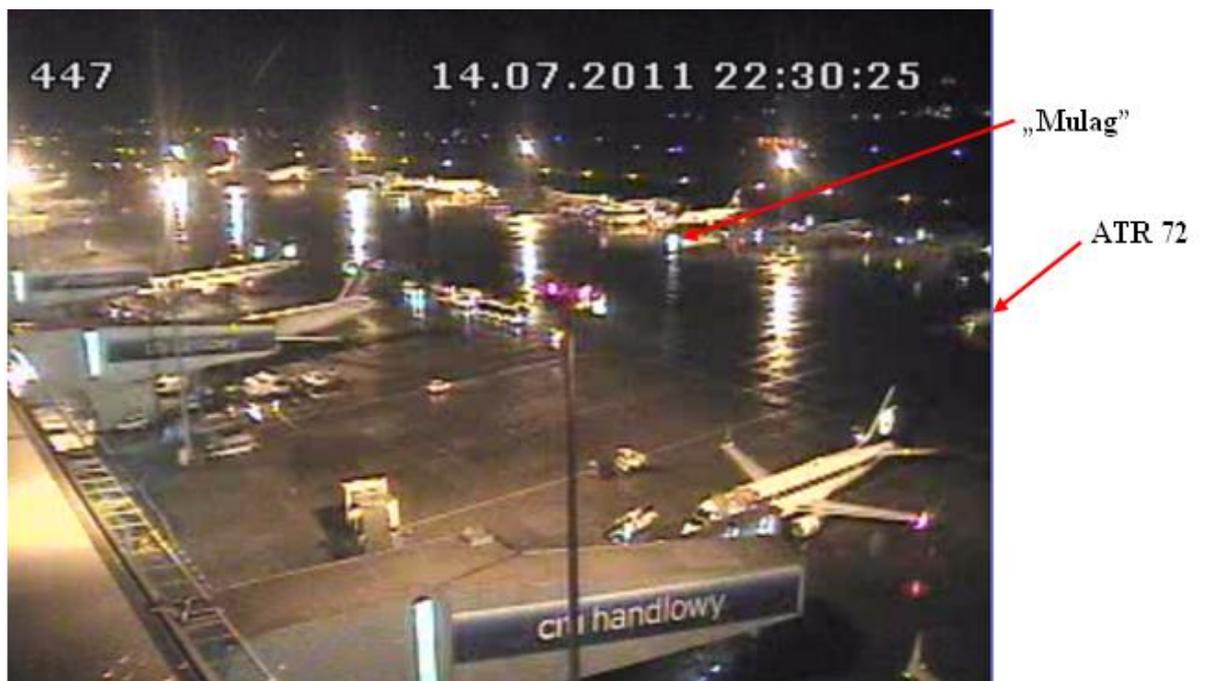
Recording No 1 from CCTV camera.

Photo No 10 shows the position of Embraer airplane beginning a turn from taxiway "O2" in taxiway "M2". Based on recording from CCTV camera No 1, when the ATR was approximately at Embraer place, the "Mulag" slowed down approaching the safety line on the parking apron at stand 38 (Recording No 1). Probably at this time, the tractor operator looked to the right at the service road parallel to taxiway "M2", which he wanted to take following the service road

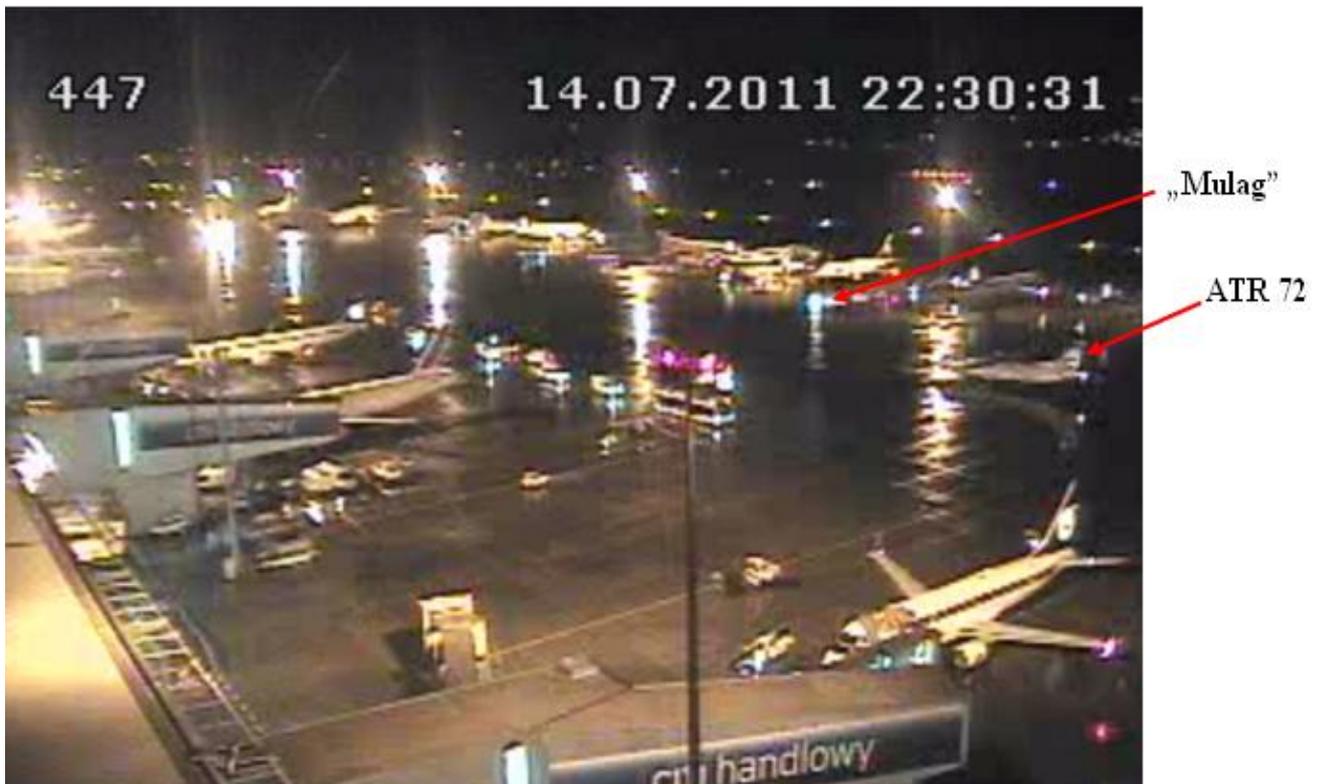
Recording No 3 from CCTV camera No 447.

Recording No 3 from CCTV camera shows ATR 72 continuing taxiing by taxiway "M2" and "Mulag" tractor crossing the service road parallel to taxiway "M2".

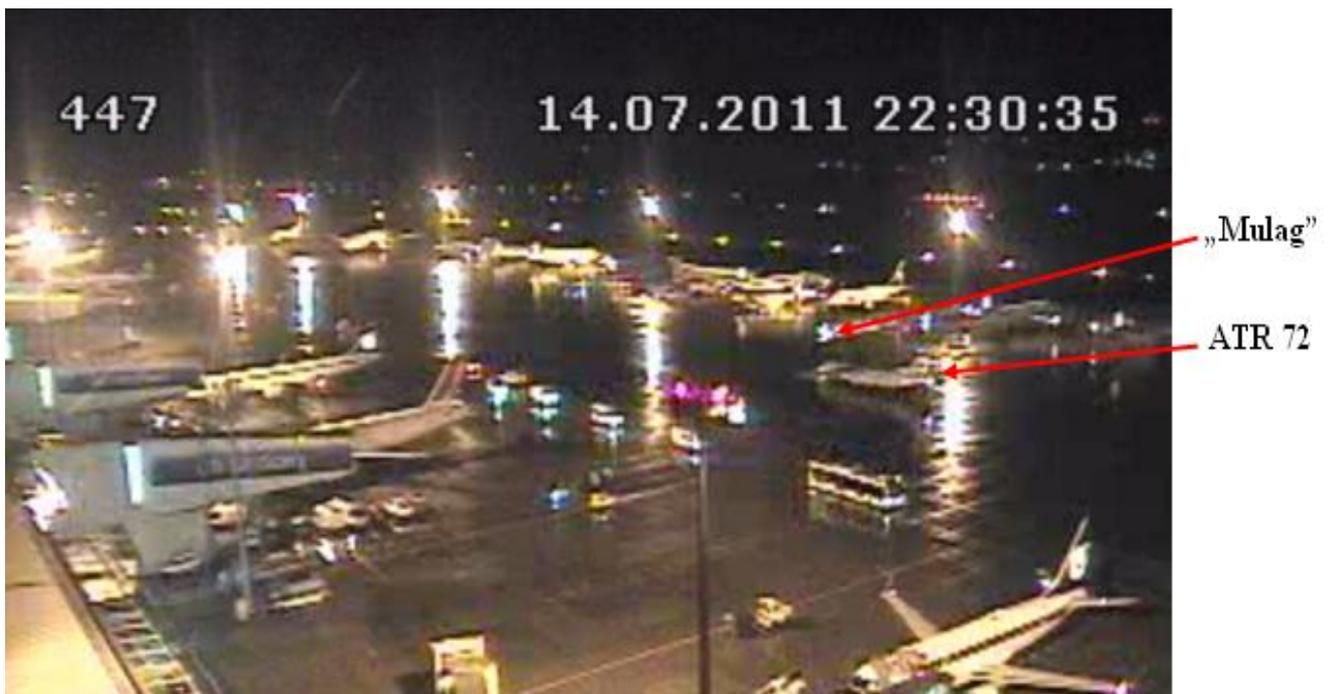
Recording No 4 from CCTV camera No 447.

Recording No 4 from CCTV camera shows that "Mulag" was already on the service road perpendicular to taxiway "M2", when ATR 72 was passing stand 16. Probably at that time the silhouette of the airplane could have been partially or completely obscured for "Mulag" driver. It could have been obscured by the left window post or as a result of light reflections from the wet apron and therefore the driver did not notice the airplane (photo No: 12-13)

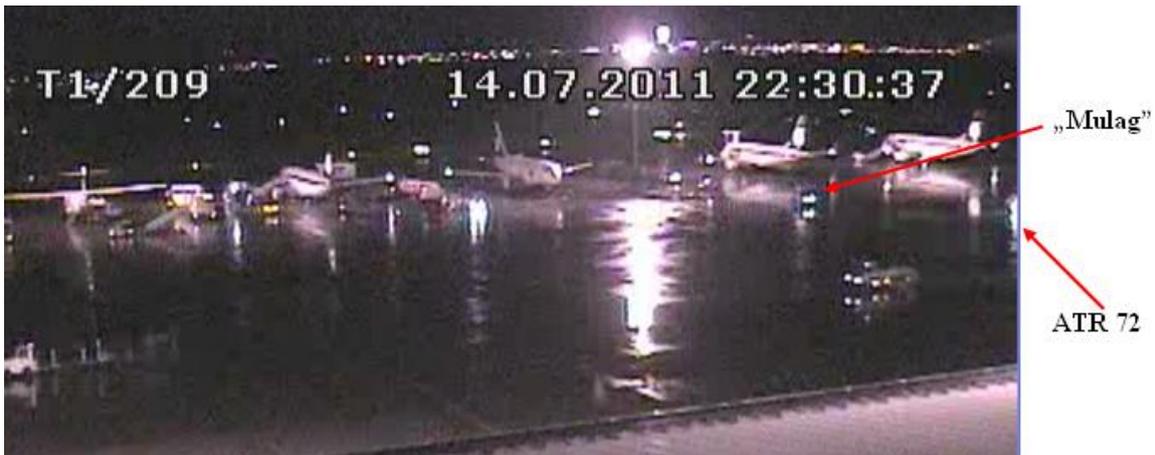
Recording No 5 from CCTV camera No 209.

Recording No 5 shows the "Mulag" tractor located on the service road and ATR-72 airplane taxiing by taxiway "M2". Probably at that time the "Mulag" driver was watching the service road in front of him or looked to the right to monitor the service road parallel to taxiway "M2", running along the airport building, on which at the time two vehicles were moving. May be because of this he did not notice ATR-72 passing stand 16.

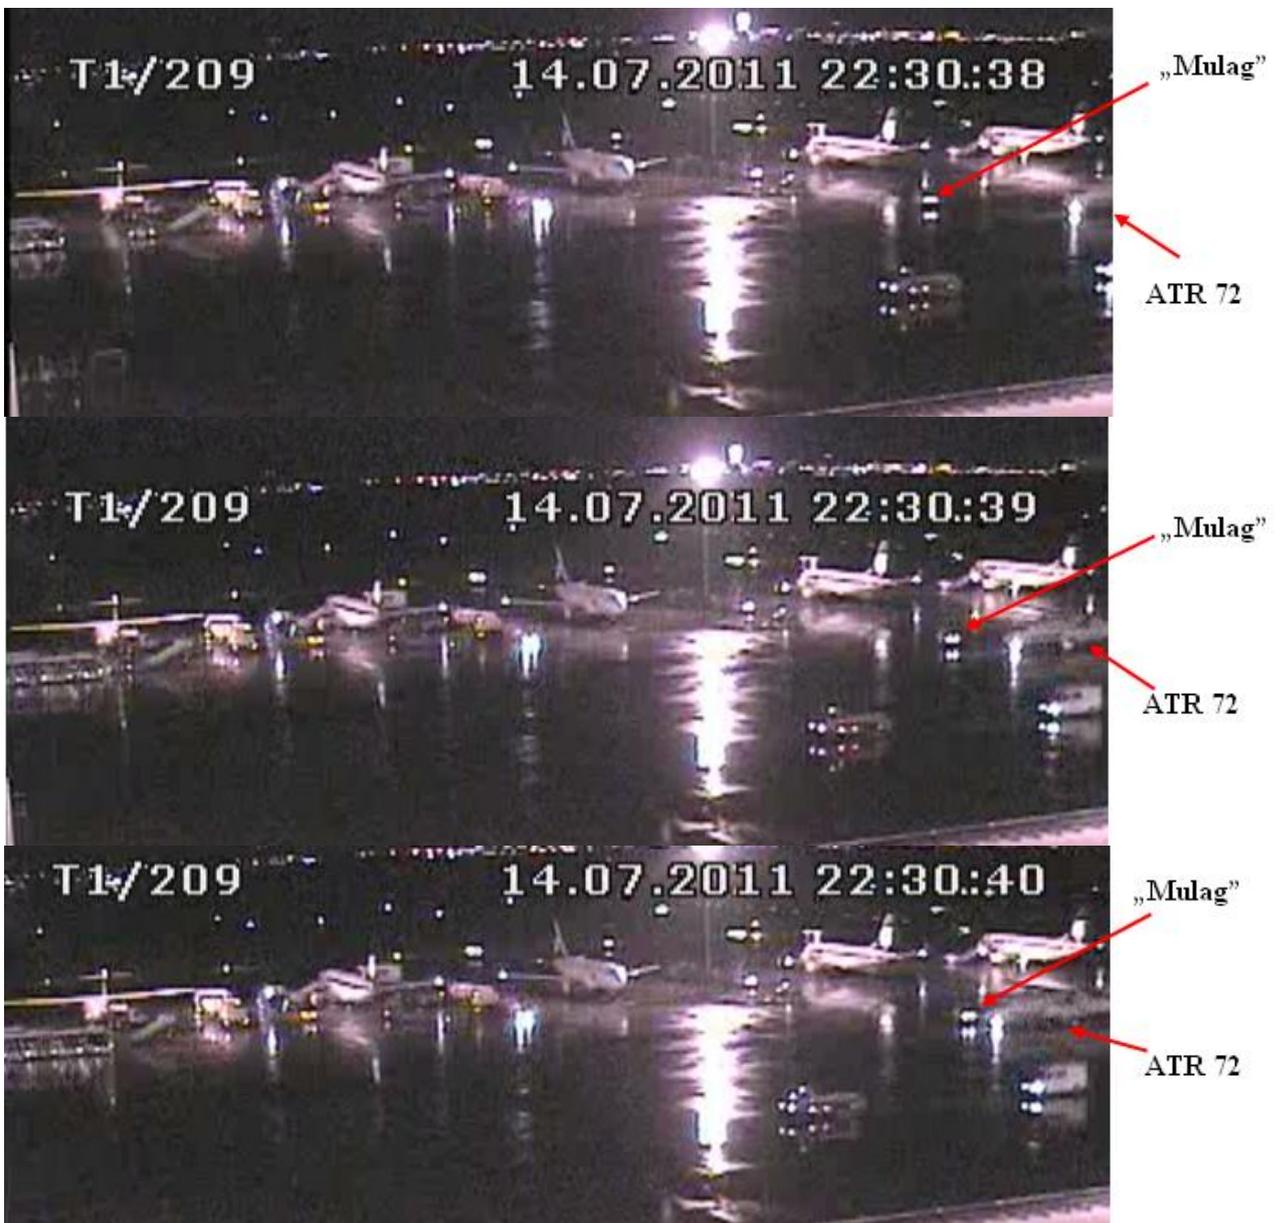
Recordings No 6-8 from CCTV camera No 209.

"Mulag" tractor and ATR 72 airplane moving in the direction of the collision place recorded at 1-second intervals are shown in the recordings No 6 to 8.

Recording No 8 (22:30:40 hrs) shows the "Mulag" tractor and ATR-72 airplane one second before the collision. According to the statement of the "Mulag" driver he probably only then spotted the airplane and made ineffective rapid movement of the steering wheel to the right to perform the maneuver preventing collision. Then, when he noticed the rotating propeller of the right engine, he instinctively lay on the floor of the cab.
