FINAL REPORT

ACCIDENT

Occurrence No.: 1400/11

Aircraft: B767-300ER, SP-LPC

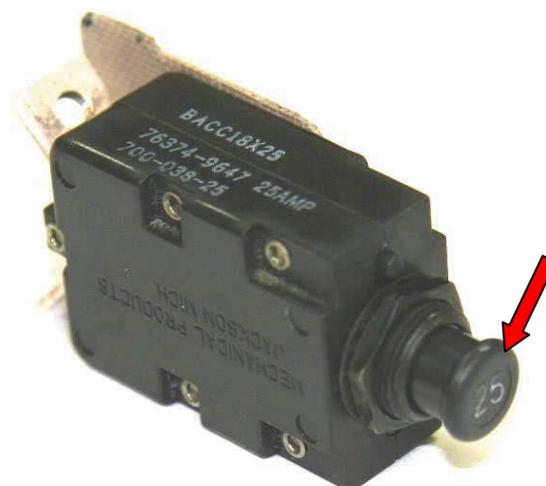
After a circuit breaker has tripped (opened) its head (Figure 5) goes out and the white shaft (Figure 25) is visible. After removing the damage that caused the circuit breaker to open, its head should be pressed to close it and enable the current to flow again.

Figure 5. C829 circuit breaker removed from SP-LPC airplane. The circuit breaker in the ON/pressed setting. Red arrow indicates the circuit breaker head (Source –Boeing).

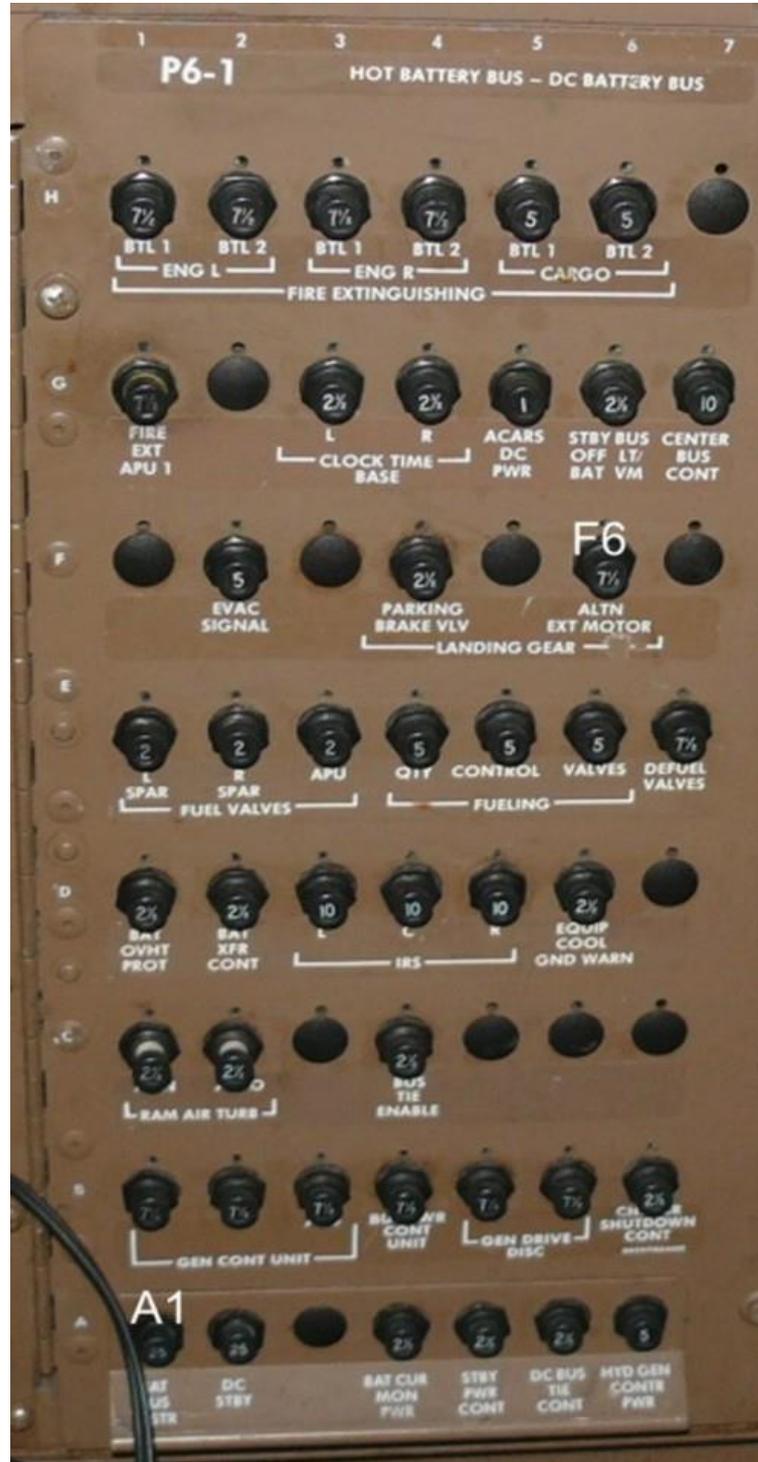
Figure 6. P6-1 panel. A1 - C829 BAT BUS DISTR circuit breaker and F6 – C4248 LANDING GEAR – ALTN EXT MOTOR

C829 BAT BUS DISTR circuit breaker, which after the accident, during visual inspection of the cockpit was in OFF setting, is situated on P6-1 panel on A1 position, in the bottom left corner just above the floor, in extremely peripheral portion of FO attention field, close to the right side of his seat (Figure 6). This circuit breaker, as the master one protects and powers circuits of the following downstream circuit breakers:

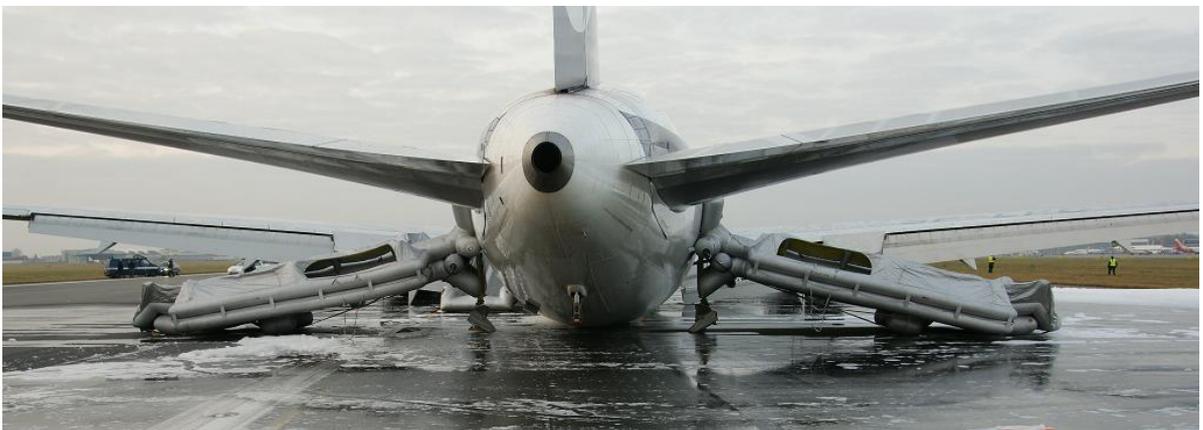
All escape slides were inflated. The aft slides at exits 3L and 3R were set at a small angle (flat position), which was slowing down the evacuation (Figure 16).

Figure 16. Setting of the rear slides of SP-LPC airplane after emergency landing.

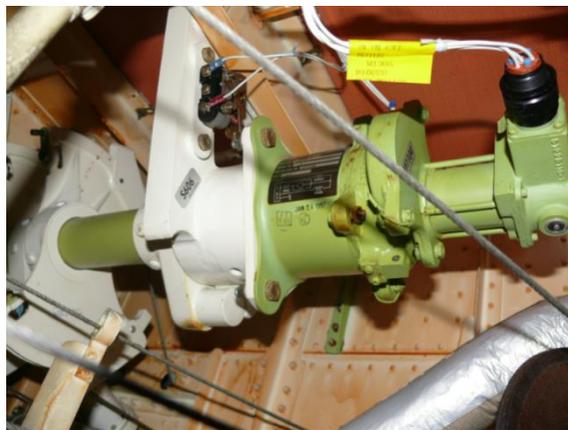
1.16.2.4.2. Electric actuator from the alternate landing gear extension system, S/N 794, P/N 724D100-3 (Figure 18)

- a) During the test of the alternate landing gear extension system the starting and operating currents of the electric actuator driving the system were measured. They were 14A and 2A respectively. According to CMM EATON S257T400-1 (-3) 32-35-01 the operating current (I_o) should not exceed 5A, and the starting current should not exceed $10 \times I_o$ i.e. 20A for the tested actuator. Therefore, both values were within the specified limits.
- b) The actuator of the alternate landing gear extension system was removed and sent to NTSB for measurements and functional testing. The tests did not show any faults in the functioning of the component (Annex 3). Part of the expert opinion on the actuator prepared under NTSB supervision is presented below:

Boeing SCD S257T400 requirements indicate that the actuator is operating as designed in the extend direction with regard to deploying the landing gear. The 23VDC clockwise stall torque value of 755 in-lbs exceeds the retract opposing load of 400 in-lbs as specified in Boeing SCD S257T400 Section 3.2.3.2. The bonding resistance value of .007 ohm compared with the ATP requirement of .005 ohm is not considered significant for purposes of this evaluation.

Figure 18. Electric actuator of the alternate landing gear extension system (Source - SCAAI).

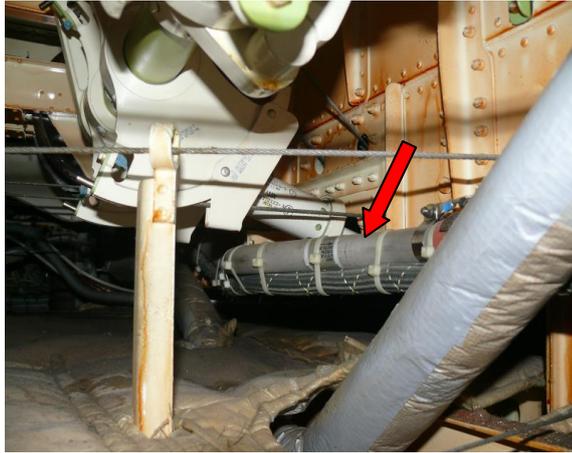
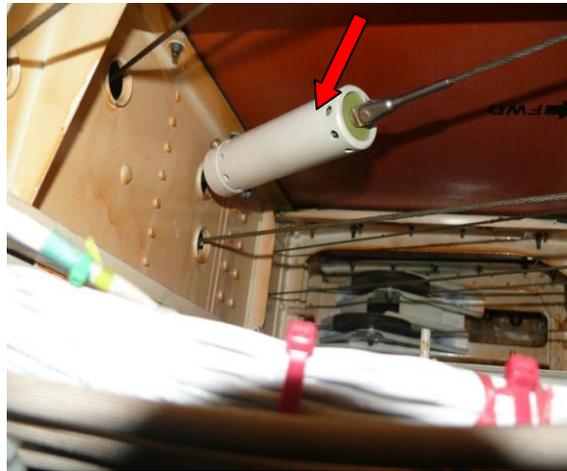
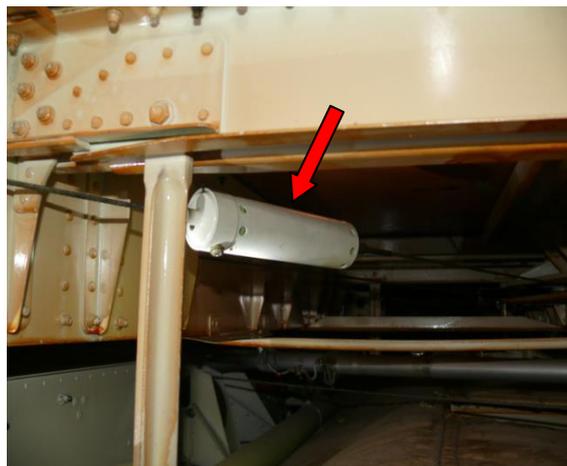
Visual inspection of the alternate landing gear extension system components was carried out. None of the three load limiters showed signs of overload in the system (Figures 19, 20 and 21).

Figure 19. Load limiter of the alternate landing gear extension system (nose gear).
(Source – SCAAI)

Figure 20. Load limiter of the alternate landing gear extension system (left main gear).
(Source – SCAAI)

Figure 21. Load limiter of the alternate landing gear extension system (right main gear).
(Source – SCAAI)

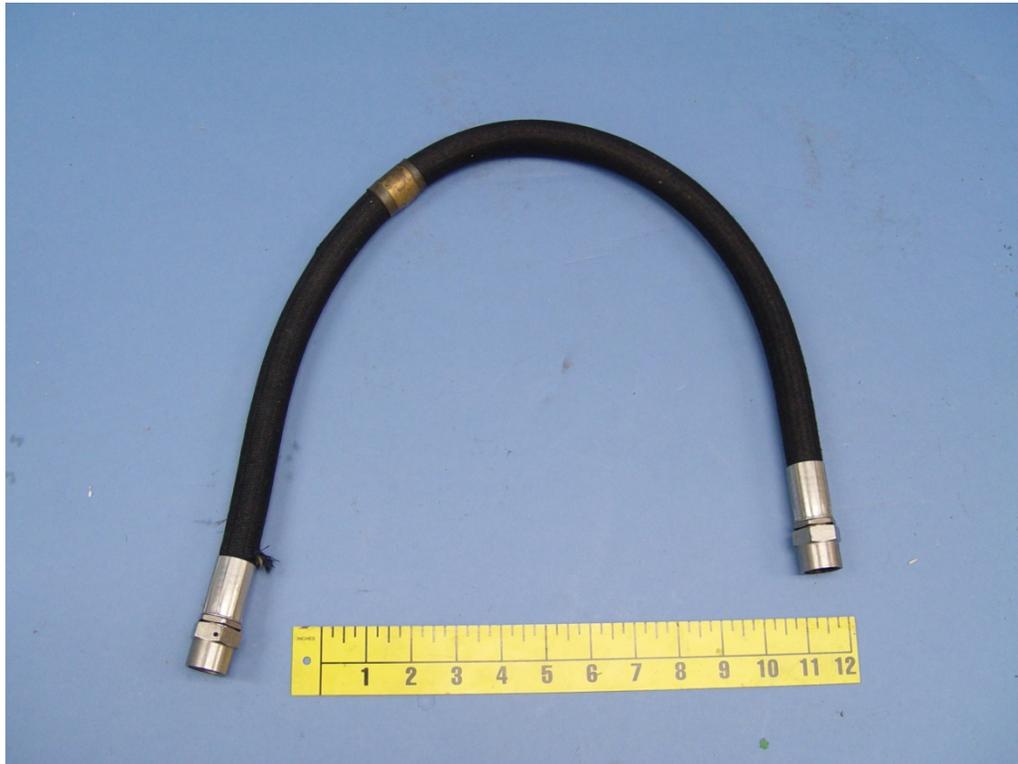
A landing gear hydraulic hose, as shown in Figures 1 and 2, was submitted to the NTSB Materials Laboratory for examination to determine the failure mechanism for the hose. The submitted hose was an Aeroquip AC127J-0300SS hose. The high pressure, 0.625 inch hose consisted of a two-layer Teflon® hose covered with a two-ply pressure sleeve that consisted of a textile outer layer with a Kevlar® inner layer. The hose had a flareless crimp, male connector on each end. Each connector was made up of a barb, called a nipple, which the Teflon hose was fitted over. The nipple, hose and pressure sleeving were then covered with a metal collar called the socket.

Figure 1. Overall photograph of accident hydraulic hose.

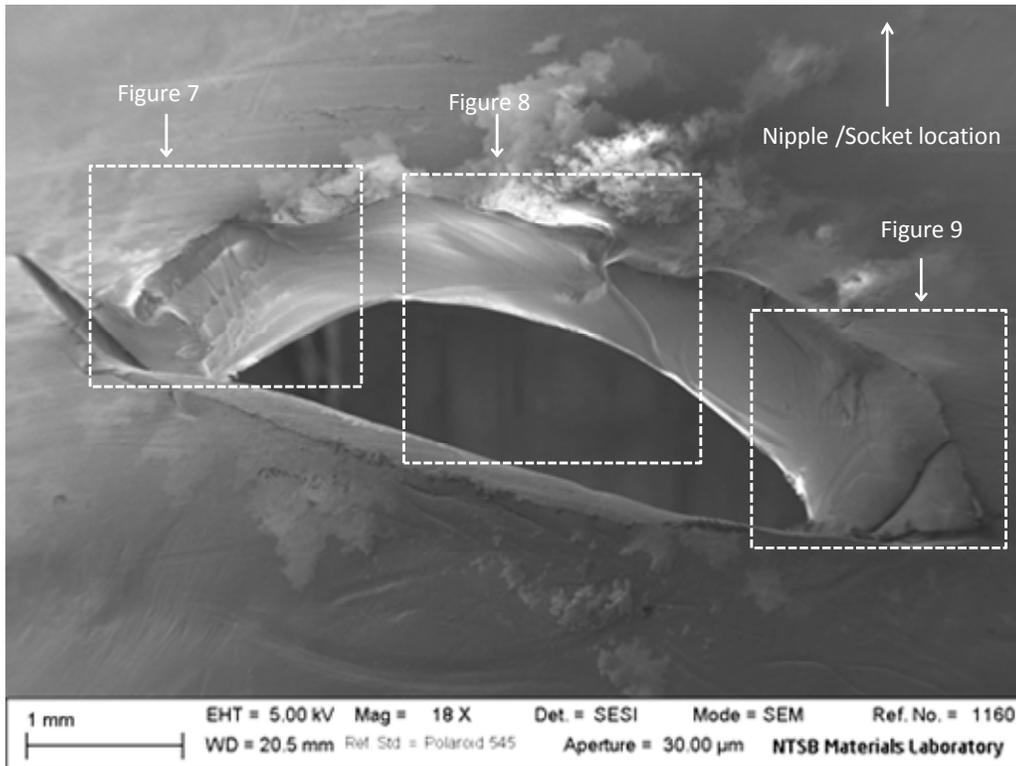
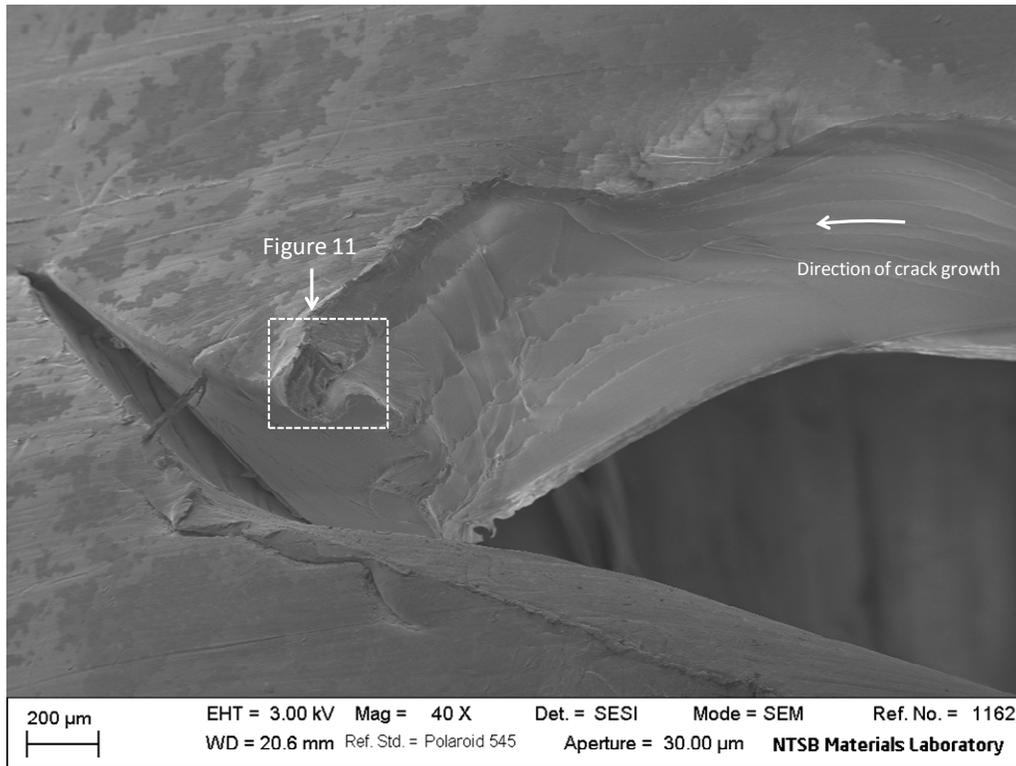
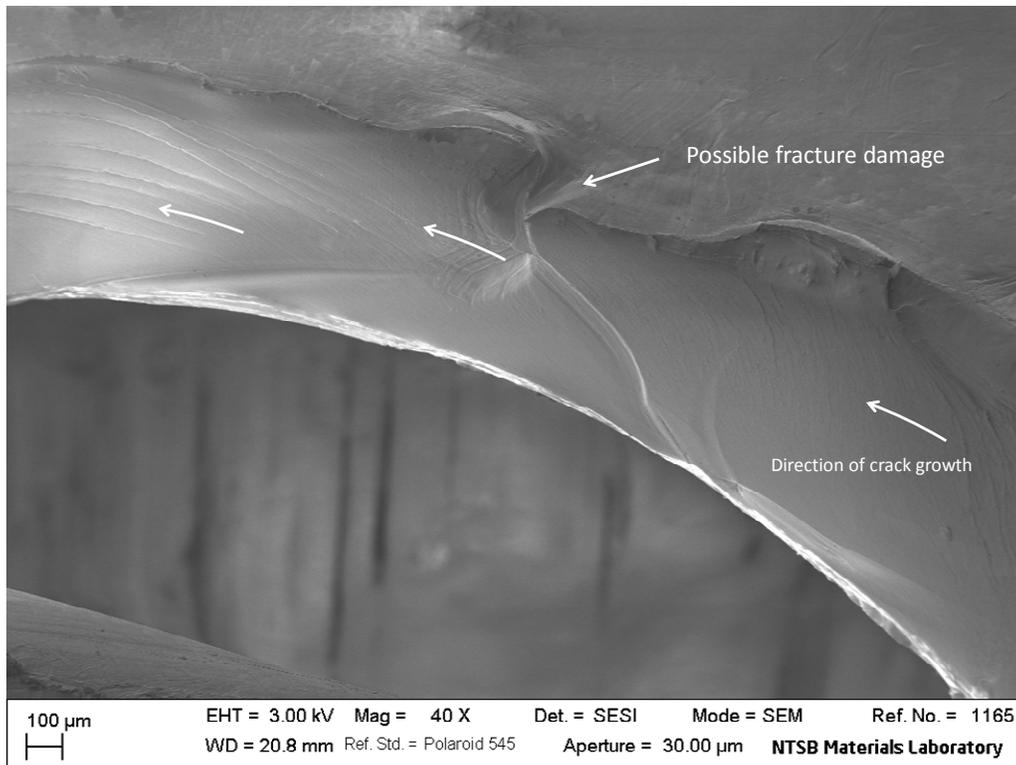
surface, indicative of significant crack recontact damage and no identifiable fracture features could be visualized. The secondary fracture surface, as shown in Figures 5-7, exhibited several distinct fracture features consistent with those identified in ASTM C1256^{1,2}. Branching fractures as shown in Figure 8 and fine fibrils as shown in Figure 9 are typical signatures in slow crack growth in polymeric materials. Based on the direction of crack growth, the initial fracture likely initiated on the right side of the crack (with the nipple/socket located above the crack) and on the interior surface of the hose as shown in Figure 7. The nature of the crack indicates that there was possible stress relaxation of the hose material resulting in material creep. This was a result of possibly kinking at the nipple and socket. According to the hose manufacturer (Aeroquip/Easton), kinking at this location is common because the hose does not swivel and often gets kinked during installation.

Figure 5. SEM image of crack with areas of interest highlighted.

Figure 7. SEM image of left side of secondary fracture surface.

Figure 8. SEM image of center section of secondary fracture surface.

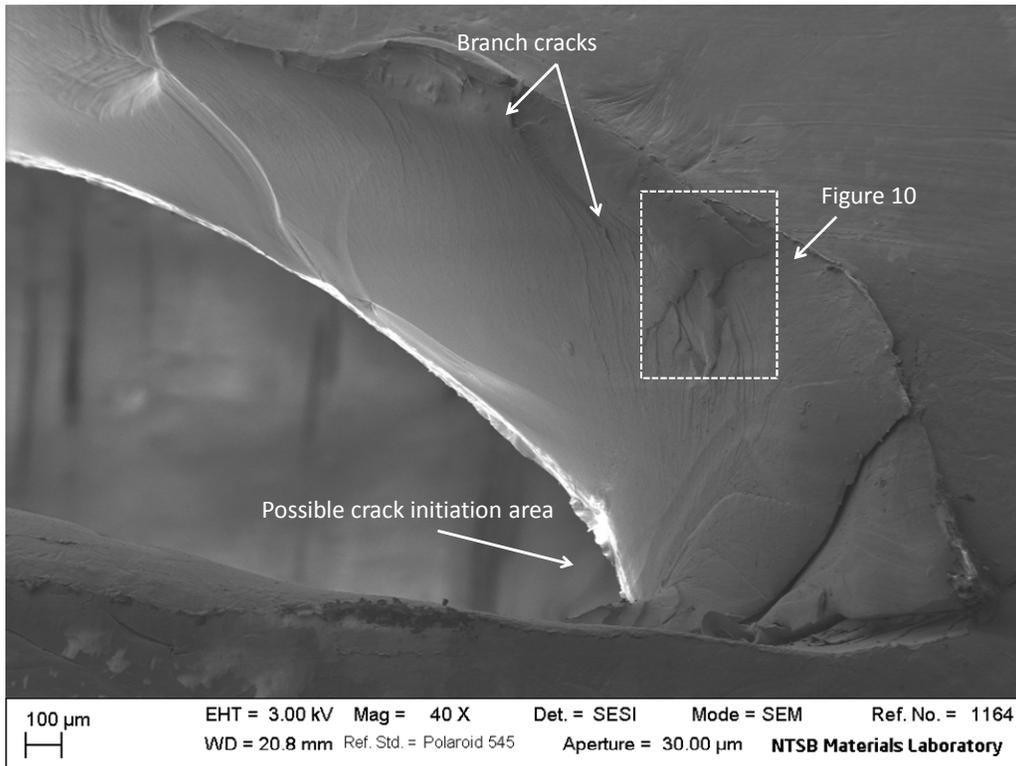
Figure 9. SEM image of center section of secondary fracture surface and crack initiation area.

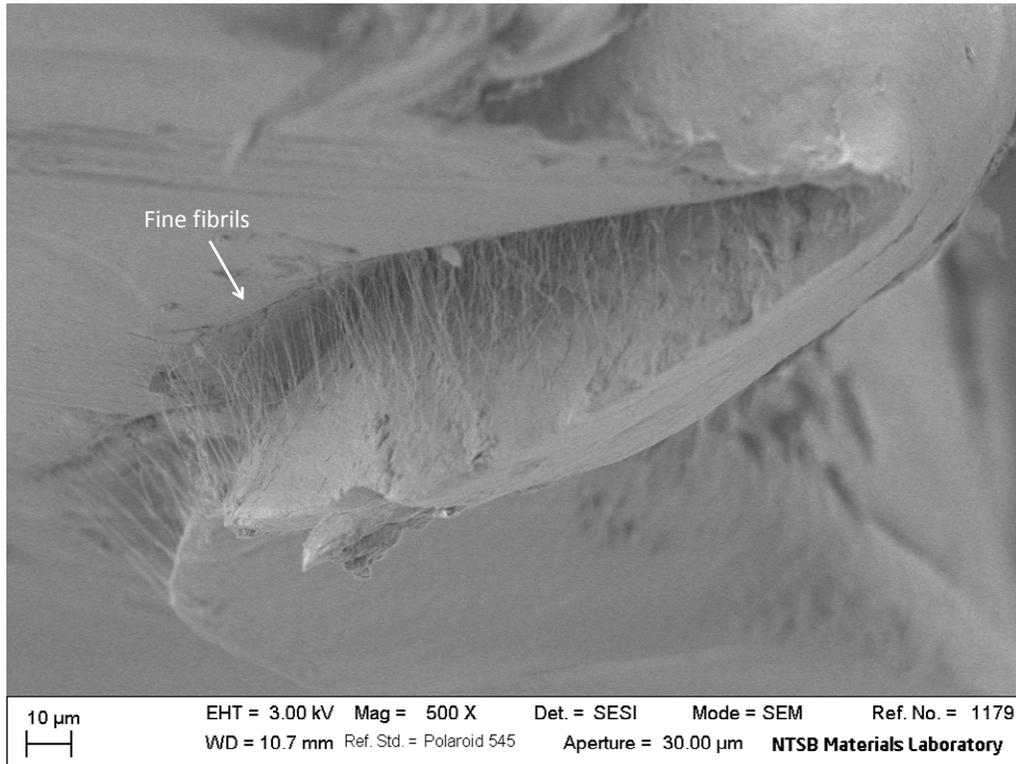
Figure 11. Close-up SEM image of fine fibril formation.

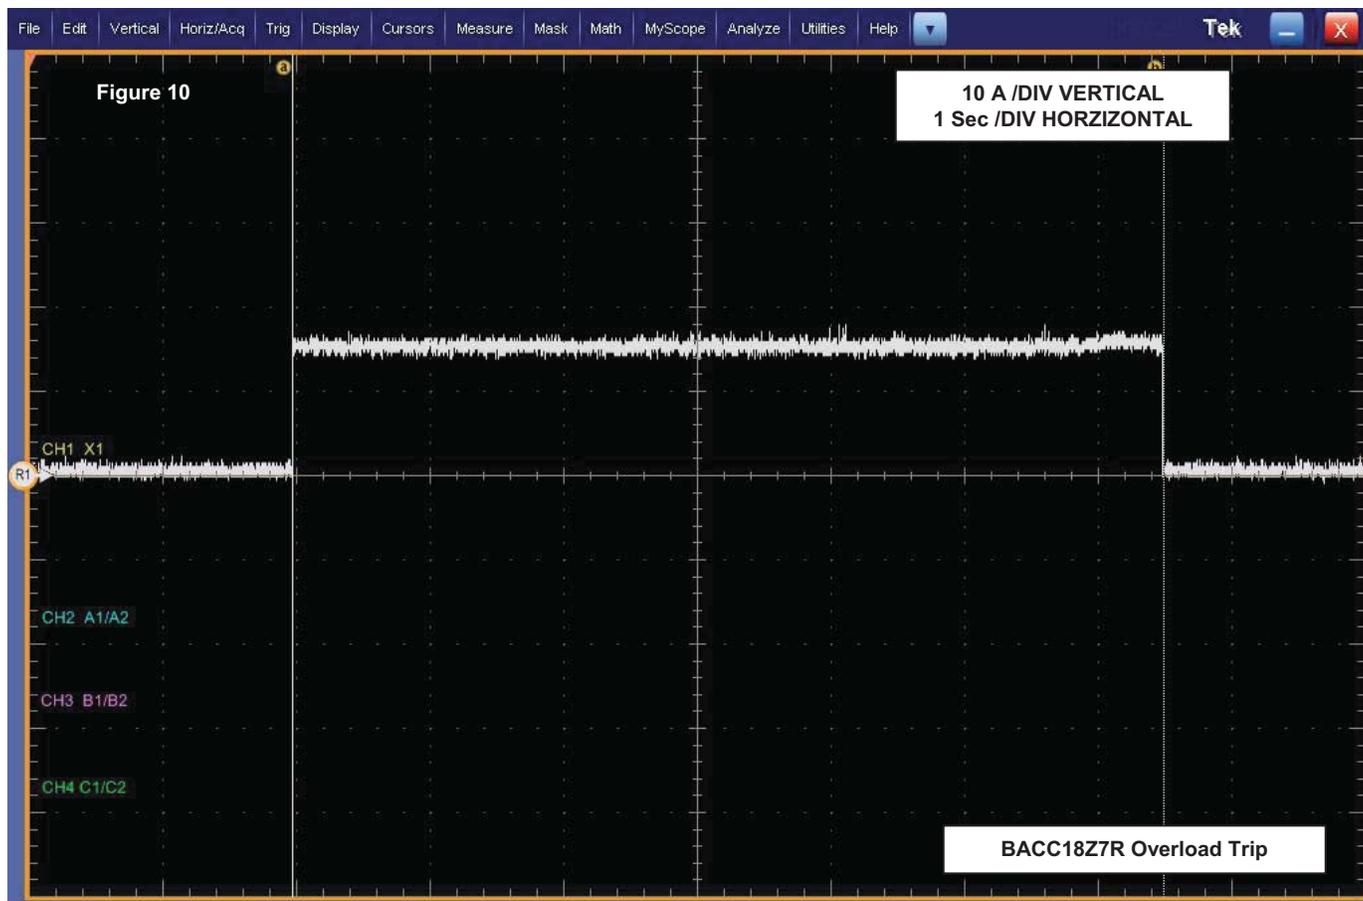
TABLE II. Electrical Test Results for BACC18Z7R			
Ambient Temperature: 73 degrees F			
Test	@ Percent Rated Current	Specified Trip Time	Actual Time
Ultimate Trip Time	115 %	Min 1 hour	Did not trip in 60 sec.
Ultimate Trip Time	138 %	Max 1 hour	56 seconds
Overload Calibration	200 %	Min 5 seconds to Max 20 seconds	13 seconds
Voltage drop	115 %	Max voltage drop not specified	183 mV
Contact resistance	115%	Max contact resistance not specified	0.020 Ω

Figure 10 shows the oscilloscope image of current versus time for the 200% current overload trip-time test of circuit breaker BACC18Z7R.

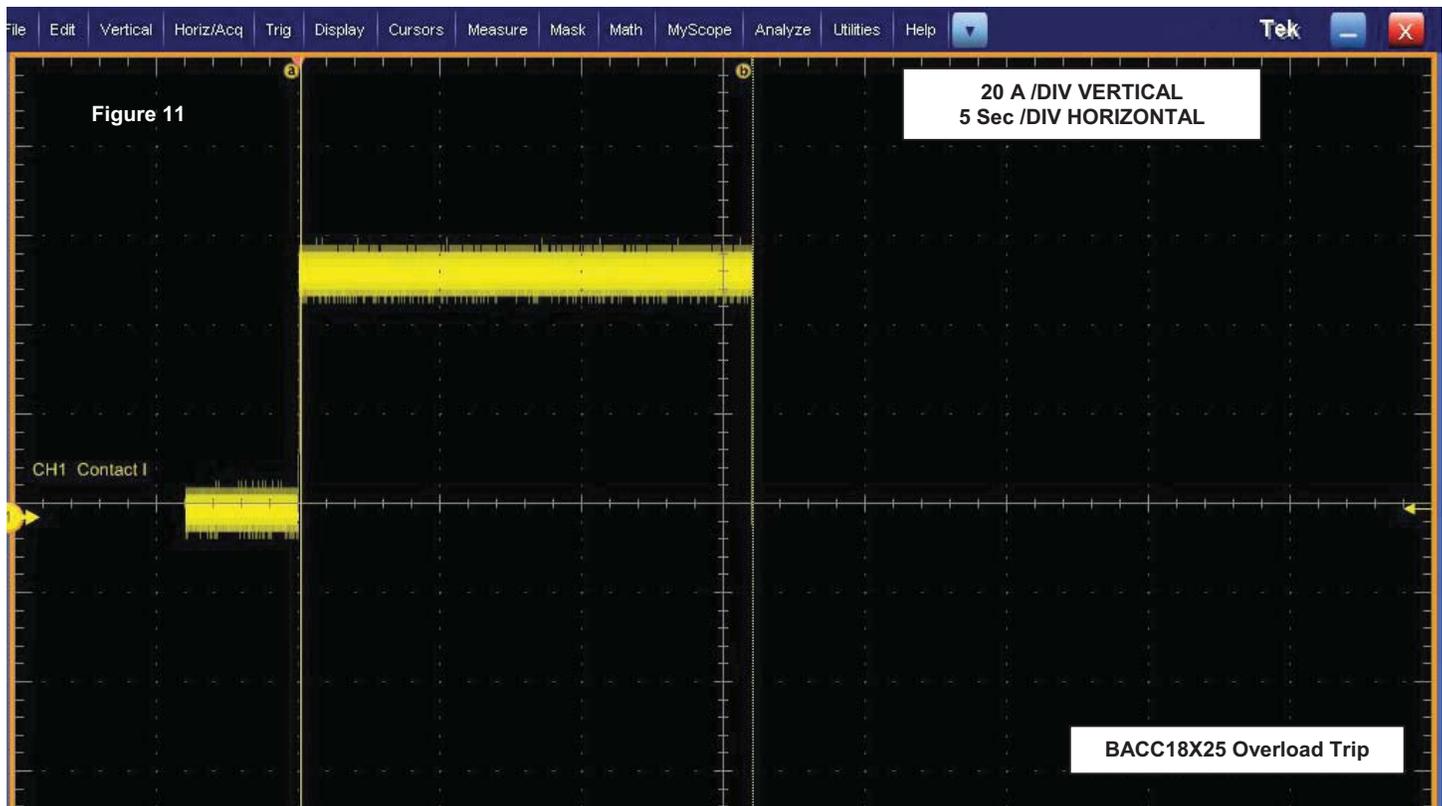
TABLE III. Electrical Test Results BACC18X25			
Ambient Temperature 73 degrees F			
Test	@ Percent Rated Current	Specified Trip Time	Actual Time
Ultimate Trip Time	115 %	Min 1 hour	Did not trip in 60 sec.
Ultimate Trip Time	138 %	Max 1 hour	203 Seconds
Overload Calibration	200 %	Min 12.5 seconds to Max 55 seconds	16 seconds
Voltage drop	115 %	Max voltage drop not specified	167 mV
Contact resistance	115%	Max contact resistance not specified	0.020 Ω

Figure 11 shows the oscilloscope image of current versus time for the 200% overload current trip-time test of circuit breaker BACC18X25.

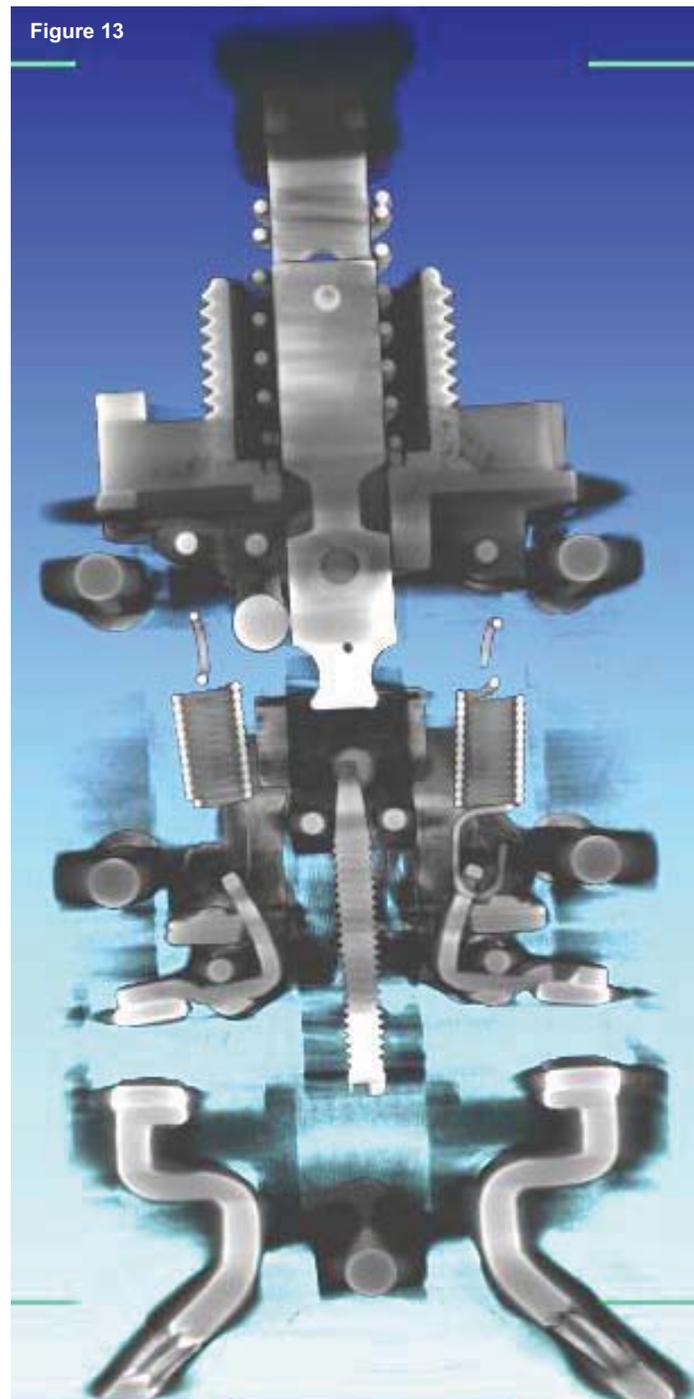
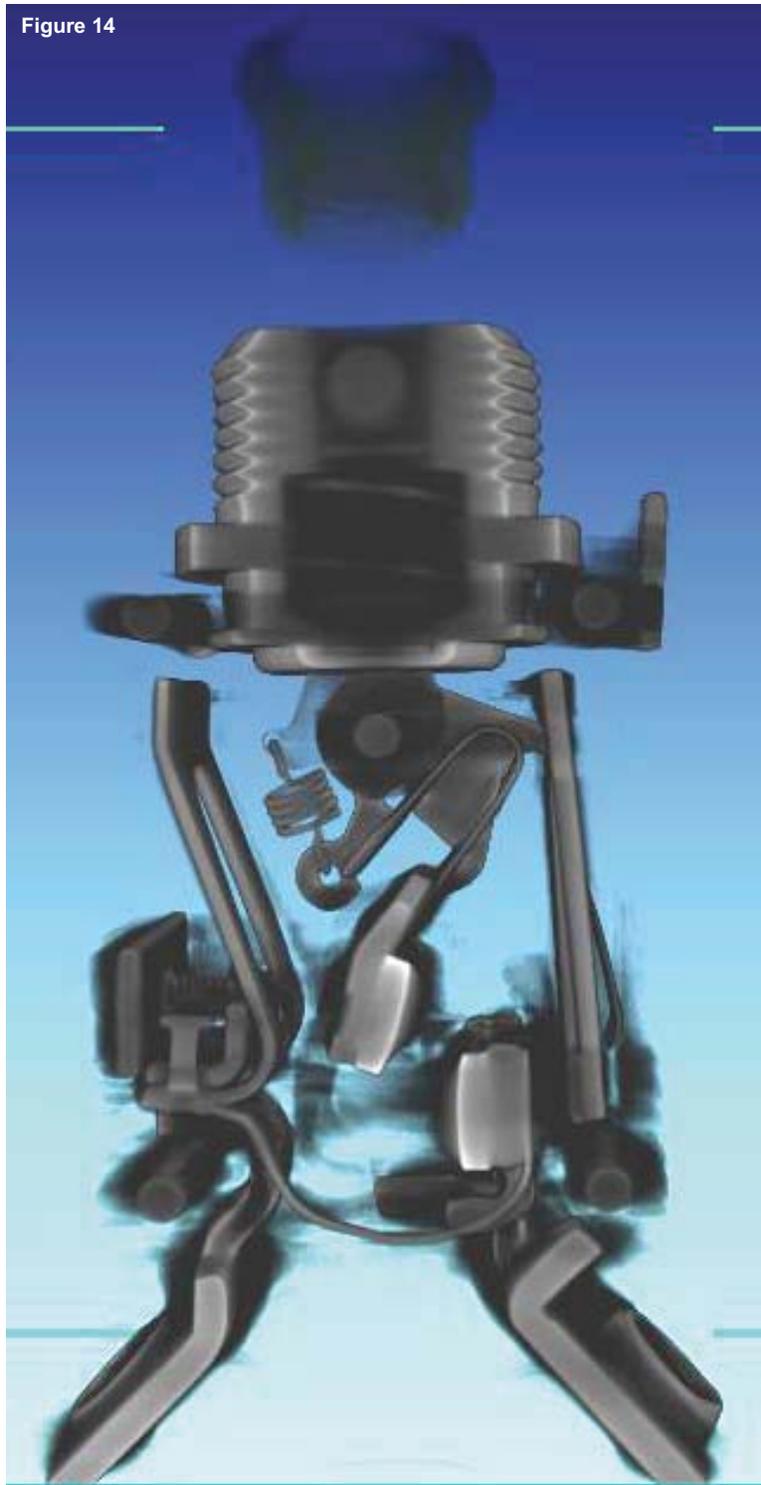
BACC18X25 CT Image Figure 13

Computed tomography (CT) images were taken of each circuit breaker before disassembly; see figures 13 and 14. There were no obvious anomalies observed.

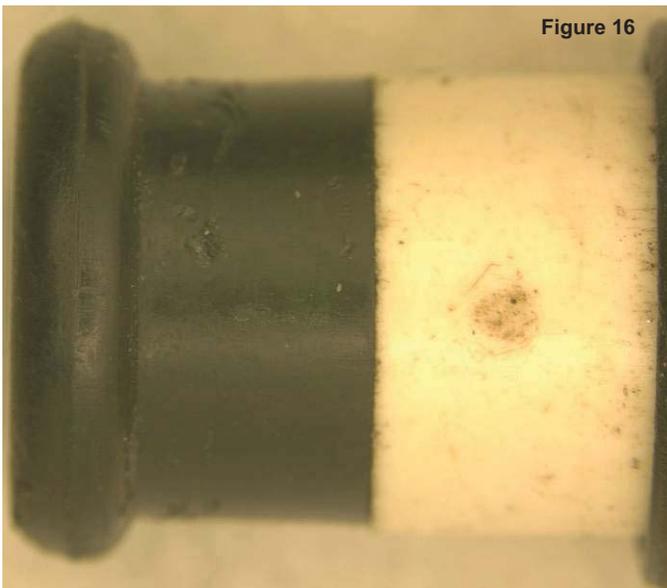
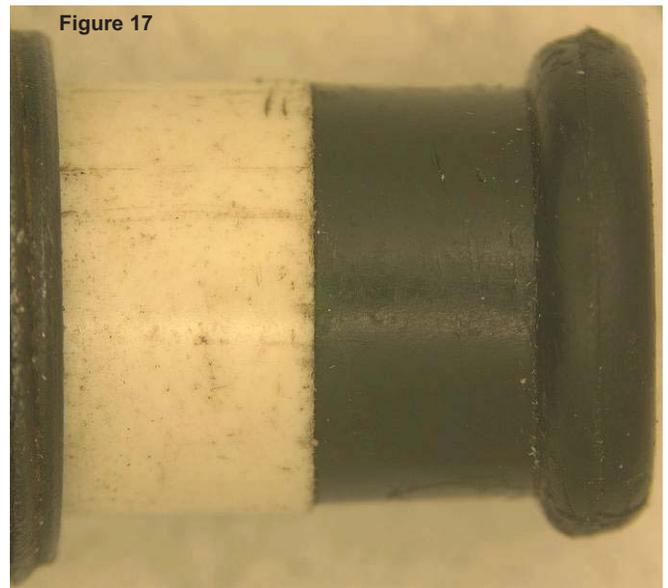
Figure 16

Figures 16 and 17 show the circuit breaker button and shaft. Slight damage on the button was caused by the push-pull fixture utilized in the mechanical properties testing.

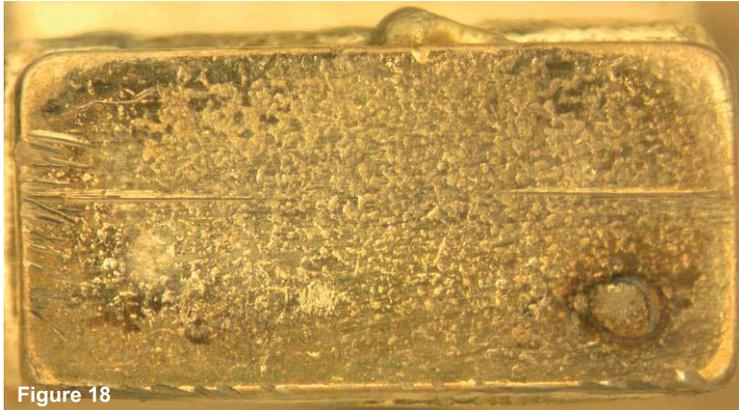
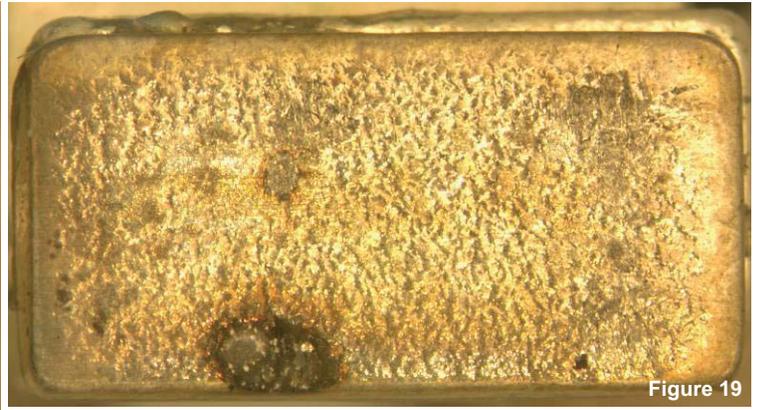
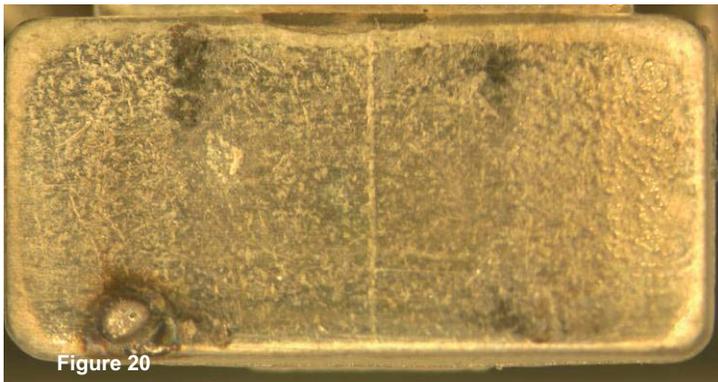
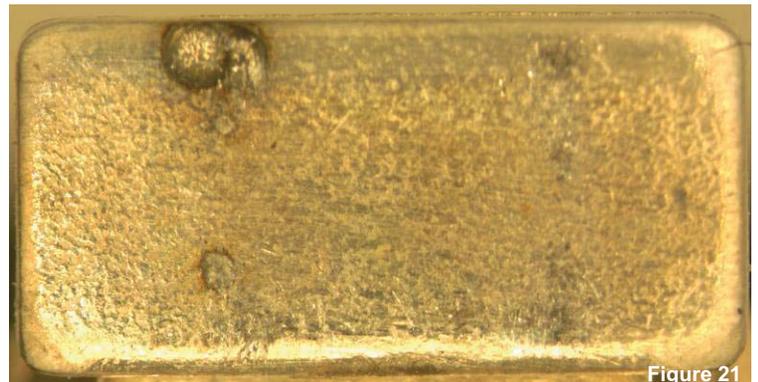
The contacts from the BACC18X25 circuit breaker are shown in figures 18 through 21. The condition of the contacts was unremarkable.

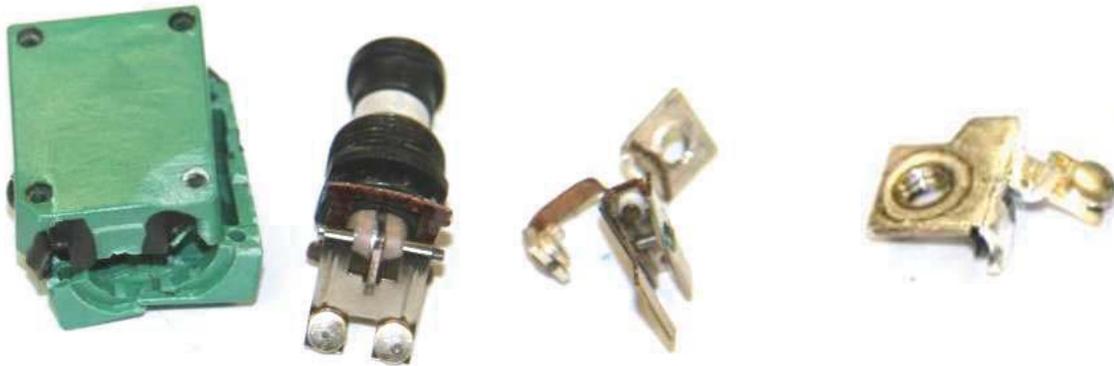
Figure 22: The BACC18Z7R circuit breaker disassembled.

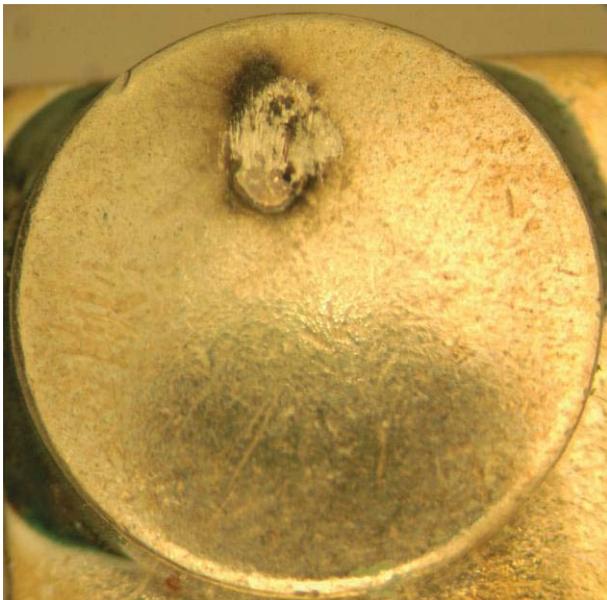
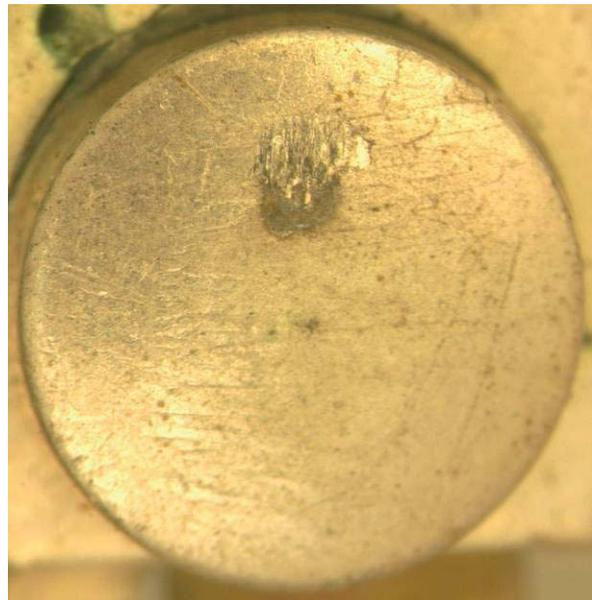
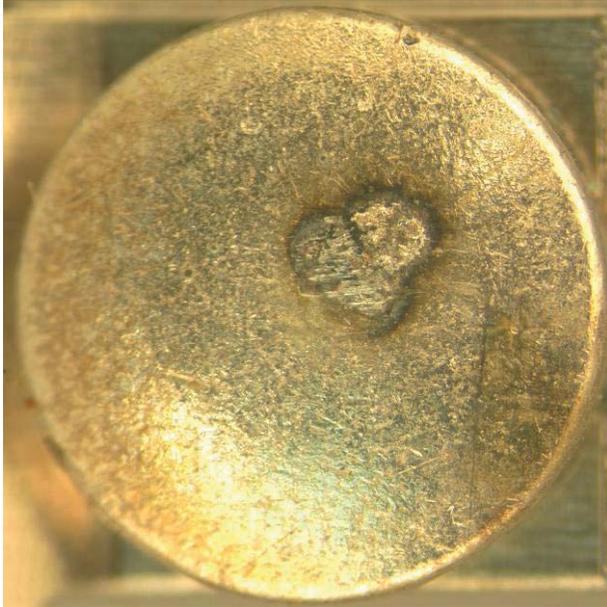
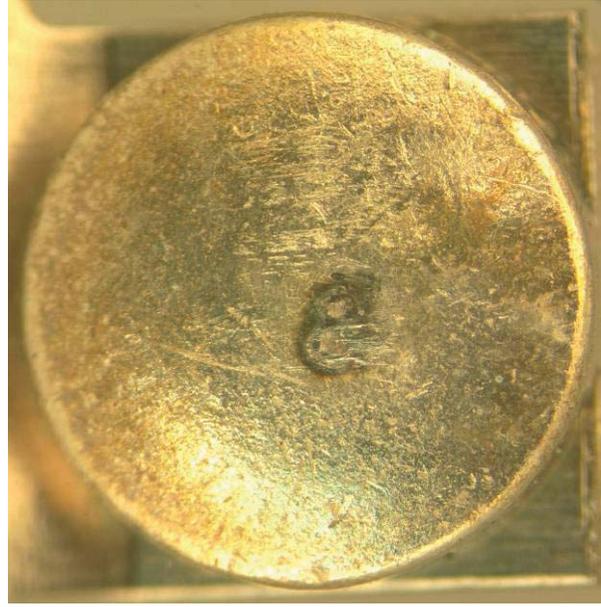
The contacts from the BACC18Z7R circuit breaker are shown in figures 23 through 26. The condition of the contacts was unremarkable.

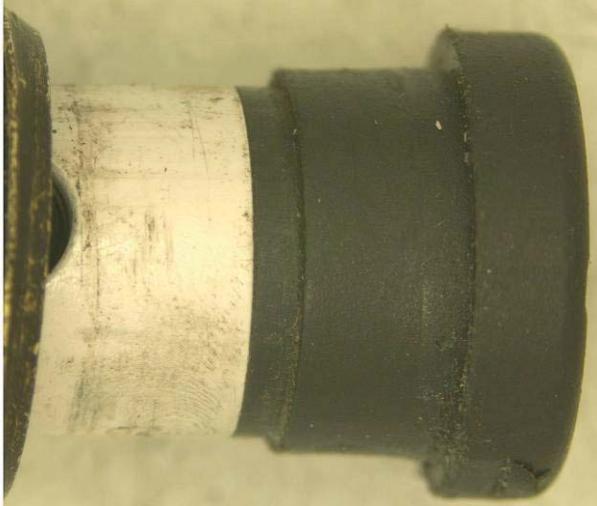
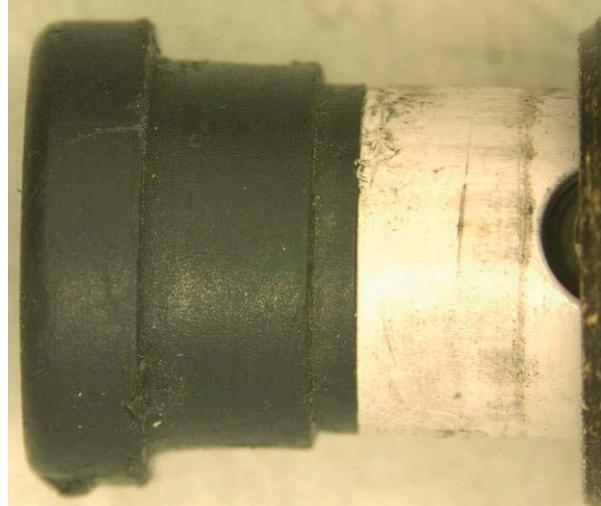
Figures 27 and 28 show the circuit breaker button and shaft. Slight damage on the button was caused by the push-pull fixture utilized in the mechanical properties testing.

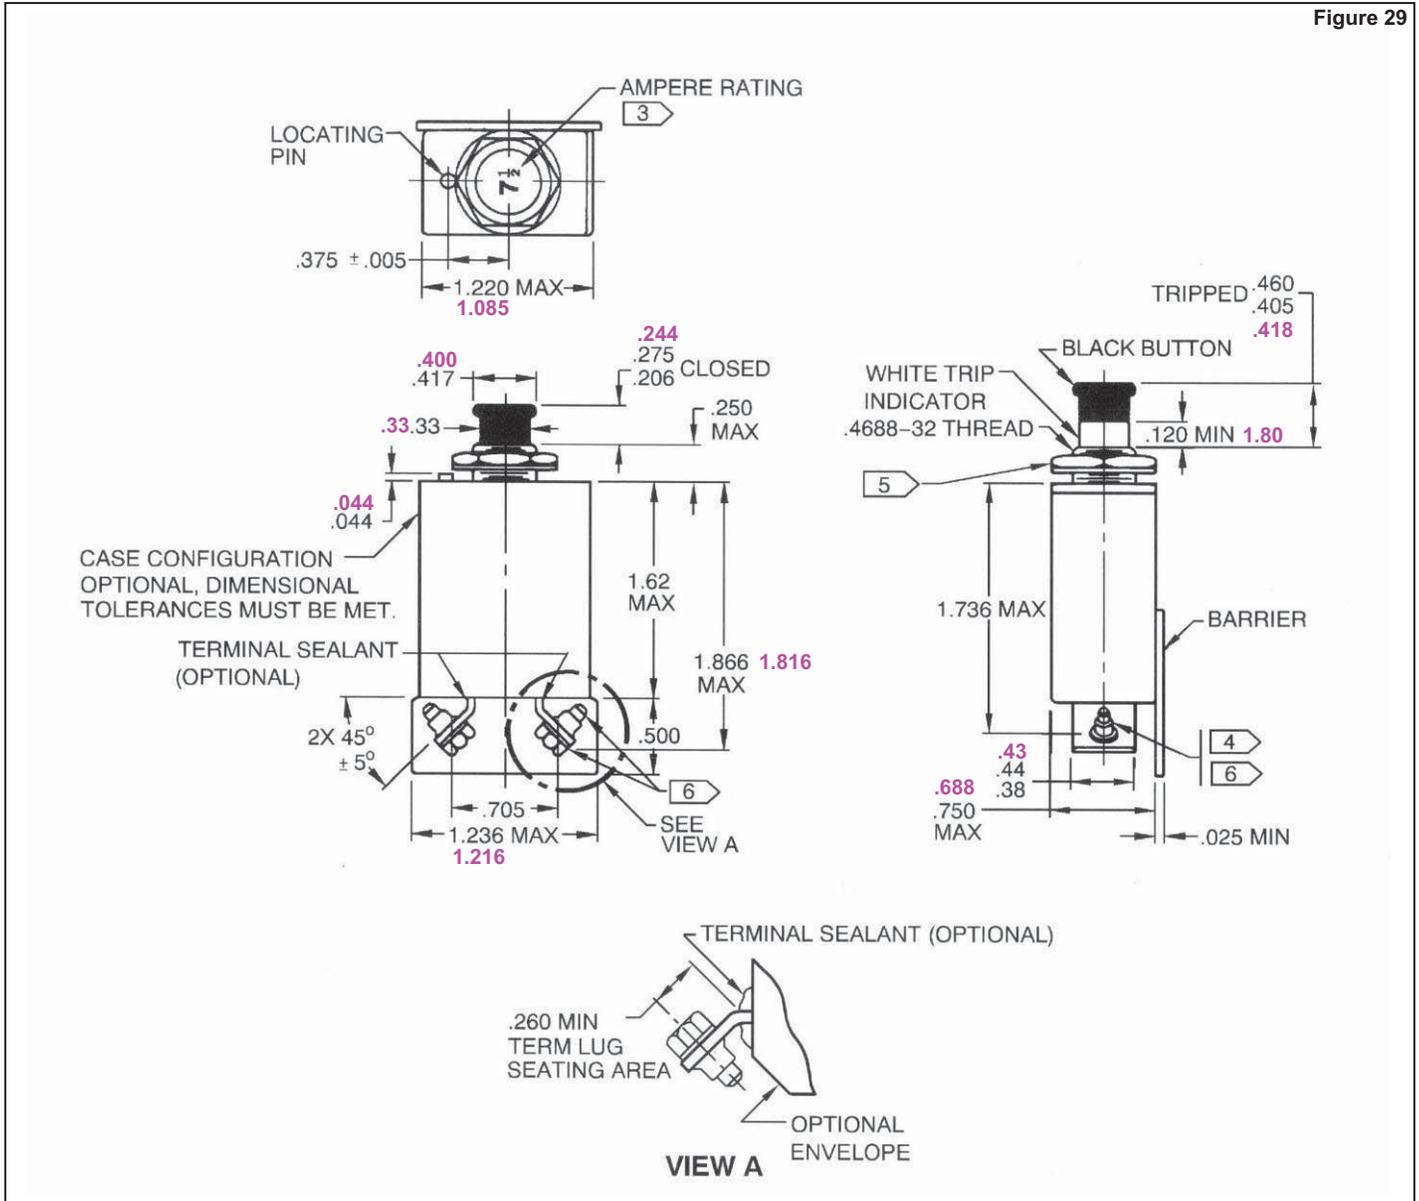
Figure 29

Dimensional measurements of each circuit breaker were compared to those of the applicable part standard (figures 29 and 30, magenta fonts).

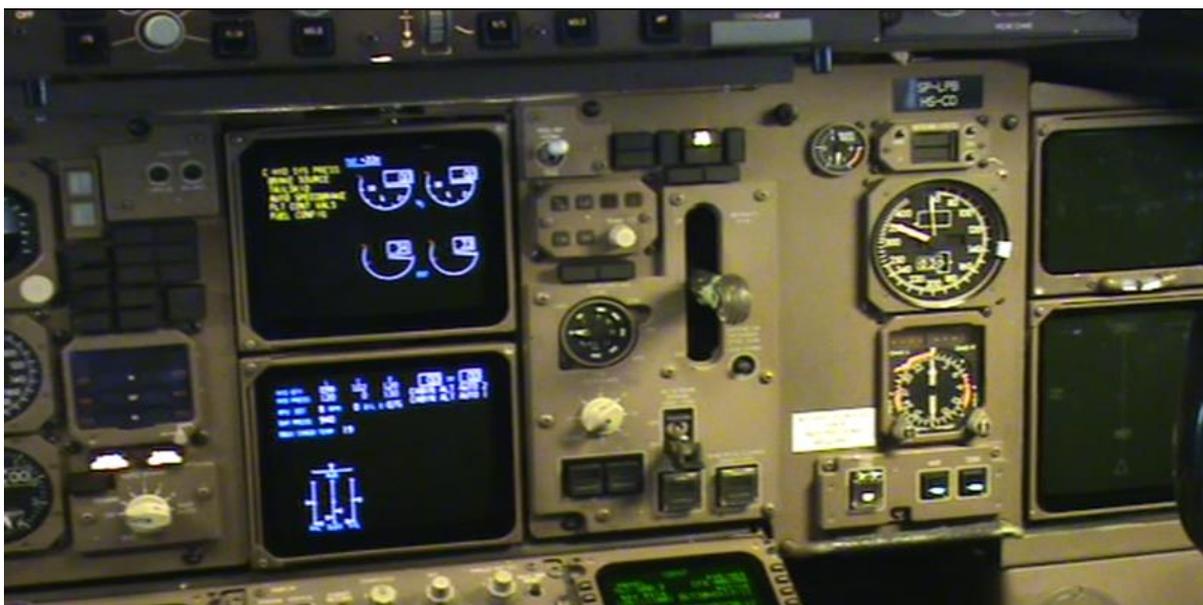
Fig. 2. Test of landing gear extension, C829 (A1) in OFF setting

- When C829 circuit breaker was in ON setting (pushed) – moving ALT GEAR EXTEND switch into DN position caused extension of the landing gear;
- When C829 circuit breaker was in OFF setting (pulled out) – moving ALT GEAR EXTEND switch into DN position did not cause extension of the landing gear.

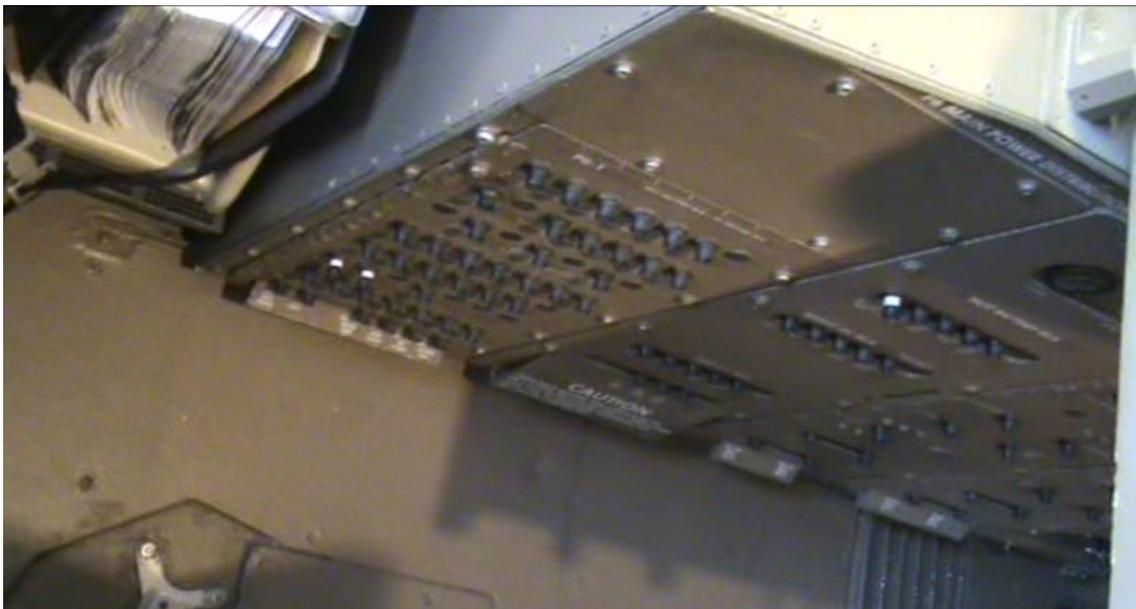
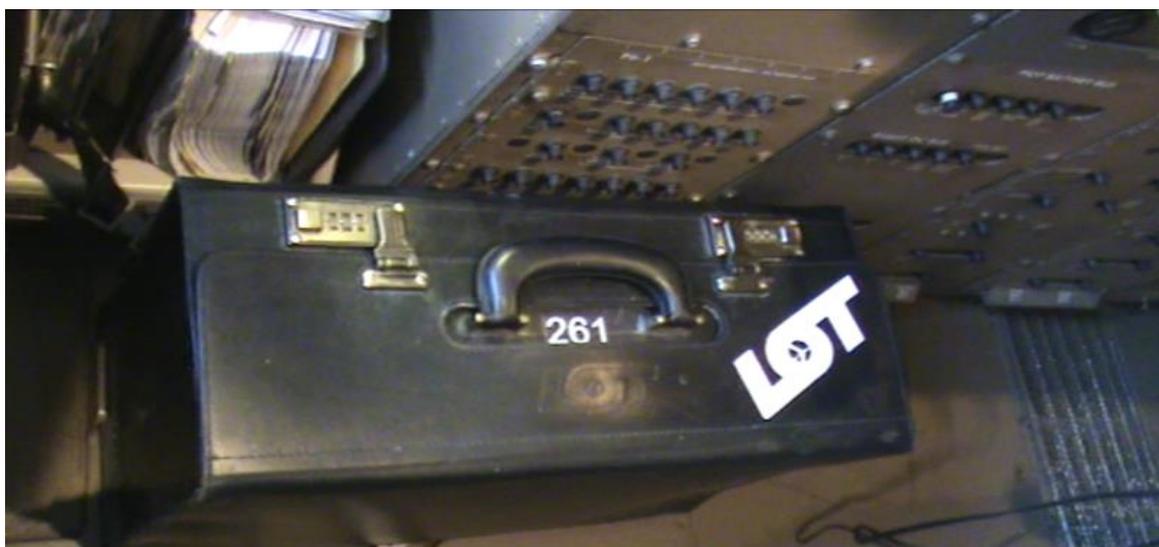
Fig. 3. View from FO seat on P6 panel (no briefcase)

Fig. 4. View from FO seat on P6 panel (briefcase present)

It was found that while seated normally in the FO seat, the observation of C829 (A1) circuit breaker was very difficult if any briefcase was placed close to P-6 panel.
