FINAL REPORT

ACCIDENT

Occurrence No.: 1400/11

Aircraft: B767-300ER, SP-LPC

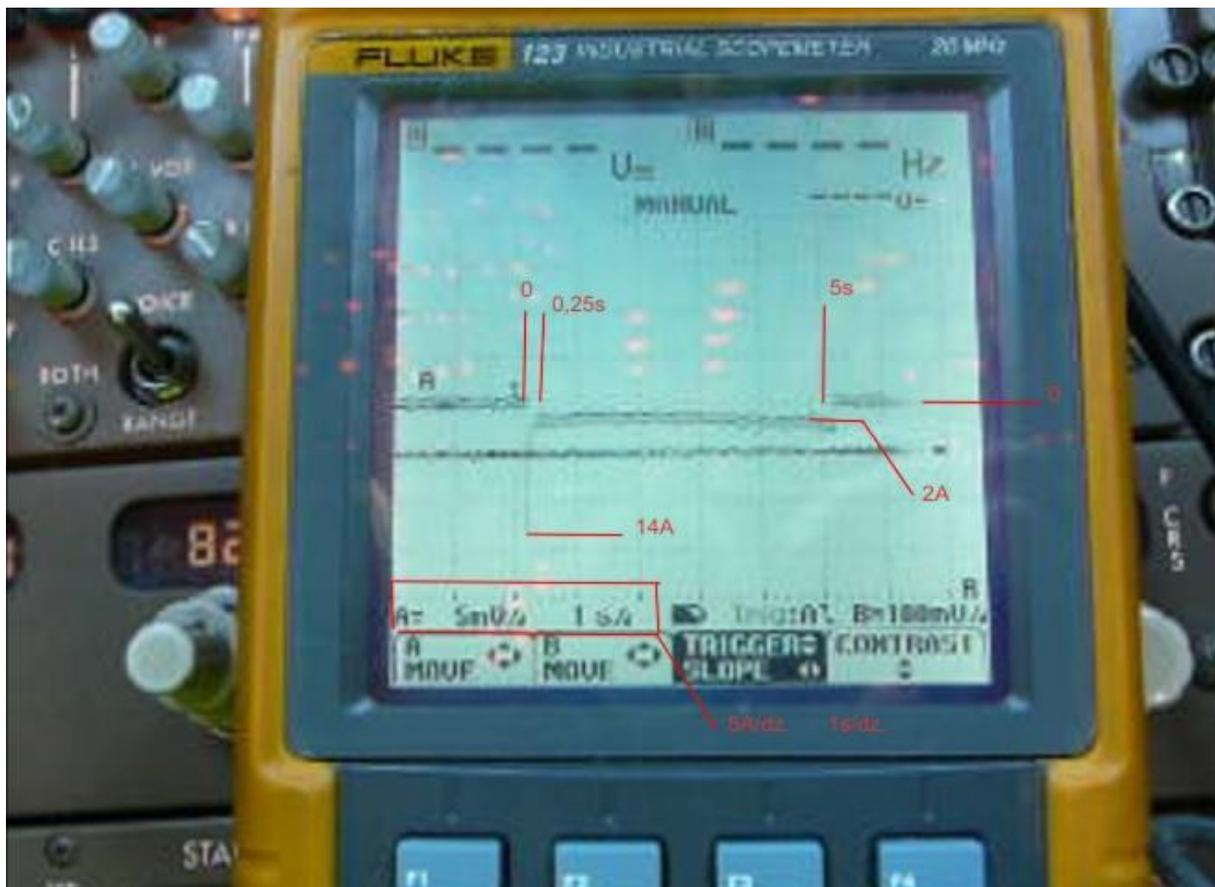
1. During the test of alternate landing gear extension TASK CARD B767 32-021-01 (Boeing) the current of electric motor driving the system was recorded (NRC step 1). The recorded current waveform is shown in Figure 5.
2. The value of the operating current was within limits and was 2A, and the value of the starting current was 14A. According to CMM EATON S257T400-1 (-3) 32-35-01 at a normal load the operating current should not exceed 5A, and the starting current should not exceed 10 x operating current i.e. 20A for the investigated case.

Fig. 5. Recorded waveform of the current of the alternate landing gear extension motor

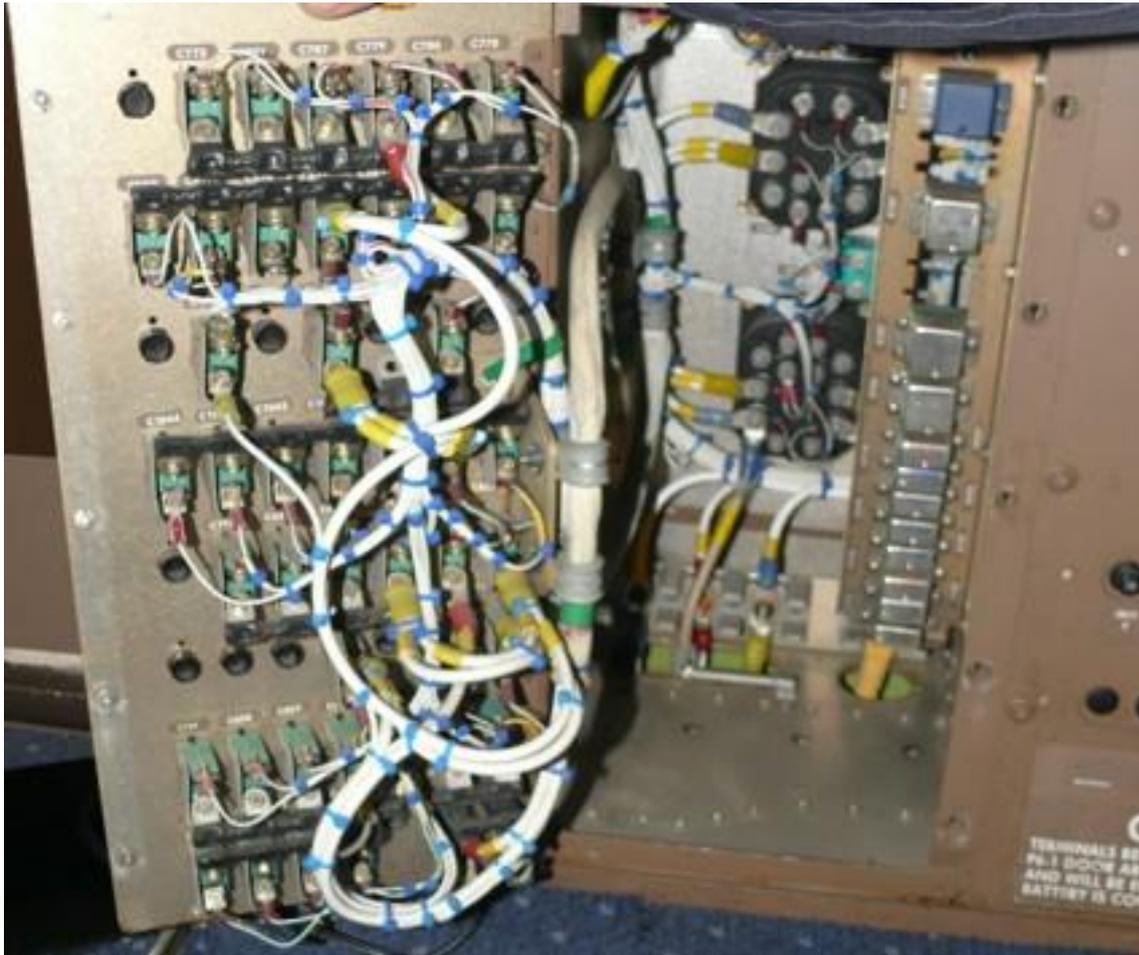
3. Examination of inside of P6-1 panel was carried out, in particular the area of the wiring harness connected with the above circuit breakers: W1040-009, -010, -044, -047 (NRC step 2). No irregularities or foreign objects were found.

Fig. 7. View of the inner side of P6-1 panel

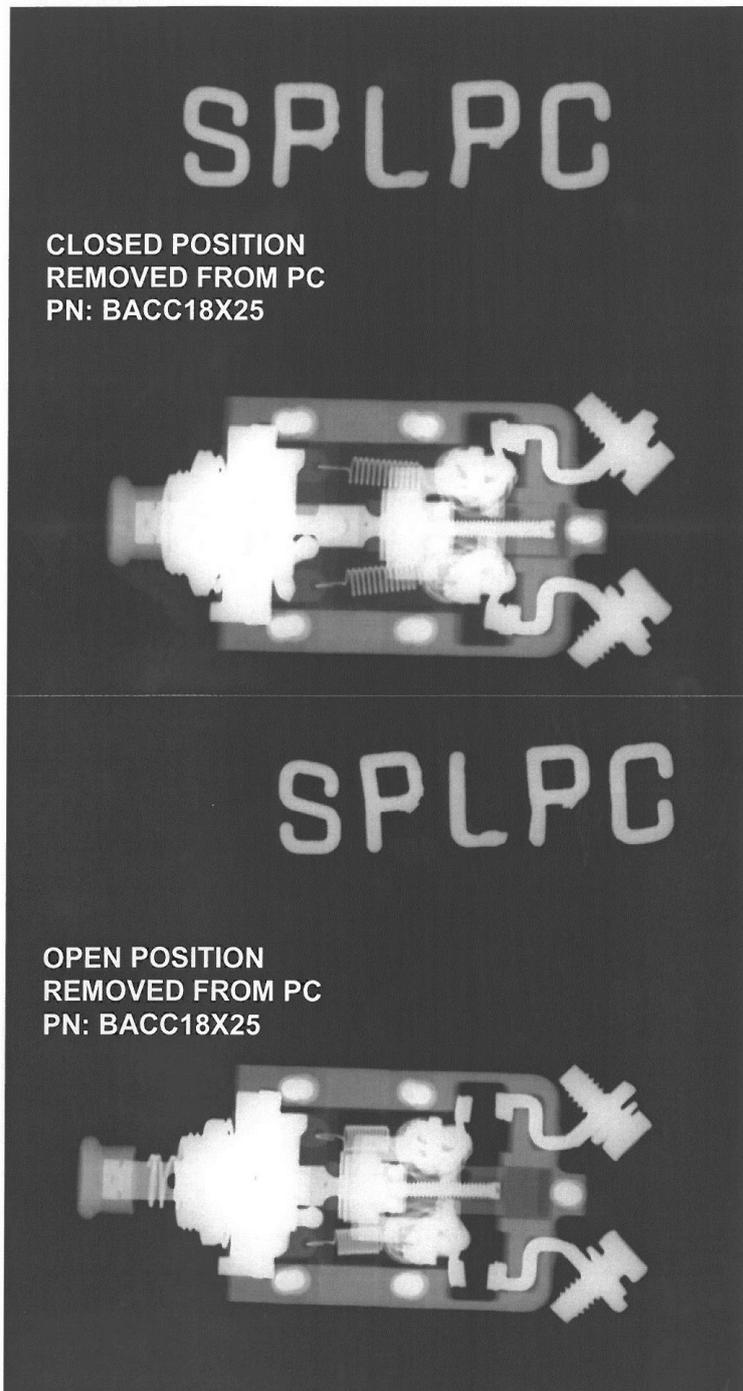
For this purpose X-ray examination of the circuit breaker was done and its pull-out force was measured. X-ray picture (Fig. 8) showed no internal damage to the circuit breaker, and in particular to the latch holding the breaker in ON position.

Fig. 8. X-ray picture of C829 circuit breaker

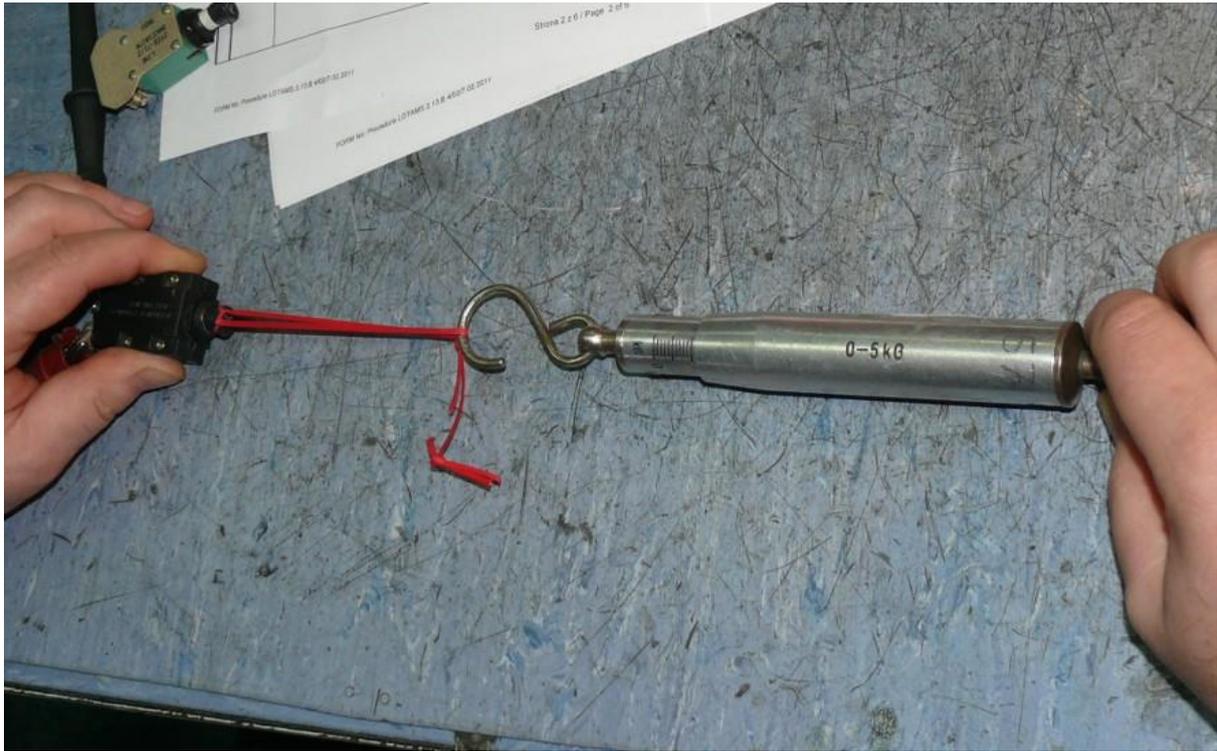
Fig. 11. Measurement of pull-out force (OFF setting force) of C829 circuit breaker

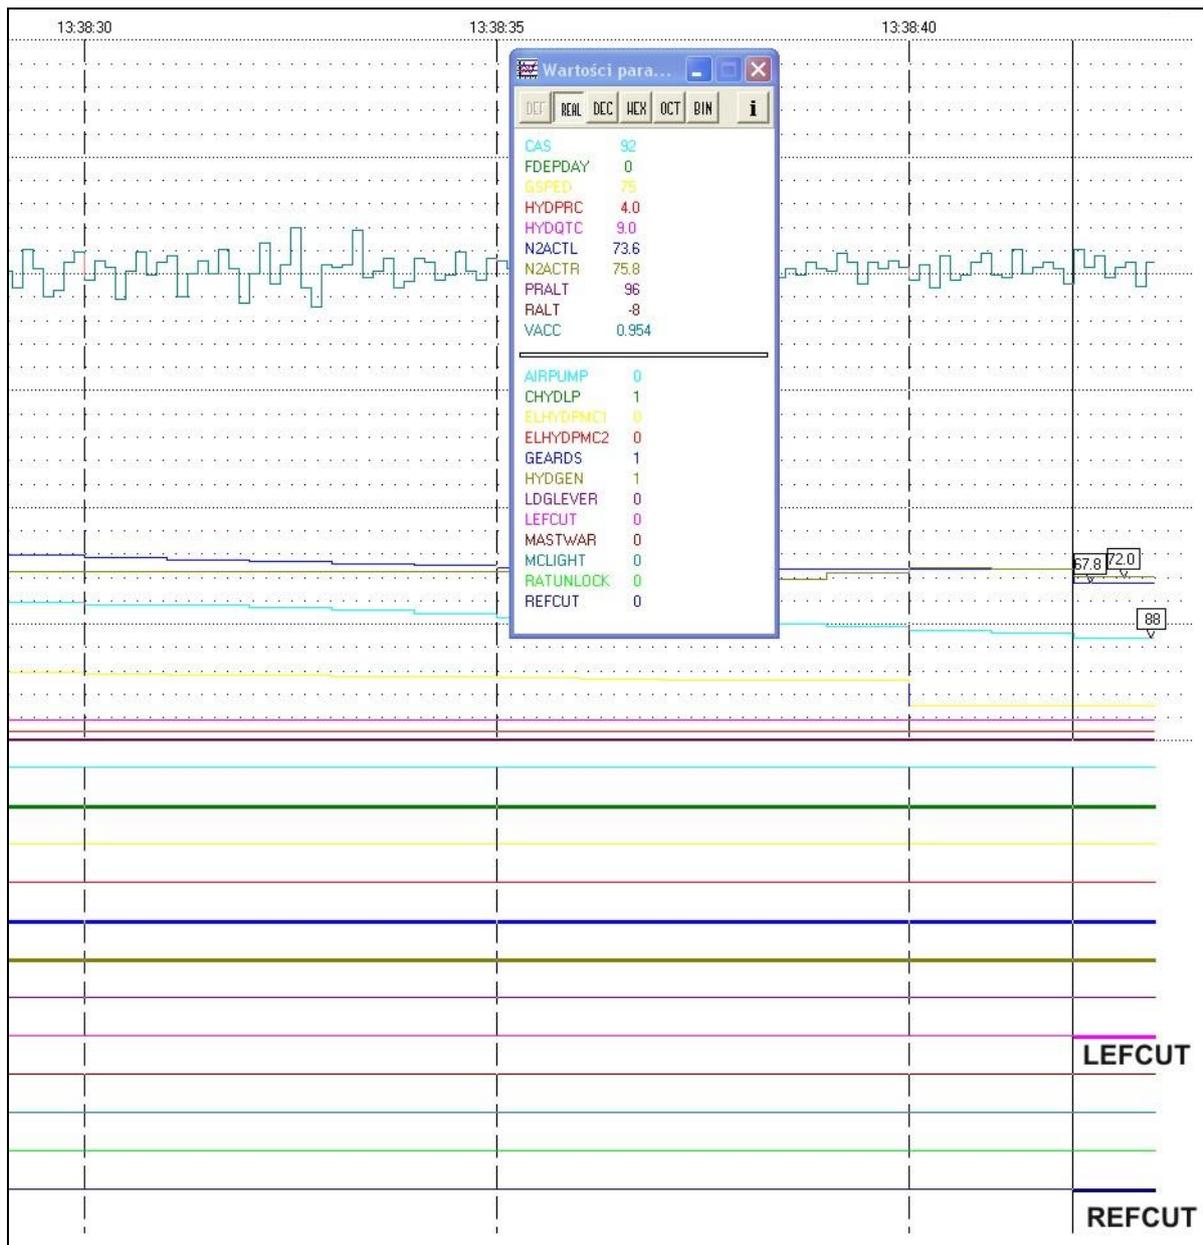
RAT activates automatically in the AIR configuration if the RPMs of both engines are below 50% and the aircraft speed is above 80 kts. At 13:38:42 hrs (Fig. 15) the engine fuel cut-off valves (LEFCUT, REFCUT) were activated and one second later (the FDR recording ended at 13:38:43) the engines speeds were: L_ENG 67.8%, R_ENG 72% and the aircraft speed was 88 kts.

Fig. 15. Image of the end of FDR recording

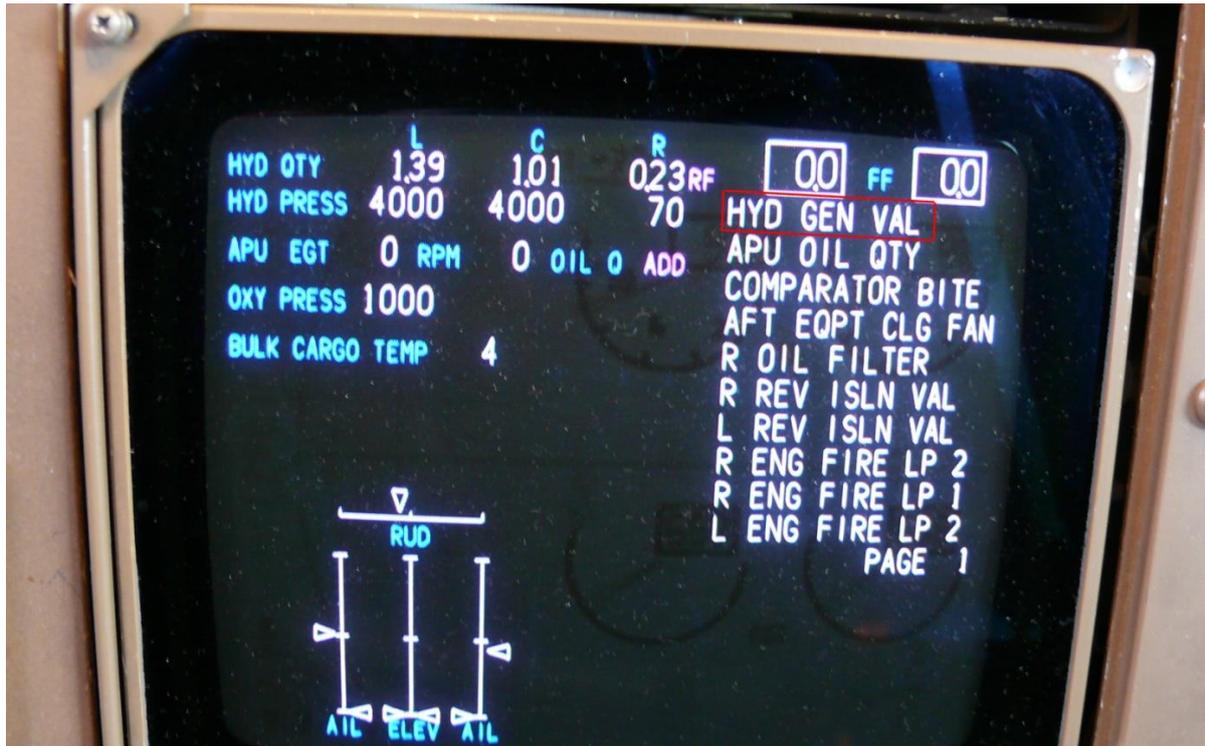
On December 13, 2011 a functional check of the HMG VALVE and measurements of the valve current were carried out on SP-LPC airplane. The tests were carried out with the use of the test function (TEST HMG switch on P61). After setting the switch in the TEST position the valve opened and communicated that fact by EICAS message HYD GEN VAL (Fig. 16). The valve motor current was 0,63 A, which was much lower than the rated current of C906 individual circuit breaker (2,5 A). After releasing the test switch the valve started to close and the current was also 0,63 A.

Fig. 16. HYD GEN VAL message on EICAS

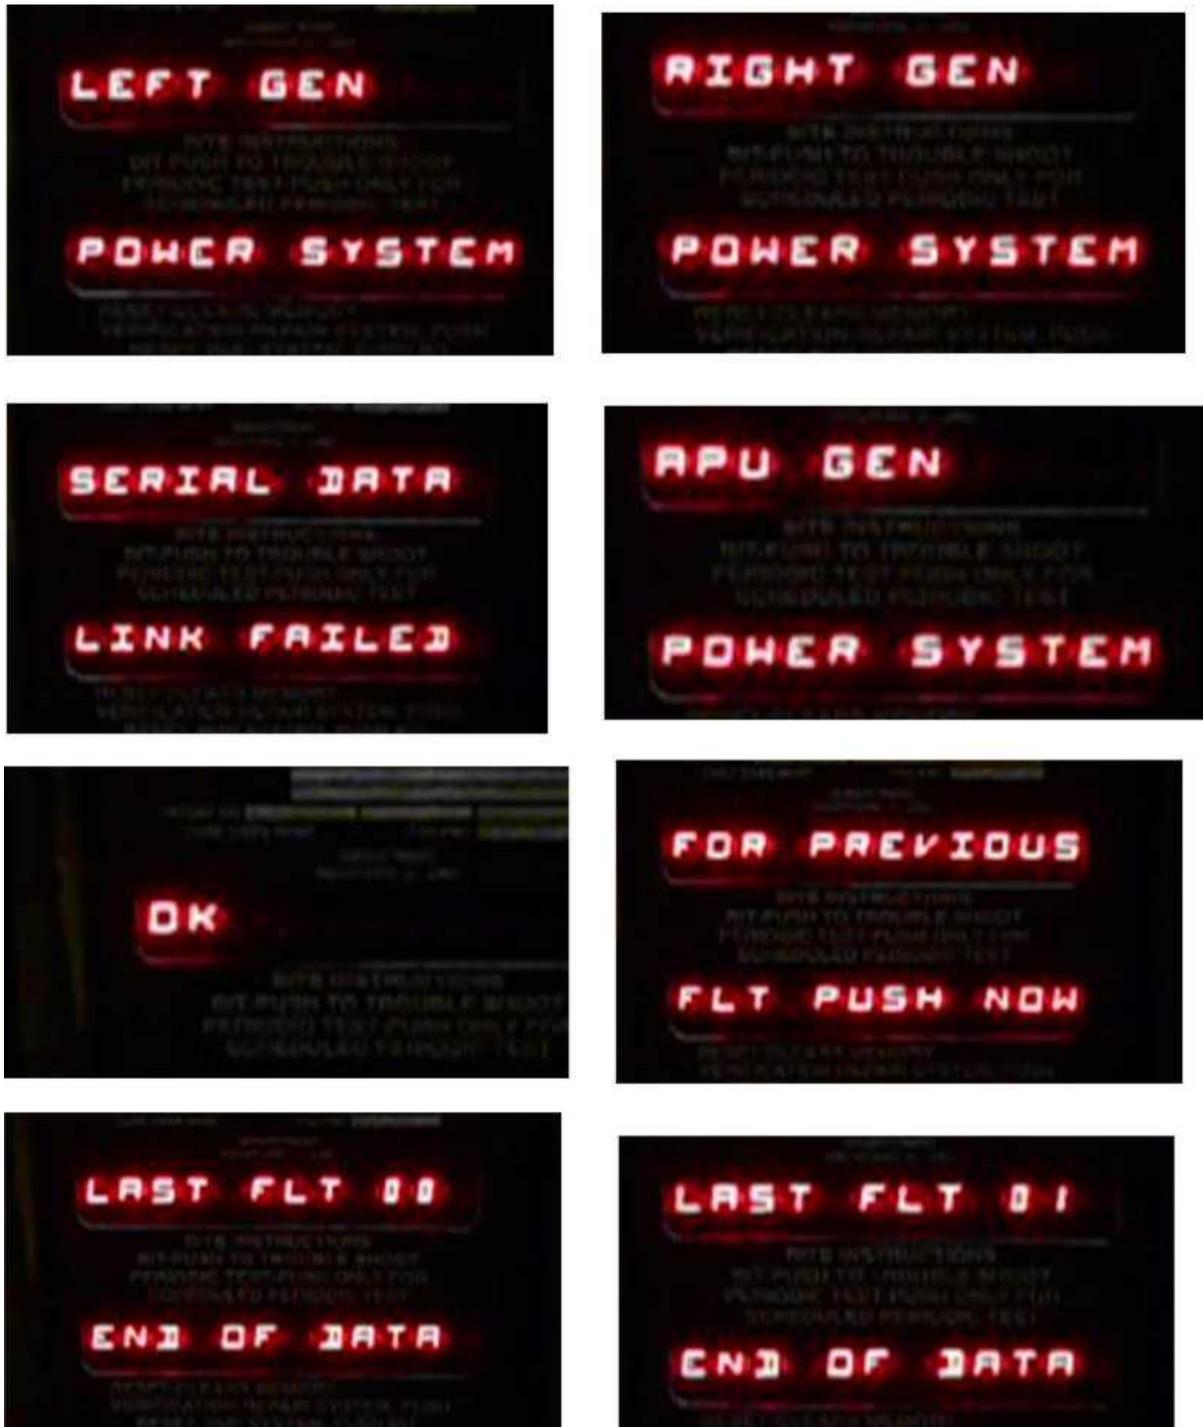
In the previous flights (01-03, 01 is the flight WAW-EWR on 31 October 2011) for all three power systems (L, R IDG, GEN APU the displayed status was "SYSTEM OK" (Fig. 18).

Fig. 18. BPCU display images

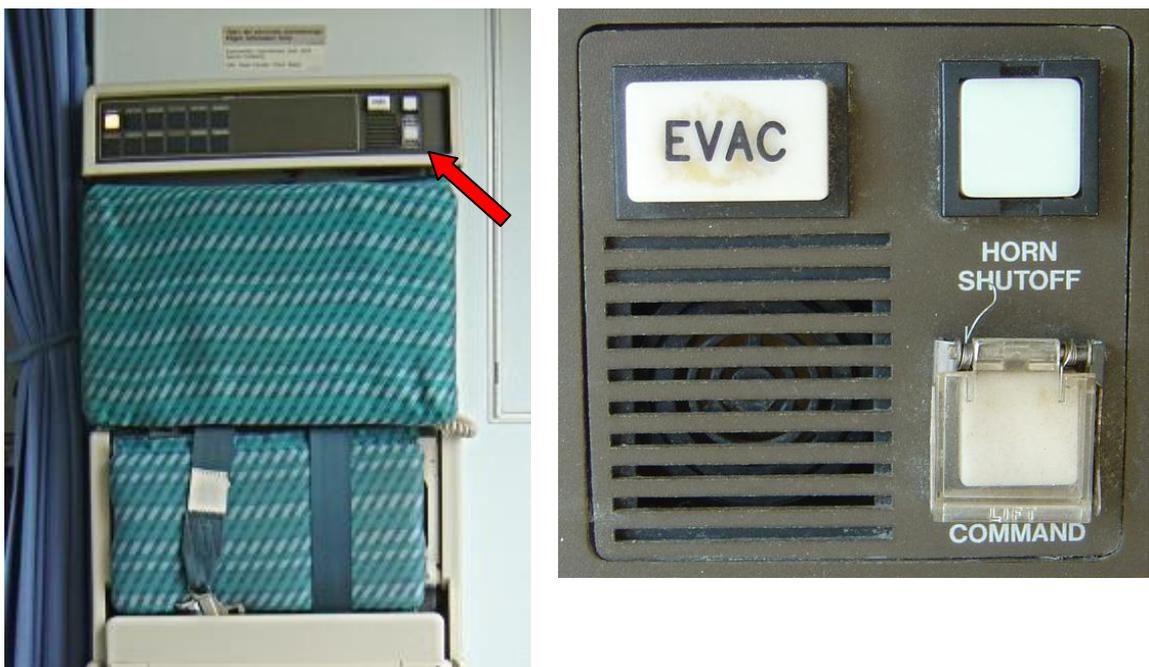
The cabin crew used evacuation commands adequate to the situation. EVAC system was activated at 3L door by CC5, who pressed the button.

Figure 6. Evacuation signaling system over CC5 seat.

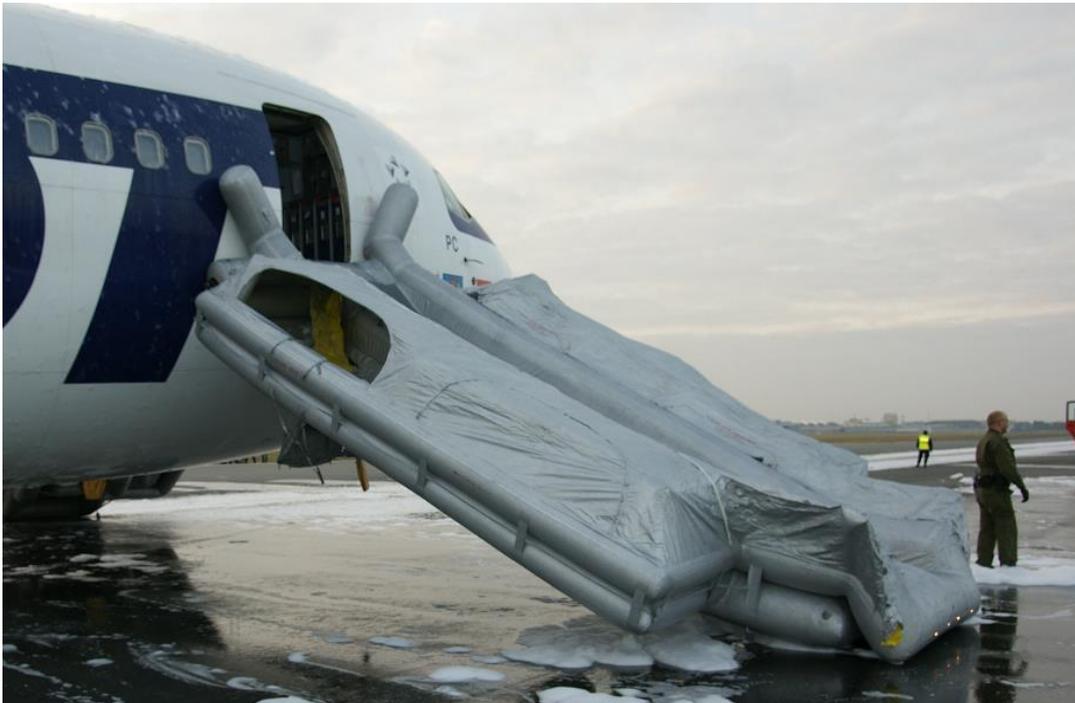
- CC4 and CC8 left the airplane via exit 1R;
- CC2, CC5, CC6, CC7, CC3, CC1, FO and CPT left the airplane via exit 3L.

Figure 7. Escape slide at door 1R

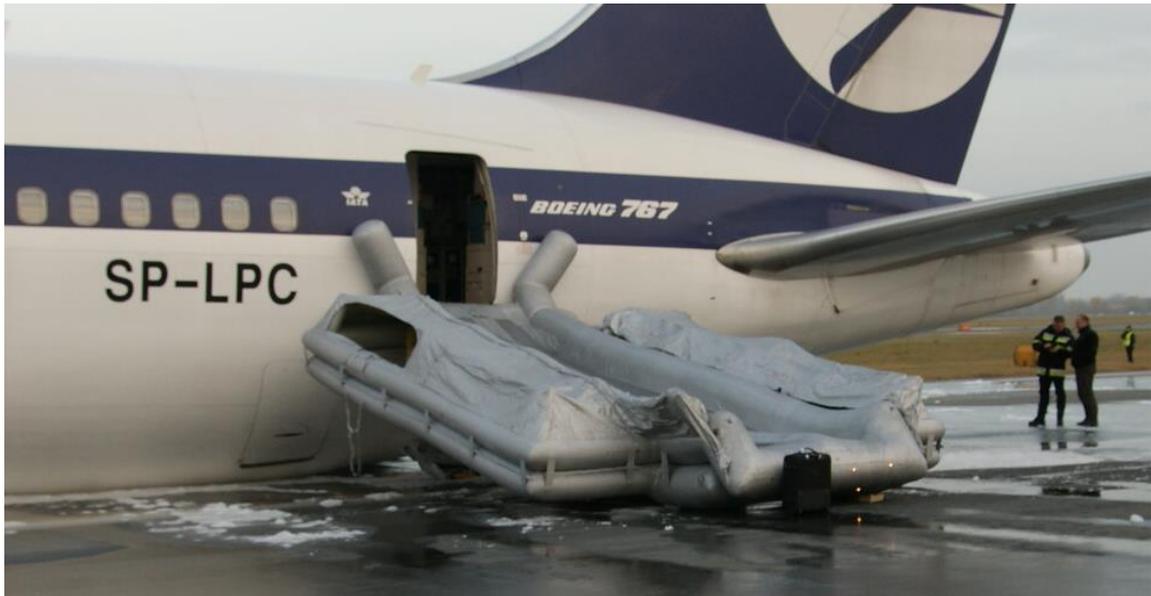
Figure 8. Escape slide at door 3L.

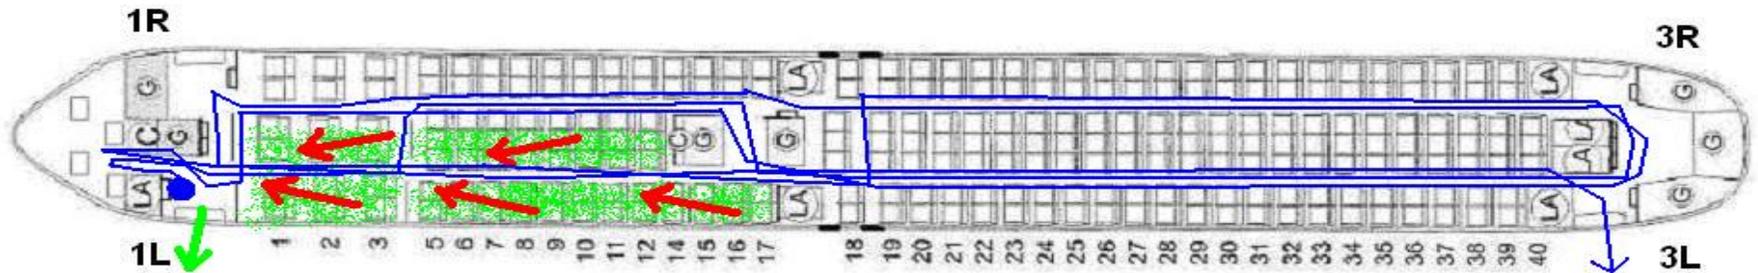
CC1 action zone

8. On CPT order took part in the arrangements for evacuation, participated in checking circuit breakers, removed from the cockpit and secured all loose objects

21. Entered the airplane twice via slide 3L

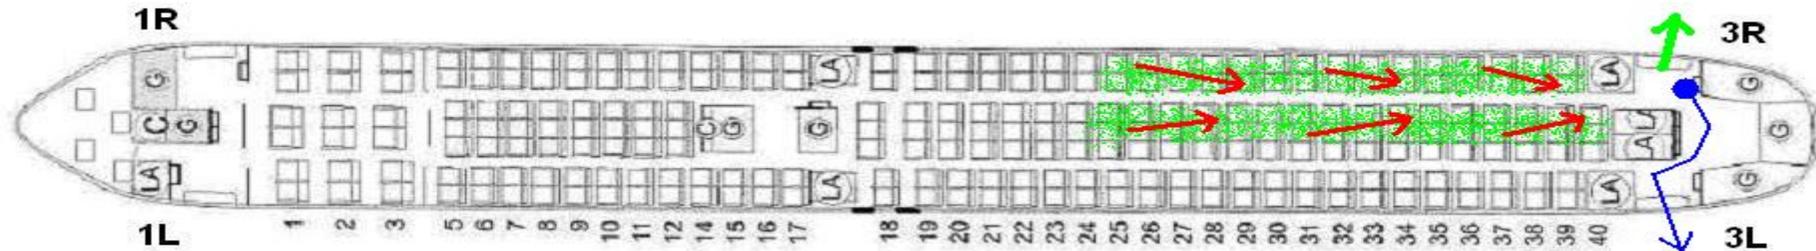
CC2 action zone

Duties and responsibilities, description from CCM	Actual actions
<ul style="list-style-type: none"> ✓ Receives information from C/C#1 ✓ Switches lighting in sections B and C on full ✓ During emergency announcement adopts position: B 767 300 – row 29 section C, right aisle ✓ Prepares passengers for emergency landing or ditching: B 767 300 – rows 25-40 (emergency landing), 22-40 (ditching) – right aisle ✓ Designates and instructs two APs to assist by the door 3R AP seats: B 767 300 – 39 F , 40 E ✓ Checks and prepares rear galley, switches off the electrical devices of the galley ✓ Checks doors 3R and 3L armed ✓ Reports readiness to C/C#1 ✓ Reduces lighting in sections B and C to overwindow lights, switches off the light in the rear galley ✓ Takes emergency landing or ditching seat – jumpseat 3R ✓ Switches off the overwindow lights ✓ On command adopts emergency position and keeps it until aircraft has come to a complete rest ✓ After emergency landing and ditching evacuates passengers via door 3R ✓ Takes flashlight, megaphone, ELT and first aid kit type A ✓ Evacuates via door 3R 	<ol style="list-style-type: none"> 1. Received all necessary information from C/C#4 and C/C#8 2. Switched lighting in section B and C on full 3. During the emergency announcement took the seat according to the applicable procedure 4. Prepared passengers in the assigned sections 5. Designated and instructed APs for exit 3R 6. Removed the galley and aisle curtains 7. Checked doors 3R and 3L armed 8. Switched off the galley power supply 9. Reported cabin readiness to C/C#1 10. Reduced lighting in sections B and C 11. Took jumpseat 3R 12. Without „BRACE POSITION” command started shouting out own commands 13. Evacuated passengers via door 3R 14. Received report „THE BOARD CLEAR” from C/C #7 15. Left the airplane via door 3L at 13:40:39 hrs UTC 16. After evacuation entered the airplane via slide 3L

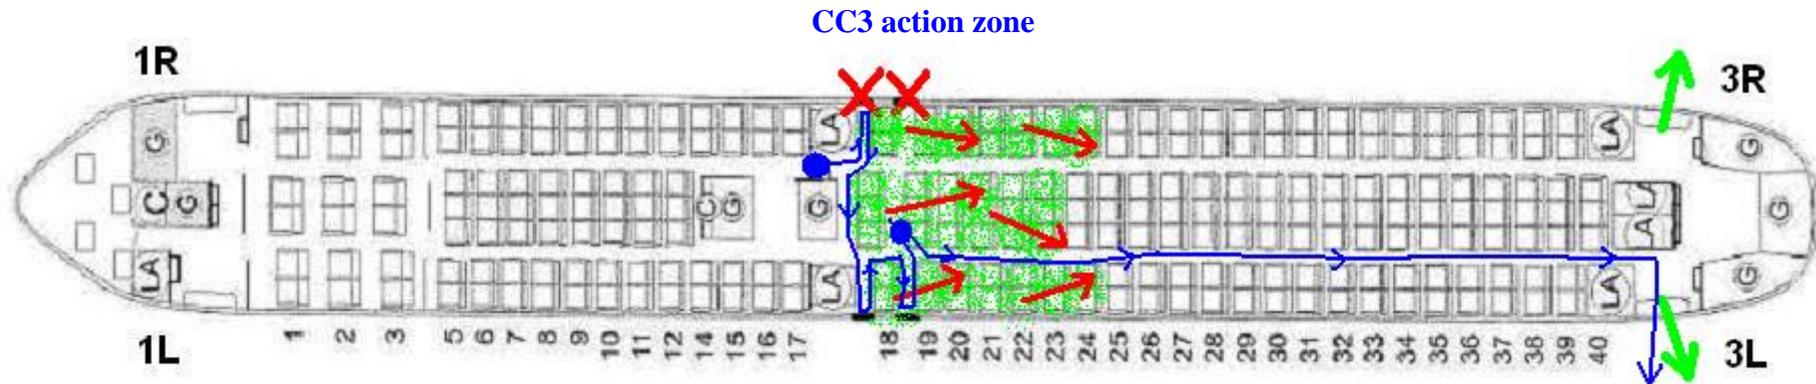
Duties and responsibilities, description from CCM	Actual actions
<ul style="list-style-type: none"> ✓ Receives information from C/C#1 ✓ During emergency announcement adopts position: B 767 300 – row 5, right aisle ✓ Prepares passengers for emergency landing or ditching: B 767 300 – rows 5-24 (emergency landing), 5-21 (ditching) –right aisle ✓ Designates and instructs 2 or 8 APs to help: B 767 300 – emergency over-wing exits 2R1, 2R2, 2L1, 2L2 APs seats (respectively) 18FG, 19FG, 18AB, 19AB ✓ Prepares middle galley, switches off electrical devices and the lighting of the galley ✓ For ditching : (along with 2 APs or one AP and C/C#6 and C/C#7) checks the additional raft ✓ Removes handles protection in emergency over-wing exits ✓ Reports readiness to C/C#1 ✓ Takes emergency landing or ditching seat B 767 300 - jumpseat 2R ✓ On command adopts emergency position and keeps it until aircraft has come to complete stop ✓ After emergency landing evacuates passengers via : B 767 300 – over-wing exit 2R1, 2R2, 2L1, 2L2 (passengers from seven rows 18-24) ✓ After ditching directs passengers to: B 767 300 - front exits 1R and 1L (passengers from four rows 18-21) and rear exits 3R and 3L (remaining passengers from section C) ✓ Takes flashlight and first aid kit type E ✓ Checks section C ✓ Evacuates via the closest exit 	<ol style="list-style-type: none"> 1. Received the information from C/C#2 2. Learned about the emergency landing from the emergency announcement 3. During the emergency announcement took the position according to the applicable procedure 4. Prepared passengers in the assigned sections 5. Designated and instructed APs for over-wing exits 2R1, 2R2, 2L1 and 2L2 6. Designated 2 APs 7. Removed the galley and aisle curtains 8. Switched off the galley power supply 9. Reported cabin readiness to C/C#1 10. Took jumpseat 2R 11. After „BRACE POSITION” command issued by C/C#1 via PA started shouting out own commands 12. Did not open exits on the right side - hazard 13. Opened over-wing exits from the left side 14. Did not evacuate anybody via emergency over-wing exit 15. Directed passengers to doors 3R and 3L 16. Checked section C and reported „THE BOARD CLEAR” 17. Left the airplane via door 3L at 13:40:38 hrs UTC 18. After evacuation entered the airplane via slide 3L

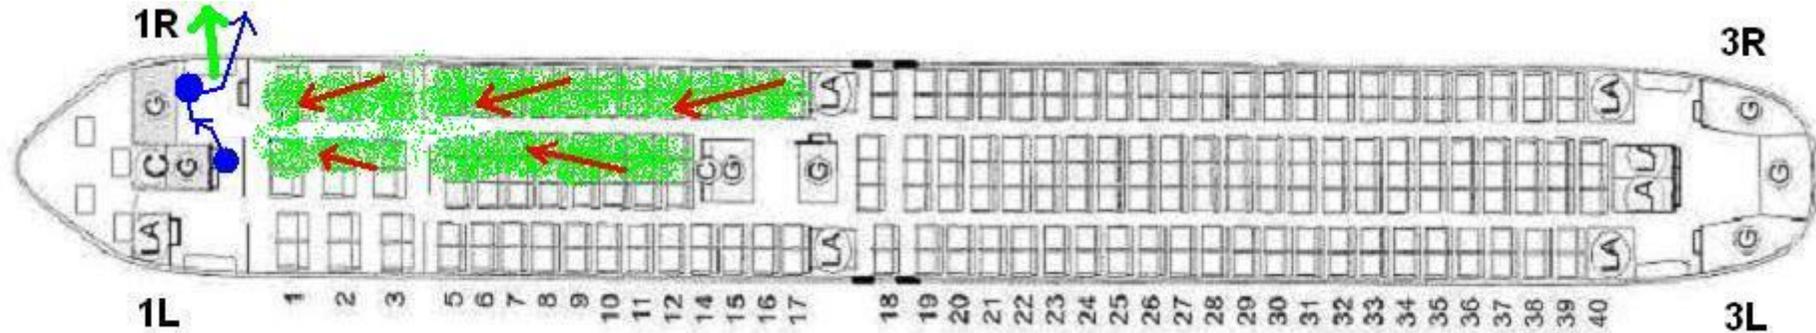
CC4 action zone

Duties and responsibilities, description from CCM	Actual actions
<ul style="list-style-type: none"> √ Receives information from C/C#1 √ During emergency announcement adopts position: row 1, right aisle √ Prepares passengers for emergency landing or ditching B 767 300 – rows 1-3 ABCDEF (section A) √ Designates and instructs 2 APs to assist by door 1R AP seats - 1 DE √ Prepares front galley, switches off electrical devices of the galley √ Checks doors 1R and 1L armed √ Reports readiness to C/C#1 √ Takes emergency landing or ditching seat – jumpseat 1RC √ On command adopts emergency position and keeps it until aircraft has come to complete stop √ After emergency landing and ditching evacuates passengers via door 1R √ Takes flashlight and first aid kit type A √ Checks sections A and B √ Evacuates via the closest exit 	<ol style="list-style-type: none"> 1. Received information about the emergency landing from C/C#1 2. During the emergency announcement did not take the position according to the applicable procedure 3. On C/C#1 order read the emergency announcement 4. Prepared passengers in the assigned section 5. Designated and instructed APs for exit 1R 6. Switched off the galley power supply 7. Checked doors 1R and 1L armed 8. Reported cabin readiness to C/C#1 9. Took jumpseat 1RC 10. After „BRACE POSITION” command issued by C/C#1 via PA started shouting out own commands 11. Evacuated passengers via door 1R 12. Did not check sections A and B 13. Received from C/C#8 „THE BOARD CLEAR” report 14. Reported to C/C#1 „THE BOARD CLEAR” 15. Left the airplane via door 3R - time unknown

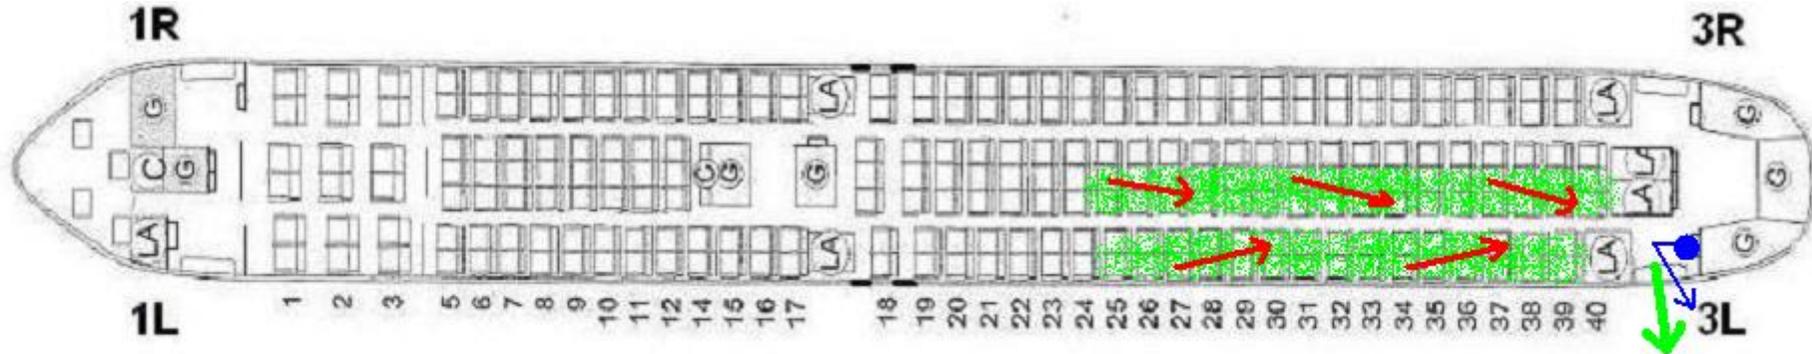
CC5 action zone

Duties and responsibilities, description from CCM	Actual actions
<ul style="list-style-type: none"> √ Receives information from C/C#1 √ During emergency announcement adopts position: B 767 300 - row 18, section C, left aisle √ Prepares passengers for emergency landing or ditching: B 767 300 – rows 25-40 (emergency landing) 22-40 (ditching) – left aisle √ Designates and instructs 2 APs to assist by door 3R AP seats: B 767 300 - 39B, 40C √ Checks doors 3L and 3R armed √ Reports readiness to C/C#1 √ Takes emergency landing or ditching seat – jumpseat 3L √ On command adopts emergency position and keeps it until aircraft has come to a complete stop √ After emergency landing and ditching evacuates passengers via door 3L √ Takes flashlight √ Evacuates via door 3L 	<ol style="list-style-type: none"> 1. Received information about the emergency landing from C/C#2 2. During the emergency announcement took the position according to the applicable procedure 3. Prepared passengers in the assigned section 4. Designated and instructed APs for exit 3L 5. Checked doors 3L and 3R armed 6. Reported cabin readiness to C/C#1 and C/C#2 7. Took jumpseat 3L 8. Without „BRACE POSITION” command started shouting out own commands 9. Evacuated passengers via door 3L 10. Checked section C 11. Received reports and reported „THE BOARD CLEAR” to C/C#2 12. Left the airplane via exit 3L at 13:40:42 hrs UTC 13. After evacuation gathered and directed the passengers running on the runway

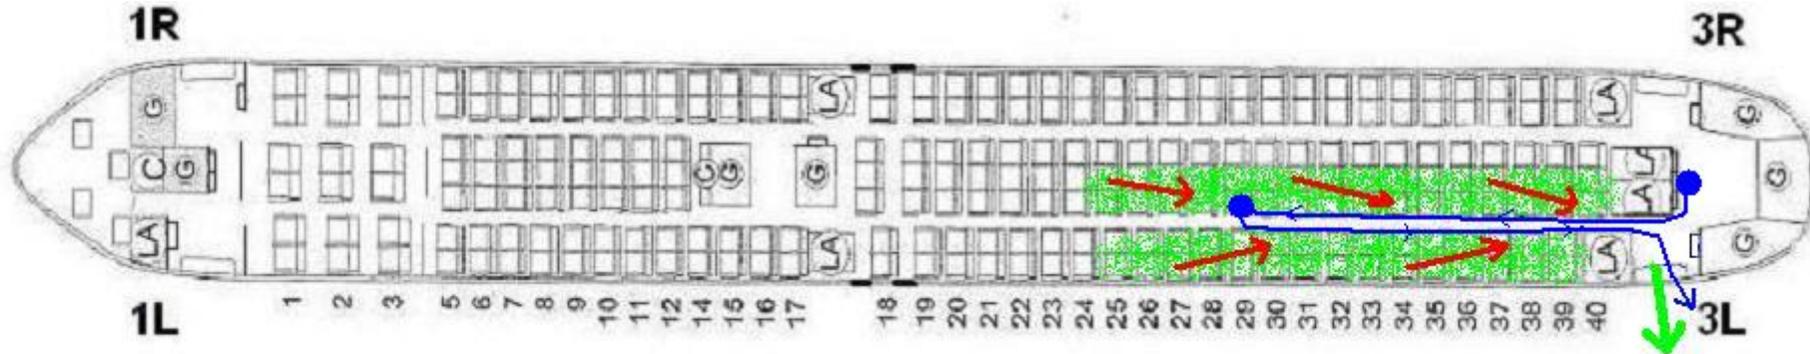
CC6 action zone

Duties and responsibilities, description from CCM	Actual actions
<ul style="list-style-type: none"> √ Receives information from C/C#1 √ During emergency announcement adopts position : B 767 300 – row 5, left aisle √ Prepares passengers for emergency landing or ditching B 767 300 – rows 5-24 (emergency landing), 5-21 (ditching) – right aisle √ Designates and instructs 4 APs to direct the passengers: B 767 300 landing, AP seats : 25 BC, 25 EF B 767 300 ditching, AP seats: 22 BC, 22 EF √ Reports readiness to C/C#1 √ Takes emergency landing or ditching seat B 767 300 jumpseat 3C √ On command adopts emergency position and keeps it until aircraft has come to a complete rest √ After emergency landing evacuates passengers via exits: B 767 300 - directs to exits 3R and 3L and over-wing √ Takes flashlight √ Evacuates via the closest exit 	<ol style="list-style-type: none"> 1. Received information about the emergency landing from C/C#2 2. During the emergency announcement took the position according to the applicable procedure 3. Prepared passengers in the assigned section 4. Designated and instructed APs directing passengers 5. Reported cabin readiness to C/C#2 6. Took jumpseat 3C 7. Without „BRACE POSITION” command started shouting out own commands 8. Did not direct passengers to the emergency over-wing exits 9. Directed passengers to door 3L 10. Checked section C, left aisle 11. Left the airplane via exit 3L at 13:40:38 hrs UTC

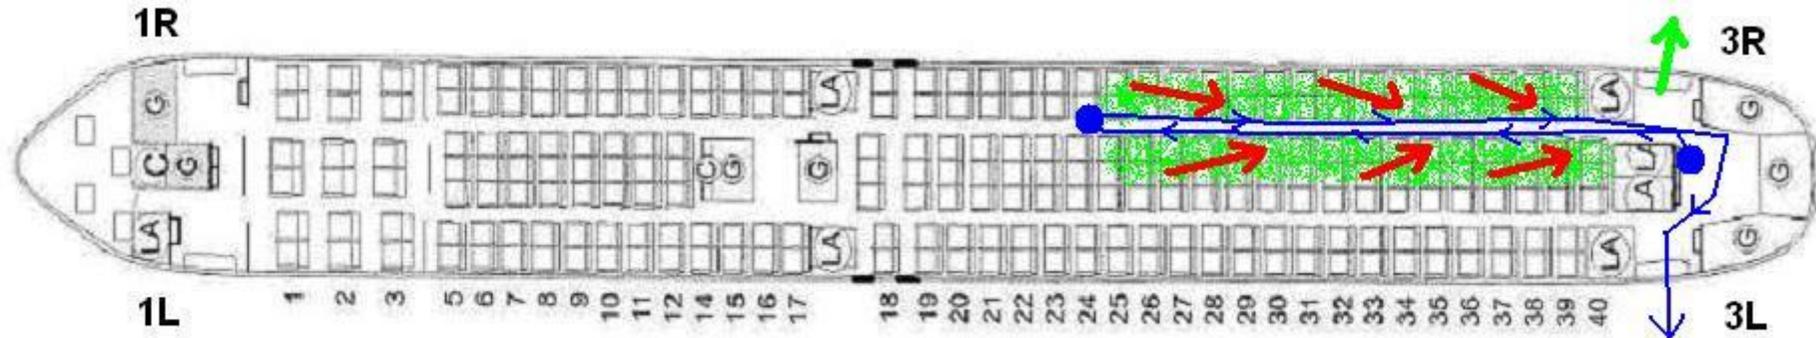
CC7 action zone

Duties and responsibilities, description from CCM	Actual actions
<ul style="list-style-type: none"> √ Receives information from C/C#1 √ During emergency announcement remains at C/C#1's disposal In case of full set of passengers on board his suggested position is: B 767 300 – row 18 section C, right aisle √ For emergency landing or ditching: B 767 300 – remains at C/C#1 disposal and follows his commands √ If necessary helps C/C#3 to check and prepare the additional raft √ Reports readiness to C/C#1 √ Takes emergency landing or ditching seat – jumpseat 3RC √ On command adopts emergency position and keeps it until aircraft has come to a complete stop √ After emergency landing follows C/C#1 commands √ In case of full set of passengers on board C/C#7 is suggested to direct the passengers to: B767300 – over-wing exits (passengers from first seven rows, section C) exits 3R and 3L (remaining passengers from section C) √ Takes flashlight √ Evacuates via the closest exit 	<ol style="list-style-type: none"> 1. Received information about the emergency landing from C/C#4 2. During the emergency announcement took the position according to the applicable procedure 3. Prepared passengers in section C 4. Helped to instruct APs directing passengers 5. Reported cabin readiness to C/C#2 6. Took jumpseat 3RC 7. Without „BRACE POSITION” command started shouting out own commands 8. Did not direct passengers to the over-wing exits 9. Directed passengers to door 3R 10. Checked section C, right aisle 11. Reported to C/C#2 „THE BOARD CLEAR” 12. Left the airplane via exit 3L at 13:40:44 hrs UTC

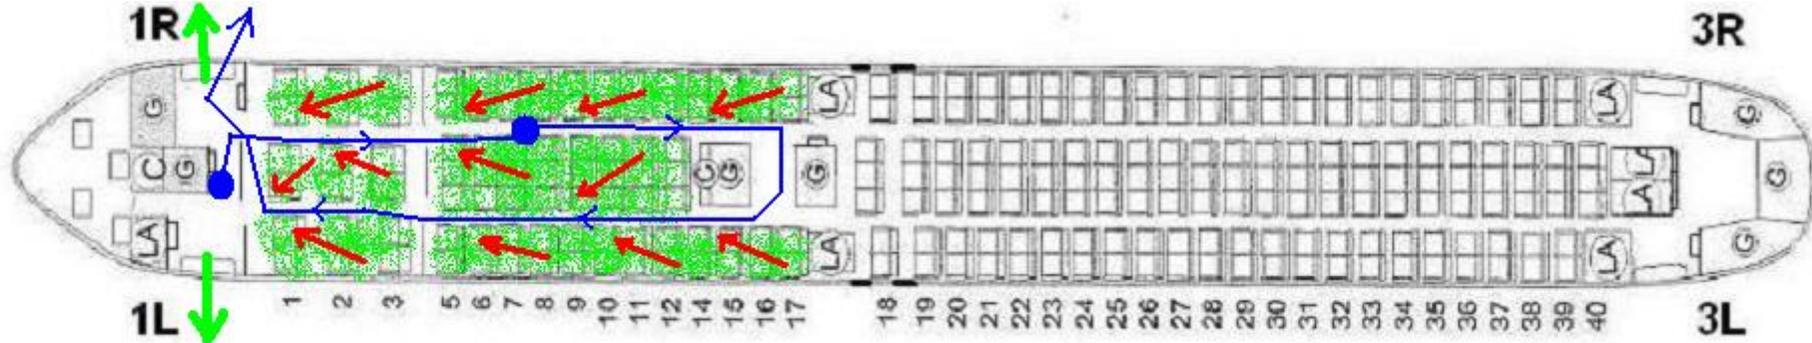
CC8 action zone

- √ Receives information from C/C#1
- √ During emergency announcement remains at C/C#1's disposal
In case of full set of passengers on board the suggested position is:
B 767 300 – row 29 section c, left aisle
- √ Prepares passengers for emergency landing or ditching:
B 767 300 – remains at C/C#1 disposal and follows his commands
- √ Reports readiness to C/C#1
- √ Takes emergency landing or ditching seat – **jumpseat 1LC**
- √ On command adopts emergency position and keeps it until aircraft has come to a complete rest
- √ **After emergency landing** follows C/C#1 commands
- √ In case of full set of passengers on board C/C#7 is suggested to direct the passengers to:
B767300 – exits 1L and 1R (passengers from sections A and B)
- √ Takes **flashlight**
- √ Evacuates via the closest exit

1. Received information about the emergency landing from C/C#1
2. During the emergency announcement took C/C#4 position (first row, right side)
3. Prepared passengers in section A
4. Designated and instructed APs for exit 1L
5. Reported cabin readiness to C/C#1 and C/C#4
6. Took jumpseat 1LC
7. After „BRACE POSITION” command issued by C/C#1 via PA started shouting out own commands
8. Directed passengers to door 1L and 1R
9. Checked sections A and B
10. Reported to C/C#4 „THE BOARD CLEAR”
11. Left the airplane via exit 1R at **13:40:.... hrs UTC**

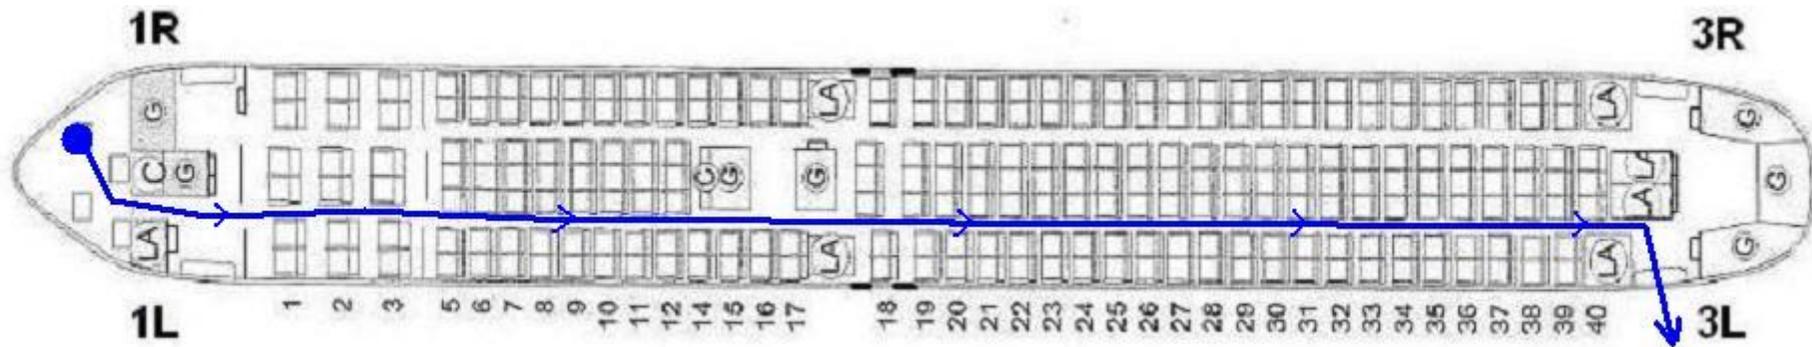
FO action zone

On Captain order FO checked the cabin to make sure that nobody remained on board the airplane.
He left the airplane at 13:41:28 hrs UTC.

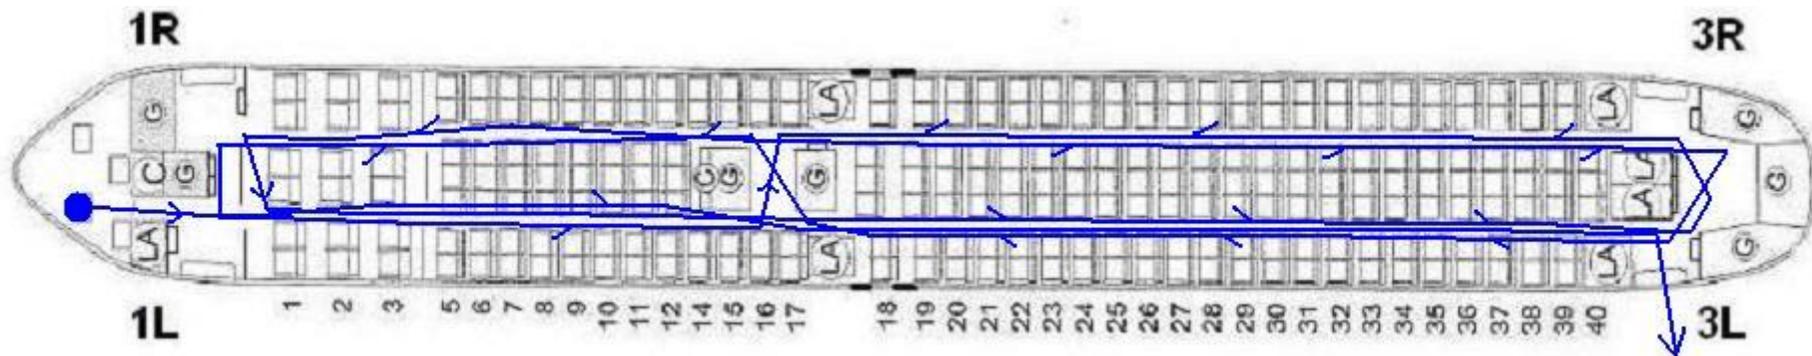
CPT action zone

CPT and CC1 were in the cabin for more than 5 minutes checking the cabin several times.
It was not determined when they left the airplane.

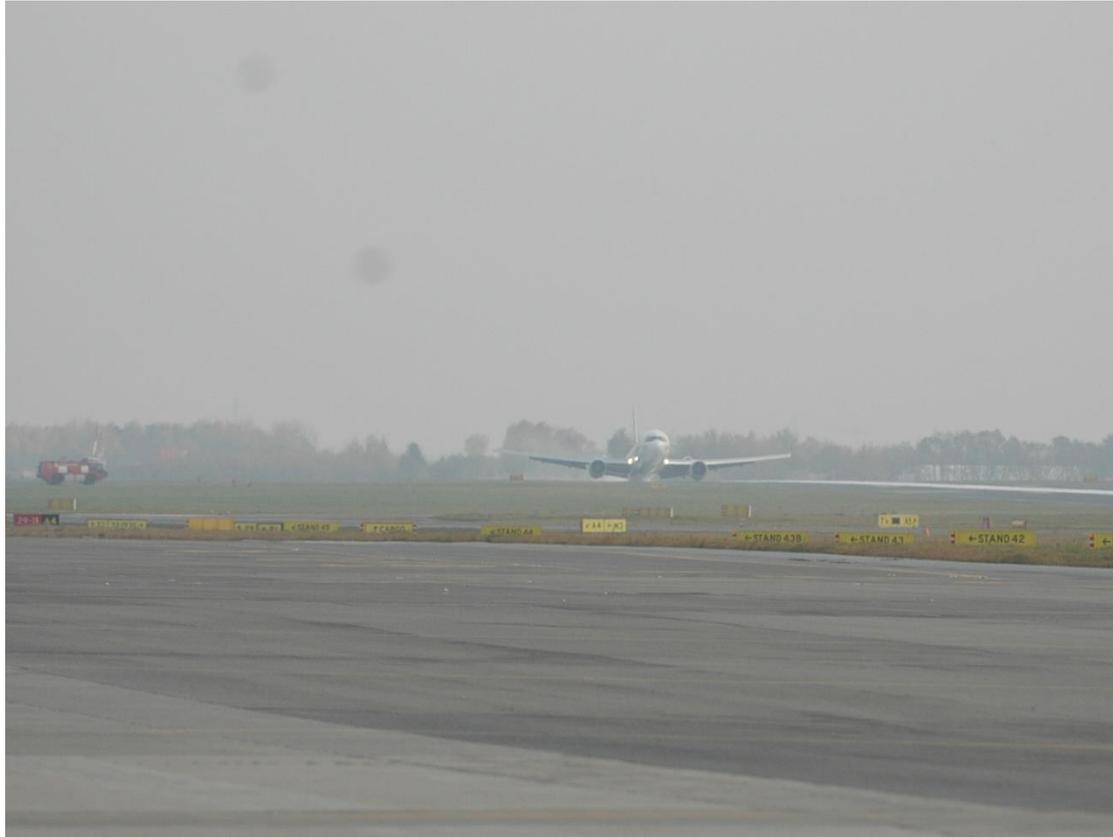
Photo 6. Touchdown of SP-LPC airplane.

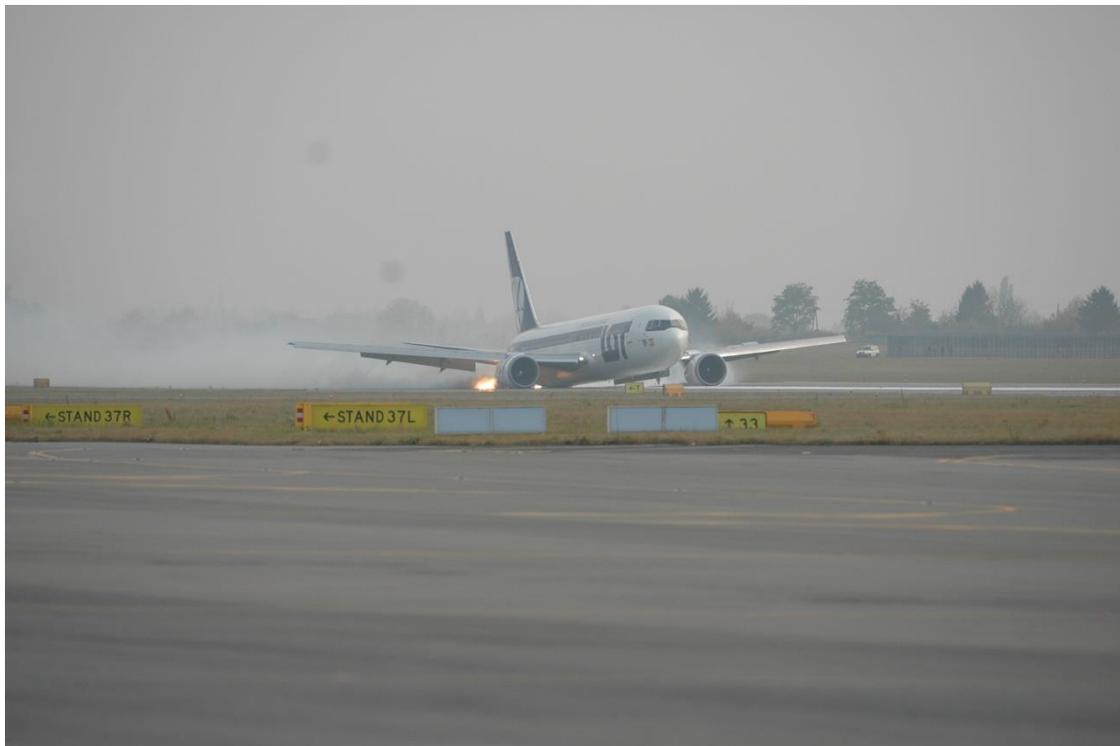
Photo 7. Landing roll of SP-LPC airplane and fire of the right engine.
