FINAL REPORT

ACCIDENT

Occurrence No.: 1400/11

Aircraft: B767-300ER, SP-LPC

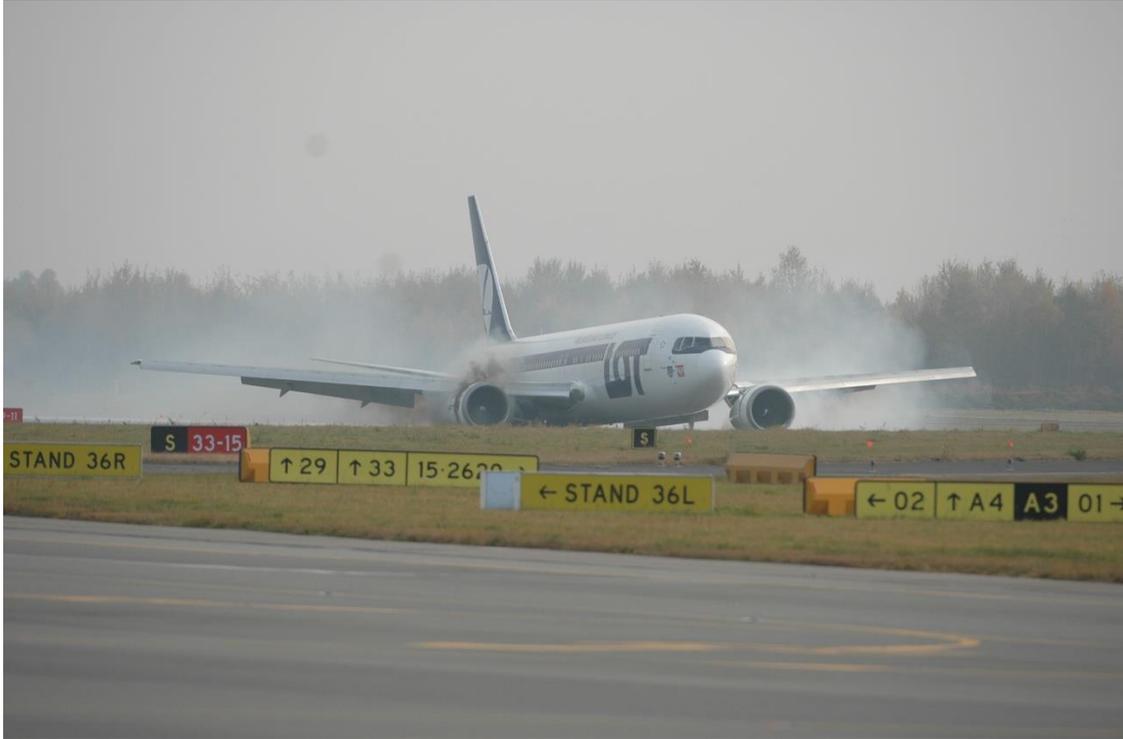
Photo 8. Stop of SP-LPC airplane.

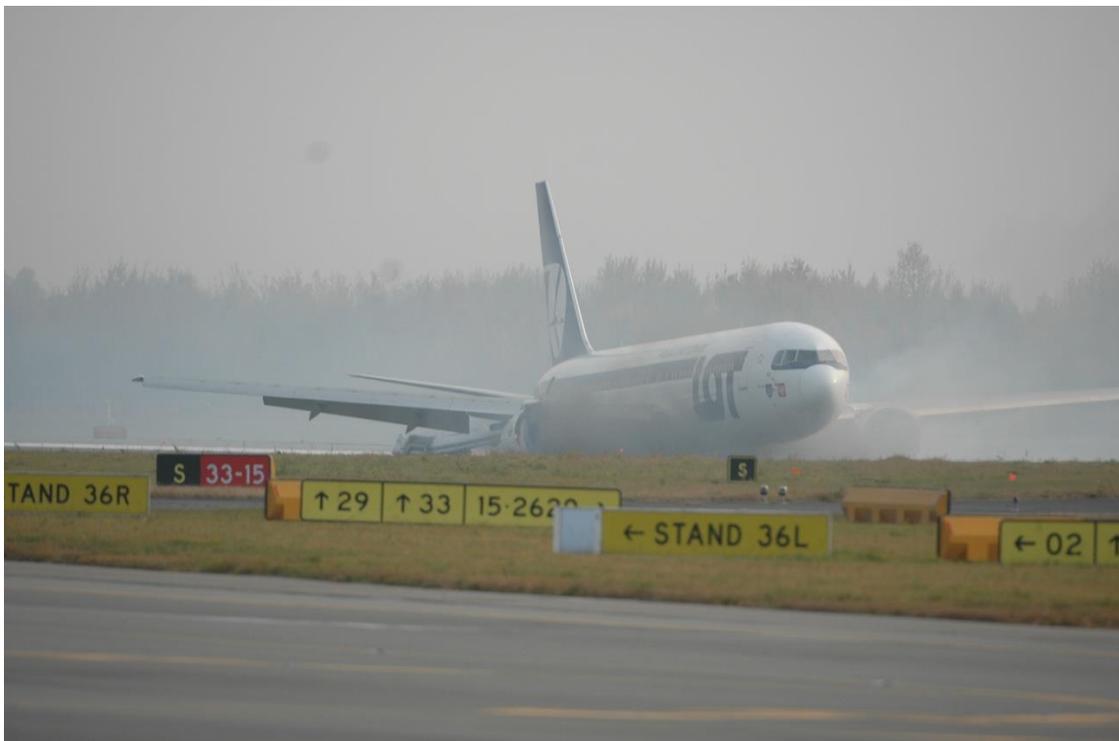
Photo 9. Deployment of the rear right emergency escape slide .

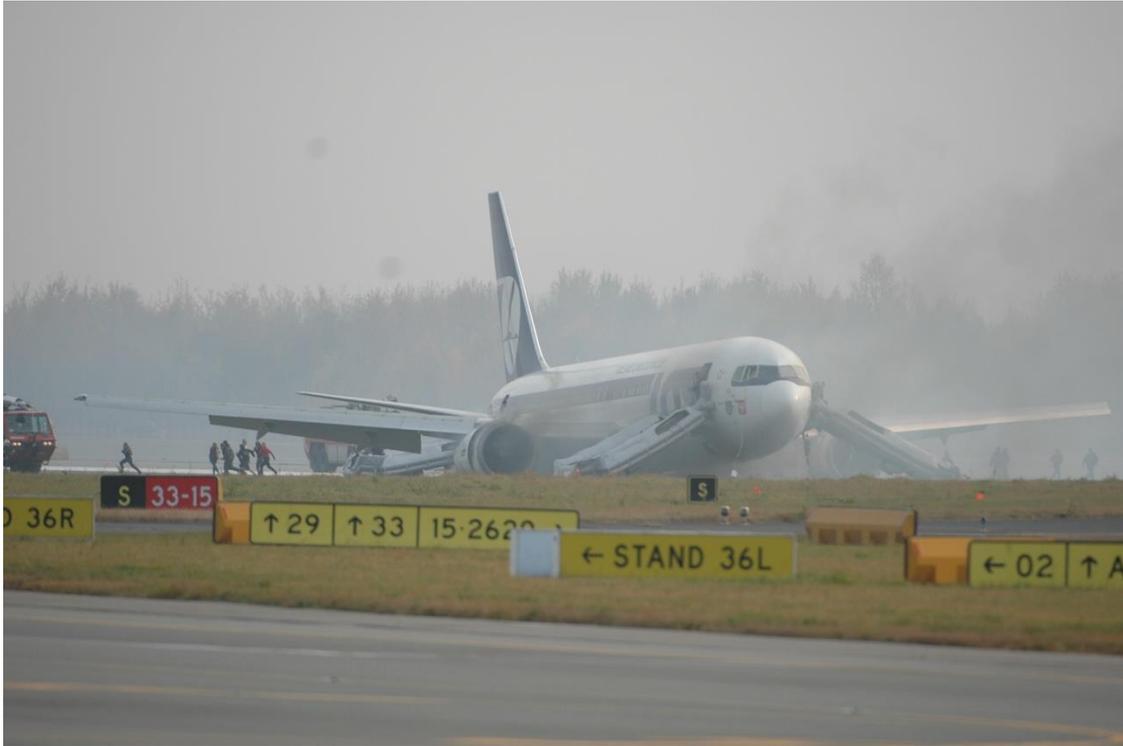
Photo 10. Deployed escape slides of SP-LPC airplane.

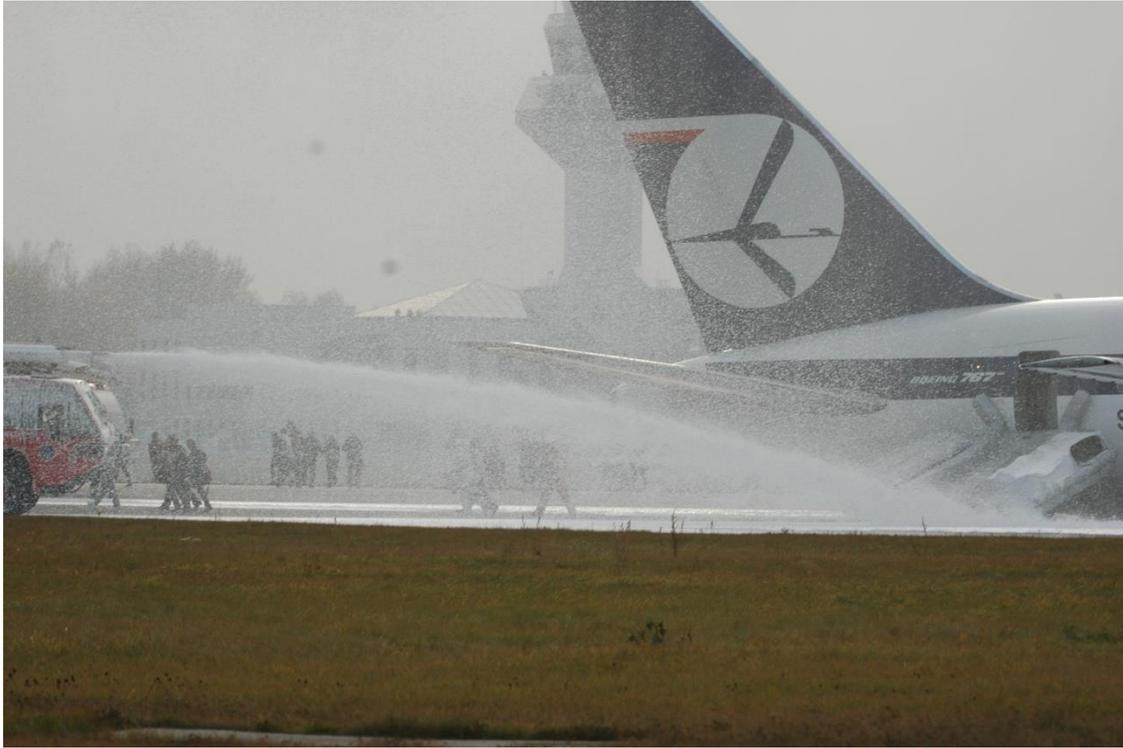
Photo 12. Firefighting action carried out from a vehicle of Airport Fire Brigade

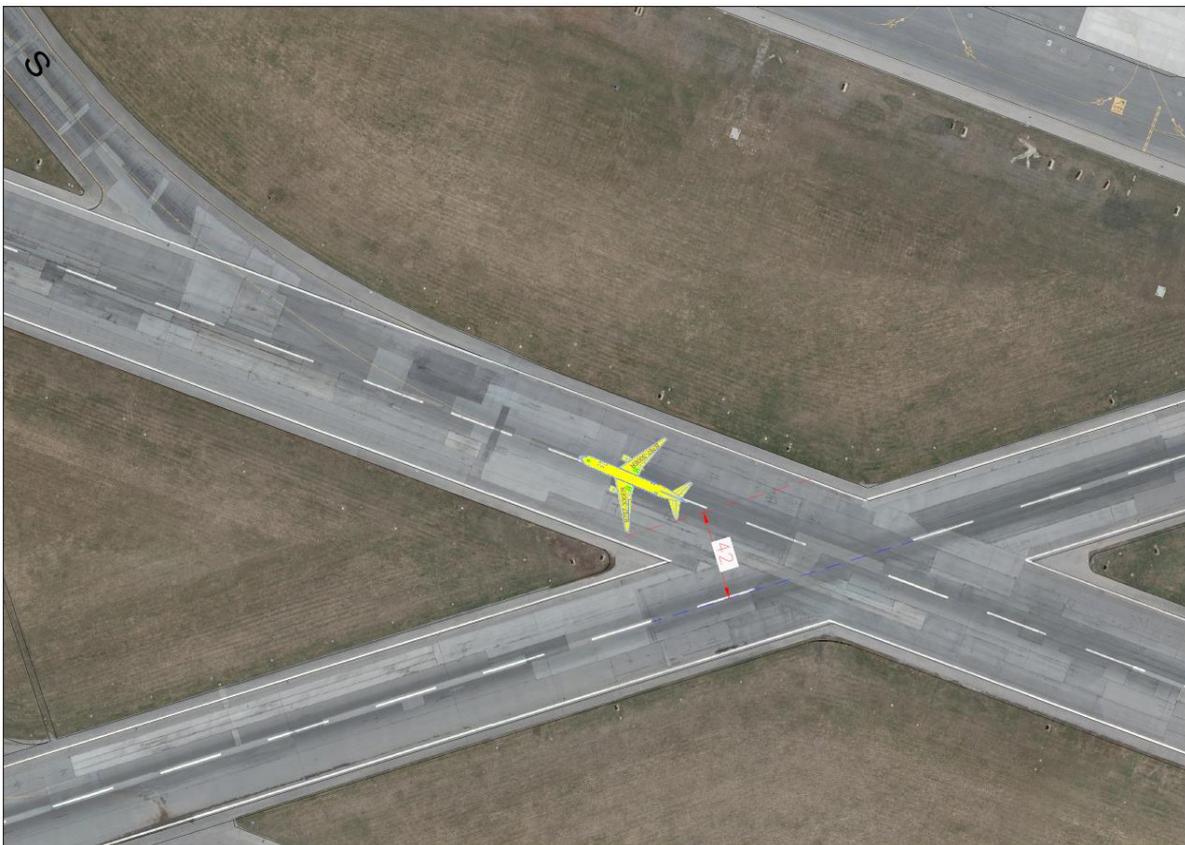
Photo 13. Stop place of SP-LPC airplane.
