Aircraft Accident Report

Operator: Sita Air Pvt. Ltd.

Aircraft Type and Model: Dornier 228-202(K)

Registration: 9N-AHA

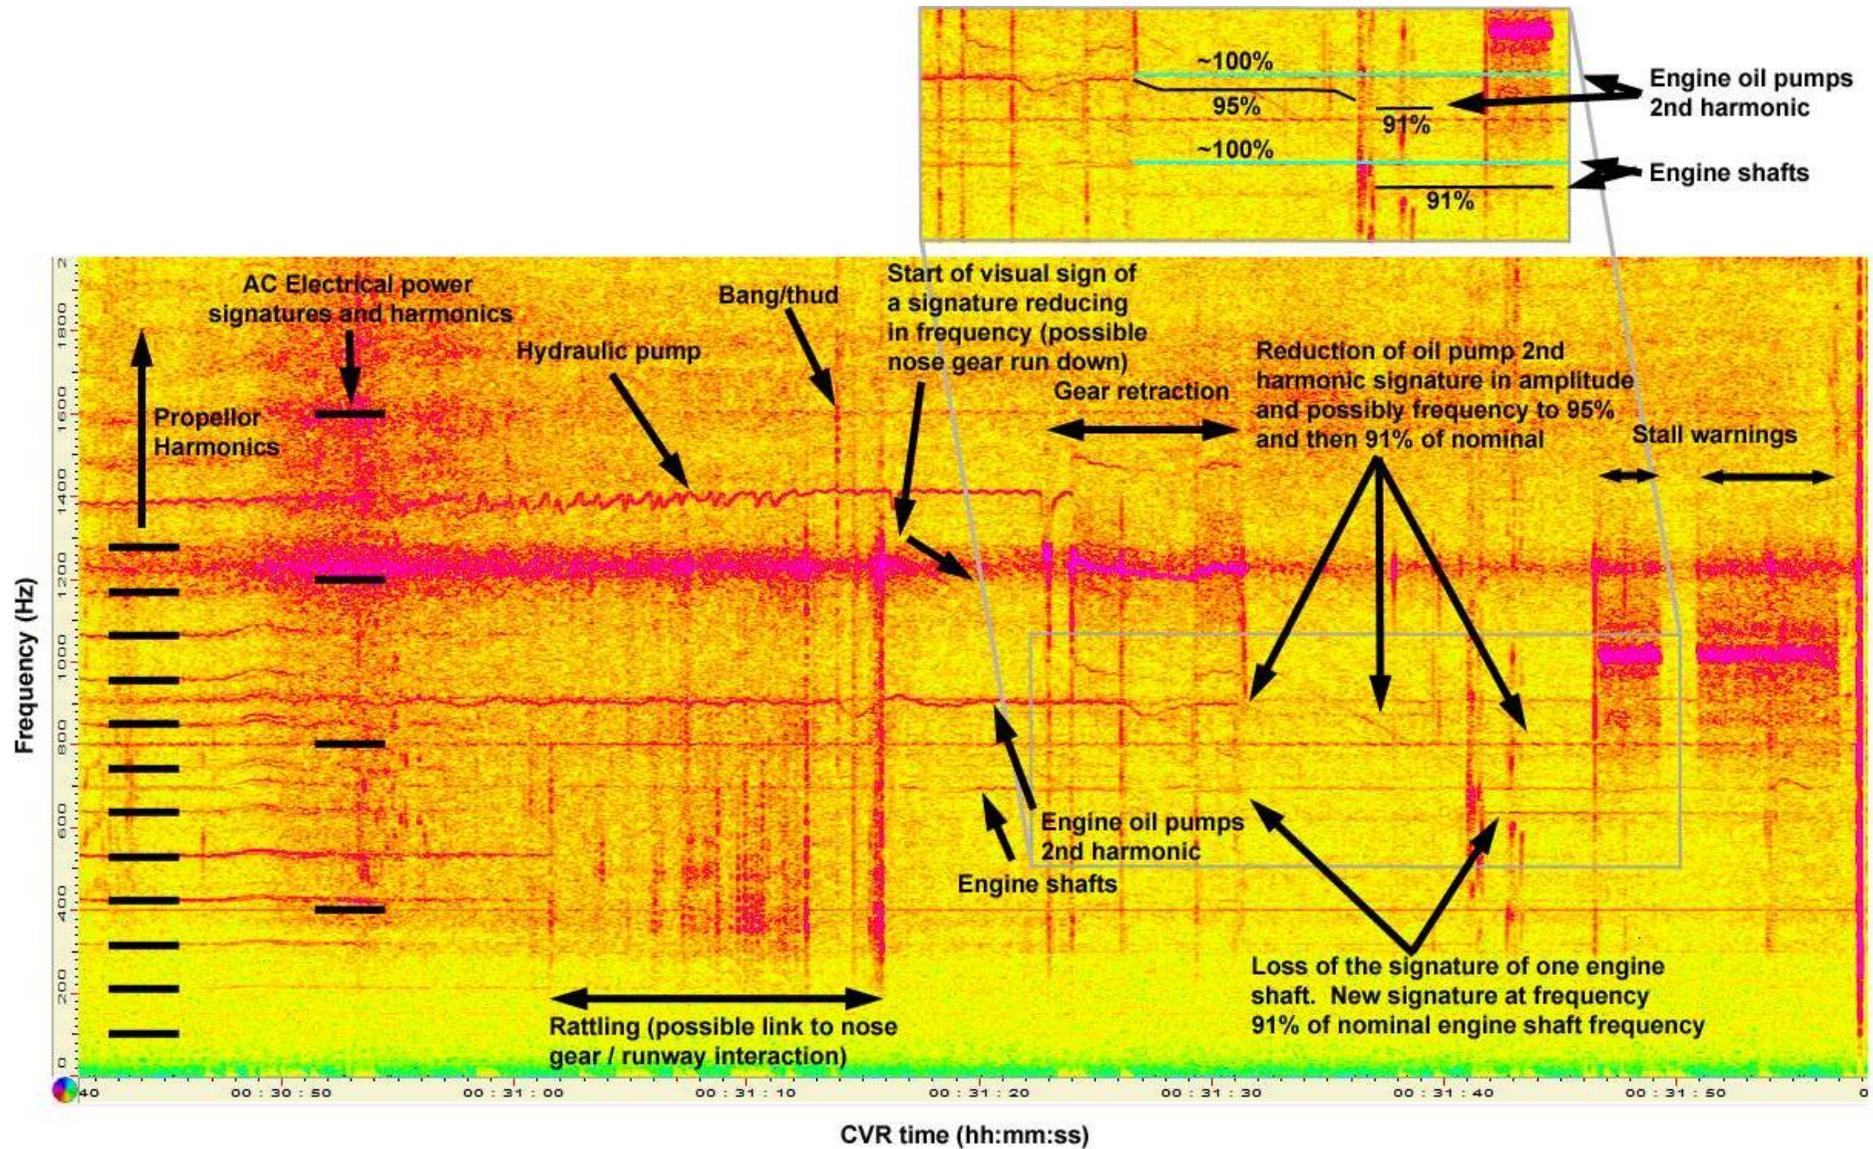
Figure 1.11-3.
Spectrum analysis of the CVR CAM channel

Spectrum analysis of the CVR CAM channel highlighted prominent features that have been associated with rotation rates, blade pass frequencies and gear teeth meshing frequencies of various propeller, engine or system parts during different phases of the accident flight. The key features are shown in Figure 1.11-3.

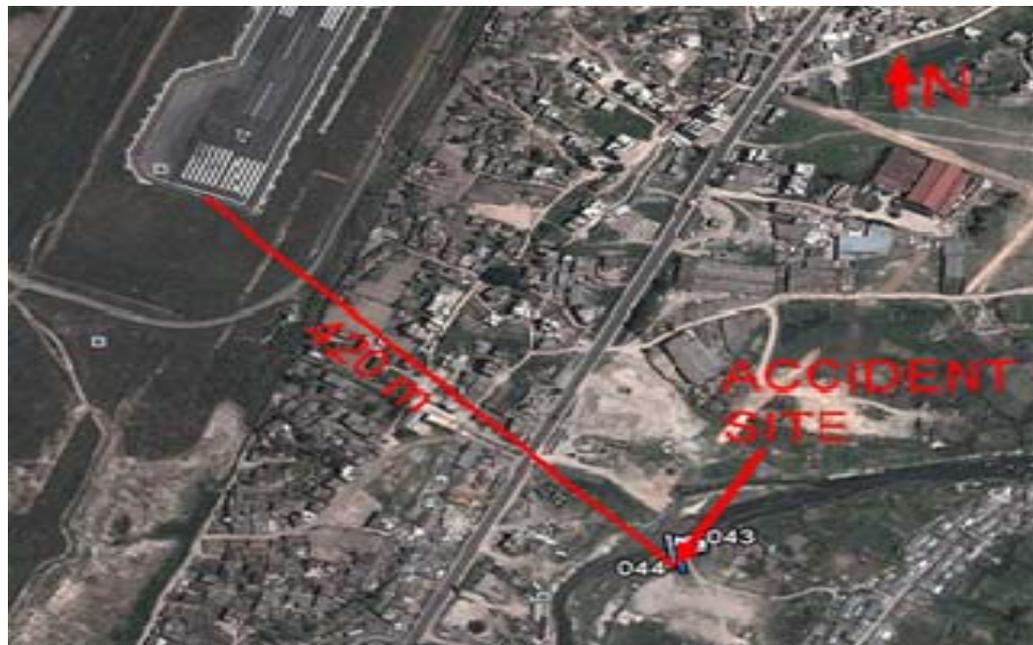
Figure 1.12-1
Location of accident site

The aircraft struck the ground on the banks of the Manohara river, 420 m south-east of the threshold of Runway 02 (Figure 1.12-1). The impact crater and ground marks indicated that the aircraft struck the ground in the approximate direction of $124^{\circ}M^6$. There was a large post-impact fire which consumed most of the aircraft, but the tail section was mostly intact and only minimally affected by fire. The wreckage was moved by rescue personnel so it was difficult to establish an accurate impact attitude, but the small size of the main wreckage field (approximately 17 m in diameter) indicated a steep impact with high vertical speed. Photographs taken by the media shortly after the accident revealed a large post-impact fire and showed the tail section, upright, with the front pointing towards the north-west (Figure 1.12-2) – opposite to the direction of travel at impact. This suggested that the aircraft hit the ground in a near vertical attitude with its upper surface facing towards the north-west, but with some horizontal speed towards the south-east.

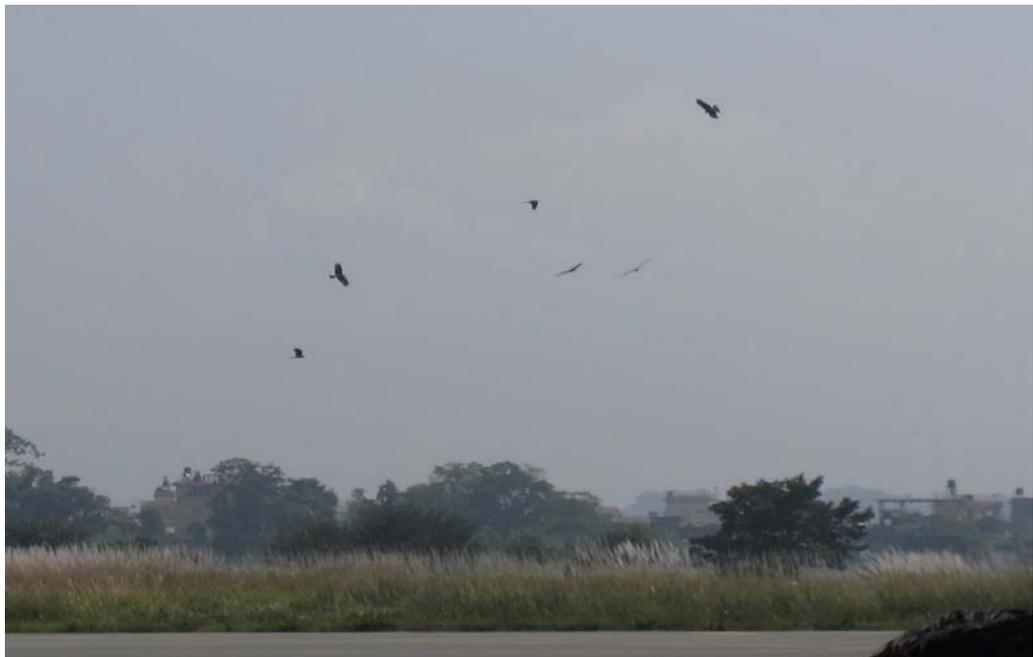
Figure 1.18-1
Birds over the runway at TIA on 3 October 2012

There are some bird dispersal techniques being applied at TIA to scare birds away from airports: ‘wailer’ units producing sonic and ultrasonic sound; ‘quad blaster’ ultrasonic units; gas cannons; scare crow visual equipment; patrols with personnel armed with weapons; earthworm control techniques; cleaning of the runway and taxiways; issuing of NOTAMs about bird activities; and a public awareness program. Despite applying these measures, bird activity remains an issue at TIA (Figure 1.18-1).

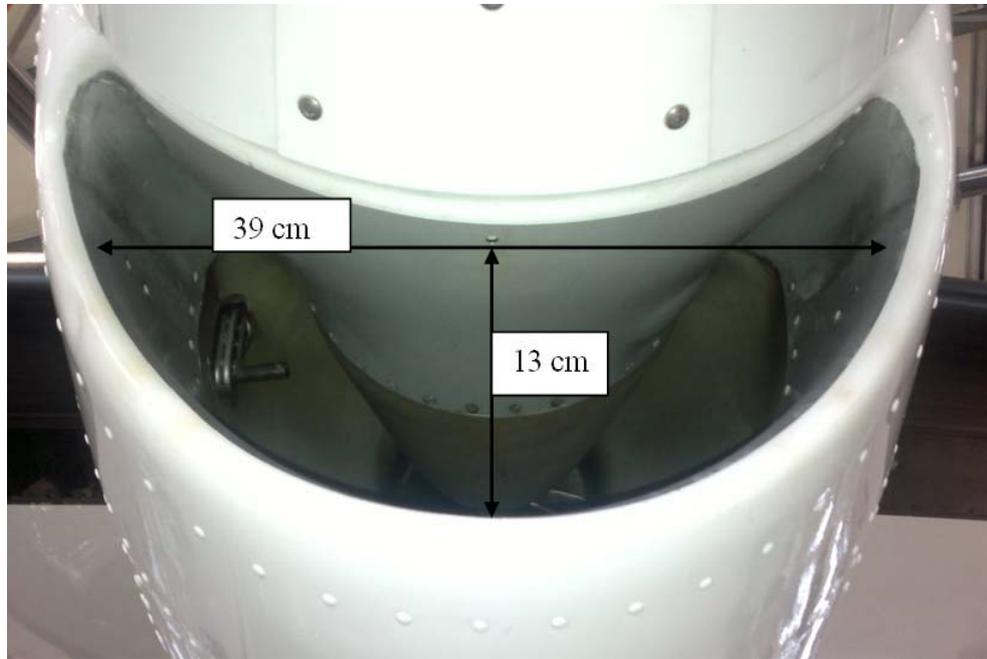
Figure 1.18-1
Dimensions of engine air intake

The engine air intake is U-shaped and is approximately 39 cm wide and 13 cm high in the centre (Figure 1.18-3).
