**AVIATION INVESTIGATION REPORT
A12Q0216**

**LOW-ENERGY REJECTED LANDING AND
COLLISION WITH TERRAIN**

**PERIMETER AVIATION LP
FAIRCHILD SA227-AC METRO III, C-GFWX
SANIKILUAQ, NUNAVUT
22 DECEMBER 2012**

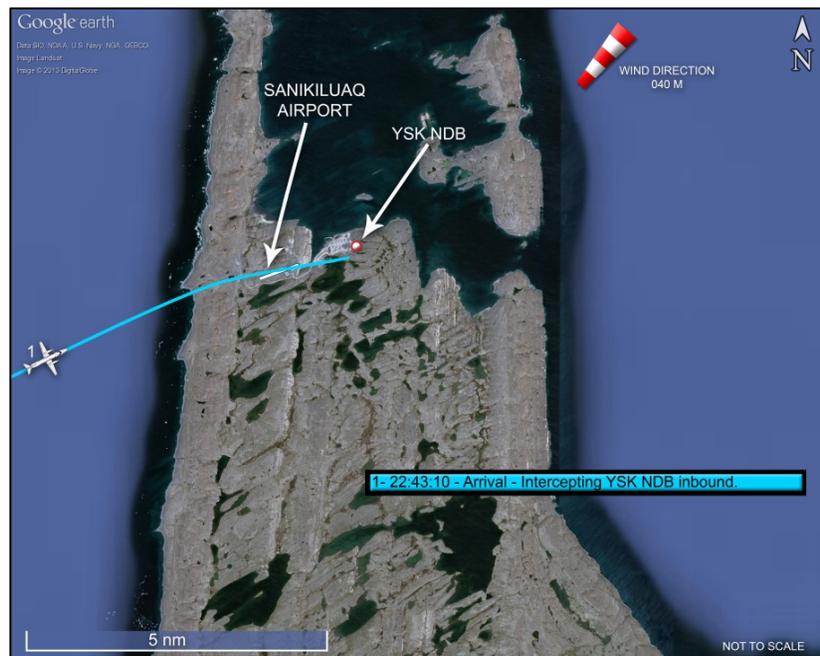
Figure 1. Approximate trajectory arriving at CYSK from the west
(Source: Google Earth, with TSB annotations)

arrival track. There is no published instrument approach for Runway 09 at CYSK. The crew's plan was to descend to the minimum safe altitude (MSA) of 1600 feet asl and, if the runway environment for landing Runway 09 could be seen, then a straight-in visual approach Runway 09 would be executed (Figure 1).

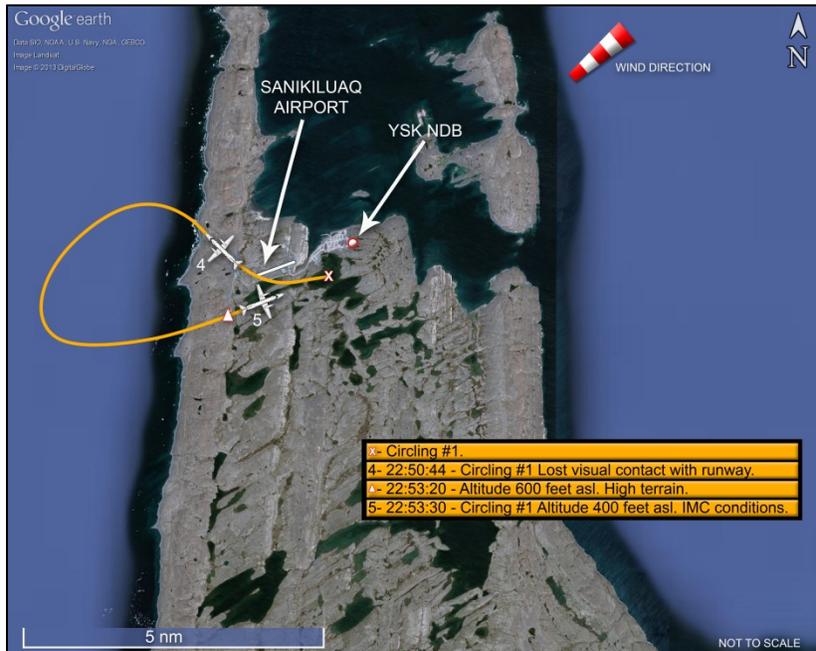
Figure 3. Approximate trajectory of the first circling (Source: Google Earth, with TSB annotations)

At 2253 UTC while continuing to circle in IMC, the aircraft descended to an indicated altitude of 400 feet, at a speed of 140 knots. The wind was pushing the aircraft south of the Runway 09 centreline in an area southwest of the runway where the terrain elevation is 223 feet asl, resulting in a height of 155 feet above ground level (agl) when applying cold temperature corrections (Figure 3).¹⁸

¹⁸ 400 feet above sea level (asl) – 223 feet terrain height = 177 feet above ground level (agl). Application of cold temperature corrections, the true altitude above ground was 155 feet agl. Terrain information is also available in the *Canada Flight Supplement*.

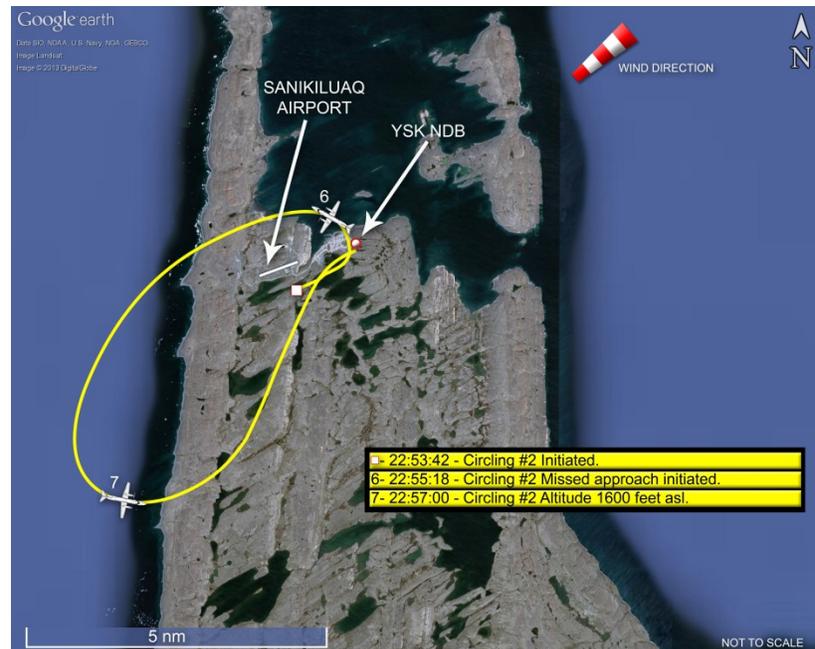
Figure 4. Approximate trajectory of the second circling (Source: Google Earth, with TSB annotations)

during this procedure, the FO reminded the captain that the MSA was 1600 feet. The captain responded 1500 feet, and no correction was applied; this error was not corrected by the FO. The aircraft continued to circle left and climb back towards the NDB (Figure 4).

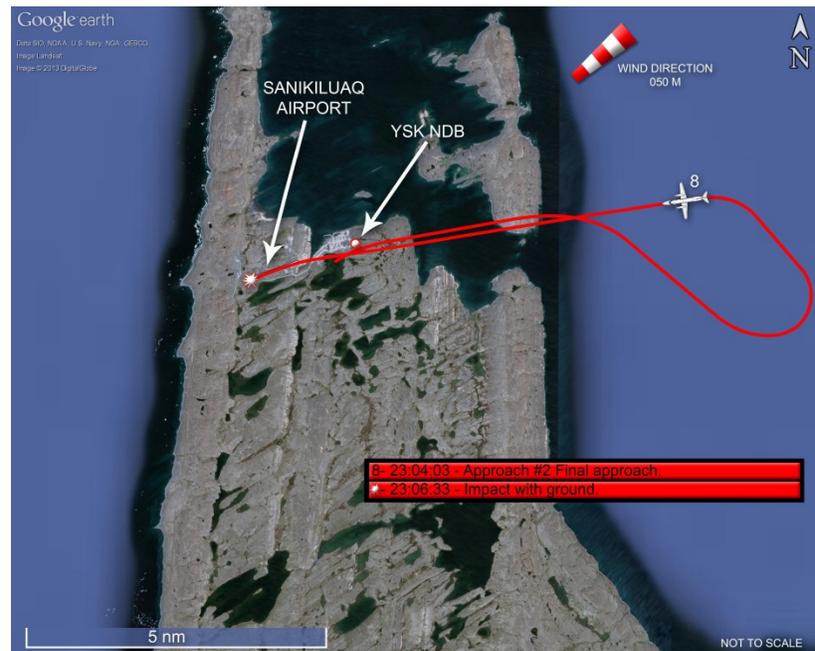
Figure 5. Approximate trajectory of the second approach (Source: Google Earth, with TSB annotations)

The captain indicated this would be the last attempt at landing at CYSK. They would then proceed to the flight-planned alternate, CYGW, approximately 30 minutes away. Fuel at this time was 1000 pounds, giving approximately 1.6 hours of flight. The full procedure turn was once again flown on the opposite side of the published procedure, this time at an indicated altitude of 1500 feet (1389 feet asl when applying cold temperature corrections), 211 feet below the published MSA of 1600 feet asl (Figure 5).

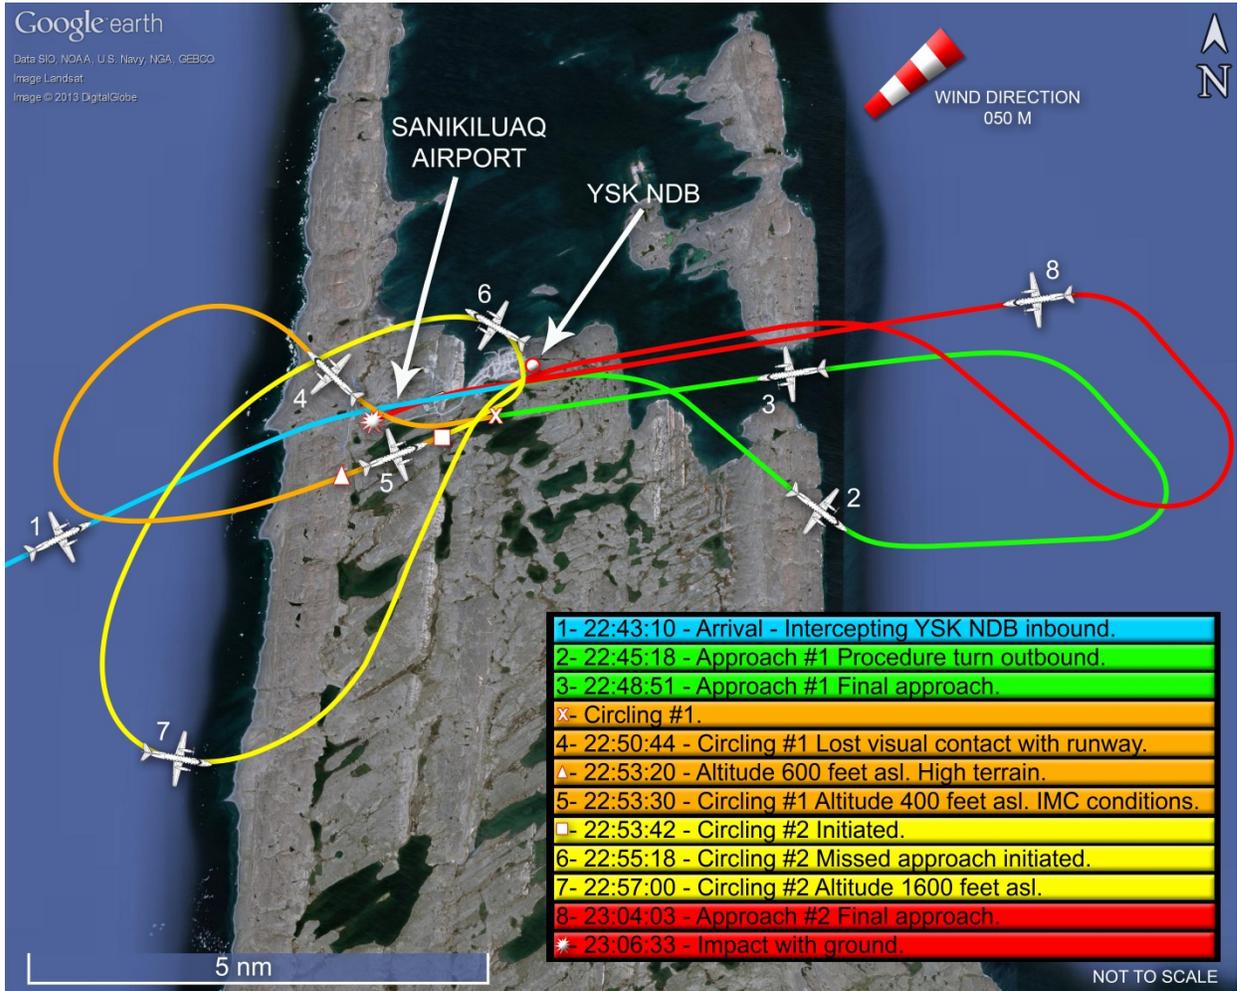
Appendix B – Flight path

Appendix B shows a compilation of all flight trajectories during the attempted landings at CYSK. The aircraft arrived from the west, and the wind direction was slightly left of the

As the aircraft came abeam and south of the runway, the crew sighted the runway again but were not in a position to land on Runway 09. Initially, a second circling manoeuvre for Runway 09 was commenced (Appendix B). While in the left turn, visual contact with the runway was lost again. At 2255 UTC, a missed approach was initiated north of the runway. However, the missed approach procedure as published was not followed (Appendix A).¹⁹ Twice in quick succession

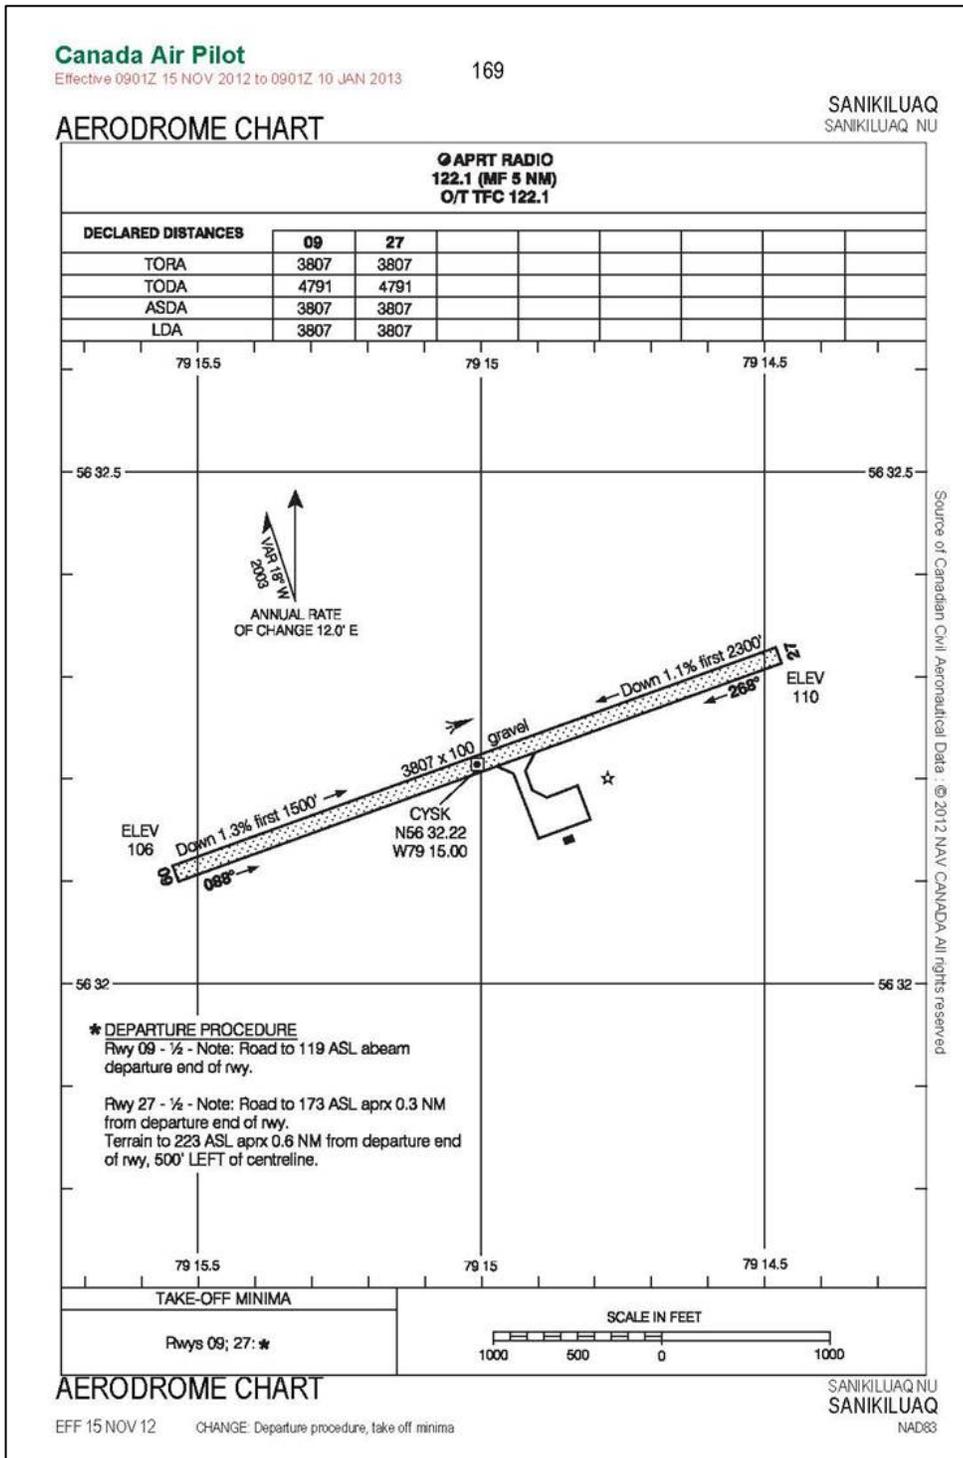
Appendix C – Sanikiluaq, NU (CYSK) aerodrome chart

overlay approach, to navigate towards the airport. The GPS was set up to navigate to the airport reference point, located at the centre point of the runway, to provide the crew with the approximate distance of the aircraft from the threshold of Runway 27 and more precise tracking to the airport (Appendix C).
