Final Report No. 2205 by the Swiss Accident Investigation Board SAIB

concerning the accident involving the
Embraer EMB-505 aircraft, CN-MBR

on 6 August 2012

St. Gallen-Altenrhein (LSZR) regional
aerodrome, Thal/SG municipality

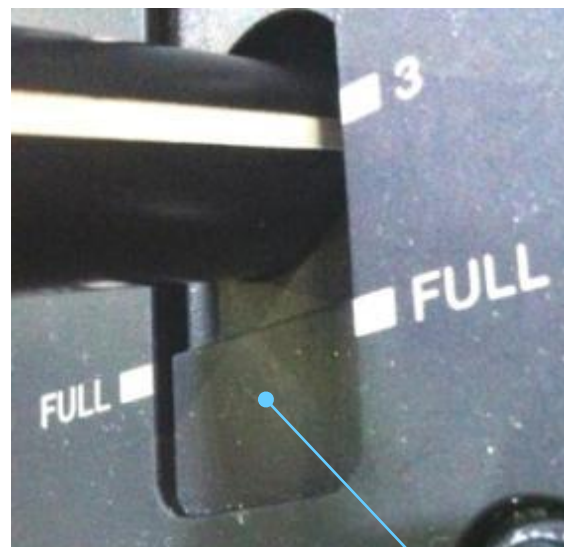
Figure 27: FSL with mechanical stopper

In addition, it was also examined whether the FSL had a so-called stopper present, which prevents the flap selector lever from being set in the FULL position, as this position is not permitted. Figure 26 was taken on the day of the accident in the cockpit of CN-MBR. There was no stopper fitted. Figure 27 shows the fitted stopper. This picture was taken on another Phenom 300 aircraft.

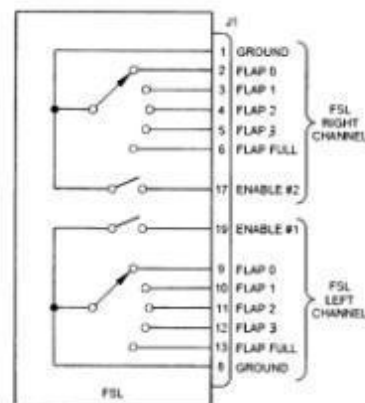
Figure 28: Wiring diagram of the flight selector lever (FSL)

The rotary switches are such that they interrupt between the positions. The movable contact is connected to the aircraft earth. The enable switches are attached to the selector lever, as mentioned above. They close when the selector lever is raised and placed into another position. In this way they signal to the FCE that the selector lever is moving. Figure 28 shows the electrical wiring diagram of the FSL.
