Investigation report

L2014-02

Aircraft Accident Resulting in the Death of Eight Skydivers at Jämijärvi on 20 April 2014

OH-XDZ

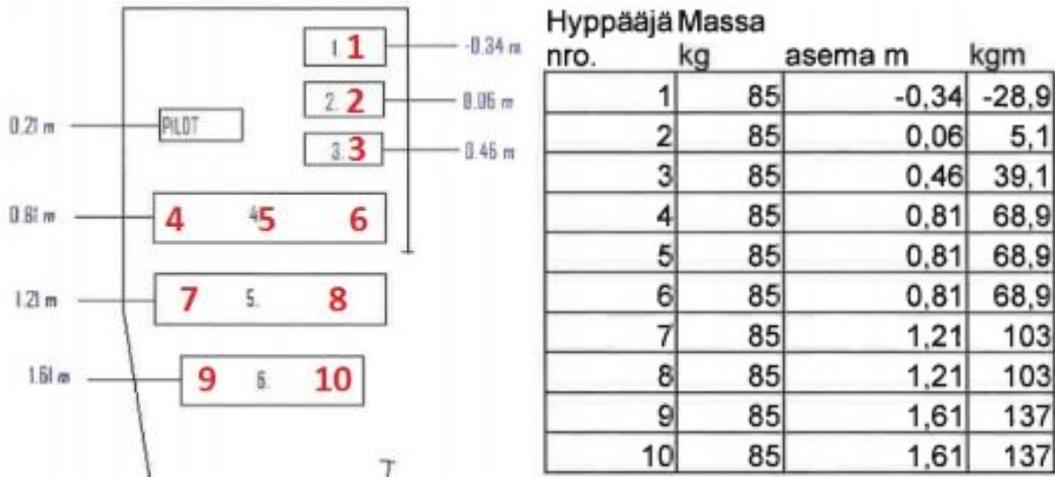
Figure 2. The image on the left is the loading chart for ten skydivers as per the airplane’s flight manual. The red numbers added to the image show where the skydivers were seated, in principle. The table on the right contains the flight manual’s instruction for calculating the centre of gravity with regard to the skydivers.

The table below presents a comparison between the flight manual-specified values and those achieved through measurements when skydivers are seated as tightly as possible, facing rearwards. As per the measurements the persons in positions 7-10, wearing full parachuting gear, sat at least 23-29 cm further back compared to the values given by the flight manual.

When the airplane approaches the jump run in normal skydiving operations the rearmost skydivers move towards the rear of the cabin to crack open the jump door for the purpose of catching sight of the jump run, and to prepare for the skydive. This moves the CG towards the rear. The scale model was used to reconstruct a situation where skydivers 7 and 9 got onto their knees and skydivers 8 and 10 went to open the jump door and to catch sight of the jump run. In this case the CG, when computed with the actual weights of the persons on the accident flight, would have been at 0.612 m, i.e. slightly outside the flight manual's aft CG limit.

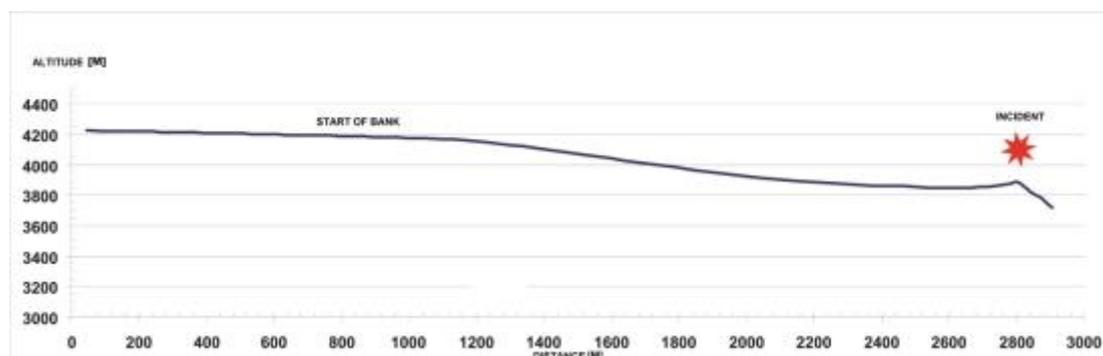
Following an approximately 20 sec long glide the flight path then changed into a shallow climb for a few seconds. At this point in time the altitude was approximately 3 850 m AGL. After this the airspeed clearly decreased. The airplane fell for 55 seconds in a flight condition resembling an inverted spin before it collided with the ground.

Figure 10: The OH-XDZ's altitude from the end of the jump run to the time of the incident.

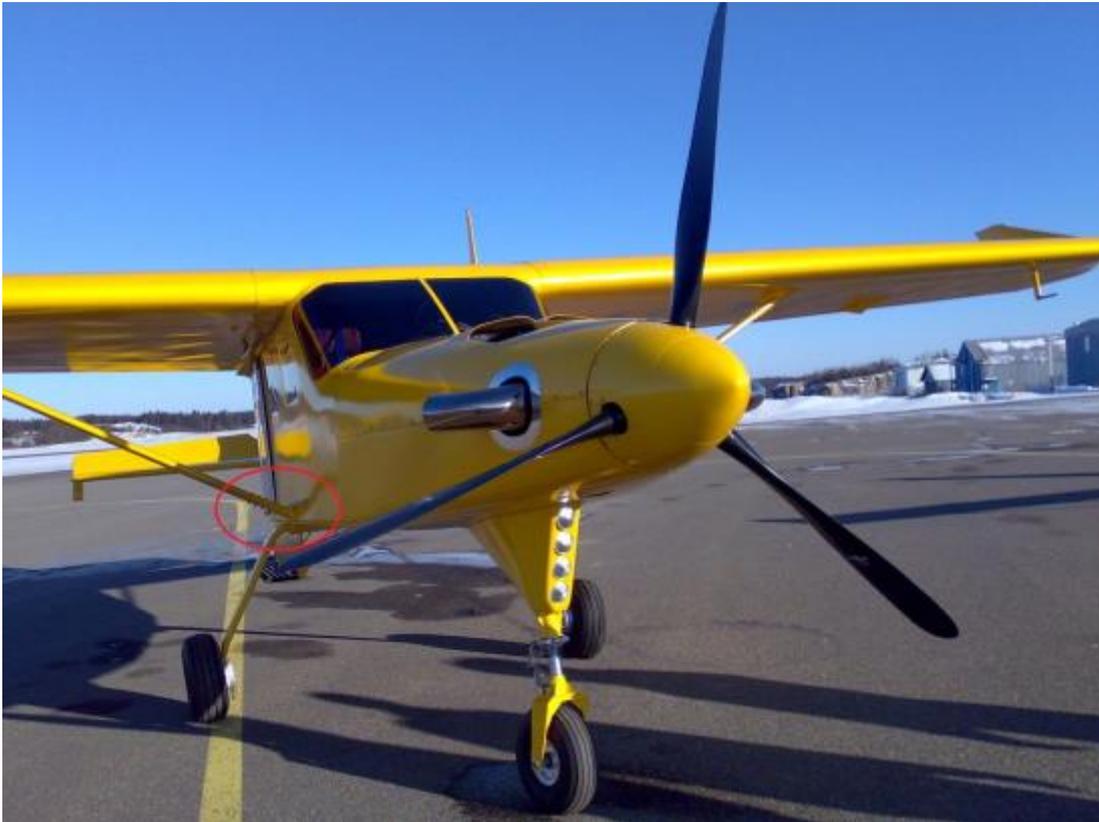
The SIAF commissioned an analysis of the material and fracture characteristics of the lower part of the right wing's wing strut, found at the site of the accident, from VTT Expert Services Oy. Surplus wing strut material was provided as a reference. The goal of the analysis was to examine the fracture mechanism of the lower part of the wing strut. Of particular interest was whether the wing strut's perpendicular or longitudinal fracturing occurred when the strut was cold, i.e. when airborne, or in the collision with the ground, or did it occur in the fire that followed the crash. The aim was to also evaluate the directions of the relevant force vectors, and to analyse the wing strut material. VTT's research report is attached as Appendix 2 (note: in Finnish only).

Figure 12. The analysis focused on the lower part of the right wing strut.

In order to analyse the fracture surface of the crack (Fig. 12), samples were cut from the lower part of the broken wing strut and a non-through thickness crack was bent open. The fracture surfaces were investigated visually and their features were studied in more detail with a stereo microscope. Details of the fracture surfaces were examined with a scanning electron microscope (SEM), and analysed with an energy dispersive spectrometer attached to the SEM. Both secondary electron (SE) and backscattered electron (BE) analysis were used in the fractography.

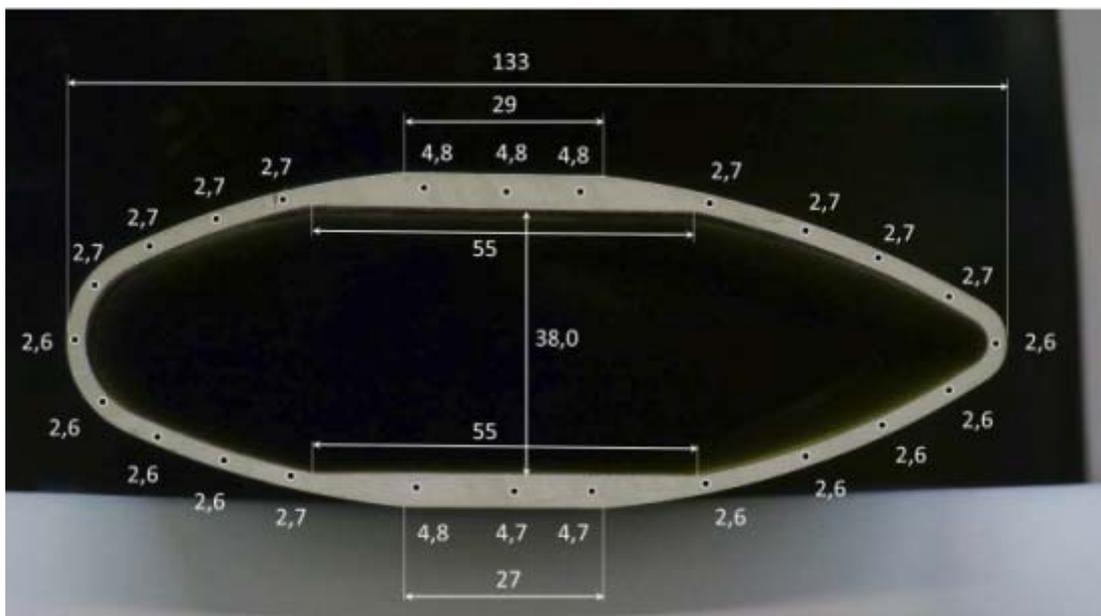
On the basis of a photograph obtained from the builders the length of the wing strut profile is 2 092 mm. By using photographs and measurements from the damaged parts the distance between the wing strut's mountings was 2 152 mm. When the assembly instruction's upper mounting point at 1 765 mm from the wing root and the installation angle of 30 degrees are taken into the calculations, the resulting length of the wing strut is 2 038 mm. The analysis computed the buckling resistance for both of these values.

Figure 17. The wing strut's cross-section dimensions (mm) (Photo VTT.).

In order to calculate the tension and compression resistance of the wing strut two through-thickness tensile tests were performed. The longitudinal test rods were taken from the upper and lower surface of the profile. The characteristics determined from both test pieces were nearly analogous.

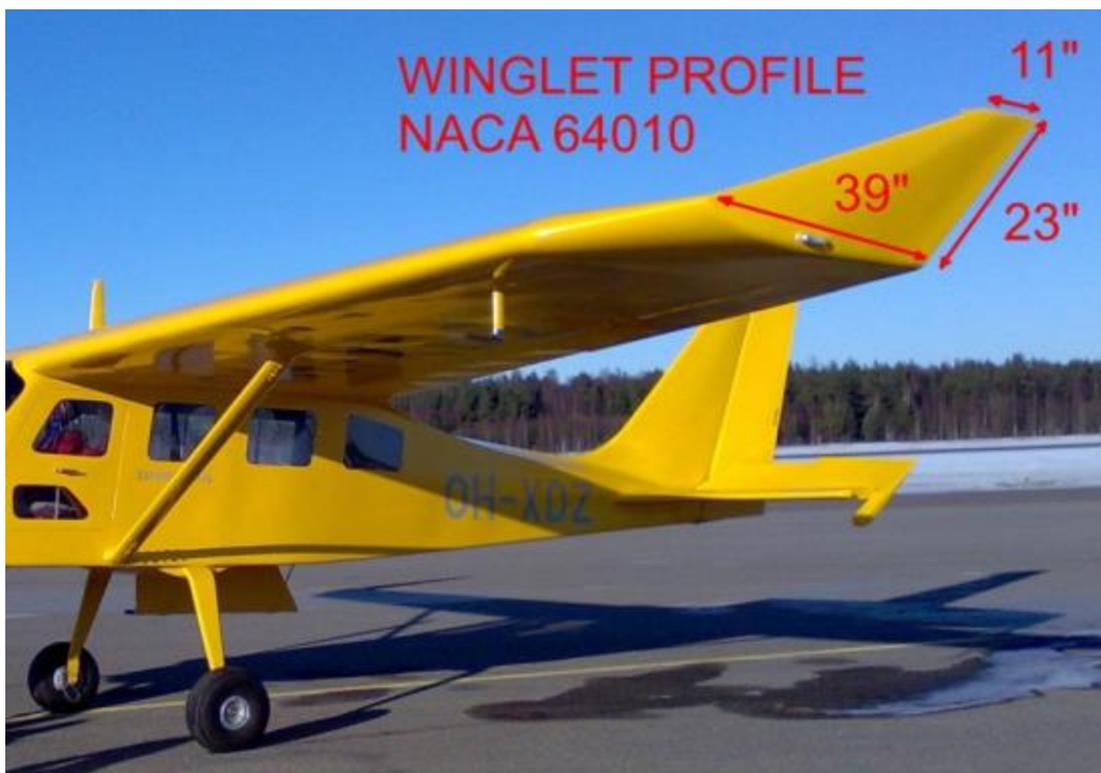
Figure 18. The winglet's main dimensions.

A simple textbook method was applied to determine the wing's lift coefficients; based on this the wing extensions and the winglets on the OH-XDZ generally increased the wing root's aerodynamic bending moment by 18-25 % in comparison to the wing that came with the kit. The alteration also increased the wing strut's aerodynamic tension and compression resistance effects correspondingly, i.e. by 18-25 %. In the further analyses

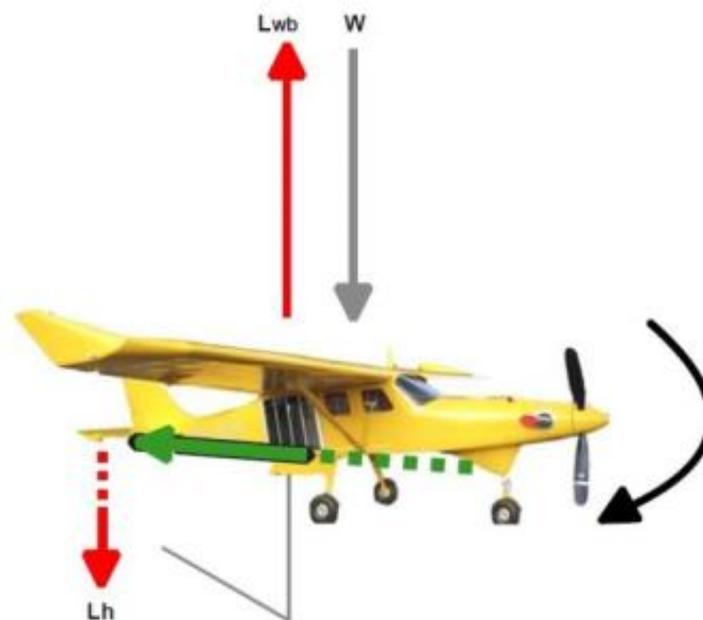
The pilot attempted to reduce airspeed by converting the glide into a climb by pulling on the control stick. He said that the longitudinal stick forces were relatively high while straightening out from the glide. It is possible that the increased control force was caused by the elevator's growing hinge moment associated with the high airspeed. It is also possible that when the aircraft turned away from the jump run the pitch trim remained close to its forward position, i.e. on the 'push' side. None of the pilots who had flown the OH-XDZ had any experience in the required flight control forces at such high airspeeds and at high loads.

LOCATION OF THE CG IS FRONT OF THE CENTRE OF LIFT IN THE CONSIDERED FLIGHT CONDITION. THIS INDUCES TENDENCY OF PITCH DOWN MOMENT. THIS MUST BE COMPENSATED BY A DOWNWARD FORCE OF THE ELEVATOR

KINETIC PRESSURE AND THEREBY THE ELEVATOR'S DOWNWARD FORCE INDUCED BY THE COMBINED EFFECT OF AIRSPEED AND PROPELLER'S AIRFLOW IS DECREASING WITH REDUCED ENGINE POWER. THIS INDUCES A NOSE DOWN PITCHING MOMENT

Figure 21. Change in longitudinal equilibrium during engine power reduction.
