FINAL  
KNKT.13.05.18.04

Aircraft Accident Investigation Report

**PT. Deraya  
BAe ATP Freighter; PK -DGI  
Wamena Airport, Wamena, Papua  
Republic of Indonesia  
31 May 2013**

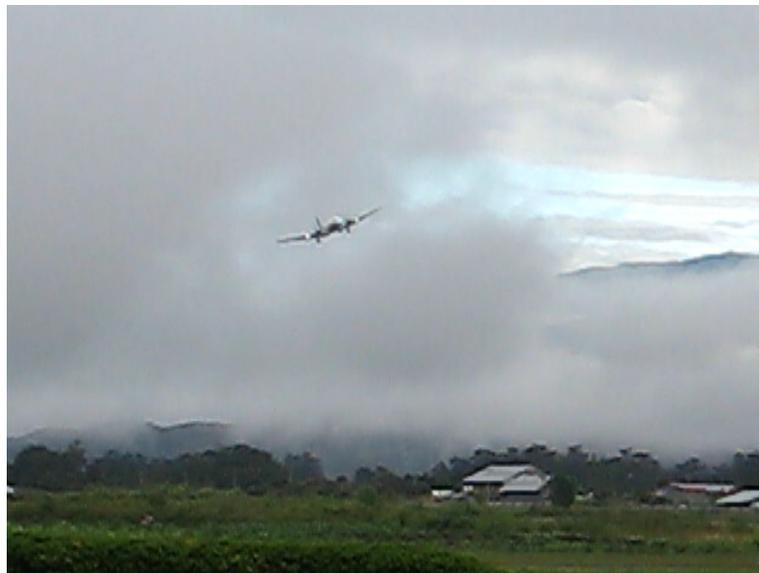
**Figure 1: When the aircraft on short final**

During the landing roll at about 750 meters from the beginning of runway 15 the aircraft veered to the left of the runway shoulder, the pilot recovered by applying the right rudder and asymmetry reverses thrust but the aircraft continued veer to the left and stopped at about 10 meters on the left shoulder of the runway 15.
