FINAL
KNKT.13.06.19.04

Aircraft Accident Investigation Report

**Merpati Nusantara Airlines
Xi 'An Aircraft Industry MA60; PK-MZO
El Tari Airport, Kupang
Republic of Indonesia
10 June 2013**

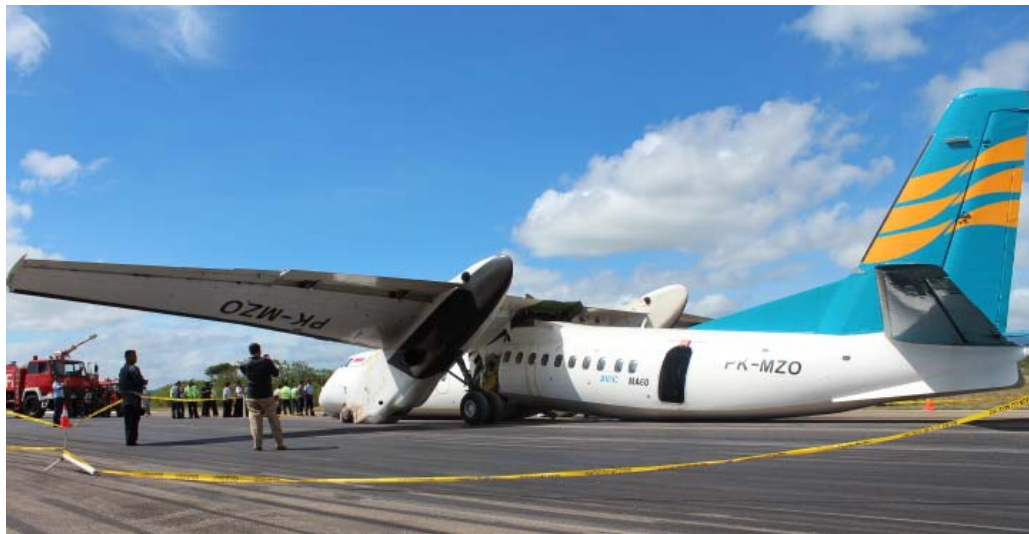
The aircraft was substantially damaged.

Figure 1: The accident aircraft

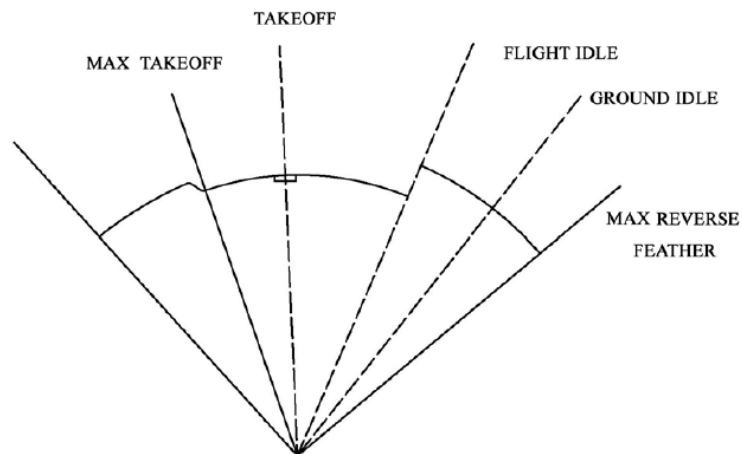
Figure 4: Positions of Power Lever

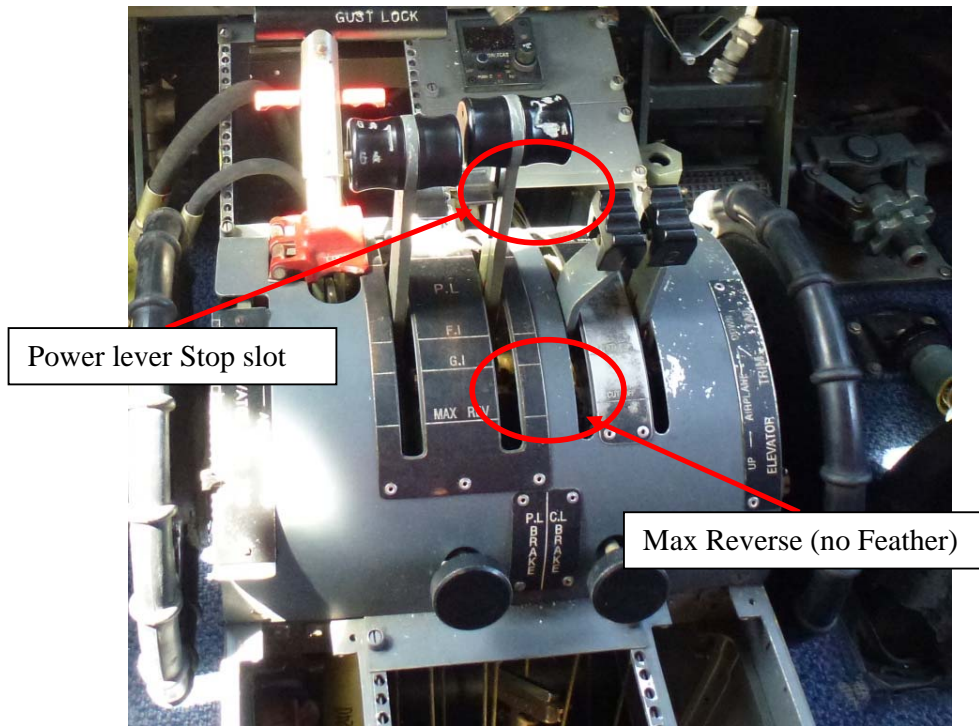
Figure 6: Power lever stop slot

The picture of center console taken from the aircraft (figure 6) showed that the power levers do not have feather position as mention in the FCOM.

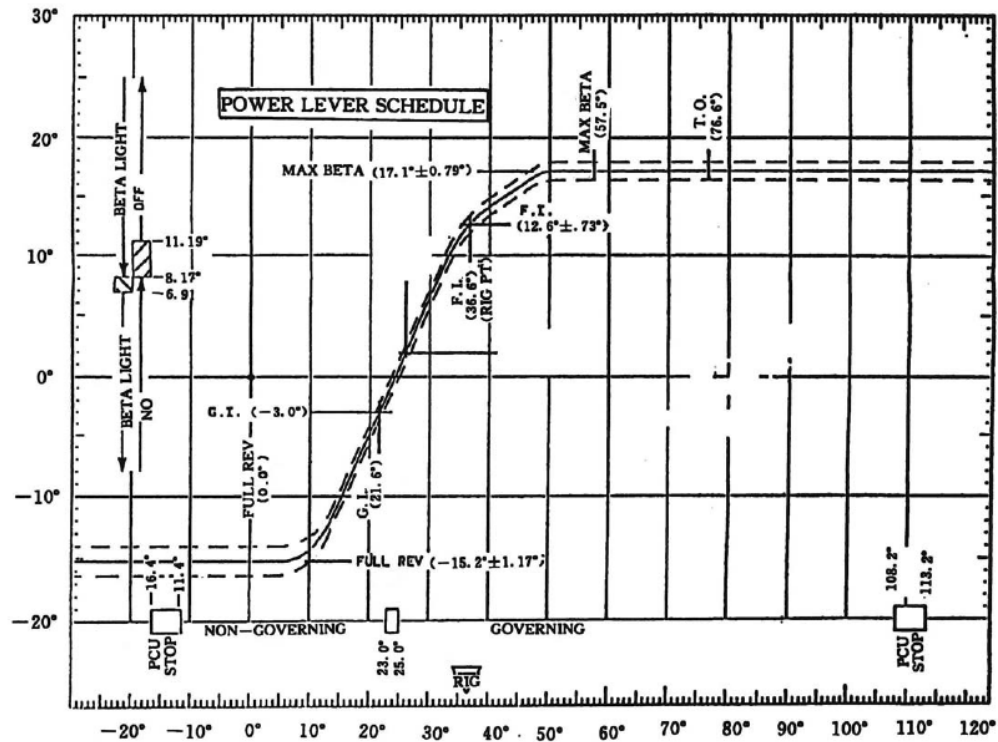
Figure 7: BETA operation curve of propeller

Refer to the graph (figure 5), the BETA range will set the propeller pitch angle below 8°. If the propellers pitch angle moves to BETA range will create significant drag.

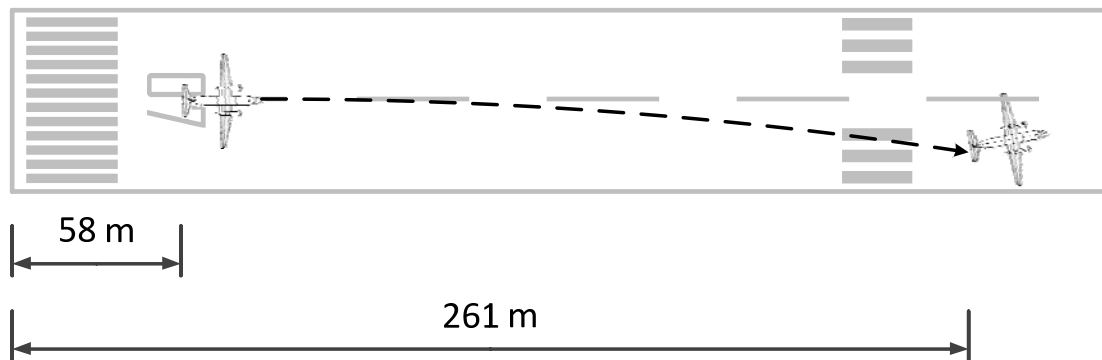
The main wheel touchdown marks found approximately 58 meters from the beginning runway 07.

The aircraft halted approximately 261 meters from the beginning runway 07.

Figure 11: The illustration of the ground roll accident
