**FINAL**  
KNKT.14.04.10.04

# KOMITE NASIONAL KESELAMATAN TRANSPORTASI

Runway Excursion Investigation Report

**PT. Adventist Aviation Indonesia**  
**Kodiak-100; PK-SDF**  
**Doyo Baru Airstrip, Papua**  
**Republic of Indonesia**  
**09 April 2014**

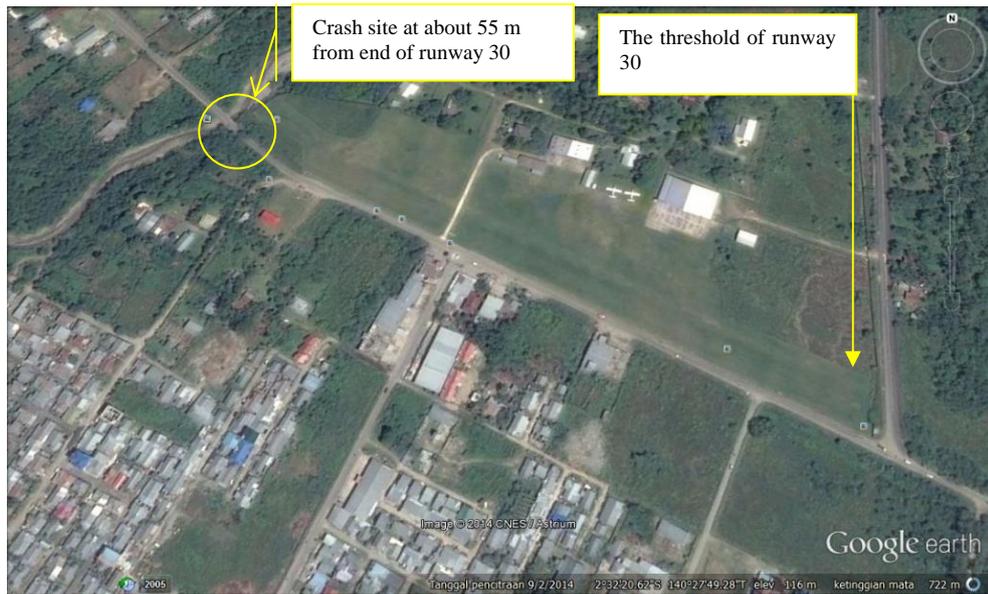
**Figure 1: Airport layout and the accident site**

An engineer after received the information went to the accident site and saw appearance of white smoke came out from the side of the river which was known as the accident aircraft located. After arrived at the accident site the engineer saw the Adventist's staffs and local people tried to extinguish the fire on the aircraft engine by throwing some water and used two fire extinguishers while some people moved the passengers from the wreckage.

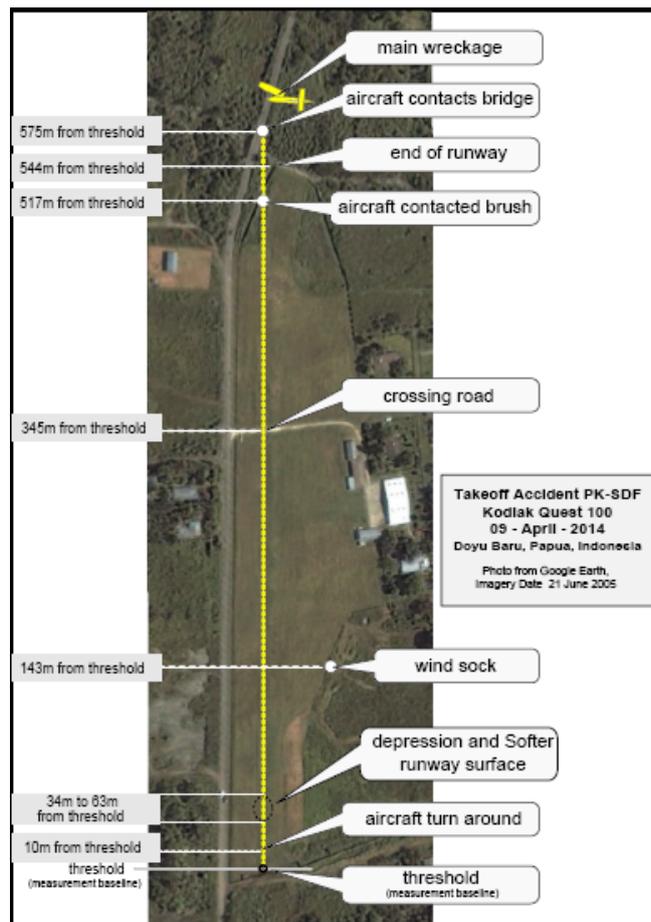
**Figure 2: Illustration of takeoff track and significant marks superimposed to Google earth**

Assumed that the aircraft speed was 75 knot and flaps travel time from 0 to 5° was 4 seconds, the position of initial flap selection was at 155 meter prior to impact point. Refer to the data that the first impact point was 30 meter from the end of the runway; hence the initial wing flap selection was approximately 125 meter before the end of the runway or at 419 meter (1375 feet) from the beginning runway (runway length based on the measurement stated on the figure 2 of this report).

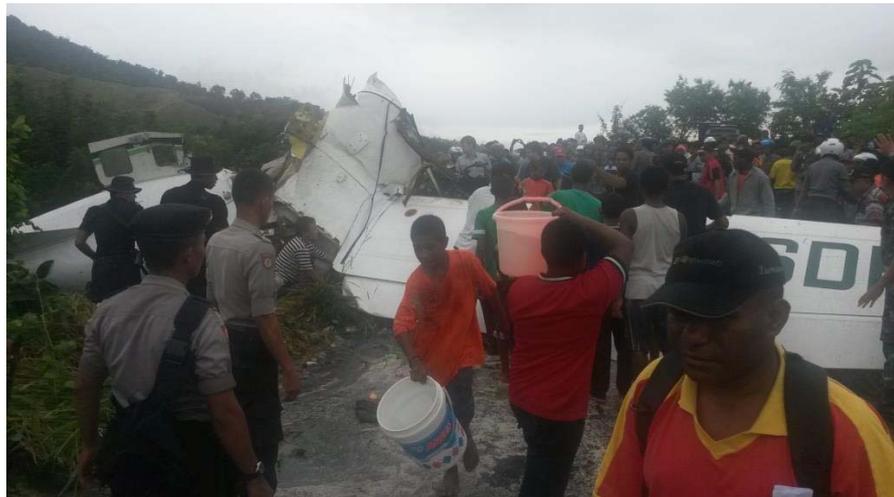
**Figure 12: Local people carried water to extinguish the fire**

All occupants were evacuated by local people.

The fire truck of the Kabupaten Jayapura arrived later assisted the emergency response.

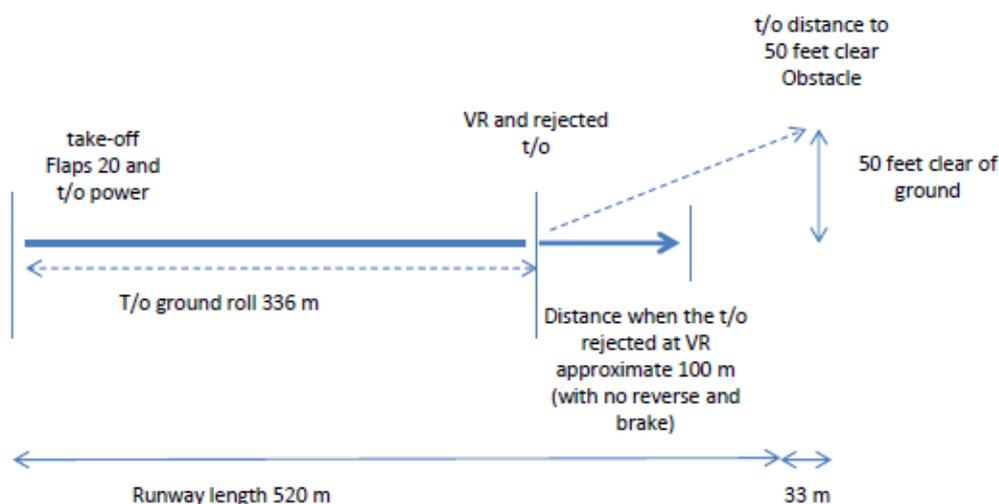
**Figure 19: RTO and T/O illustration refer to the performance calculation.**

As described in 1.18.6 using a simple method of rejected take-off calculation, the distance if the take-off rejected at VR speed would be approximately 100 m.

Therefore the total stop distance in case the alternative decision was selected by the pilot will be 336 m (ground roll) plus 100 m resulted 436 m or it was similar to the remaining runway length available of 84 m, which the aircraft will still on the runway.

Based on the calculation of the assumed conditions, the investigation predicted the distance required for the aircraft to accelerate to VR (65 knots) would be approximately 336 m or 1102 feet. The predicted distance for the aircraft to stop from 65 knot speed would be approximately 100 m. The Accelerate Stop Distance (ASD) required or the total distance for the aircraft from stand still position to accelerate to 65 knot and to stop from that point in the case the takeoff was
