# Fuel starvation and forced landing, involving PA31, VH-OFF

Near Aldinga ALA, South Australia, 29 January 2014

**ATSB Transport Safety Report**

AO-2014-017

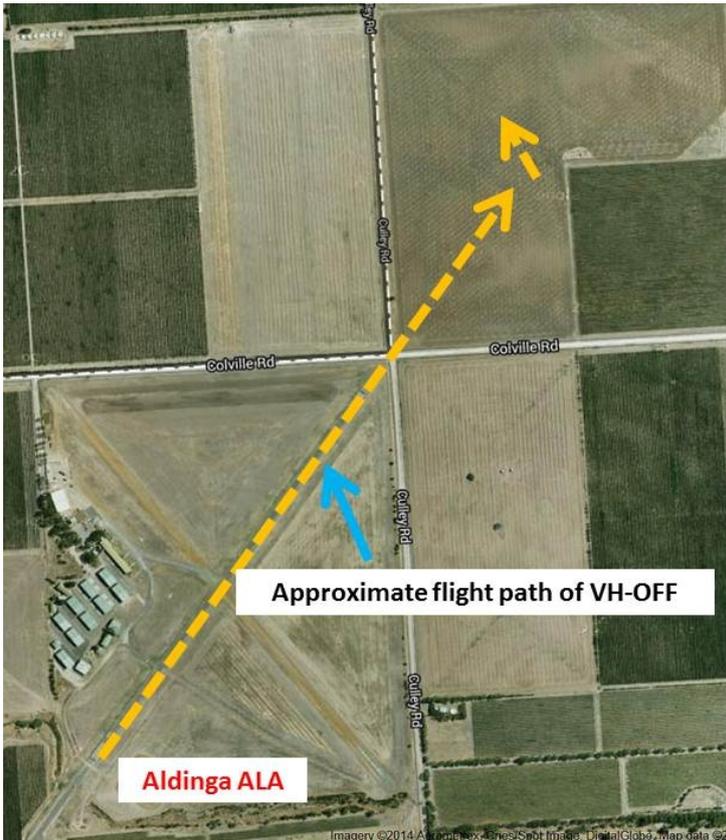
**Figure 2: Approximate flight path of VH-OFF**

The pilot was familiar with Aldinga ALA (Figure 2), which is a non-controlled airport. At uncontrolled airports, unless a restriction or preference is listed for a certain runway in either the Airservices en route supplement Australia (ERSA), or other relevant publications, selection of the runway is the responsibility of the pilot. Operational considerations such as wind direction, other traffic, runway surface and length, performance requirements for the aircraft on that day, and suitable emergency landing areas in the event of an aircraft malfunction are all taken into consideration.

On this day, the pilot assessed the wind to be favouring runway 14, which already had an aircraft in the circuit intending to land. However, he decided to use runway 03 due to the availability of a landing area in case of an emergency. He then completed a full run-up check of the engines, propellers and magnetos prior to lining up for departure. The pilot reported that all of the pre-take-off checks were normal.

After broadcasting on the common traffic advisory frequency (CTAF) he commenced the take-off. At the appropriate speed, he rotated the aircraft as it passed the intersection of the 14 and 03 runways. Almost immediately both engines began surging, there was a loss of power, the power gauges fluctuated and the aircraft yawed from side to side. Due to the surging, fluctuating gauges and aircraft yaw, the pilot found it difficult to identify what he thought was a non-performing engine. He reported there were no warning lights so he retracted the landing gear, with the intent of getting the aircraft to attain a positive rate of climb, so he could trouble shoot further at a safe altitude.
