VFR flight into IMC involving de Havilland DH-84 Dragon VH-UXG

36 km SW of Gympie, Qld | 1 October 2012

ATSB Transport Safety Report
Aviation Occurrence Investigation
AO-2012-130
Final – 19 December 2013

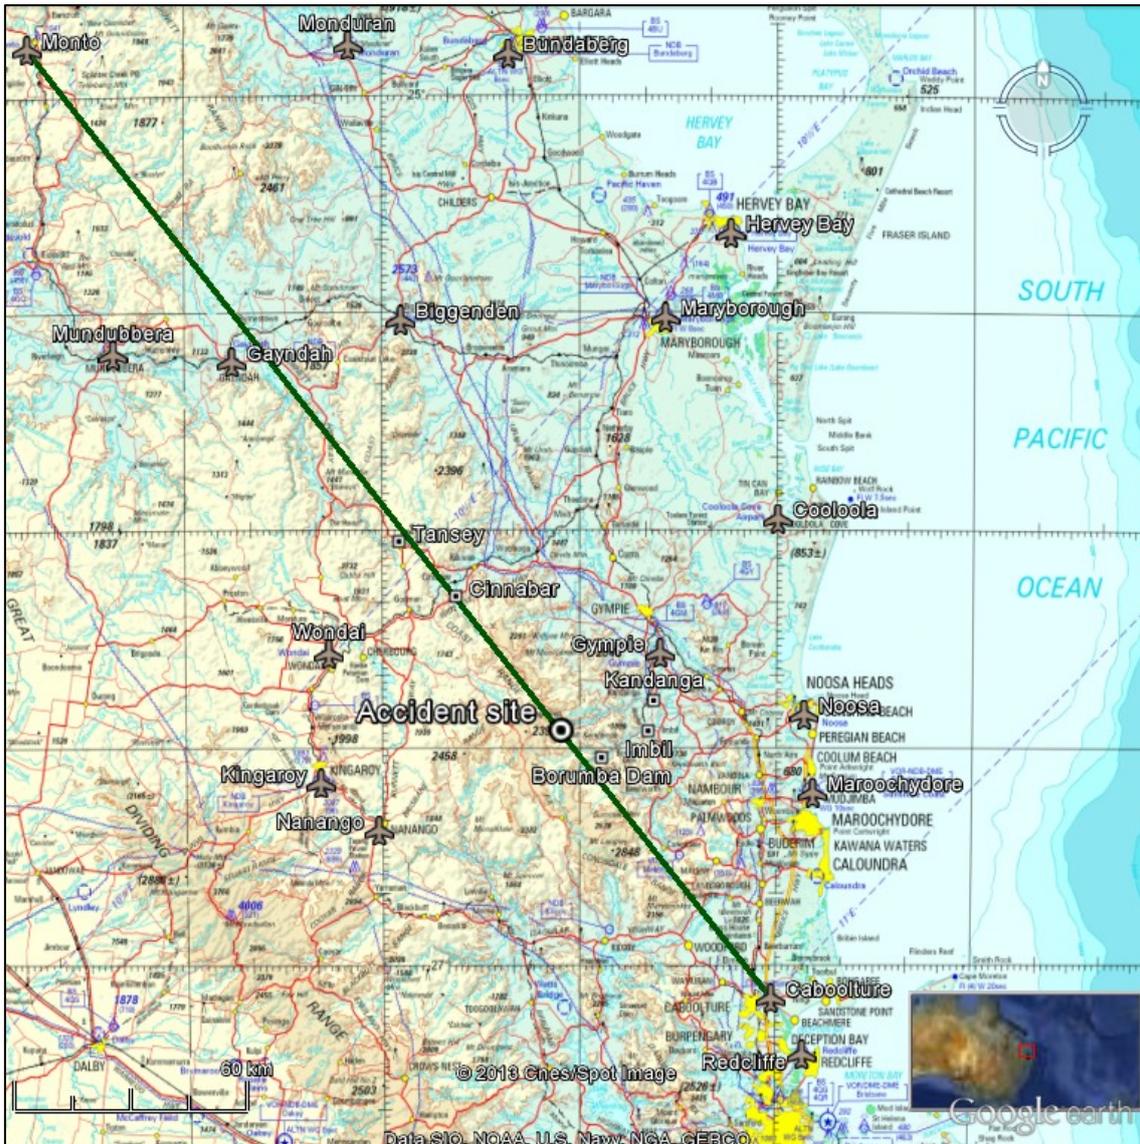
Figure 1: Overview of the area with the direct route from Monto to Caboolture shown in green

A significant portion of the direct route from Monto to Caboolture passes over a mountain range (Figure 1). About 85 km south-east of Monto, near Gayndah, a gap in the range provides a low-terrain route from the direct track to the coast. Further south and for most of the direct track, the topography is rugged, with thickly forested and mountainous terrain, at elevations up to 2,848 ft. The terrain along the coastal route from Bundaberg to Caboolture is generally quite flat.

There were several airports and aerodromes in the region, as marked with aeroplane symbols in Figure 1. A small private airfield was located in Kandanga valley, 2.5 km north-east of the accident site at an elevation of about 650 ft. The airfield was unlicensed and was not included in the En Route Supplement Australia²⁵ or any of the charts found in the aircraft wreckage.

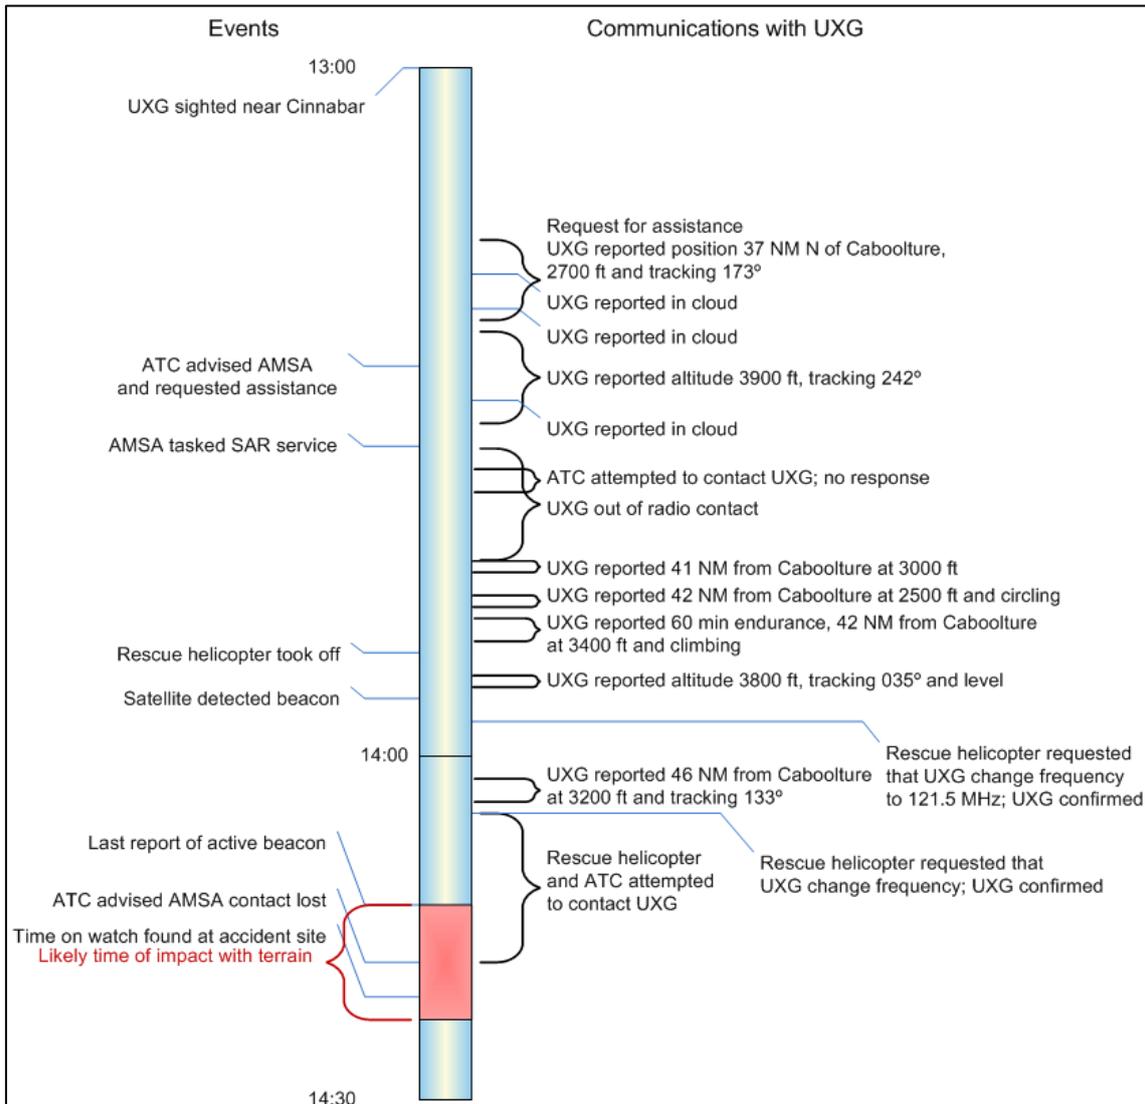
Figure 2: Partial occurrence timeline

Figure 2 provides a summary of significant events and communications on 1 October from 1300 onwards. The first recorded radio transmission from UXG was at 1315, when the pilot contacted Brisbane Centre air traffic control (ATC) to advise that the aircraft was 37 NM (69 km) north of Caboolture at 2,700 ft. In response, ATC provided the area QNH.⁴ The pilot then requested navigation assistance. At 1318, in response to a query from ATC, the pilot reported that the aircraft was in 'full cloud'. ATC advised the pilot to maintain wings level and initiated in-flight emergency response (IFER) procedures.⁵ ATC advised the pilot that the lowest safe altitude (LSALT)⁶ in the aircraft's likely grid location was 4,300 ft and suggested that he climb to a safe altitude to establish terrain clearance, if able. Although the pilot had not formally declared an emergency, ATC declared an alert phase⁷ at 1320.

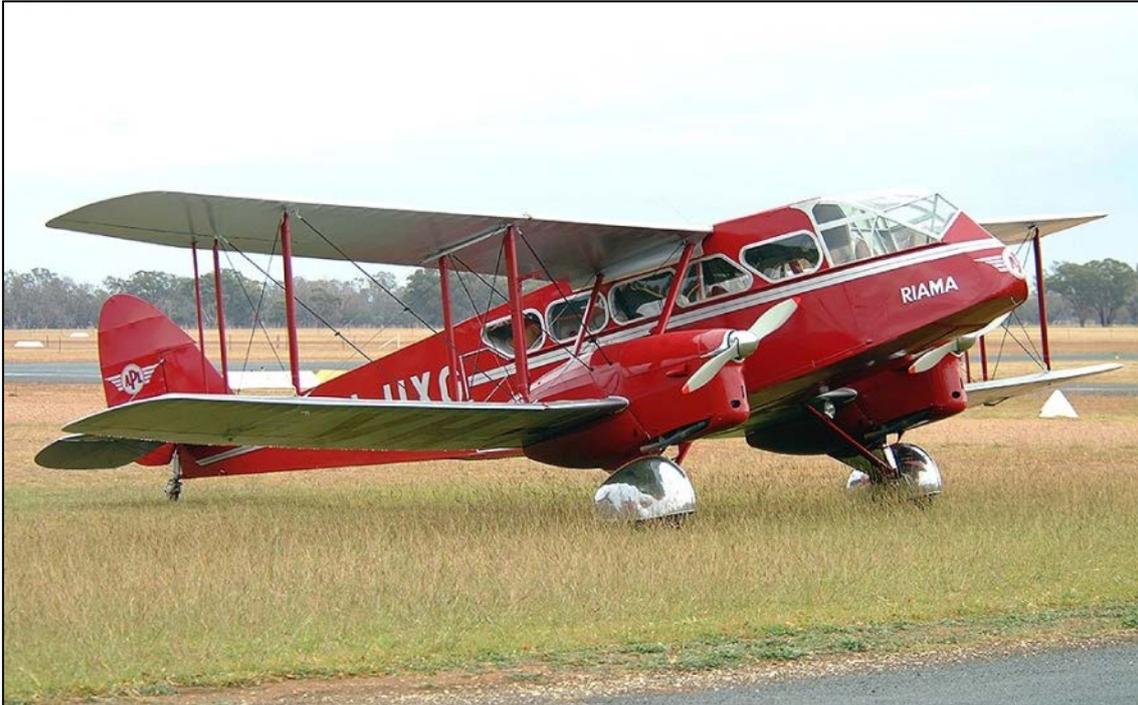
Figure 4: VH-UXG in 2003

The aircraft, a de Havilland Aircraft Pty Ltd DH-84 Dragon Mk 2, serial number 6077, was a twin-engine medium transport biplane manufactured in the United Kingdom in 1934, and was first registered in Australia in 1936. It was substantially damaged in an accident in 1954 and later underwent an extensive rebuild, which was completed in about 2003 (Figure 4).

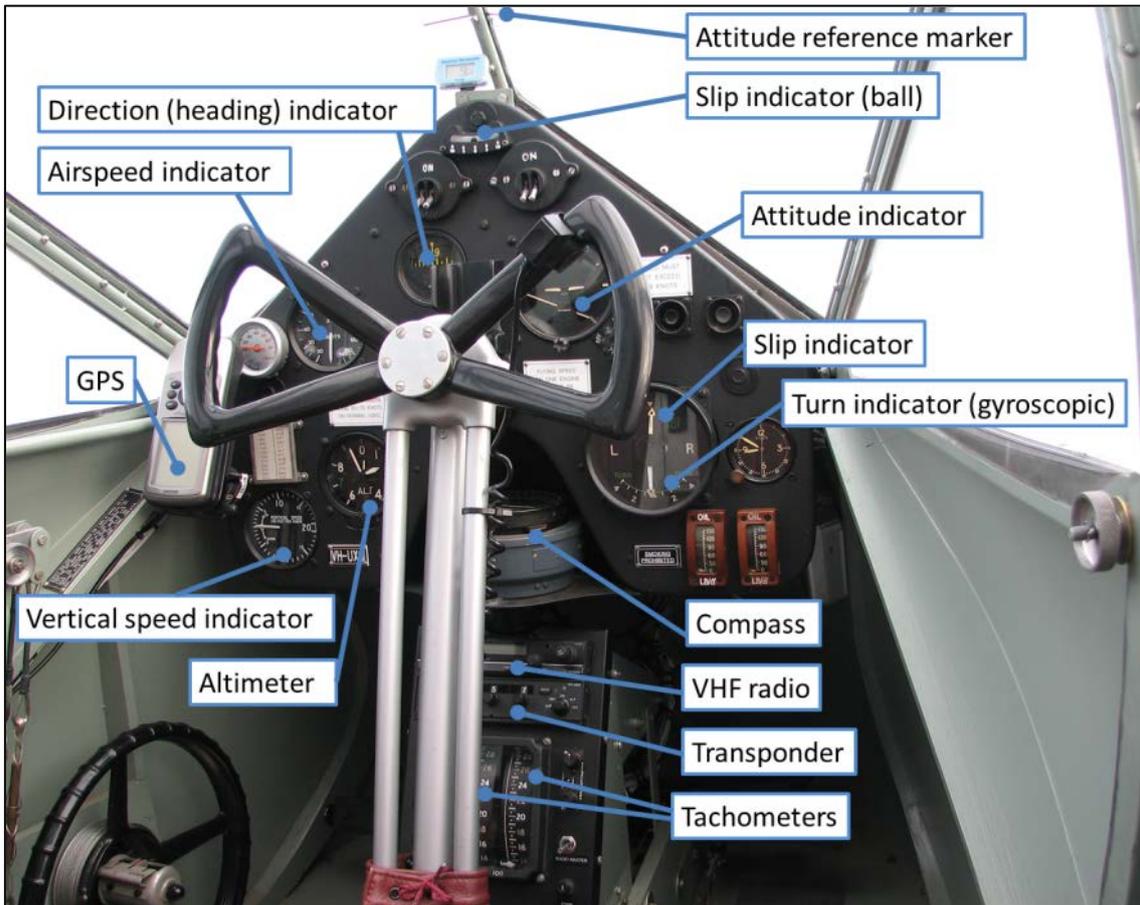
Figure 5: VH-UXG cockpit in 2006

The aircraft's instrument panel layout was close to the original, including mostly period instruments with the addition of modern radios (VHF transceiver and transponder), a cradle for a mounted handheld-style global positioning system (GPS) receiver,¹⁷ and two air temperature gauges (Figure 5). The cockpit was fully enclosed, with extensive glazing providing excellent forward and side visibility but limited 'aircraft reference' (parts of the aircraft that can be used as visual points of reference to aid in determining the aircraft's attitude relative to the horizon).

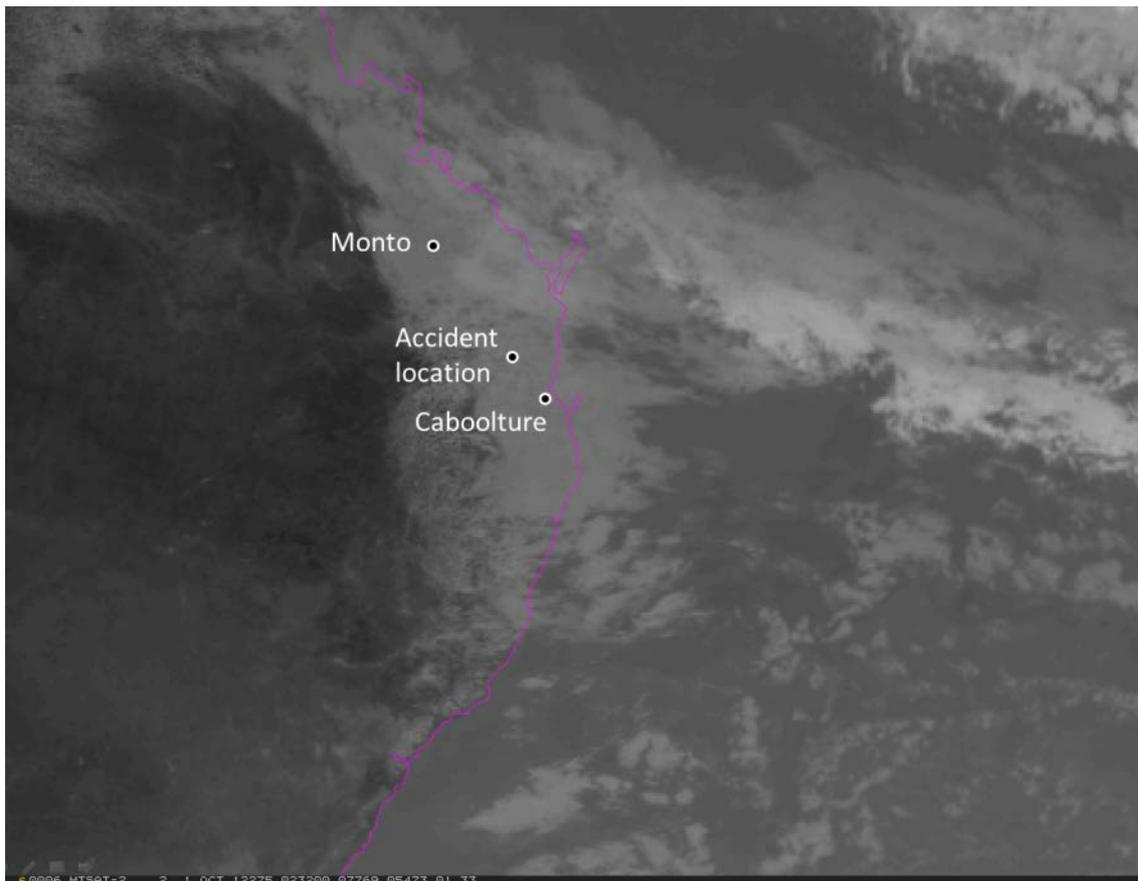
Figure 9: Infra-red band satellite image³⁰ taken at 1232

The BoM reported that while there were no recorded observations or measurements of the height and amount of cloud that was reported by witnesses in the vicinity of the accident site, it is reasonable to state that at the time and location of the accident, there was overcast cloud at or below the top of the mountain range and up to 10,000 ft. An infra-red satellite image taken at 1330 showed overcast cloud along the coast and ranges, as far west as Kingaroy (Figure 9).
