### **Aircraft Accident Investigation Final Report**

# Crash Near Airfield Following Aircraft One Engine Failure Just Upon Lift-Off

Sepahan Airlines Flight 5915 Antonov 140-100, MSN 90-05 Tehran, Mehrabad International Airport August 10, 2014

File Number: A13930519EPGPA

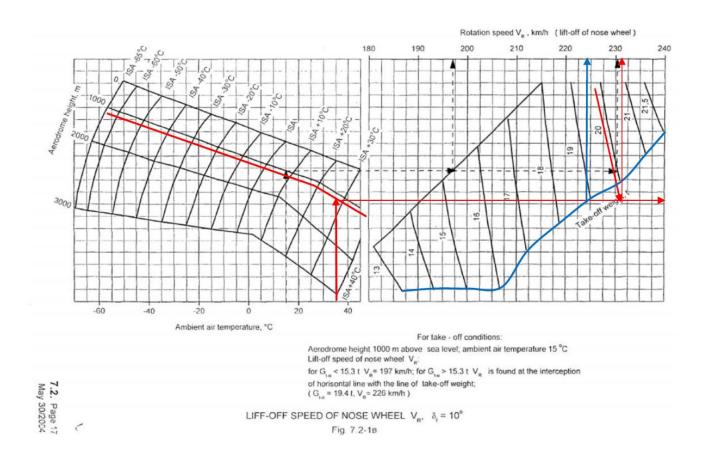
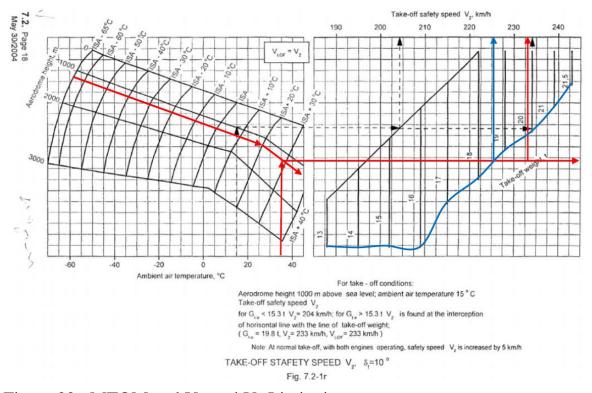
Figure 21: MTOM calculation chart

Using chart of the AFM Fig.7.2-1B as shown in Figure 21 and 22 below, revealed that VR must be at least 231 km/h, but because of even weight of 19500 kgf which by designer considered allowable is outside of graph limits. According to section 7.1.1 of the AFM which state the parameters should not be determined outside the limits stated in the graphs. Therefore, this weight will not be allowable. By using this chart following Information derived:

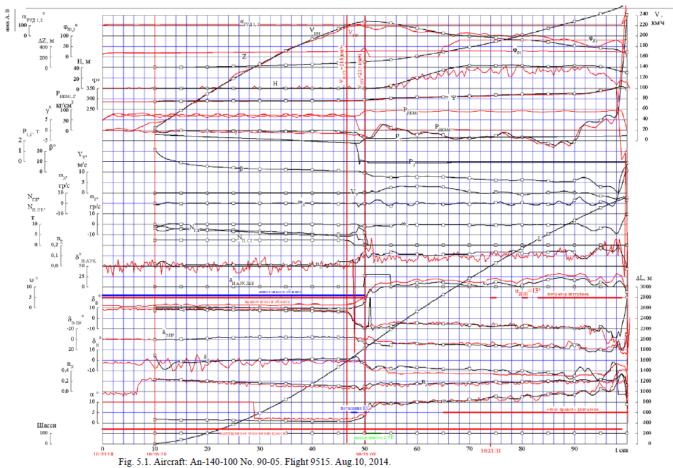
Fig. 5.1. Aircraft: An-140-100 No. 90-05. Flight 9515. Aug.10, 2014.

The result of ANTONOV Co. calculation which also approved by the Ivchenko-Progress SE and MOTOR SICH JSC has written in technical report dated on October 25, 2015.(Appendix D) according to the report even if crew performs take-off as recommended in AFM, the mentioned airworthiness requirement of AJI-25 never meet. Suppose that aircraft rotate at a speed of 224 km/h and pitch Angle selection and other action of crew comply with AFM, according to table 5.3 and Fig. 5.1 and 5.2 of mention Technical report, aircraft at a height of about 40 m above the take-off surface (instead of 10.7 m); reached V2.

Parameters of motion at continued takeoff: W=4m/s, AMH=286°; AW=60°; δFL = 10°, G=19.866t; Δt=30°; HA/D. = 1150m; μ≥0.6; XT~ 0.265; PH=662mmHg
