## *Final report RL 2016:02e*

**Accident on Björnö on 13 February 2015  
with aircraft N164ST of the model  
PA46-500TP (Malibu Meridian), operated  
by a private person.**

File no. L-15/15

2016-03-01

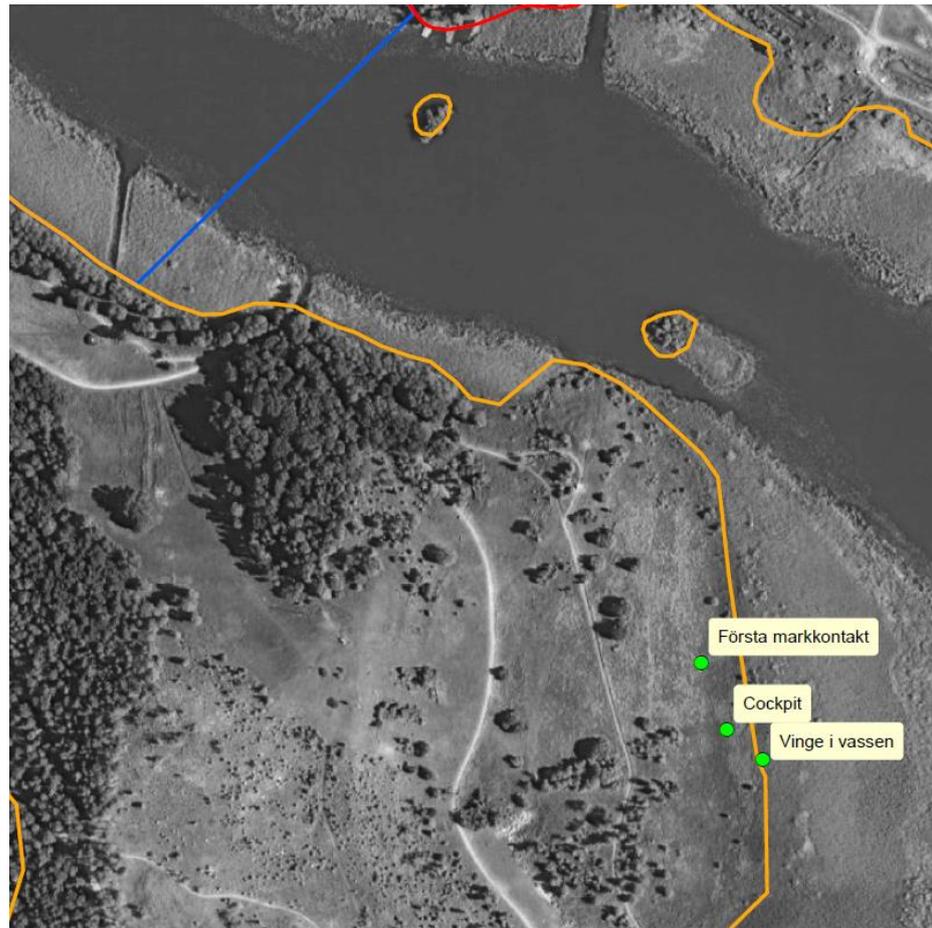
In addition to the measures taken during the rescue operation, further decontamination was necessary, including excavation of the contaminated upper layer of soil. The Health and Environment inspector gave permission to hold off on this work until the following day. The SHK investigation has since shown that the site of impact was within the source water protection zone (see figure 10).

Figure 10. Secondary source water protection zone boundary marked in yellow. The position of the first ground contact and larger wreckage parts are marked in green.  
© Lantmäteriet Ref.: R61749\_13002

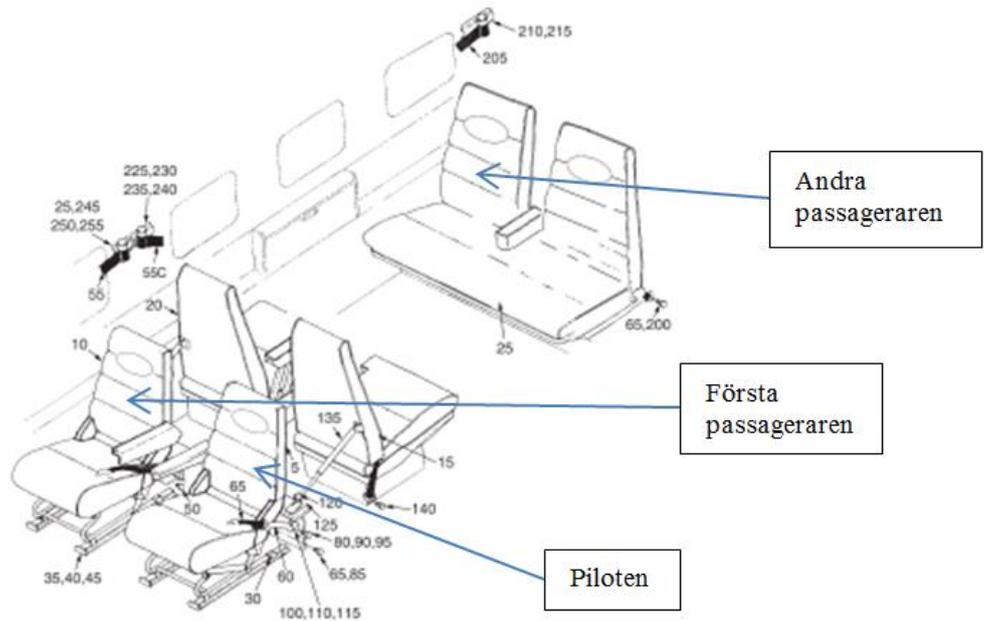
Figure 15. Cabin layout for the aircraft in question, with the placement of those on board. Source: Piper aircraft.

It is possible that the first deceleration peak on the aircraft's longitudinal axis was minor, such as powerful braking in a car. However, when combined with the yaw and the rolling movements, it might have caused the passengers to fall “out of position” for being optimally caught by the safety systems over the remainder of the accident's events. See Figure 15 for the placement of those on board.

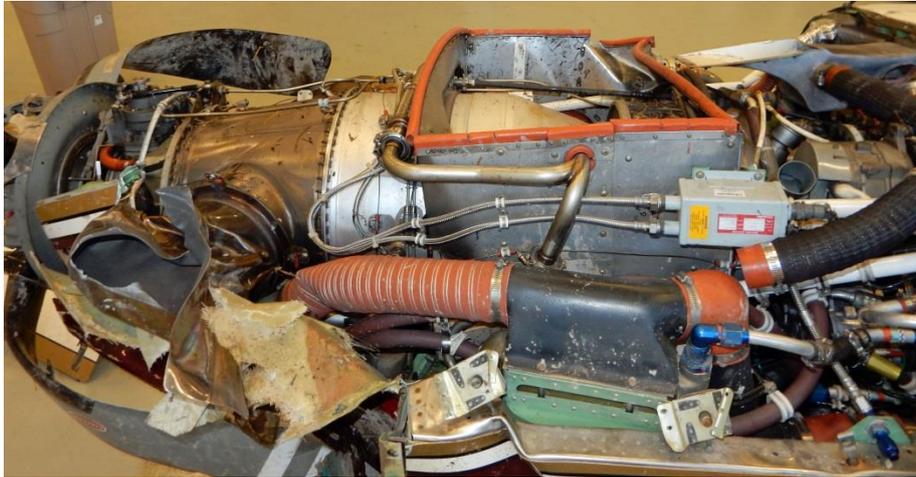
Figure 17. Left-hand side of engine.

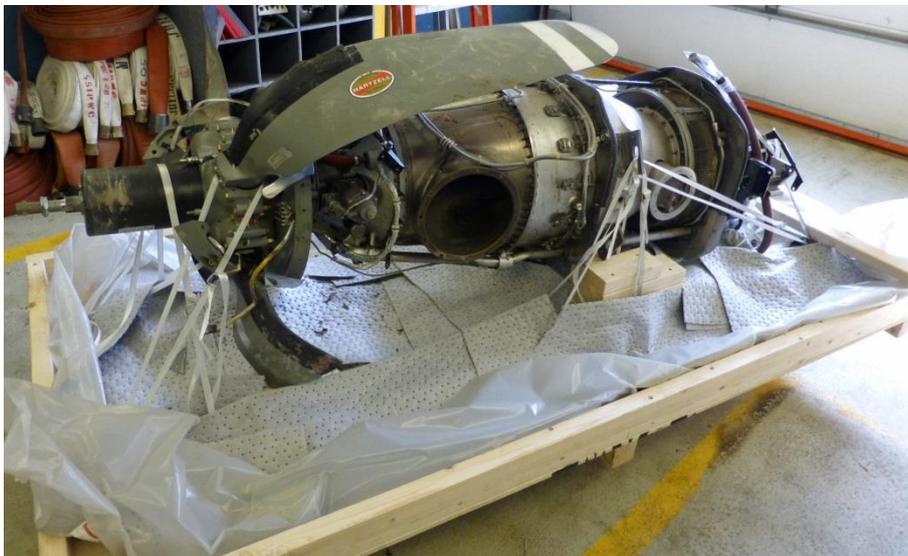
Figure 18. Propeller and engine upon arrival with PWC.

The investigation of the propeller at PWC was conducted by a representative from Hartzell Propeller Inc., under the supervision of SHK representatives. The investigation showed damage to all four propeller blades, which were bent backwards aft at midblade. Several broken pieces were found in the propeller hub. The blade knobs were fractured off two blades, and one bearing race was fractured into several pieces.

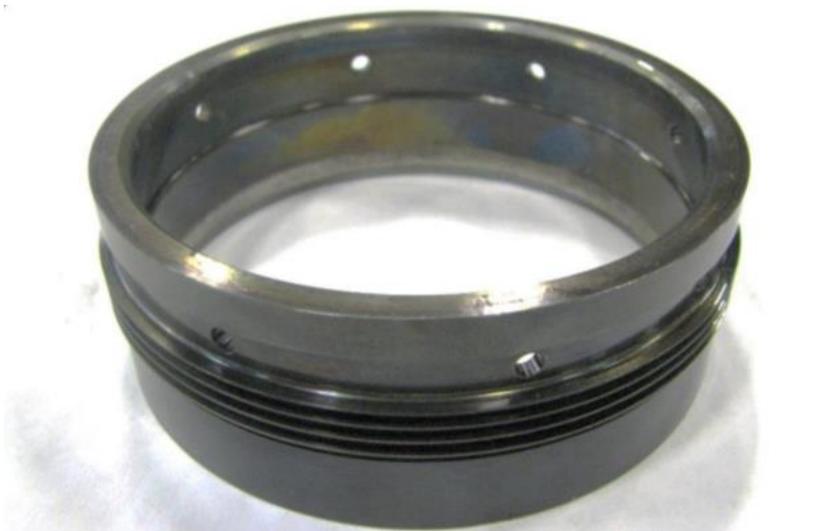
Upon continued dismantling, it became clear that the piece of metal was part of the rotor section of the power turbine's labyrinth seal. It had fractured circumferentially. The broken rotor section of the labyrinth seal shown in Figure 24, compared with an undamaged example of a rotor section in Figure 25. There was also significant rubbing to the inner diameter of the stator labyrinth seal section.

Figure 25. Comparison: New rotor section of a labyrinth seal.

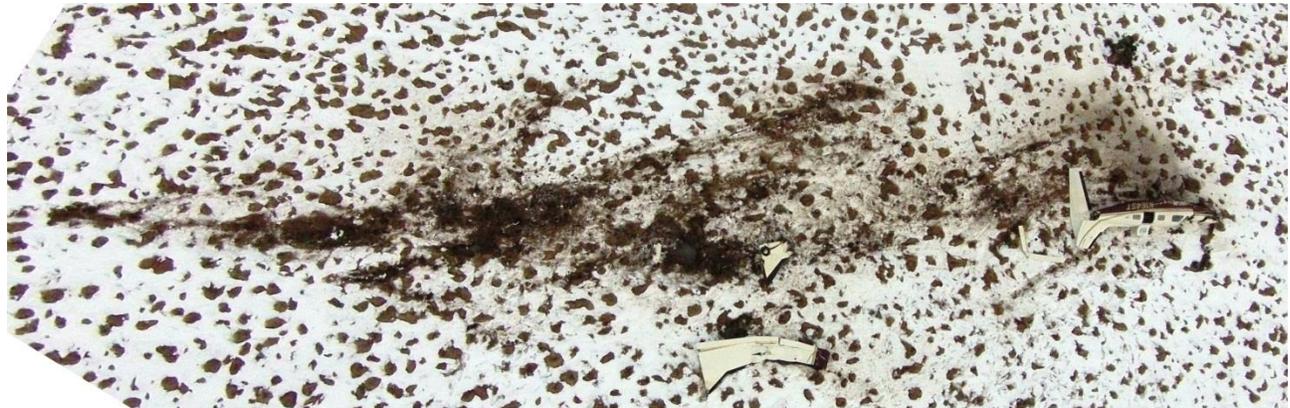
Marken på olycksplatsen utgörs av en stubbåker, snötäckt med fläckvis barmark. Avsaknad av tjäle och att marken bestod av fuktmetad jord gör det lättare att se var och hur kraftiga islagen har varit. Spåren av uppsprätt jord kan också lätt spåras på den halvt snötäckta marken.

1. Markkontakt vänster vinge
2. Vänster vinge gräver
3. Vänster vinge går av
4. Höger vinge går av i 2 delar
5. Slutposition
