This document is an English translation of the Final Report on the accident involving the Boeing 737-8KN aircraft registered A6-FDN that occurred on March 19, 2016 (00:42 UTC) at Rostov-on-Don aerodrome, the Rostov Region, Russian Federation.

**INTERSTATE AVIATION COMMITTEE
AIR ACCIDENT INVESTIGATION COMMISSION
FINAL REPORT**

Type of occurrence	Fatal accident
Type of aircraft	Boeing 737-8KN, airplane
Nationality and registration marks	A6-FDN
Owner	Celestial Aviation Trading 38 Limited, Shannon, County Clare, Ireland
Operator	Dubai Aviation Corporation, P.O. Box: 353, United Arab Emirates
Aviation authority of the place of occurrence	Southern FATA Interregional Territorial Department
Place of occurrence	Russian Federation, the Rostov region, the Rostov-on-Don aerodrome, reference position: 47°15'54.7" N, 039°49'43.8" E
Date and time	19.03.2016, 03:42 local time (00:42 UTC), nighttime

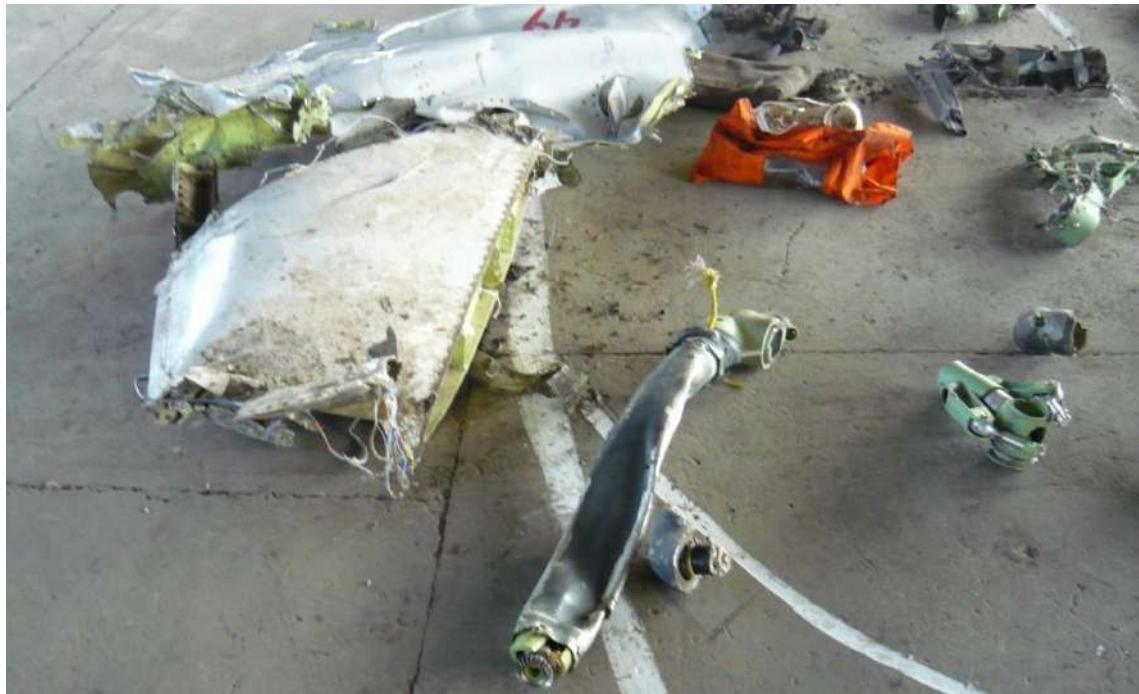
Fig. 2. The element of the F/O control column

The partly survived F/O control column part with the elements of the control wheel was discovered having been considerably deformed (Fig. 2). The control wheel elements integrated the partly destroyed trim switch.

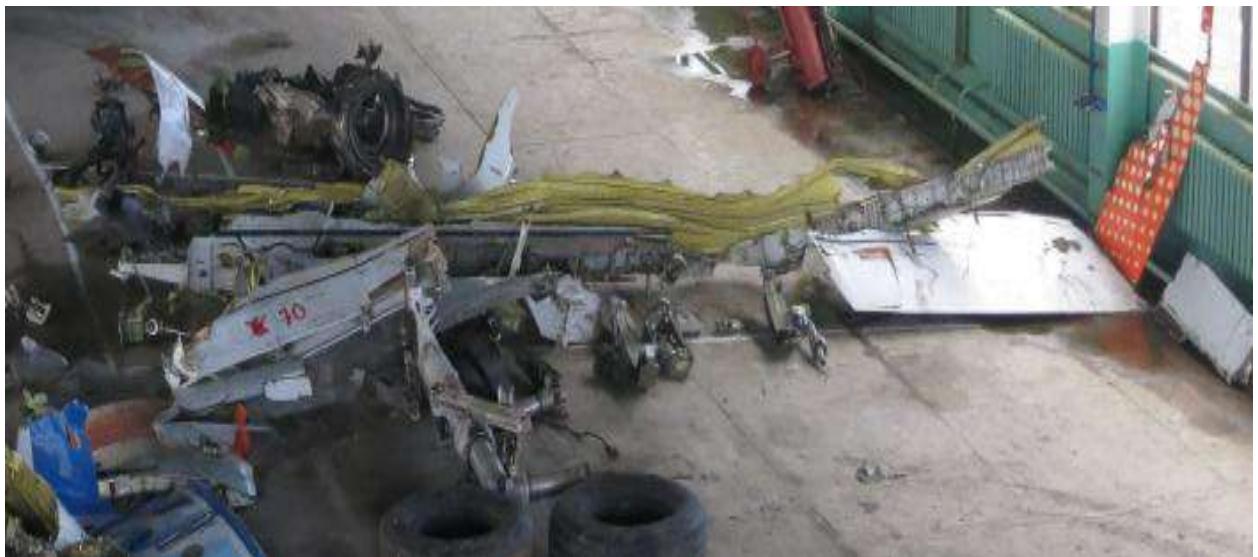
Fig. 4. The fragments of the RH wing panel

The wing is disintegrated (Fig. 4, Fig. 5).

The LH and RH wingtips (winglets) with the fragments of the lower wing panels, the single unit tracks, along which the flaps travel, the fragments of the LH outboard and inboard flaps, the fragments of the skin of the RH wing panel lower section survived.

The wing to fuselage attachment fittings are destroyed.

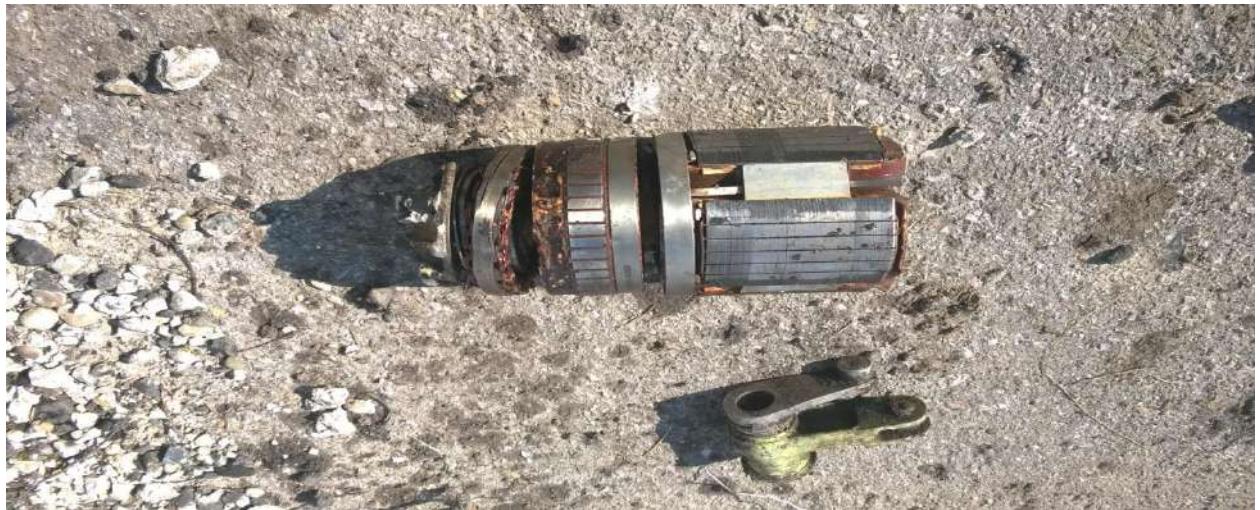
Fig. 18. The generator rotor

supply system consists of three transformer-rectifier units. The electrical battery is operated as the direct current emergency power supplies. The generators and electrical battery are completely destroyed subsequent to the impact. There was discovered the rotor of one of the generators (Fig. 18).

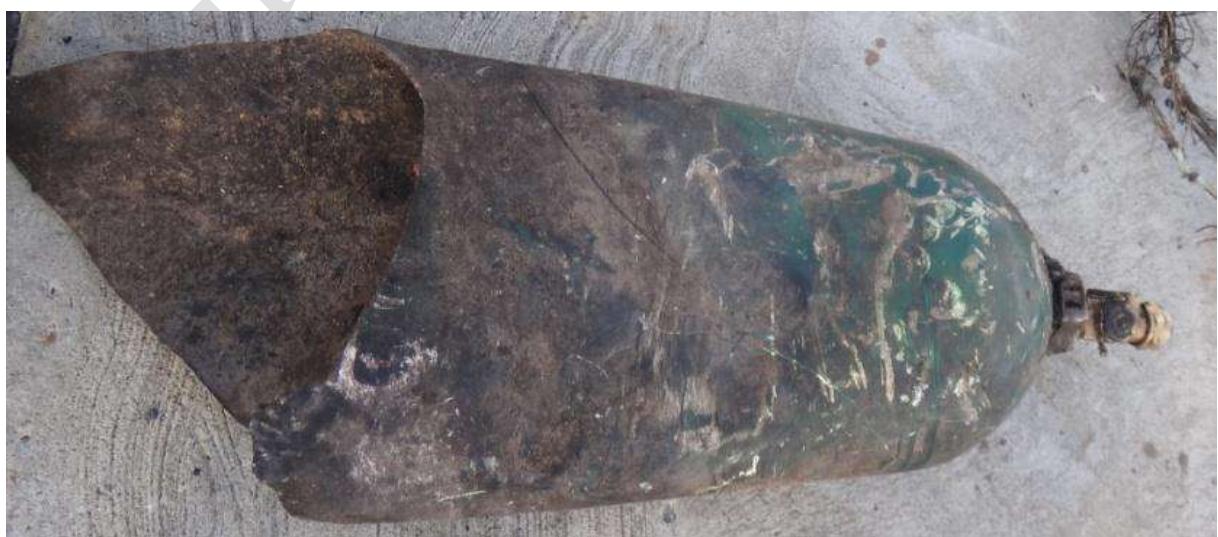
Fig. 25. Main stationary oxygen cylinder

The flight crew main stationary oxygen cylinder had been retrieved (its mounting location is in the electronics and avionics bay). Based on the nature of its destruction it can be concluded that the cylinder had been destructed in the impact sequence (Fig. 25).

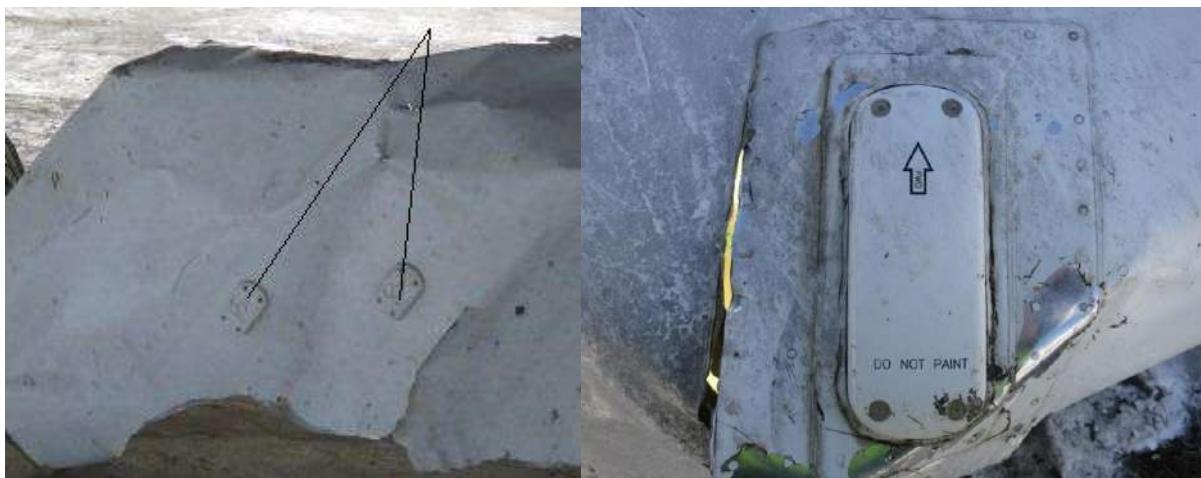
Fig. 26. The GPS and TCAS antennas

The fragments of the fuselage skin with the GPS and TCAS antennas had been discovered (Fig. 26).

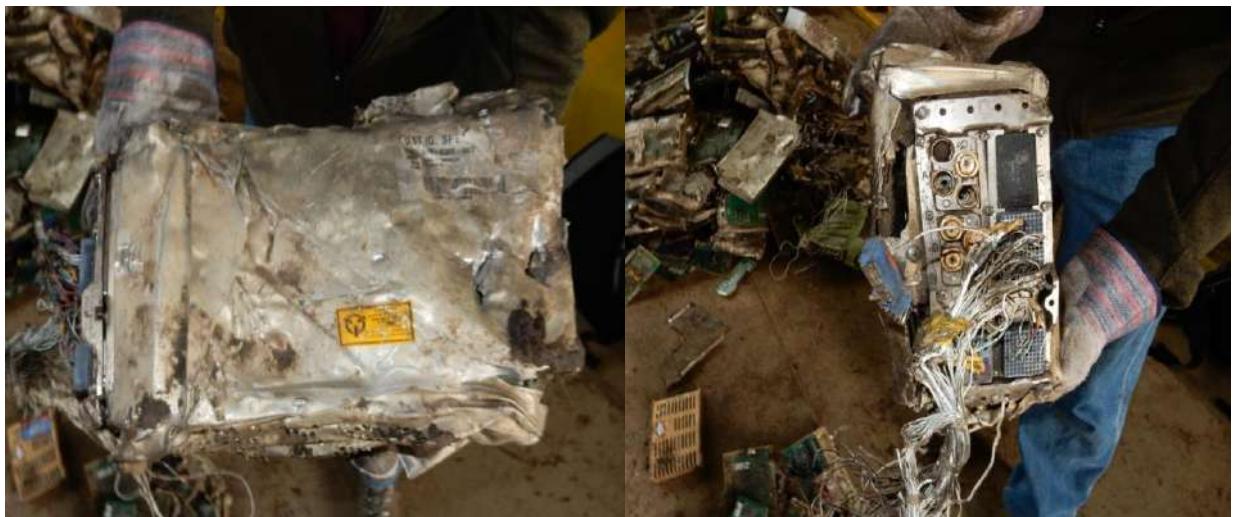
Fig. 28. The TCAS computer

- the TCAS computer, p/n 940 0300 001, s/n TPA03476 (Fig. 28);

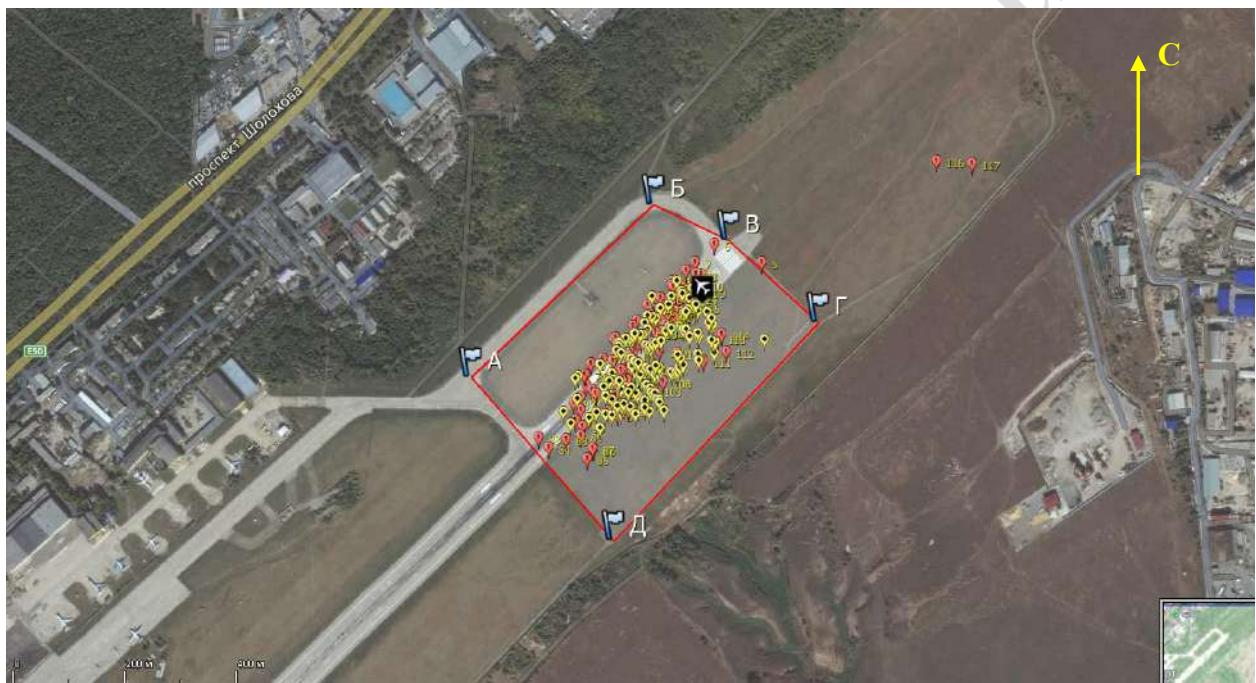
Fig. 39. The pattern of the wreckage scatter on the accident site

The origin of fire was located at the area of the crater. However, the fuselage fragments from FR500C up to 1156H, the right half of the stabilizer (having rested at the distance of 175 m off the crater) and the fin do not demonstrate the signs of fire or the thermal effect both on the outer and inner skin. Based on that it may be concluded that initially at the aircraft impact with ground, there occurred the fuselage destruction with the separation of the stabilizer and the fin and then there developed the fuel flash and fire.

The main wreckage scatter zone was located inside the А-Б-В-Г-Д polygon.

Only two smaller fragments of the fuselage skin were discovered out of the main wreckage scatter zone (the points 116 and 117 on Fig. 39), situated at the azimuth $\approx 57^\circ$ at the distance of ≈ 474 m and, most probably taken away by the wind due to their sailing capacity/windage. The actual weather observed at the Rostov-on-Don aerodrome after the alarm signal declaration as of 00:55: «...surface wind magnetic 230 0 16 m/s, gusts 22 m/s...».

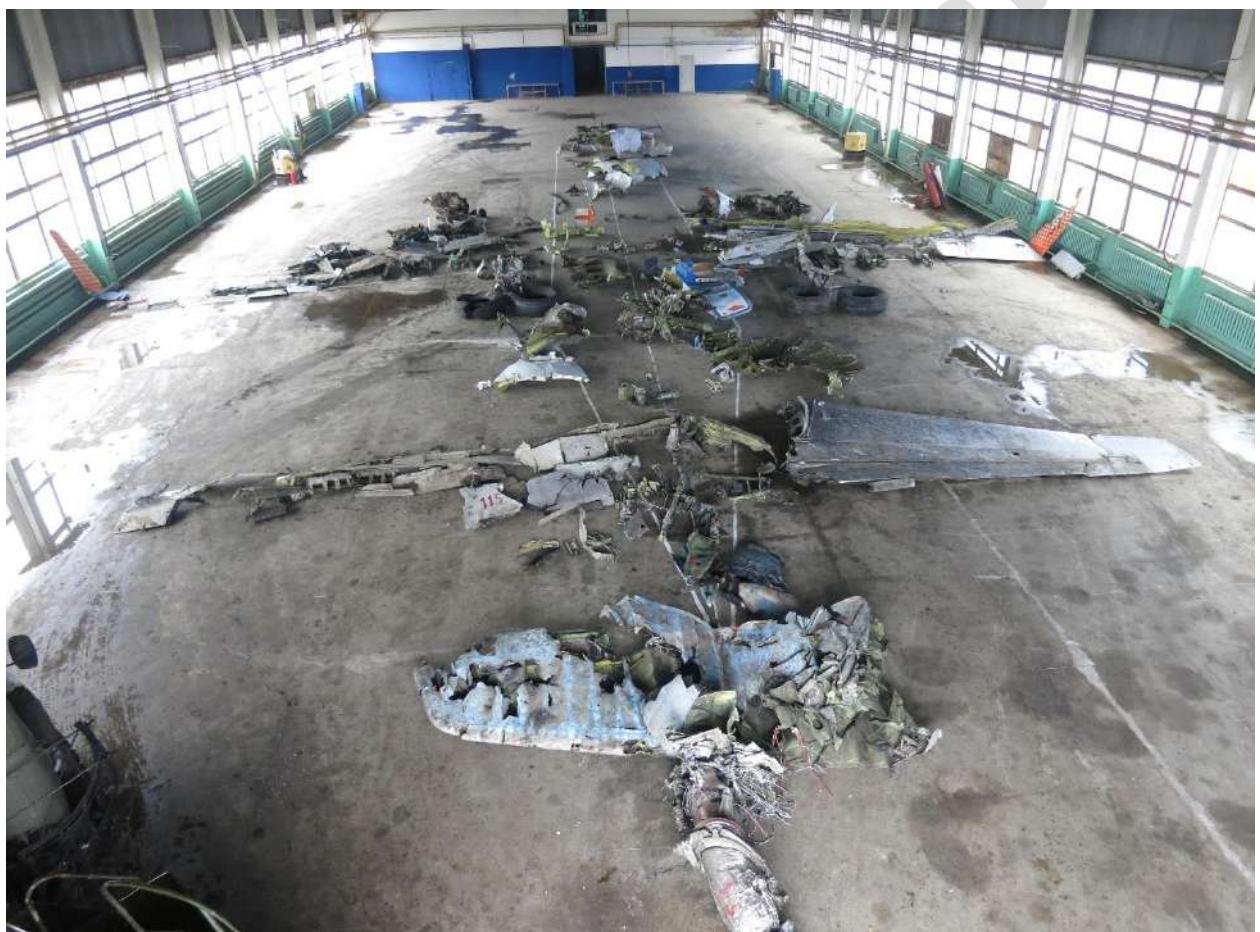
Fig. 41. The surface layout of the wreckage in the hangar

At the analysis of the wreckage map (Section 1.12) and the layout the signs of the inflight aircraft destruction prior to the impact with ground were not detected. All the damage of the airframe structure, engines and systems, as well as the disintegration of the avionics occurred due to the application of the huge loads in the accident sequence far beyond the tensile strength.

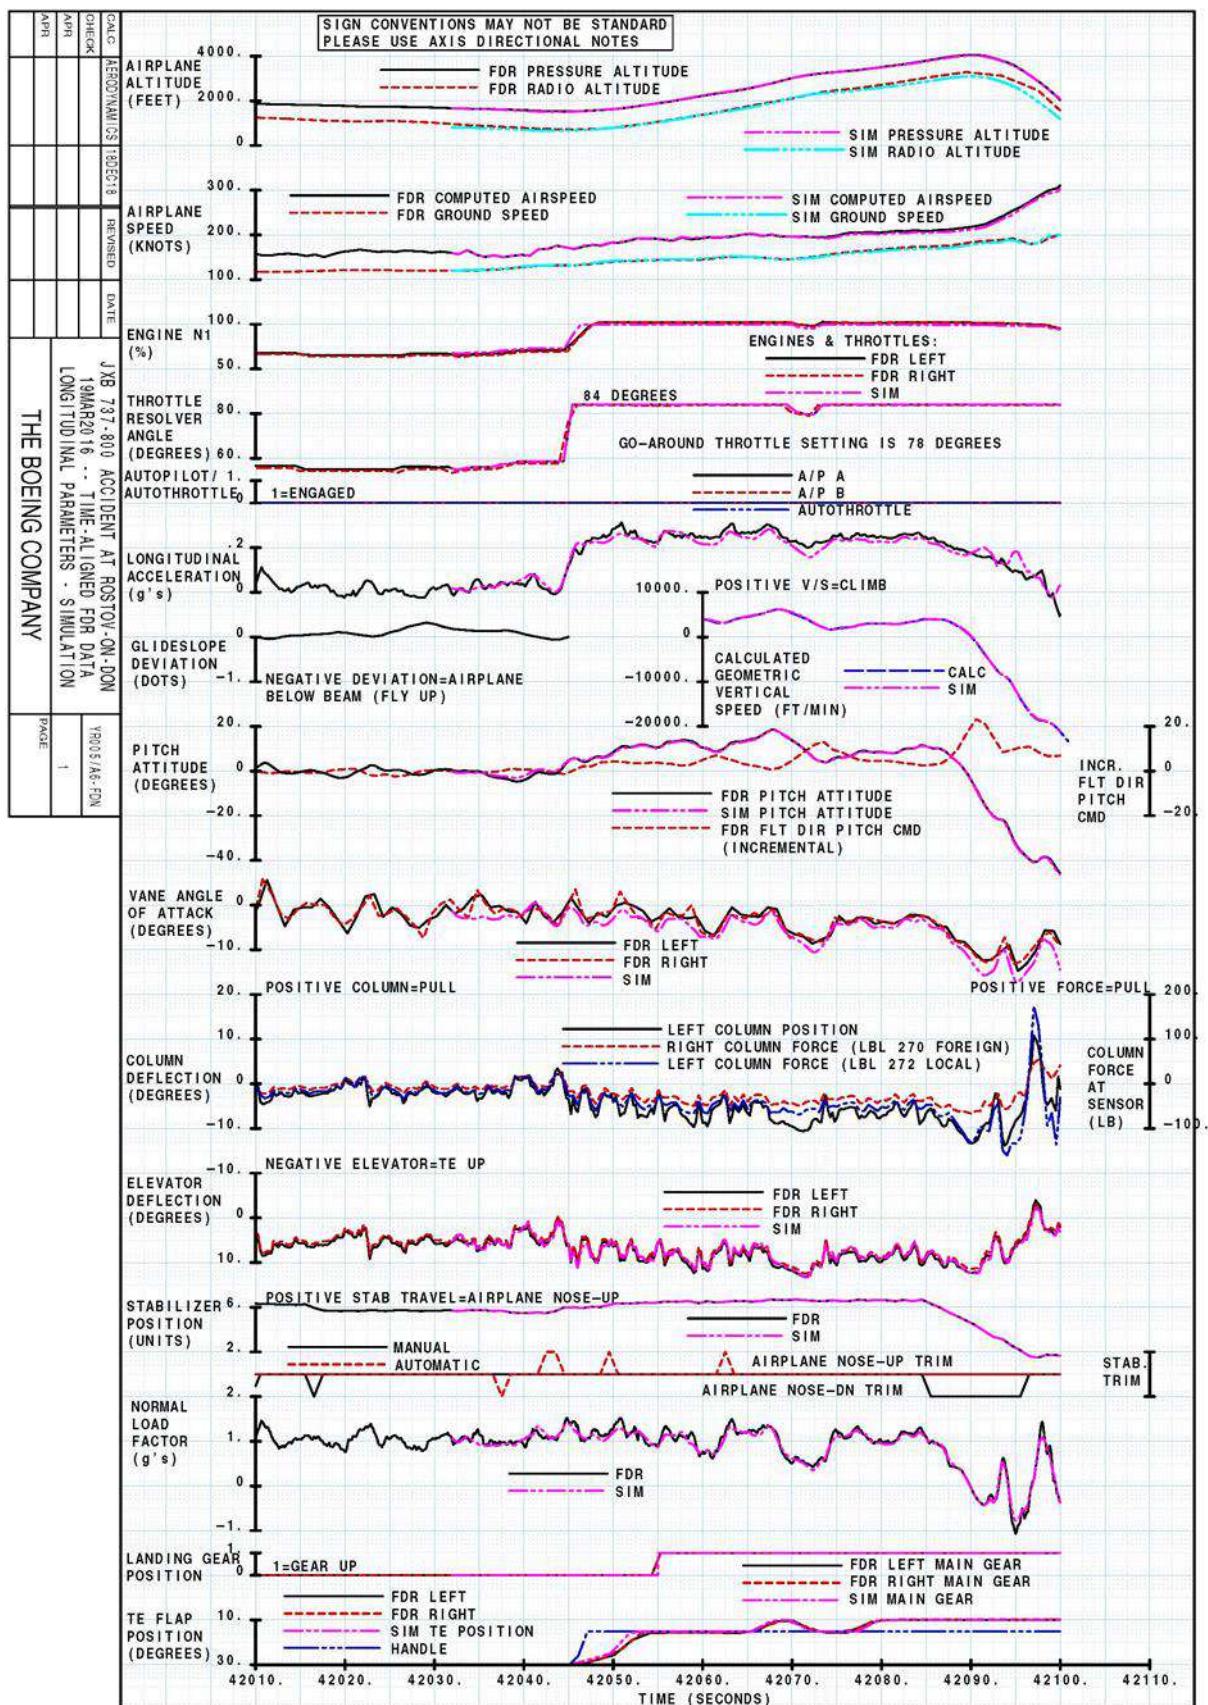
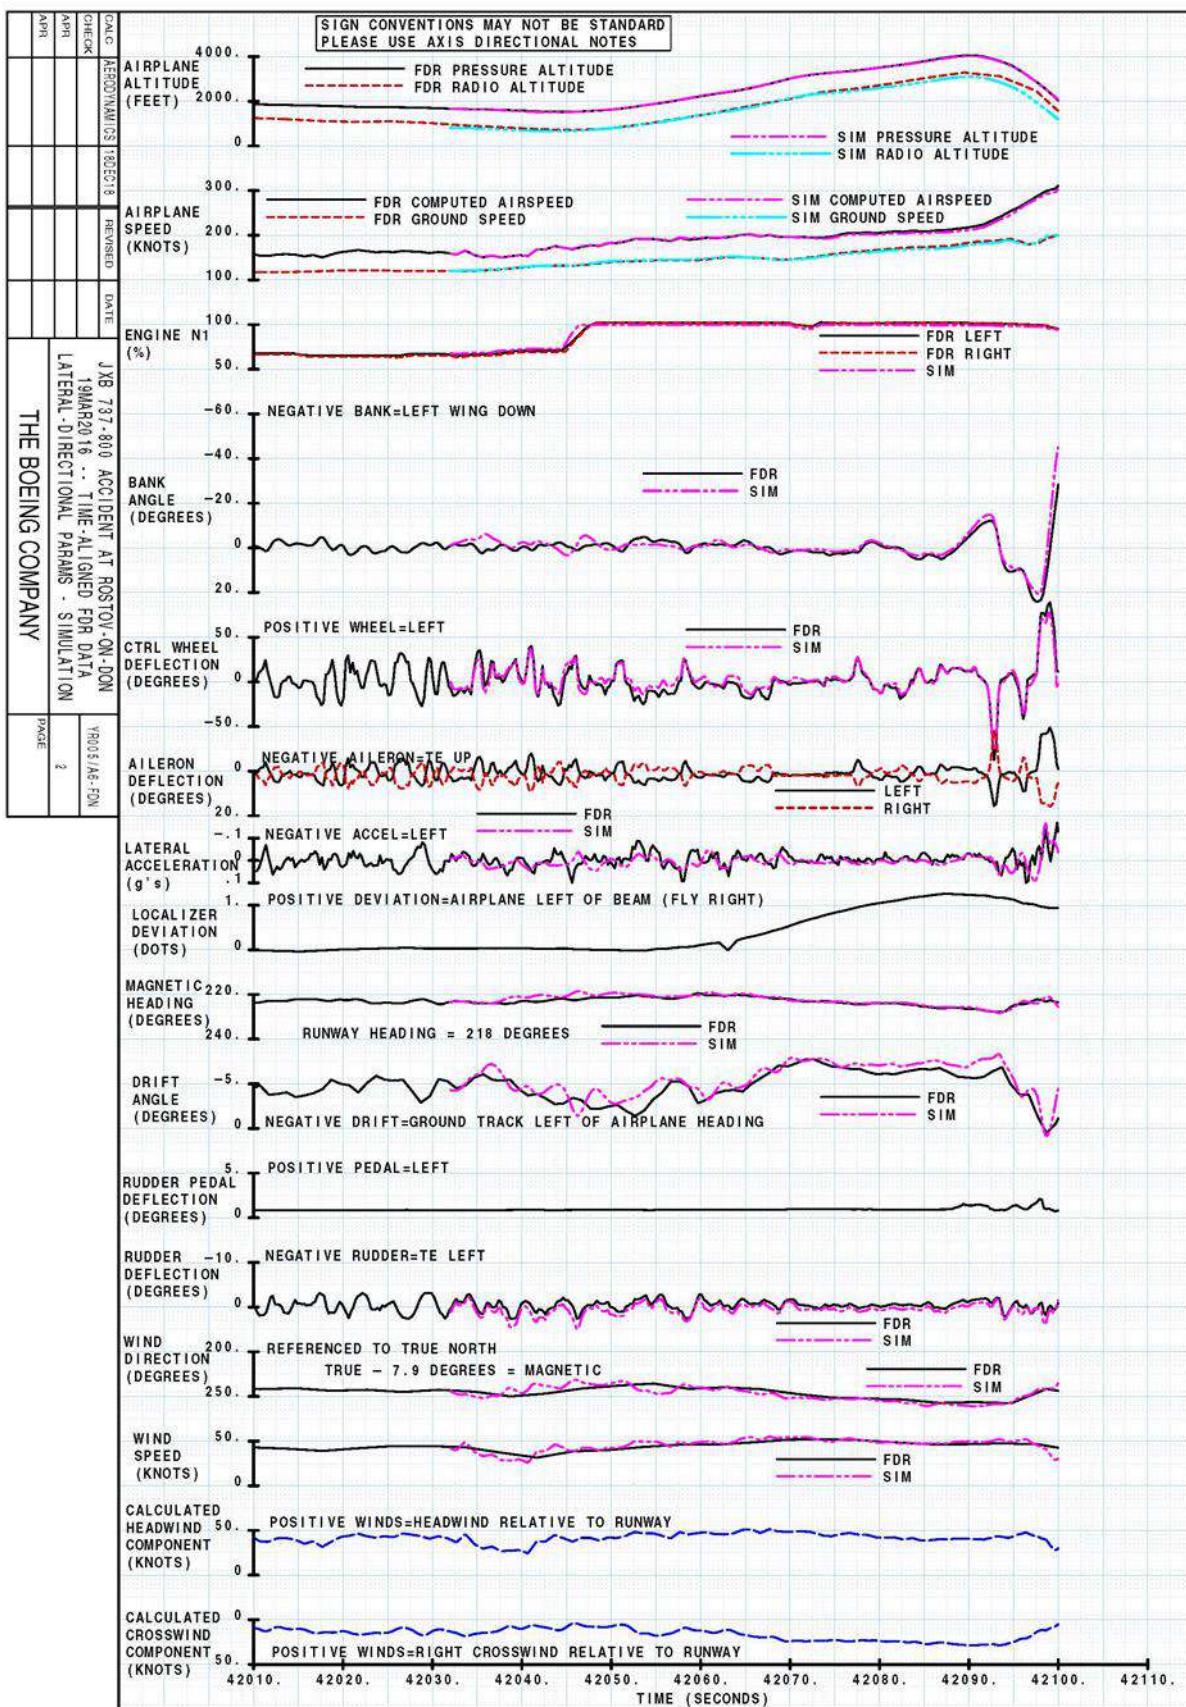
On the results of the engineering simulation, the estimated data match the FDR ones very closely. It means that the aerodynamic performance of the aircraft in the accident flight complied with the performance of the type aircraft, the airplane motion was determined by the control

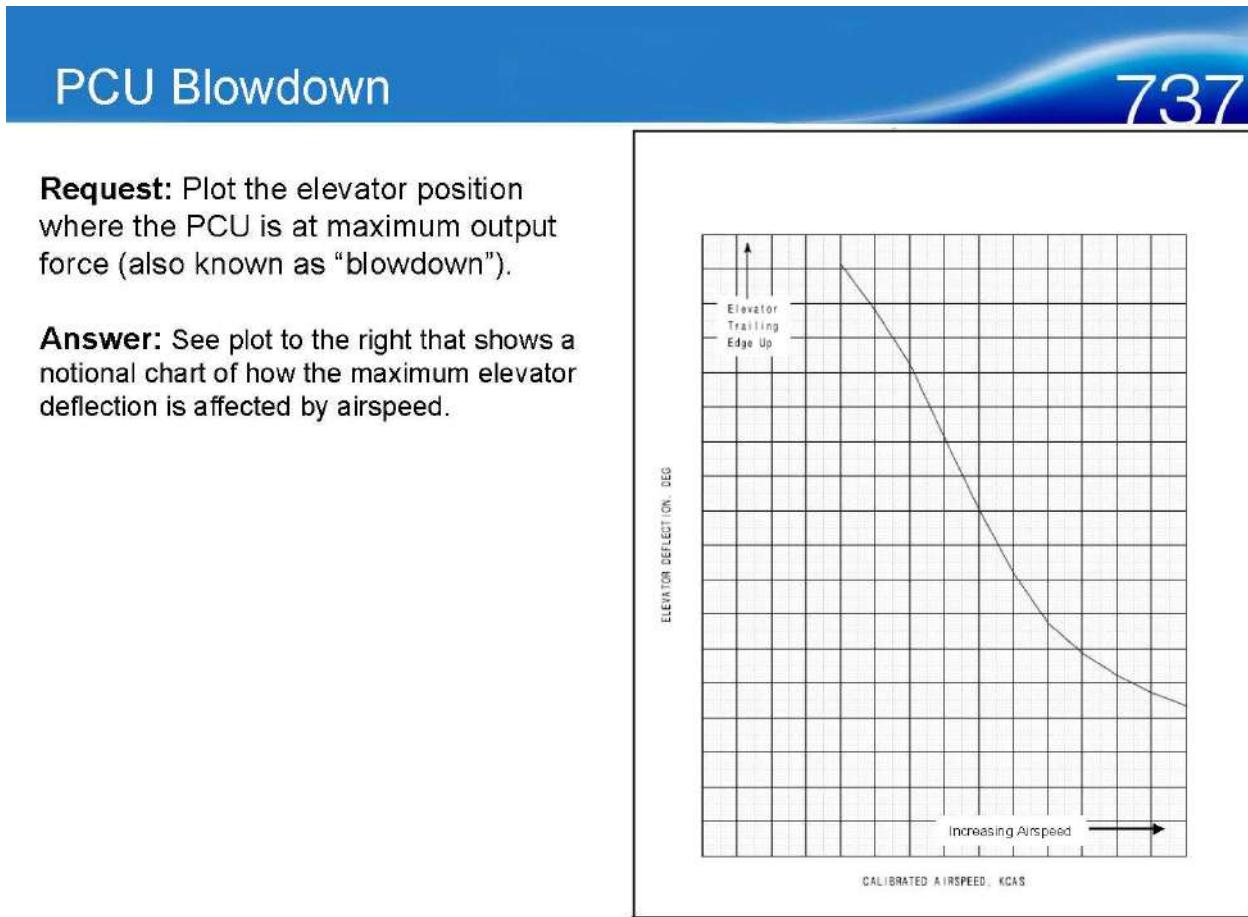
Fig. 48. The maximum elevator deflection vs airspeed dependency

The maximum elevator deflection vs airspeed dependency Fig. 48 represents the notional dependency of the maximum available elevator deflection vs IAS. The numerical values of the scales are not given as they constitute the Boeing Company trade secret. In the progress of the investigation, the investigation team had been provided with the stated dependency, comprising the numerical values. The convergence of the factual and calculated elevator deflection is satisfactory.

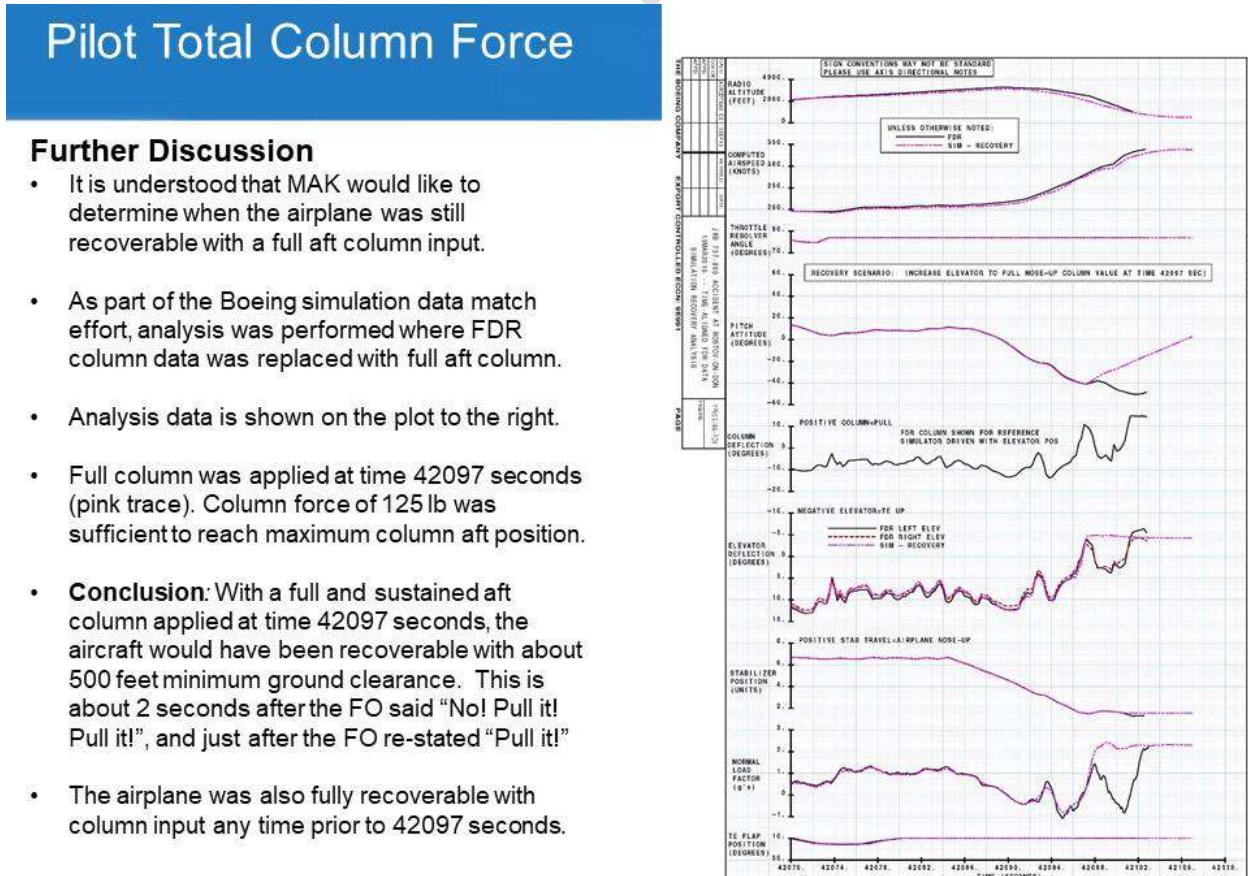
Fig. 48a. Simulation of airplane recovery

The crew capability to recover from the current state of the airplane by the control column deflection only was assessed as well (while keeping current positions of all other controls including stab trim, throttles and flaps). The simulation of the scenario, at which the control column full pull position (the corresponding forces amount to about 125 lb (55 kg)) occurred at the point of time¹², concurrent to the stabilizer trim stop, when the aircraft in descent had been passing the true altitude of ≈ 2000 ft (610 m), was the evidence that the aircraft recovery from the descent had occurred at the true altitude of about 500 ft (150 m) with the further transition to climb (Fig. 48a).

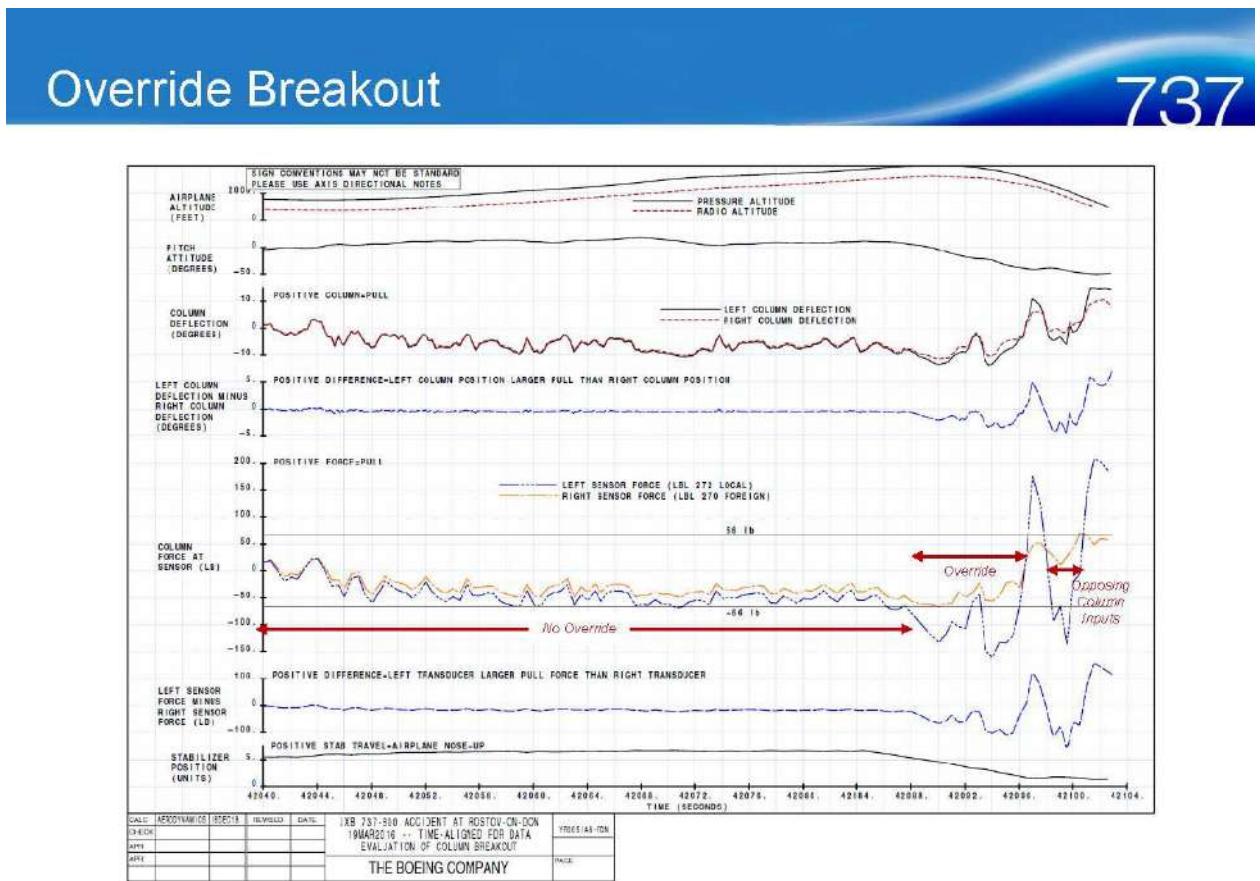
Fig. 49. The control column breakout mechanism activation and the “dual” pitch control

Based on the FDR record (Fig. 49)¹³, in the accident flight until the time of 00:41:32 (42088 on the plot below), the forces, measured by sensors had not exceeded 66 lb and the breakout had not occurred. After the indicated point of time the breakout of the control columns occurred, in this throughout the entire interval the active control was carried out from the PIC’s duty station.

Within the time of 00:41:44 – 00:41:47 (42098 – 42101 on Fig. 49) the forces by the left and the right sensor have the opposite signs that is the evidence of the divergent actions of the pilots, of the PIC - to nose down, the F/O – to nose up. The indicated interval correlates to the activation of the EGPWS alert.

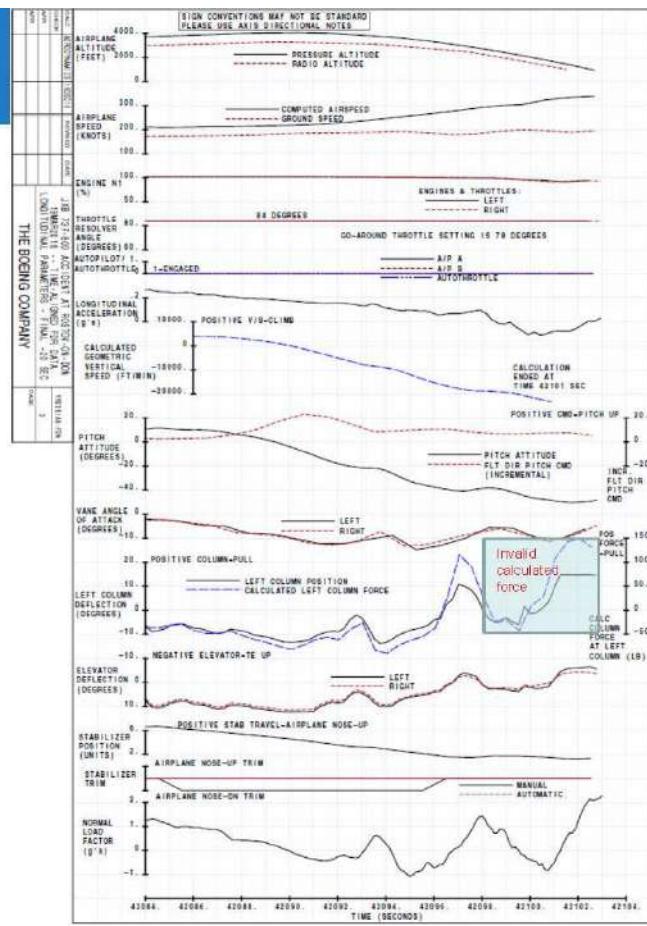
Fig. 50. The estimated forces on the PIC's control column

The results inside the crosshatched region may be unreliable as the control was exercised with both pilots. The computations were the evidence that at the moment of the stabilizer trim initiation to nose down the pilot flying, for the considerable time, had been applying the “pushing” forces of about 50 lb (23 kg)¹⁴.

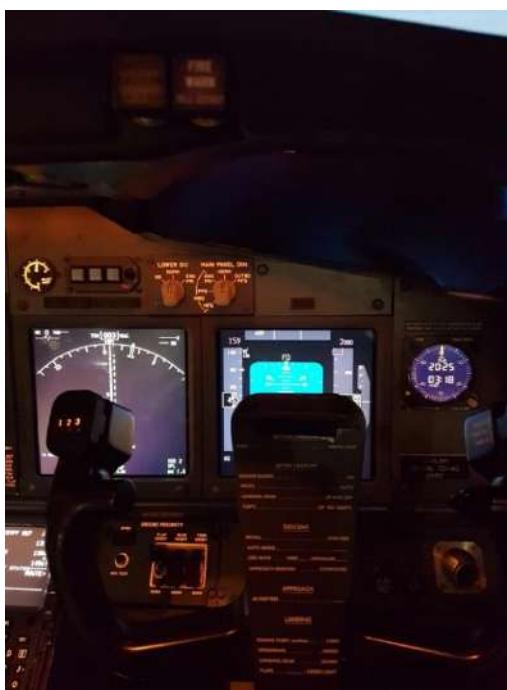
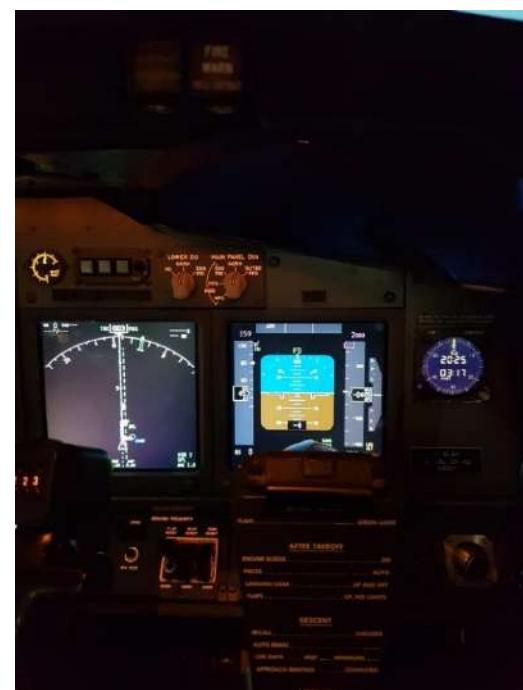
Fig. 52. The pictures of the PFD visibility at different positions of the control column

In the progress of the investigation team activities, a number of pilots noted that at the correct posture at the seat with the gradual forward deflection of the control wheel the view of the PFD indication is degraded (Fig. 52). At the deflection by $\frac{3}{4}$ of control column full travel the significant part of the PFD "is blocked" to the pilot. The investigation team is of the opinion that, as for the accident flight, this specific factor had no significant impact, as the PIC had been controlling the aircraft by HUD, whereas the F/O had the correct concept of the aircraft attitude

and had granted the appropriate prompts to the PIC. At the same time, these features should be additionally analyzed and briefed to the pilots in order to monitor the relevant risks.

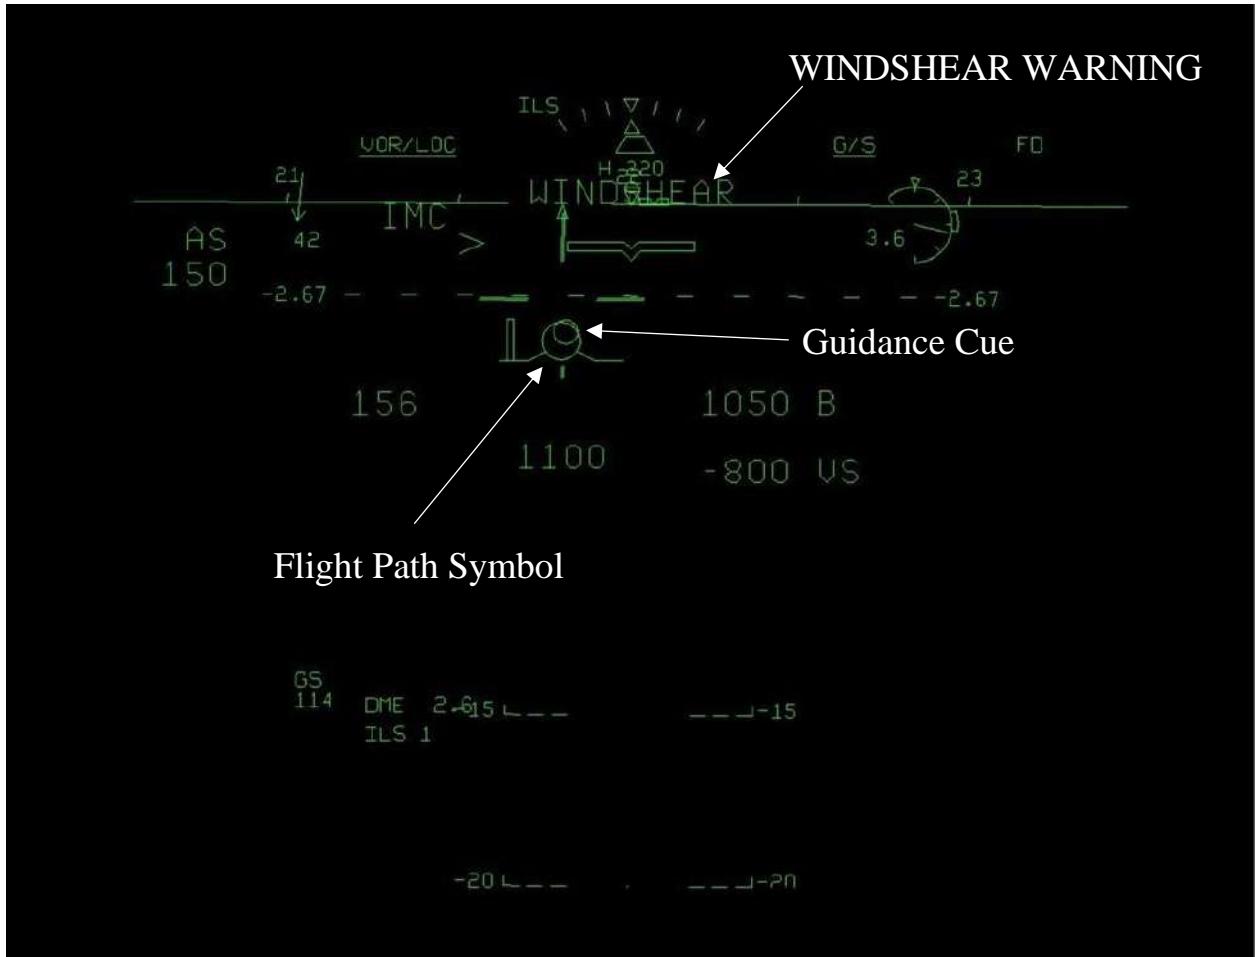
Fig. 54. The HUD reconstructed image at the point of time of 22:42:02 (the windshear warning trigger)²⁶

makes the conclusion that the PIC was controlling the aircraft, following the HUD indications. At this flight stage the Guidance Cue was obviously used. In this case, the pilot's task is "to overlay" the Guidance Cue by the Flight Path Symbol (Fig. 54).

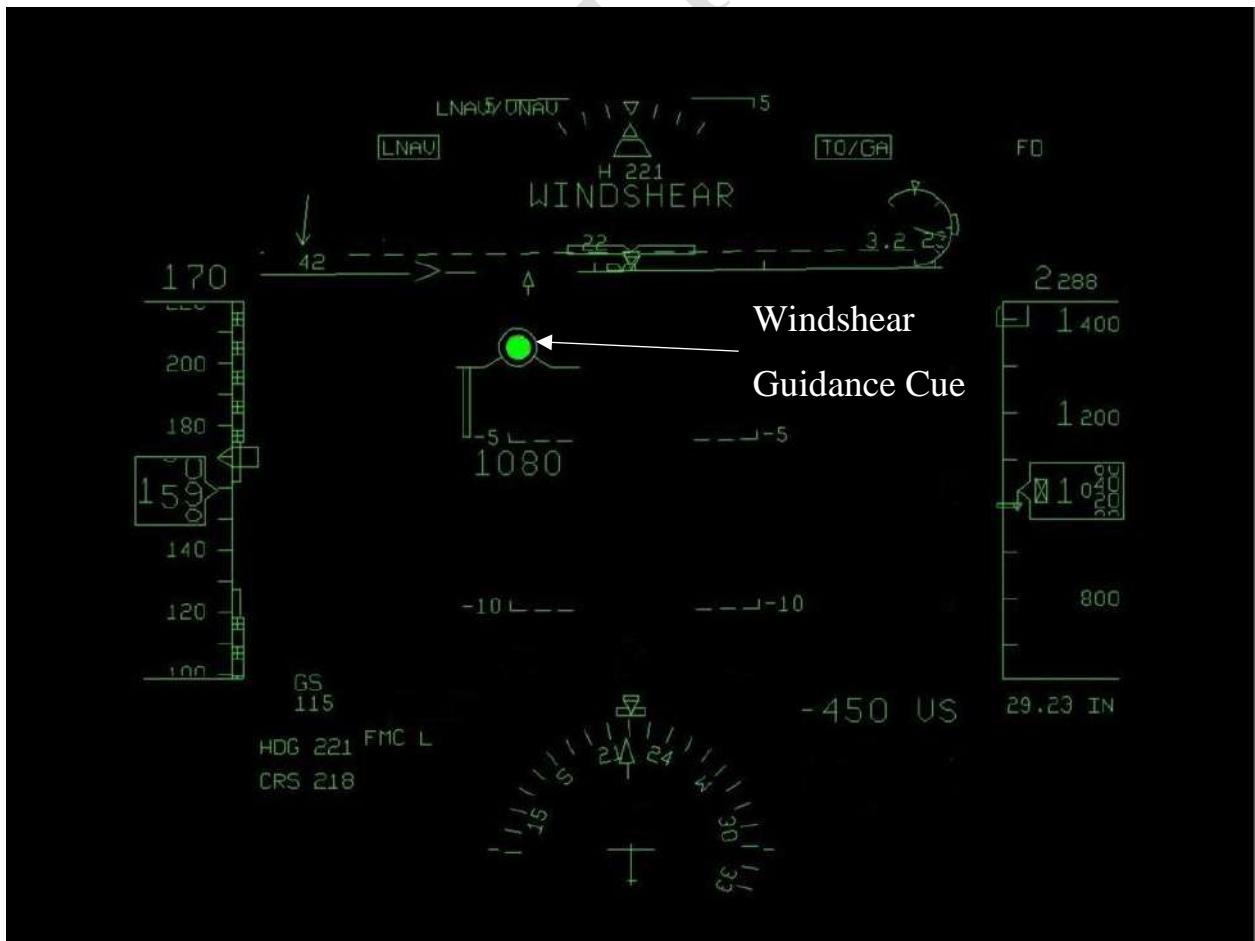
Fig. 55. The HUD reconstructed image at the point of time of 22:42:04 (after the TO/GA mode activation)

After the TO/GA mode activation the HUD automatically switched from IMC to PRI mode (Fig. 55), at the same time the Guidance Cue had become “filled” that is took the form of Windshear Guidance Cue, which is a signal of the Windshear Escape Maneuver carry out.

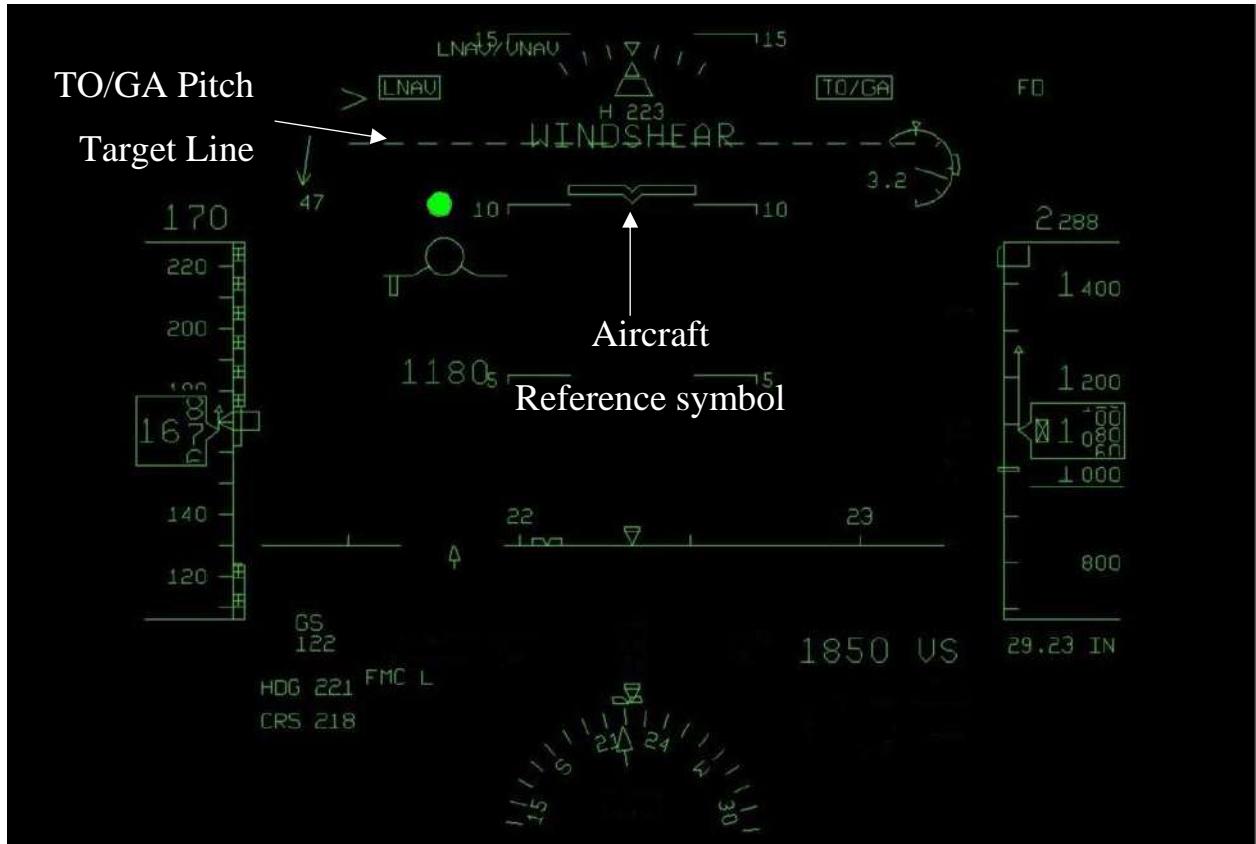
Fig. 56. The HUD reconstructed image at the point of time of 22:42:08.5

In the PRI mode, the HUD “director” indication duplicates the PFD command bars readings that are computed by FCC. Fig. 56 presents the HUD reconstructed image at the point of time of 22:42:08.5, when the position of the pitch command bar was maximum to nose-up. To maintain the target climb path the pilot needs to adjust the aircraft symbol to the TO/GA pitch target line. Alternatively, the pilot may proceed the aircraft control by overlaying the Guidance Cue and Flight Path Symbol.

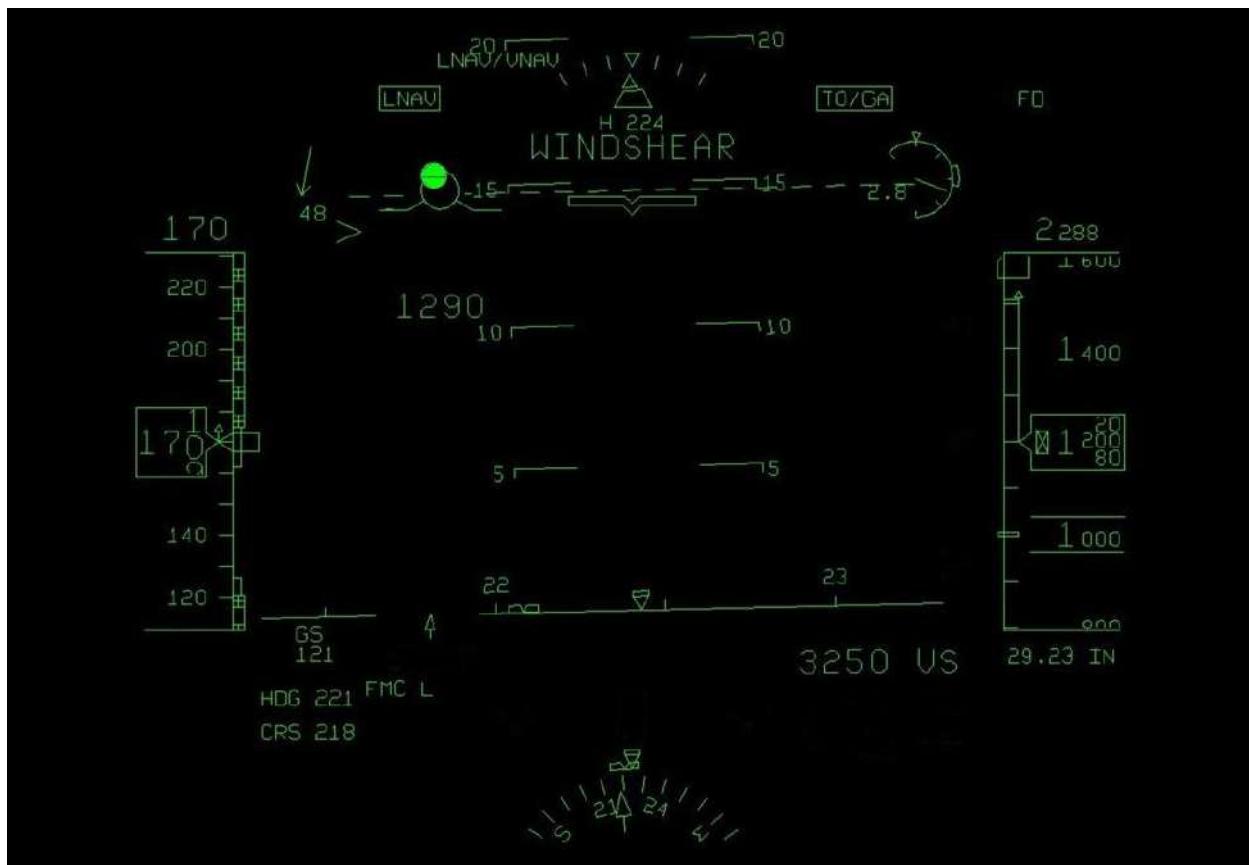
Fig. 57. The HUD reconstructed image at the point of time of 22:42:11

Initially in 10 sec, the PIC reached the pitch of 14...15°, following the HUD commands (Fig. 57) and the FCOM and QRH guidance. To counteract the excessive pitch-up moment, generated at the engine thrust increase to maximum, the PIC was forced to move the control column significantly forward.

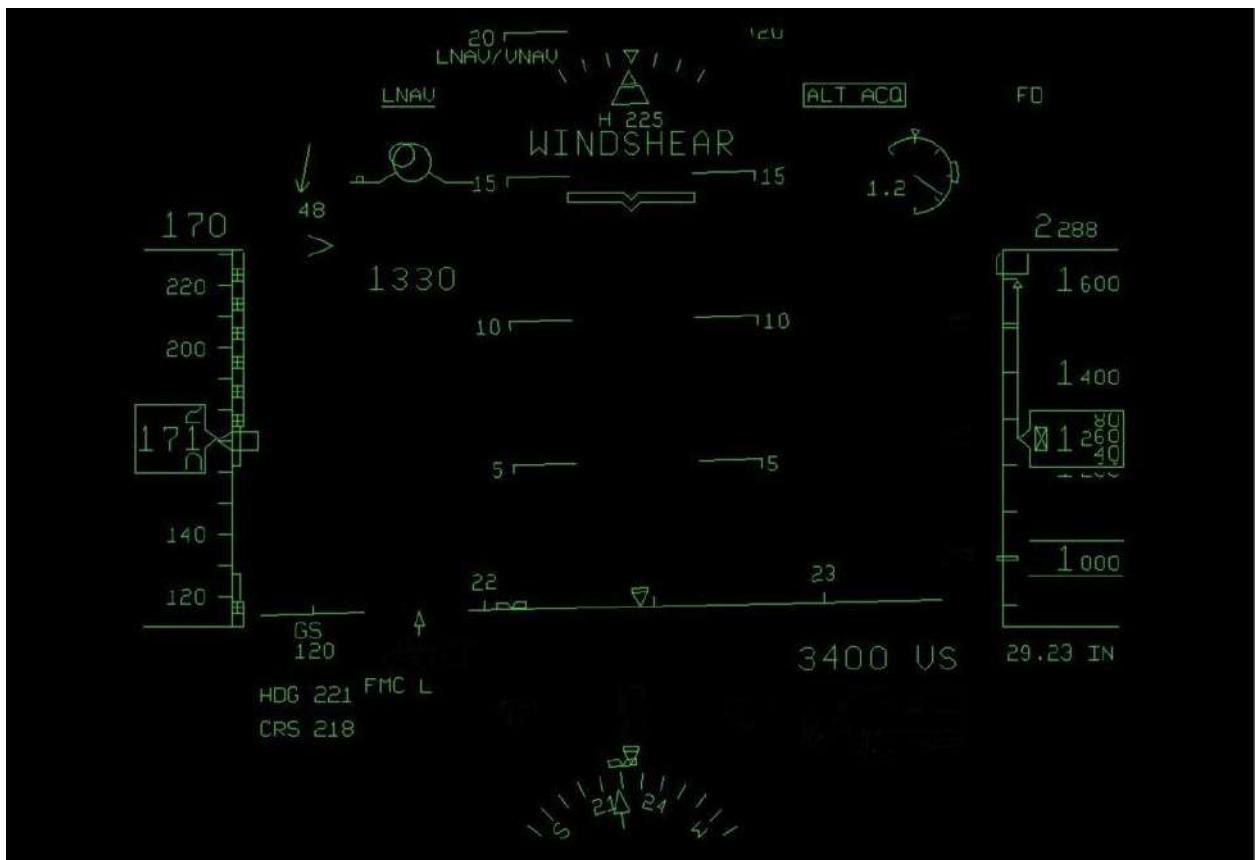
Fig. 58. The HUD reconstructed image at the point of time of 22:42:13 (the ALT ACQ mode activation)

The go-around altitude, set on MCP, was 2300 ft, at 1000 ft below that altitude (at 22:42:13), as per the AFDS logic, the ALT ACQUIRE mode was activated (Fig. 58).

The crewmembers did not speak out the activation of this mode, maybe because the F/O was then occupied with the communication with ATC. According to the airline within the flight personnel training the attention is drawn to the need to follow the AVIATE-NAVIGATE-COMMUNICATE principle. Probably such an early report on go-around “to the detriment” of the flight parameters monitoring was related to the necessity to request further climb (higher of the target go-around altitude) as the windshear warning was still displaying.
