This document is an English translation of the Final Report on the accident involving the Boeing 737-8KN aircraft registered A6-FDN that occurred on March 19, 2016 (00:42 UTC) at Rostov-on-Don aerodrome, the Rostov Region, Russian Federation.

**INTERSTATE AVIATION COMMITTEE
AIR ACCIDENT INVESTIGATION COMMISSION
FINAL REPORT**

Type of occurrence	Fatal accident
Type of aircraft	Boeing 737-8KN, airplane
Nationality and registration marks	A6-FDN
Owner	Celestial Aviation Trading 38 Limited, Shannon, County Clare, Ireland
Operator	Dubai Aviation Corporation, P.O. Box: 353, United Arab Emirates
Aviation authority of the place of occurrence	Southern FATA Interregional Territorial Department
Place of occurrence	Russian Federation, the Rostov region, the Rostov-on-Don aerodrome, reference position: 47°15'54.7" N, 039°49'43.8" E
Date and time	19.03.2016, 03:42 local time (00:42 UTC), nighttime

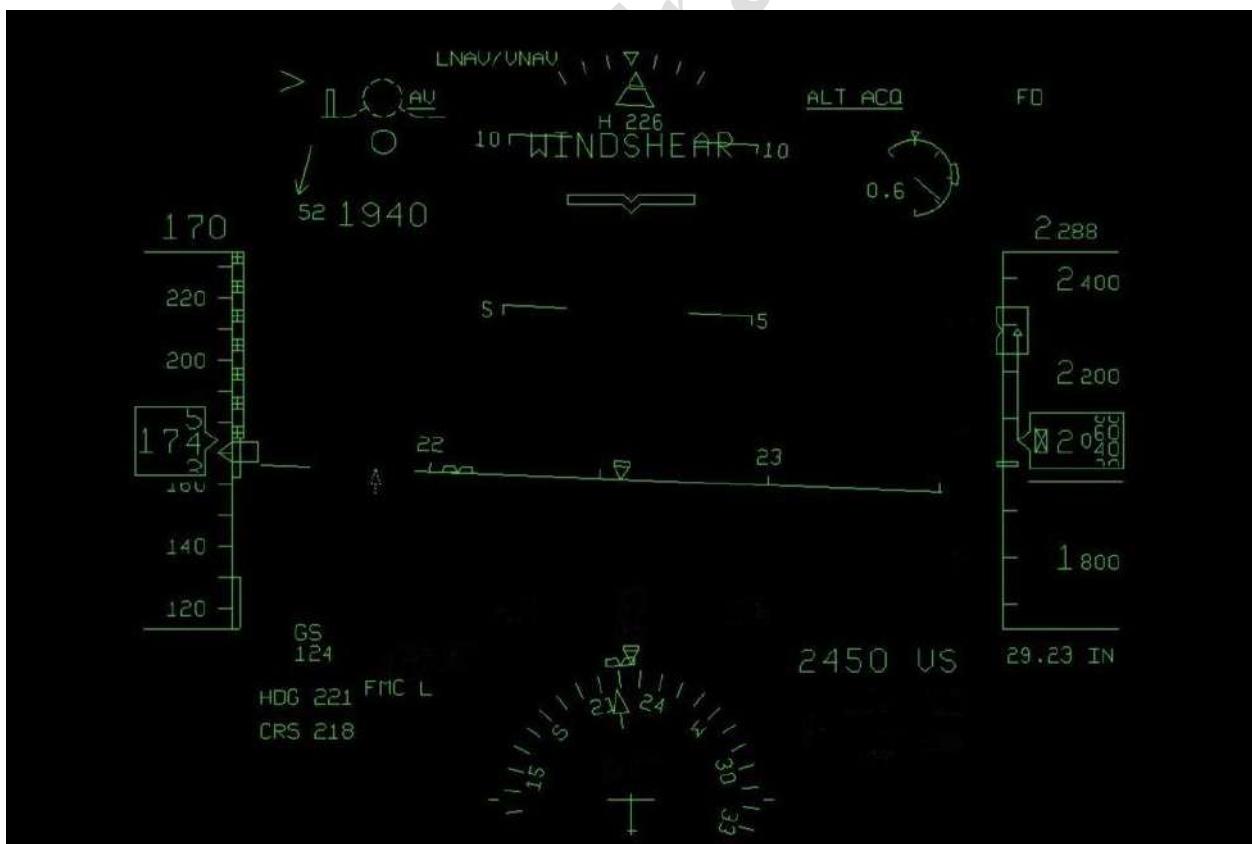
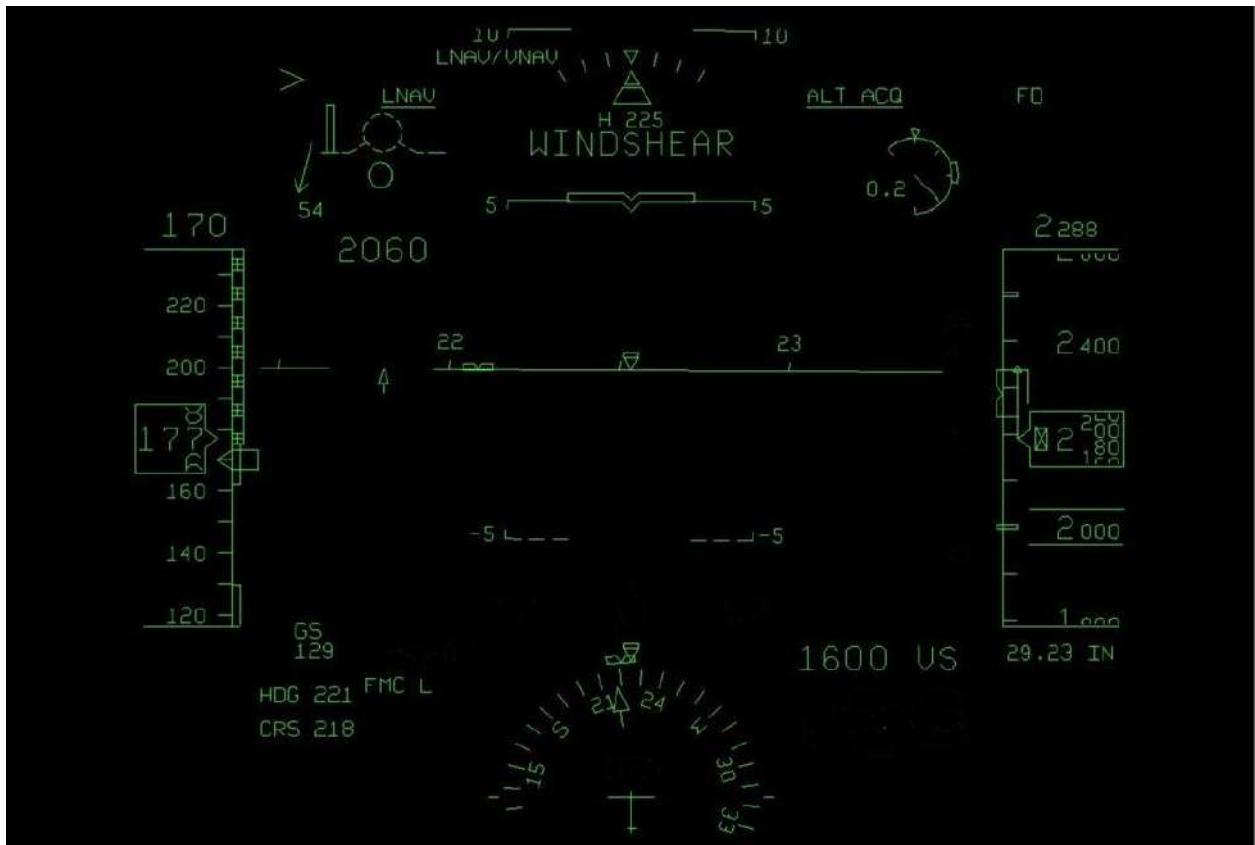
At the moment the Flight Path Symbol on HUD was higher than Guidance Cue (Fig. 59 and Fig. 60), that is to maintain the target flight path the additional control inputs to “nose-down” were required. With the control column position unchanged the PIC, in addition, pressed the trim switches on the control wheel for about 4 s to nose-down (the angle of deflection of the stabilizer was changed for 1.8°) that resulted in the pitch reduction up to 3-4° and additional acceleration.

Fig. 59. The HUD reconstructed image at the point of time of 22:42:27.5 (the first press on the stabilizer trim switches)

Fig. 60. The HUD reconstructed image at the point of time of 22:42:31.5 (the last press on the stabilizer trim switches)

As the result the IAS exceeded the limit value (with flaps, extended on 30°, Vfe is 175 kt) and TE Flap Load Relief was activated. The flaps automatically retracted to 25° (the flap handle remained at the 30° detent). It should be noted that at the initiation of go-around IAS was equal to 160 kt that is the margin to the limit (with no “flap load relief”) at the performance of Windshear Escape Maneuver amounted to 15 kt.

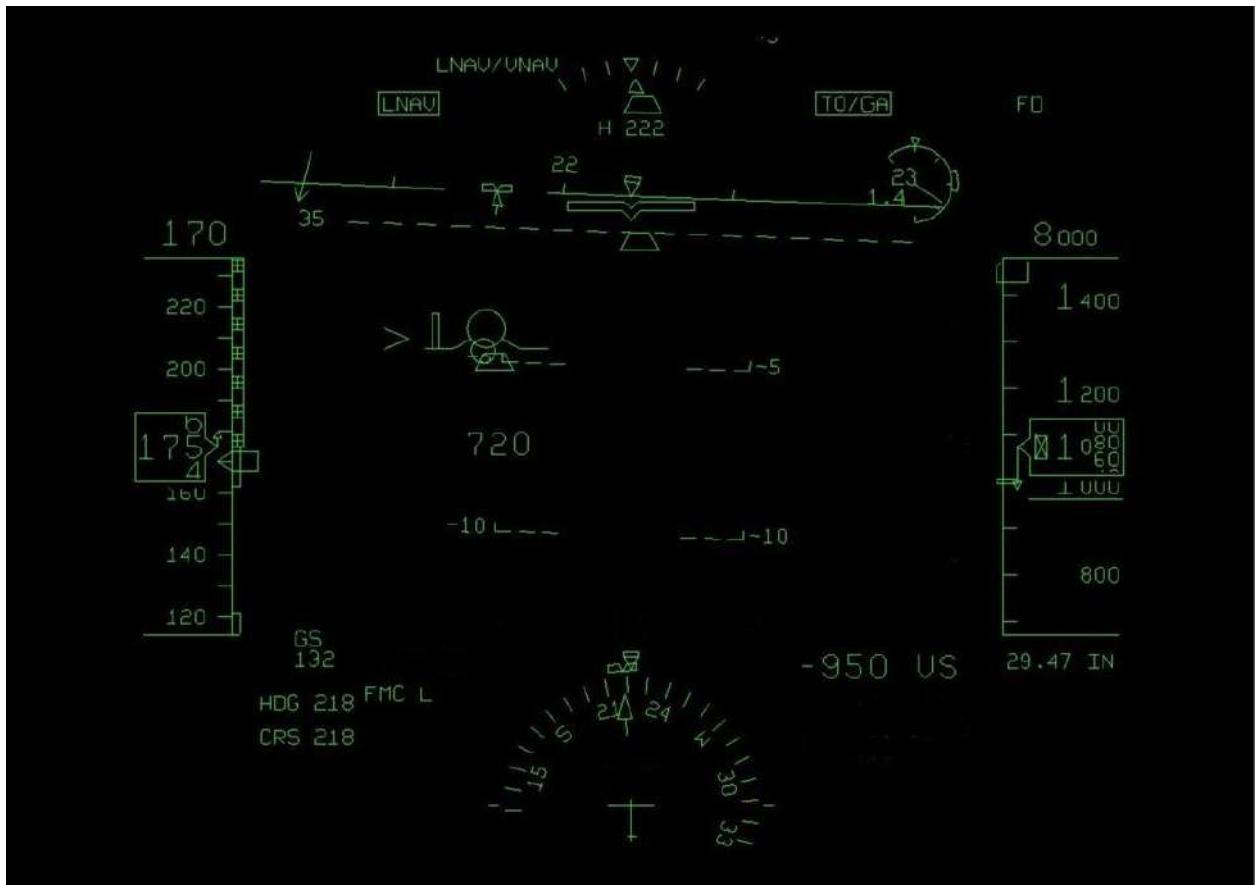
Fig. 64. The HUD reconstructed image at the point of time of 00:40:50 (the TO/GA mode activation)

Fig. 64 presents the HUD reconstructed image at the point of TO/GA mode activation.

At the point of go-around initiation the altitude was equal to 1100 ft QNH (250 m QFE) with the speed of 173...175 kt, that is it was consistent with Vfe for flaps 30°. As per the information available, it cannot be clearly established if the PIC perceived the abrupt increase of speed readings as one of the signs of the windshear encounter (according to QRH D6-27370-8KN-JXB page MAN.1.9, the IAS alteration for 15 kt at the altitude of less than 1000 ft is applicable to “unacceptable flight path deviations”, which in their turn are one of the signs of the windshear encounter), or as the ordinary sign of an unstabilized approach. It may be assumed that in advancing thrust levers to full thrust the PIC (“in his mind”) initiated, similar to the first go-around, the Windshear Escape Maneuver. Particularly given that, if the PIC perceived the speed leap in question as associated with the windshear encounter, this very maneuver is directly (without an alternative) prescribed by QRH.

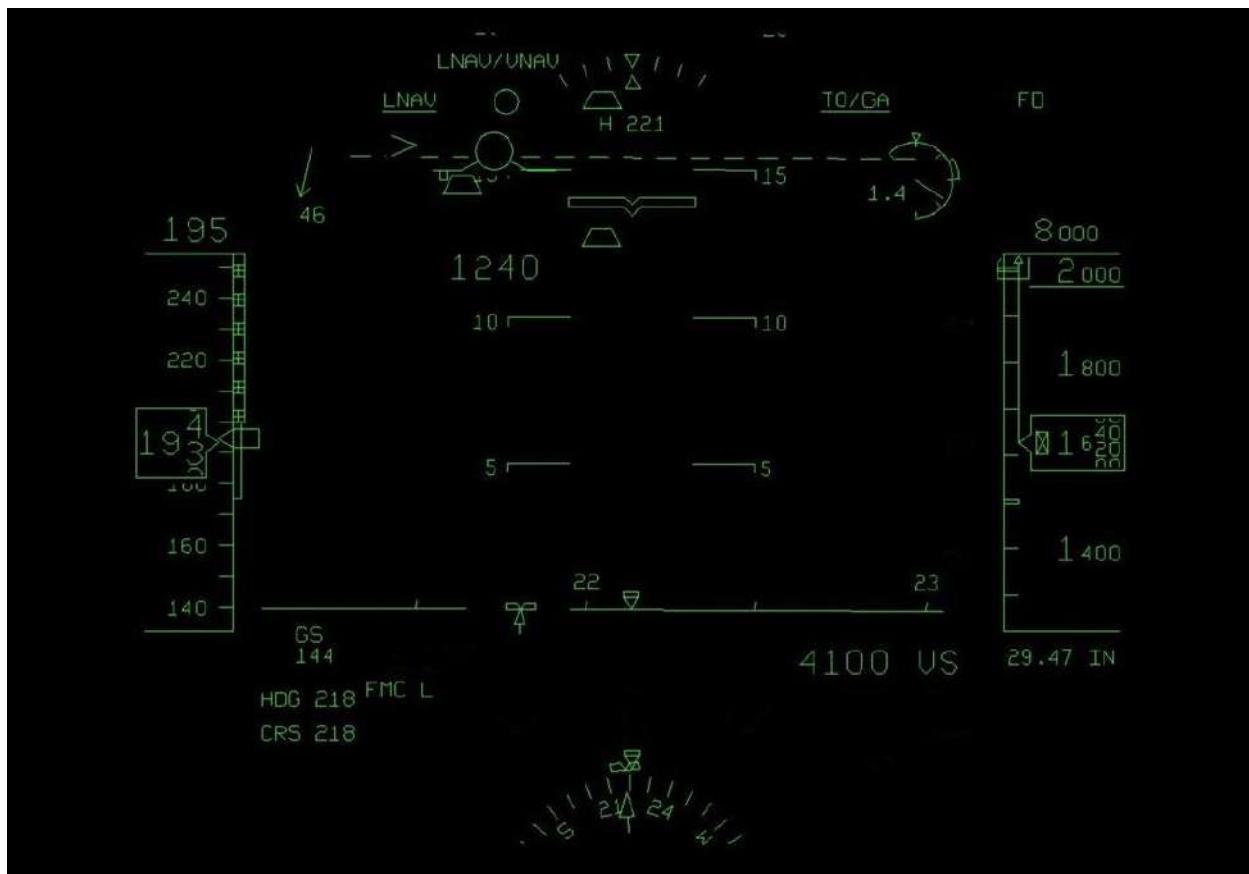
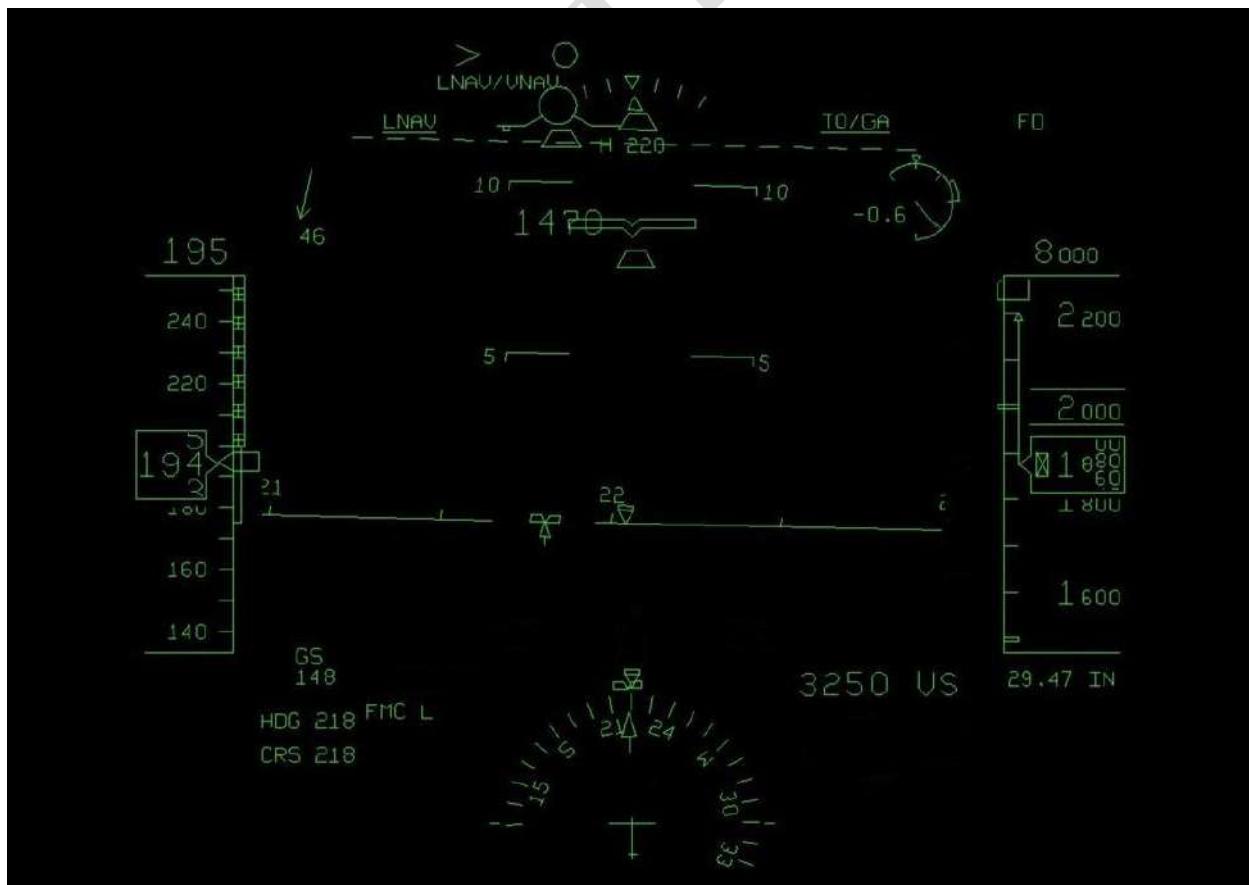
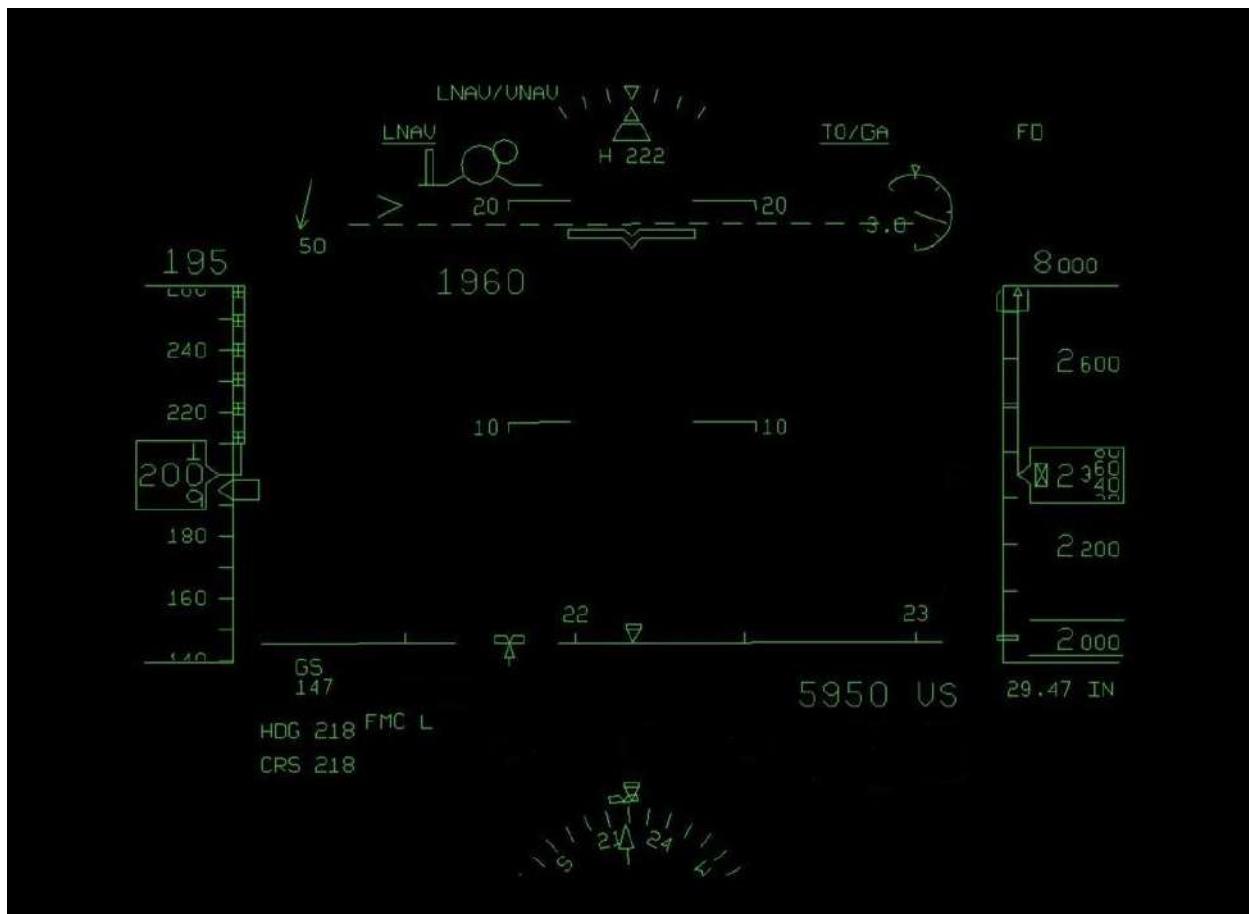
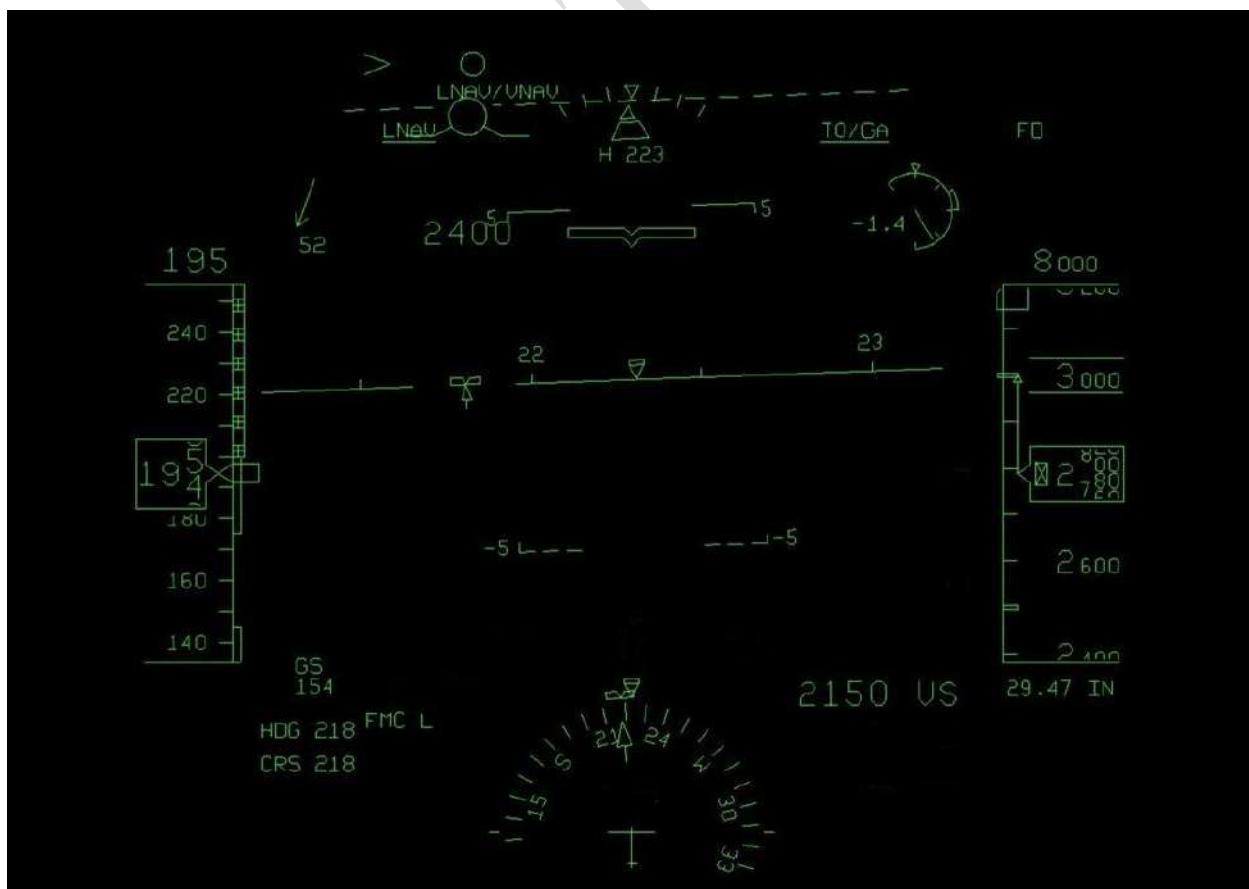
As the result all the further actions in the rapidly changing environment, that was evolving into non-standard (non-trained) situation, were of a belated character. The analysis of the angle of climb (pitch) value shows evidently that the PF (the PIC) had been never able to create the initial pitch of 15°, recommended by FCOM. The actual pitch was changing in steps (6°, 12°, 14°, 9°, 14°, 18.5°, 4°). As oppose to the first go-around, the PIC failed to maintain the climb path, set on by the pitch command bar, the position of which on PFD at the same points of time was equal to³⁰ (4°, 3.5°, 2.5°, 7°, 3°, 1°, 13°). The HUD reconstructed image as per the points of time 00:41:03 (the pitch local maximum 14°), 00:41:07 (the pitch command bar local maximum 7°), 00:41:13 (the maximum reached pitch 18.5°), 00:41:19 (the pitch command bar local maximum 13°) is given on the below figures (Fig. 65., Fig. 66, Fig. 67, Fig. 68).

Fig. 65. The HUD reconstructed image at the point of time of 00:41:03 (the pitch local maximum $\approx 14^\circ$)

Fig. 66. The HUD reconstructed image at the point of time of 00:41:07 (the pitch command bar local maximum $\approx 7^\circ$)

Fig. 67. The HUD reconstructed image at the point of time of 00:41:13 (the pitch local maximum $\approx 18.5^\circ$)

Fig. 68. The HUD reconstructed image at the point of time of 00:41:19 (the pitch command bar local maximum $\approx 13^\circ$)

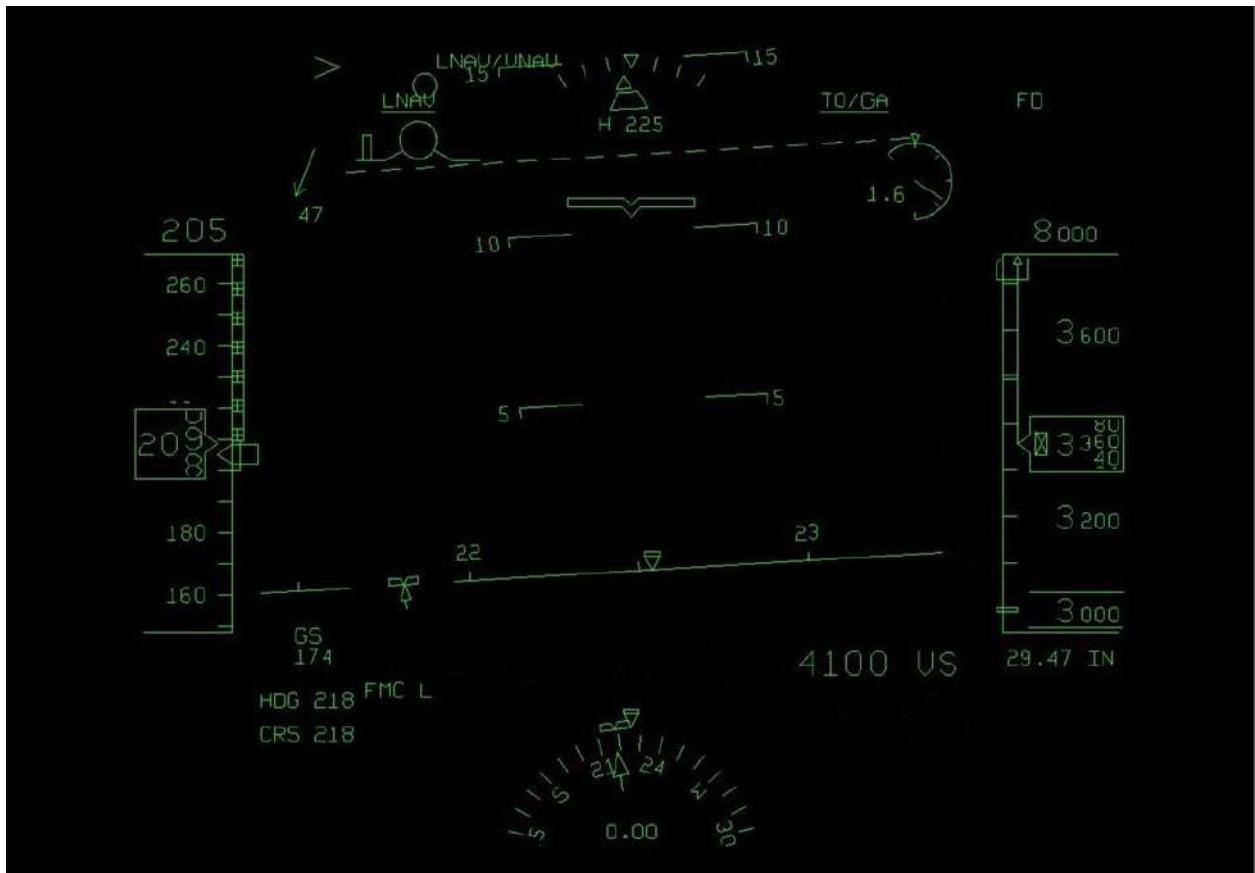
Fig. 69. The HUD reconstructed image at the point of time of 00:41:30.5 (the initiation of the stabilizer trim to nose-down)

The onset of the critical situation started at 00:41:30.5. In proceeding the piloting of the out of trim aircraft (unbalanced on forces), and obviously enduring inconvenience; at the present parameters of flight: $H \approx 3350$ ft QNH (935 m QFE), IAS – 210 kt, pitch – 10° to nose-up, the stabilizer setting – 2.7° to nose-up, flaps 10° , the power mode of the engines – the maximum thrust, the PIC pressed the stabilizer trim switches to nose-down. Fig. 69 presents the HUD reconstructed image at that point of time.

The figure is the evidence that the system “commanded” the pitch increase (the dashed line – TO/GA pitch target line – is higher than the aircraft reference symbol). In other words, most probably the PIC, having acted in such a manner, tried “to relieve” the pushing forces on the control column, rather than to transition the aircraft to nose down. However, along the stabilizer trim, the pilot did not return the control column to neutral position, with that the stabilizer trim switch remained pressed for an abnormally long time (12 s!!!).

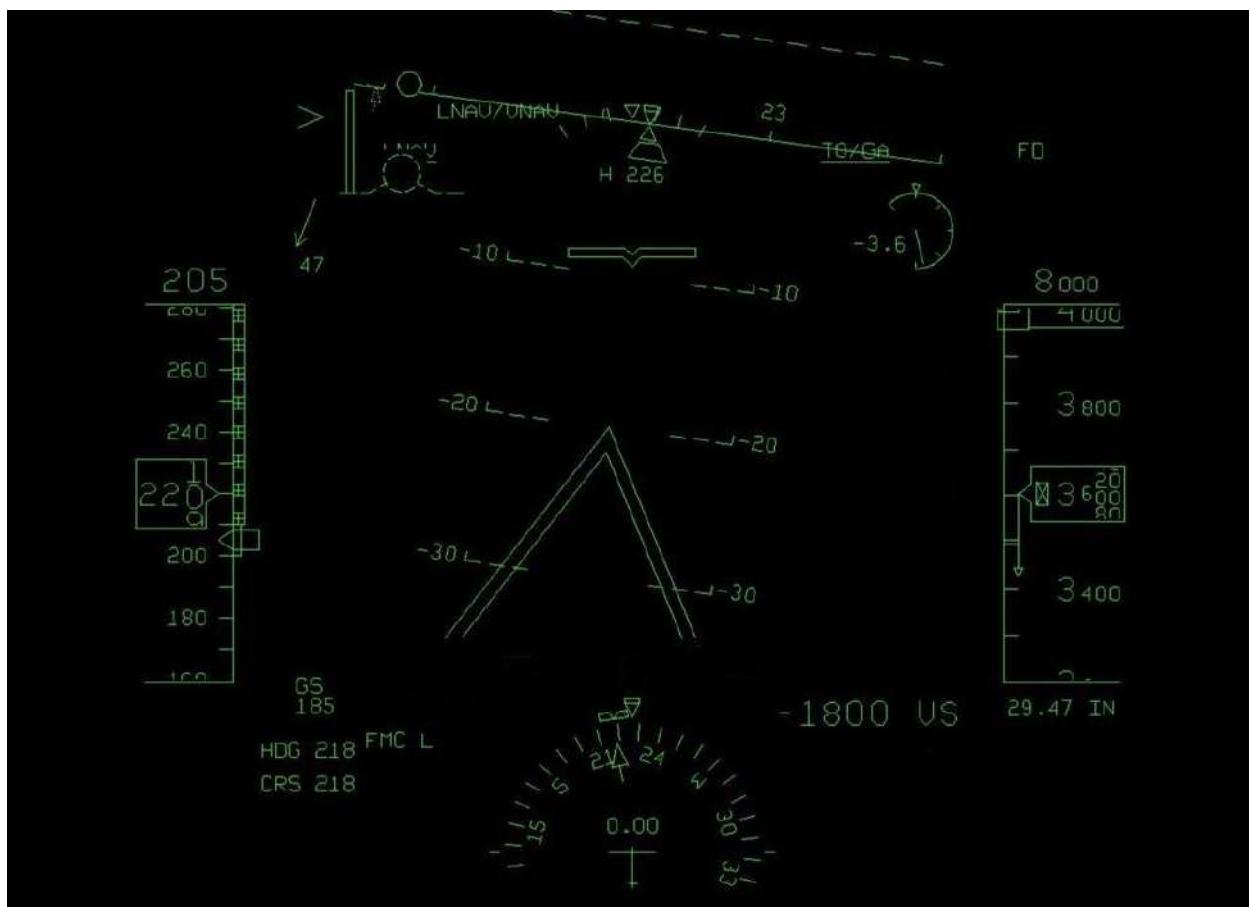
Fig. 70. The HUD reconstructed image at the point of time of 00:41:36

At Fig. 70, at the actual nose-down pitch of about 10° , the upward pointing Pitch Chevron is displayed on HUD (the direction of the aircraft recovery to the “regular” flight) with the top point at the pitch value of 20° nose-down, at the same time the HUD is still operated at the PRI mode. The Pitch Chevron appears when the HUD is switched to the compressed mode. The Pitch Scale is compressed, when the aircraft attitude is such that the Horizon Line or the Flight Path Symbol cannot be displayed conformably. In the compressed mode, the increment of the pitch scale is doubled, from 5° to 10° . The figure is the evidence that in this mode the proportion between the position of Guidance Cue and Flight Path Symbol, the target and actual pitch symbols is no longer respected. At that the Flight Path Symbol is displayed in dashed line – becomes “ghosted” (the term, used in the HUD Pilot Guide) – this means it is no longer conformal with the real world, though being in a qualitatively correct position against the Guidance Cue.

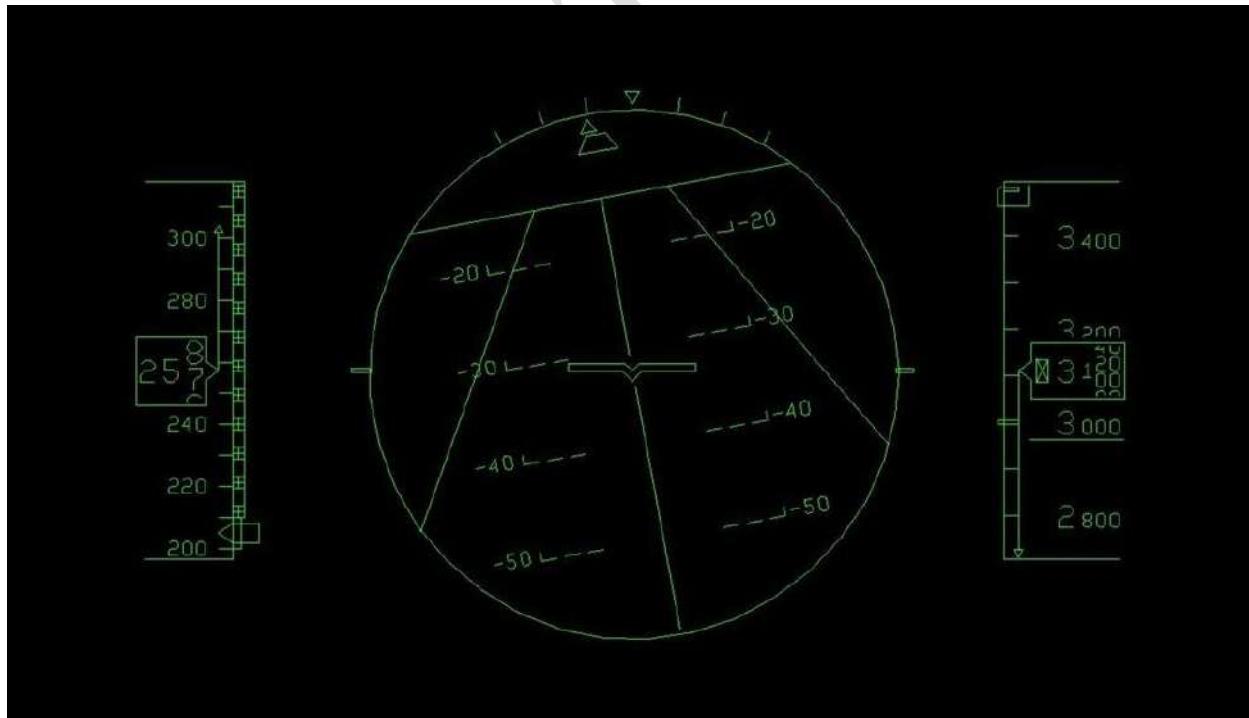
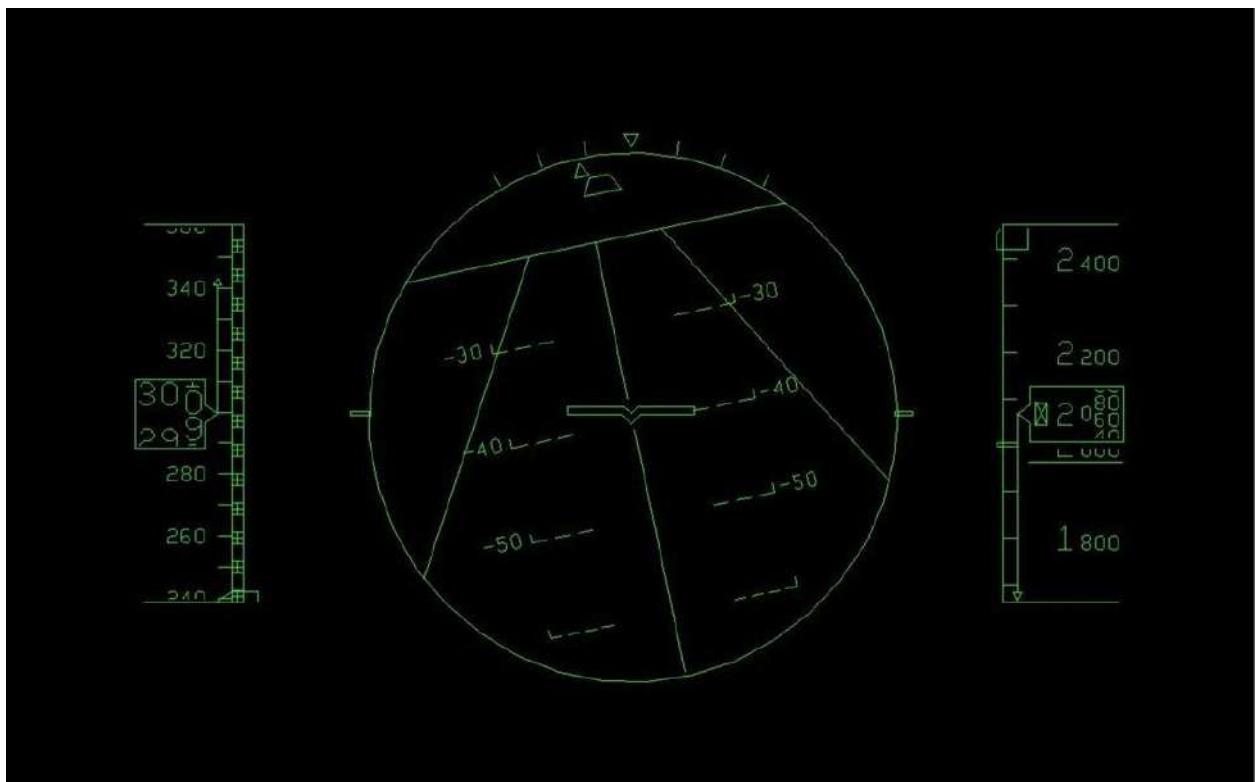
Fig. 71. The HUD reconstructed image at the point of time of 00:41:40

Fig. 72. The HUD reconstructed image at the point of time of 00:41:43

Fig. 71 and Fig. 72 represent the HUD reconstructed images at the points of time, coherent with the maximum reached negative G (-1.07) and the moment of the F/O’s interference into the control. It is apparent that HUD switched to the display mode, corresponding to upset. The HUD is switched to this mode, when the nose-down pitch exceeds 20°. According to the HGS Pilot Guide, this mode enhances interpretation of an unusual attitude by the pilot. All the “redundant” information is retracted out from the HUD screen. These are only altitude and IAS scales, pitch and roll together with the slip indicator that are displayed.

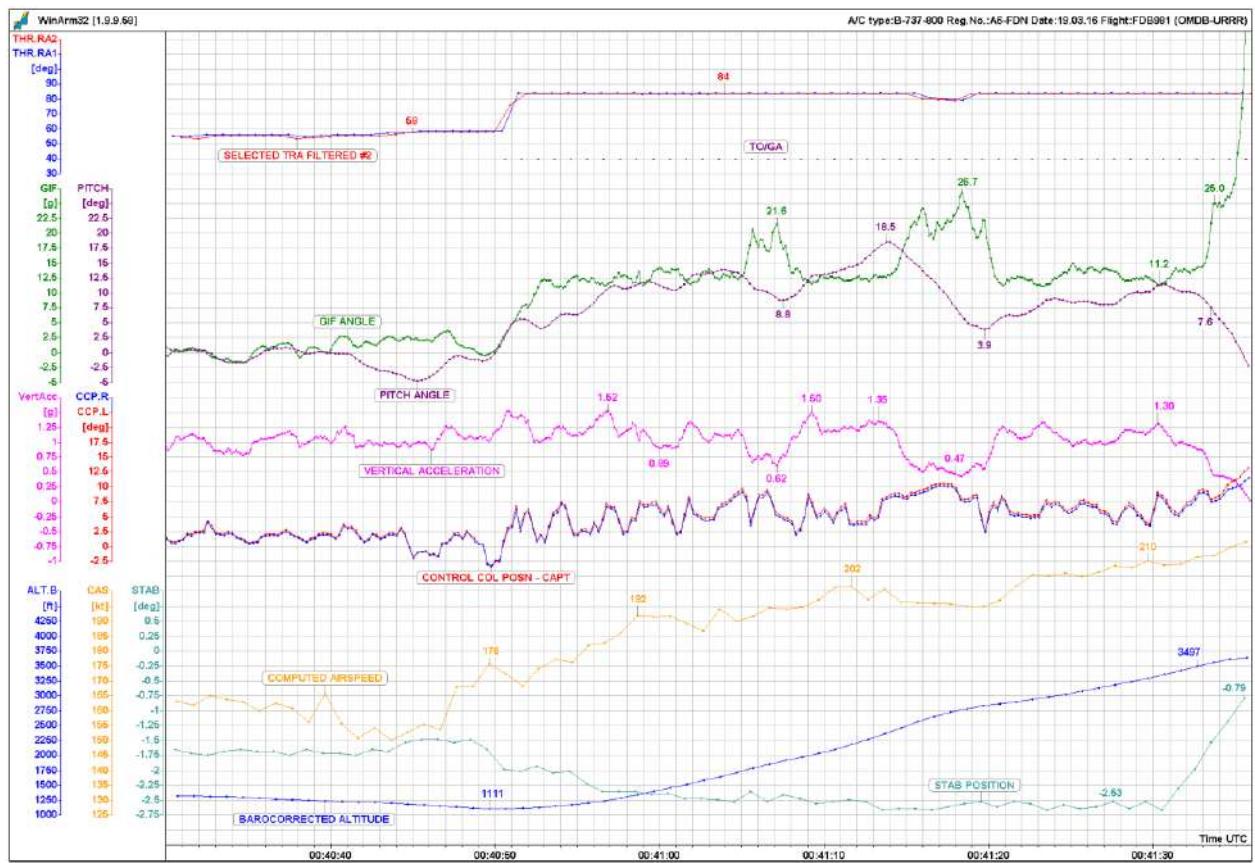
Fig. 73. The estimated GIF angle

The results of the calculations by formula are given on Fig. 73. The plot is the evidence that within time intervals of 00:40:52–00:40:56, 00:41:05–00:41:09, 00:41:14–00:41:23 and from 00:41:33 up to the end of the flight there are substantial differences in the values of the recorded pitch and GIF angle, with that the GIF angle is greater, that means that there are prerequisites for the occurrence of the “pitch-up” illusion.
