National Transportation Safety Board

Aviation Accident Final Report

Location:	San Diego, California	Accident Number:	WPR15MA243
Date & Time:	August 16, 2015, 11:03 Local	Registration:	N1285U
Aircraft:	Cessna 172M	Aircraft Damage:	Destroyed
Defining Event:	Midair collision	Injuries:	1 Fatal
Flight Conducted Under:	Part 91: General aviation - Personal

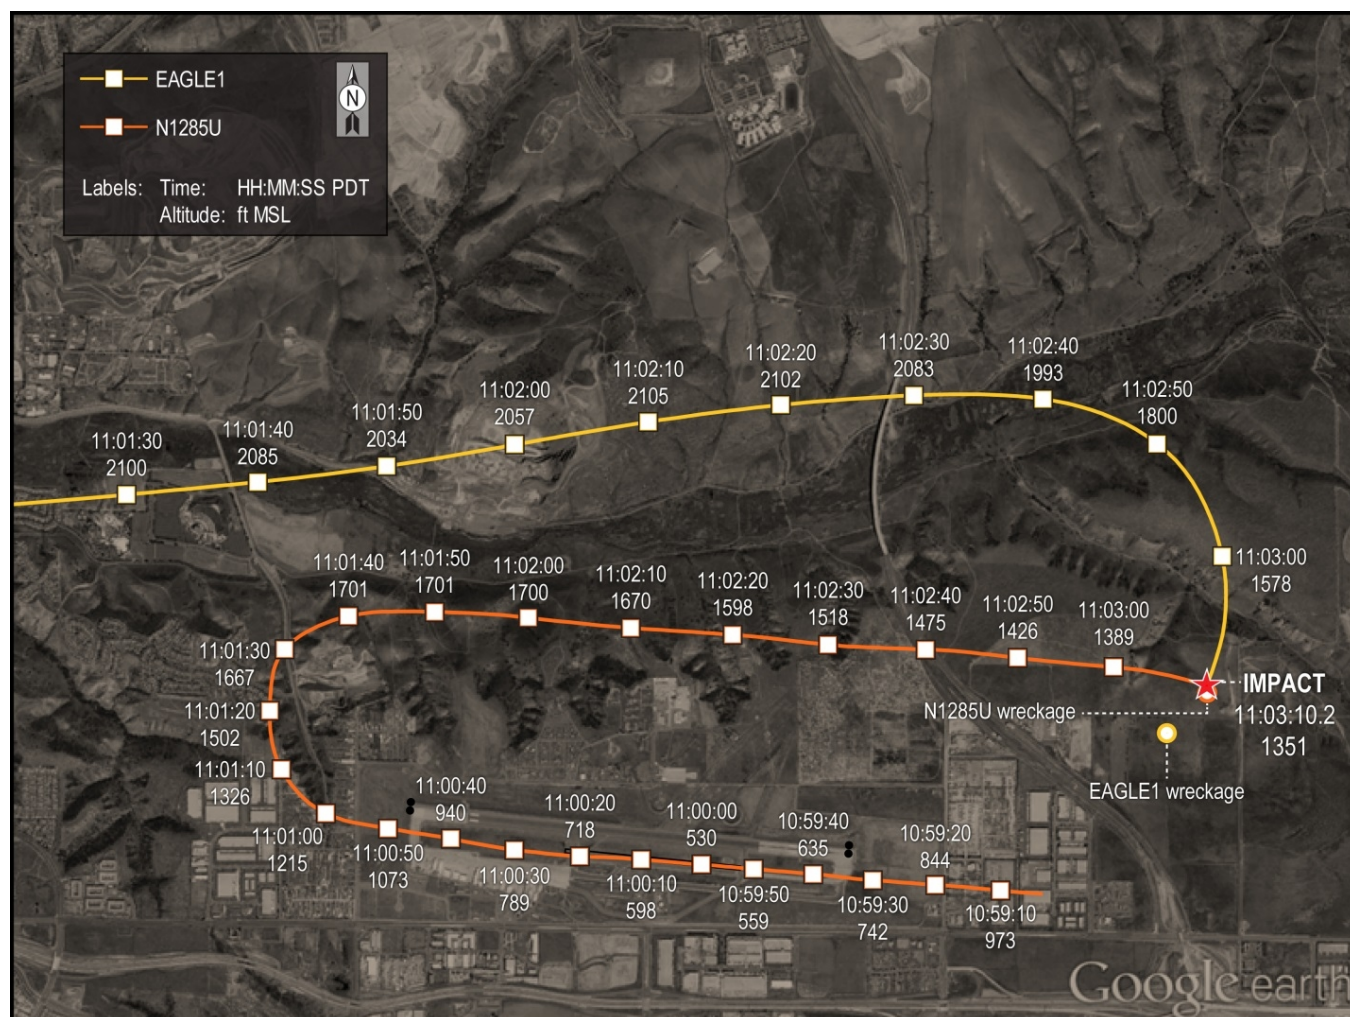
Figure 1. Aircraft in the SDM traffic pattern about 8 minutes before the accident.

At 1056:31, the LC trainee advised the pilot of N1285U to expect runway 26L on the next approach, which the pilot acknowledged. At that time, three aircraft were using runway 26R (Global Express

[N18WZ] was inbound for landing, N6ZP was on a right base for a touch-and-go, and XALVV was on short final) and three aircraft were using runway 26L (N1285U was turning right downwind for the touch-and-go, N81962 was on a left downwind for landing, and N8360R was conducting a touch-and-go operation). Figure 1 shows the aircraft in the SDM traffic pattern about 8 minutes before the accident.

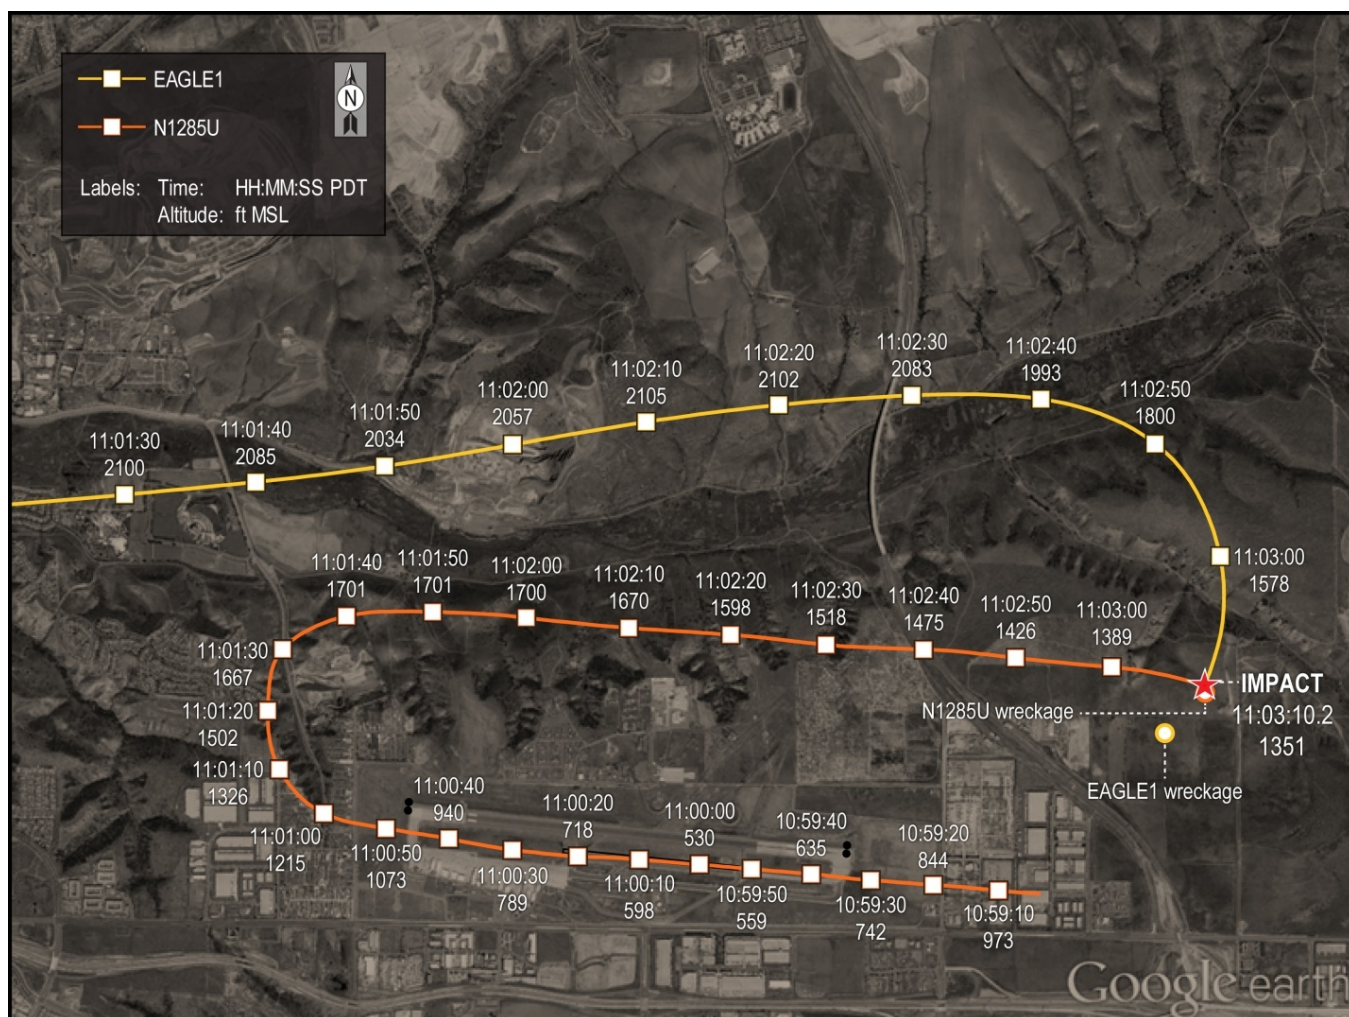
Figure 3. Calculated flight tracks of Eagle1 and N1285U.

The LC also indicated in the postaccident interview that controllers have personal limits about how many airplanes they could handle and that he could handle four aircraft on runway 26R and three aircraft on runway 26L. When the LC was asked what caused him to realize that the Cessna was N1285U and not N6ZP, he said it dawned on him that he had a right downwind departure, and through the process of elimination, it could not have been anyone else. The LC trainee stated in a postaccident interview that when the Cessna on the right did not start the right turn, he suggested to the LC that the

intended aircraft may have been N1285U. The LC indicated that, in retrospect, he should have issued a traffic alert; however, the moment he realized that Eagle1 was turning into N1285U, it was too late to help. Figure 3 shows the calculated flight tracks of Eagle1 and N1285U. Figure 4 shows the aircraft under SDM ATCT control from 1049 until the time of the collision.

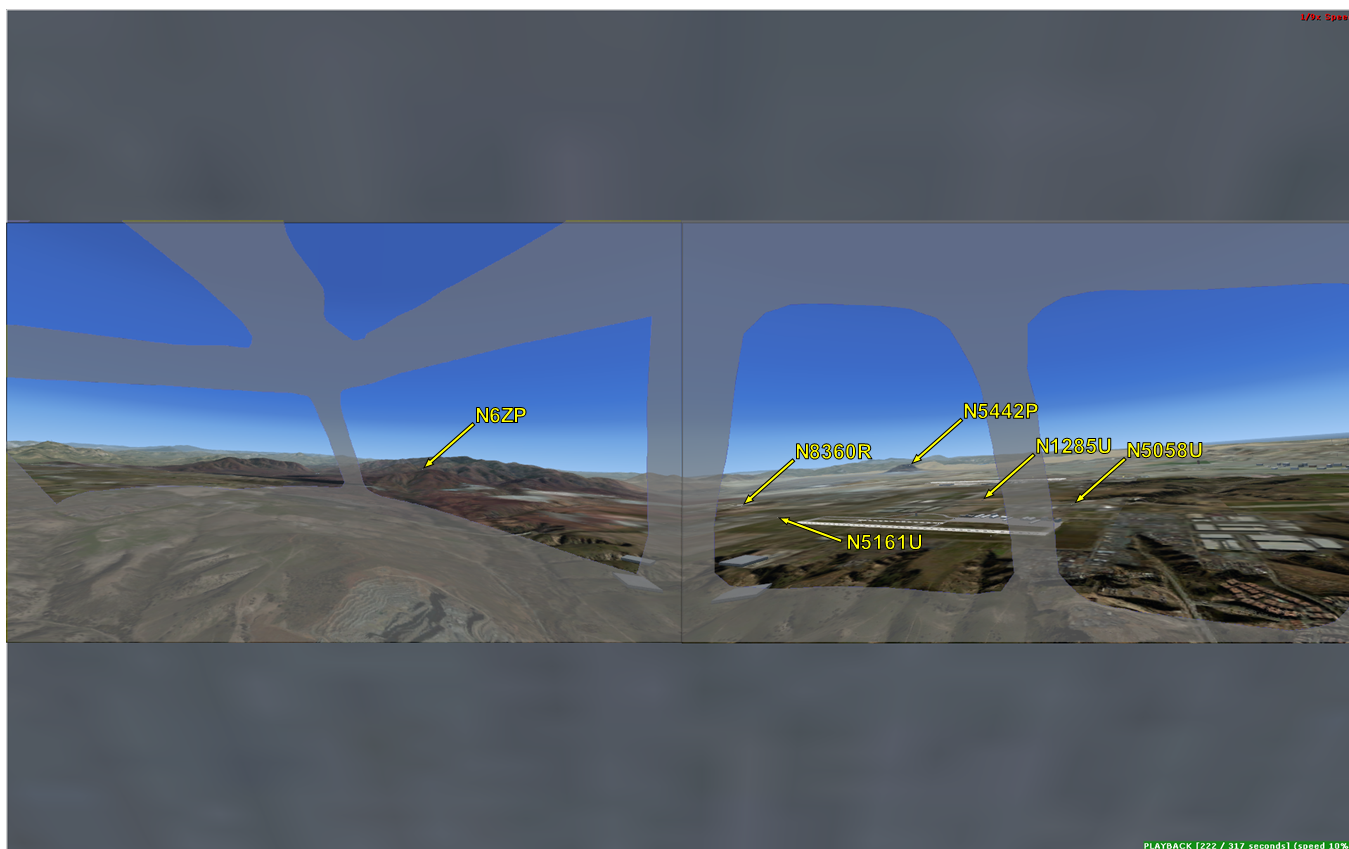
Figure 7a. View from the copilot seat of Eagle1 at 1101:43.1, when the airplanes were 0.5 nm apart.

At 1101:43.1, N1285U would have been located just to the left of the window post separating Eagle1's R2 and R3 windows, and N5058U would have been just to the right of this post (see figure 7a). Eagle1 would have appeared in the left window of N1285U, just below the wingtip (see figure 7b). Eagle1 and N1285U were both on the right downwind leg for runway 26R, with Eagle1 about 0.4 nm north of N1285U.

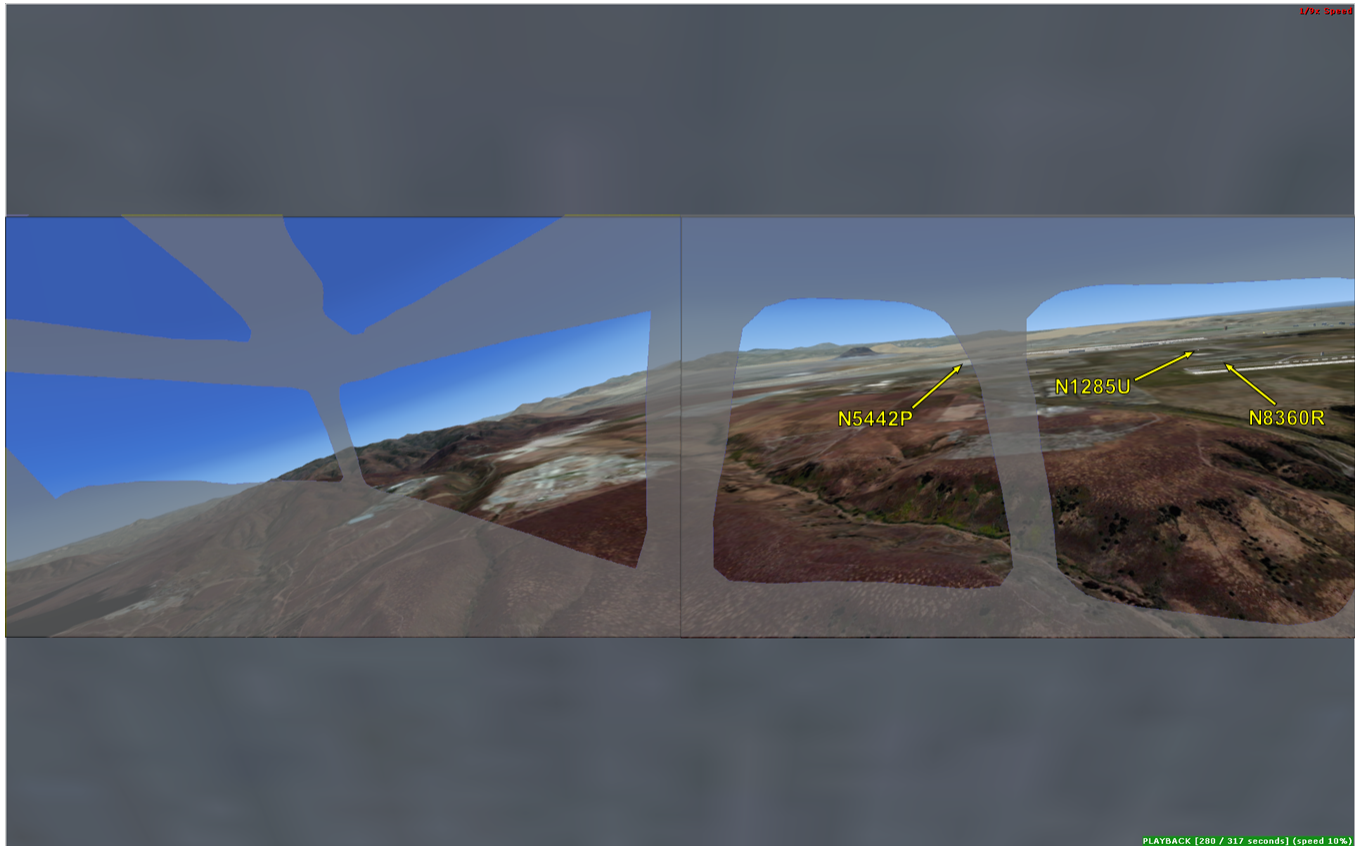
Figure 8a. View from the copilot seat of Eagle1 at 1102:32.4, when the airplanes were 0.8 nm apart.

At 1102:32.0, when the LC mistakenly instructed N6ZP to make a right 360° turn, intending the instruction for N1285U, Eagle1's CVR recorded the pilot ask "you still got the guy on the right side?" N1285U was 0.8 nm away and would have appeared in Eagle1's R3 window (see figure 8a). Also to Eagle1's right were N8360R (on short final approach for runway 26L), N5442P (on a left base leg for runway 26L), and N5058U (which was climbing through 1,500 ft about 2.6 nm to the west of the

runway 26R threshold). Eagle1 would have been obscured from the N1285U pilot's field of view by the left wing and strut (see figure 8b). Eagle1 started banking to the right, turning toward right base, shortly after this time.

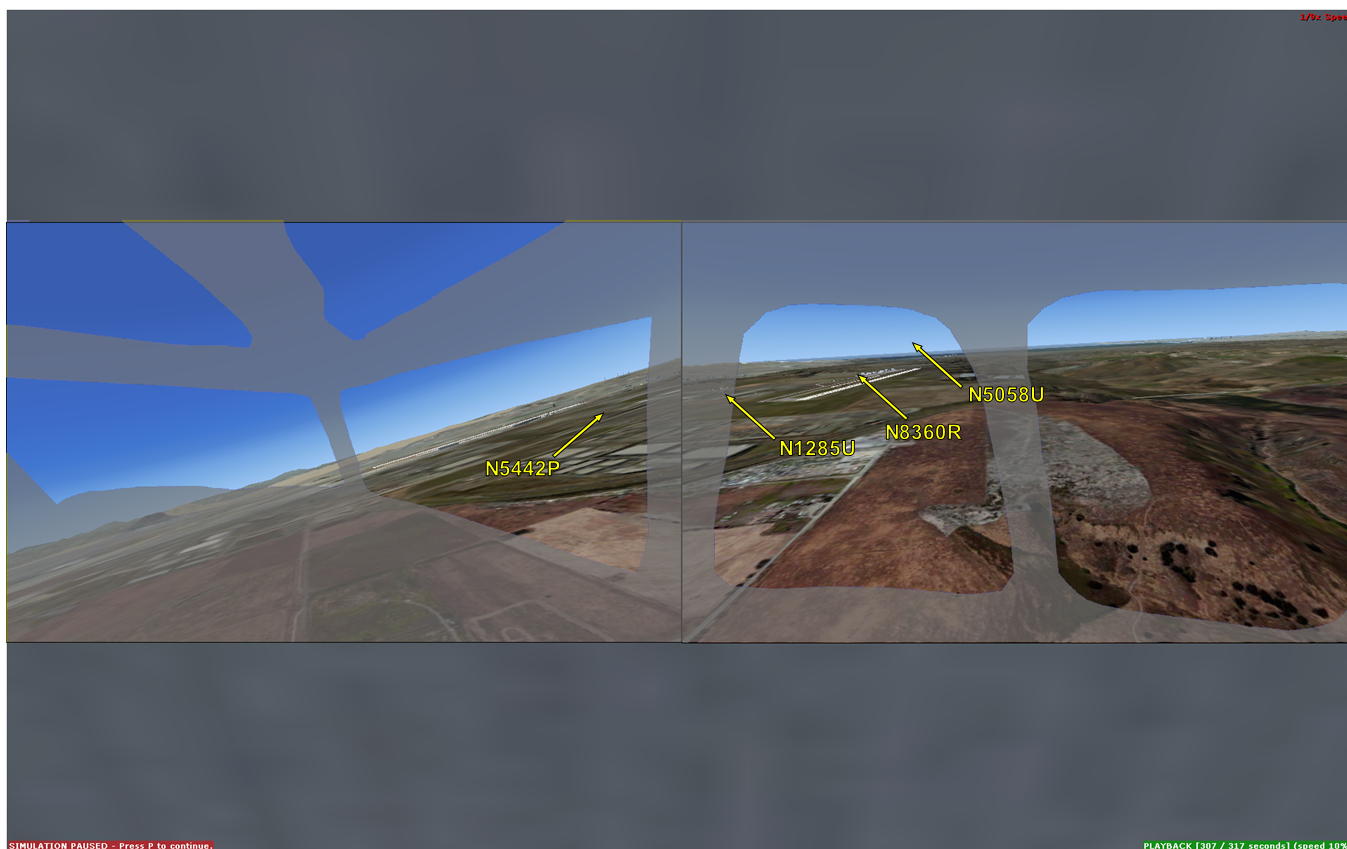
Figure 9a. View from the copilot seat of Eagle1 at 1102:42.0, when the airplanes were 0.8 nm apart.

At 1102:42.0, when the LC instructed the pilot of Eagle1 to "turn base two six right cleared to land," Eagle1 was descending through 1,960 ft in a right bank, about 1.3 nm north and 0.7 nm east of the runway 26R threshold. N1285U was descending through 1,460 ft, about 0.6 nm north and 0.3 nm east of the threshold, and would have appeared in Eagle1's R3 window (see figure 9a). Eagle1 would have appeared in the N1285U pilot's field of view near the edge or slightly behind the window post separating the left window from the windshield (see figure 9b). The airplanes were still about 0.8 nm away from each other.

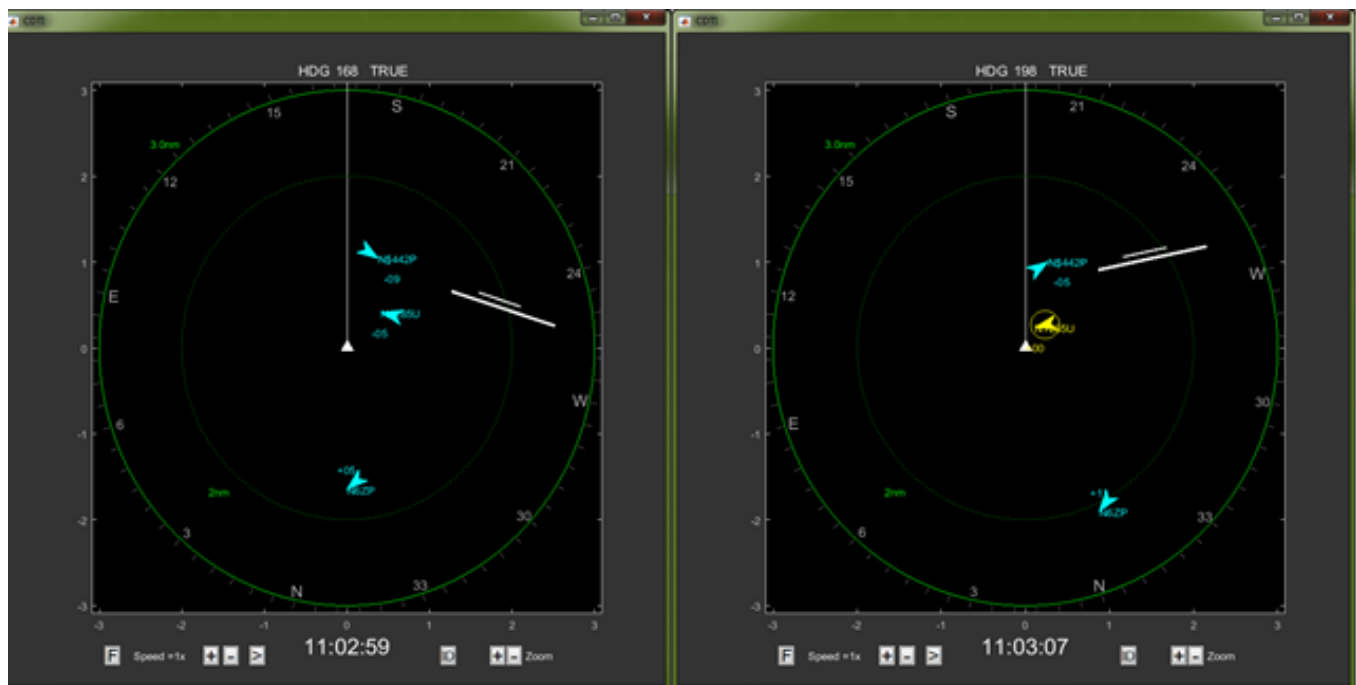
Figure 13. Simulated in-cockpit traffic display for Eagle1 at 1102:59 (left) and 1103:07 (right).

At 1102:59.3, during Eagle1's base turn, the pilot stated, "I see the shadow but I don't see him." At this time, N1285U would have been depicted on Eagle1's display at Eagle1's 2 o'clock position, between Eagle1 and the runway 26R threshold, 1 nm from and 500 ft below Eagle1. At 1103:07, about 3 seconds before the collision, N1285U would have again changed to alert status (yellow, circled arrowhead), and Eagle1 would have received a second aural alert advising, "Traffic, 1 o'clock, same altitude, zero miles" (see figure 13). At the same time, Eagle1 would have changed to alert status on N1285U's display, and N1285U would have received an aural alert advising, "Traffic, 11 o'clock, same altitude, zero miles, descending." Additional details about the traffic information that could have been displayed during the accident scenario can be found in the Aircraft Performance and Cockpit Visibility Study.
