# Collision with terrain involving Cessna 208 Caravan, VH-WTY

11 km north-east of Hamilton Island Airport, Queensland on 28 January 2016

**ATSB Transport Safety Report**  
Aviation Occurrence Investigation  
AO-2016-007  
Final – 25 June 2020

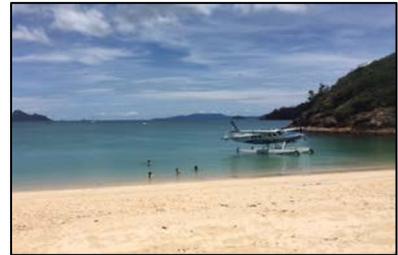
**VH-WTY at Chance Bay earlier on 28 January 2016**

On 28 January 2016, the pilot of a Cessna Aircraft Company C208 Caravan amphibian aircraft, registered VH-WTY, was flying 10 passengers on a charter flight over the Great Barrier Reef, Queensland. Before returning to Hamilton Island, the flight was scheduled to stop for about 90 minutes at Chance Bay, Whitsunday Island, about 11 km north-east of Hamilton Island Airport. During the attempted water landing, the aircraft bounced twice on the water's surface. The pilot then initiated a go-around and the aircraft bounced a third time. While attempting to climb out of the bay, the aircraft clipped trees and collided with terrain. The pilot and all passengers safely exited the aircraft with minor injuries. The aircraft was destroyed.

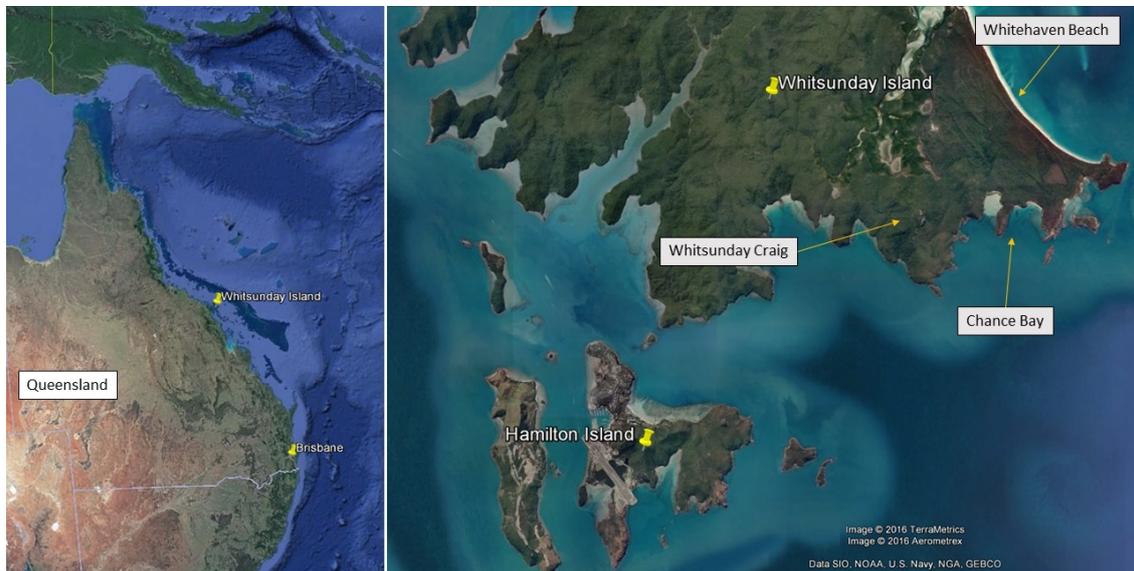
**Figure 1: Google Earth overview showing Whitsunday Island location**

Chance Bay is located at the south-east point of Whitsunday Island (Figure 1) and is separated from Whitehaven Beach by a strip of land about 1,400 m wide. Whitsunday Craig is about 350 m elevation and is about 2.5 km to the west of the bay. The terrain falls away from Whitsunday Craig over a distance of 1-1.6 km and consists of undulating hills with rock formations near the water surface.

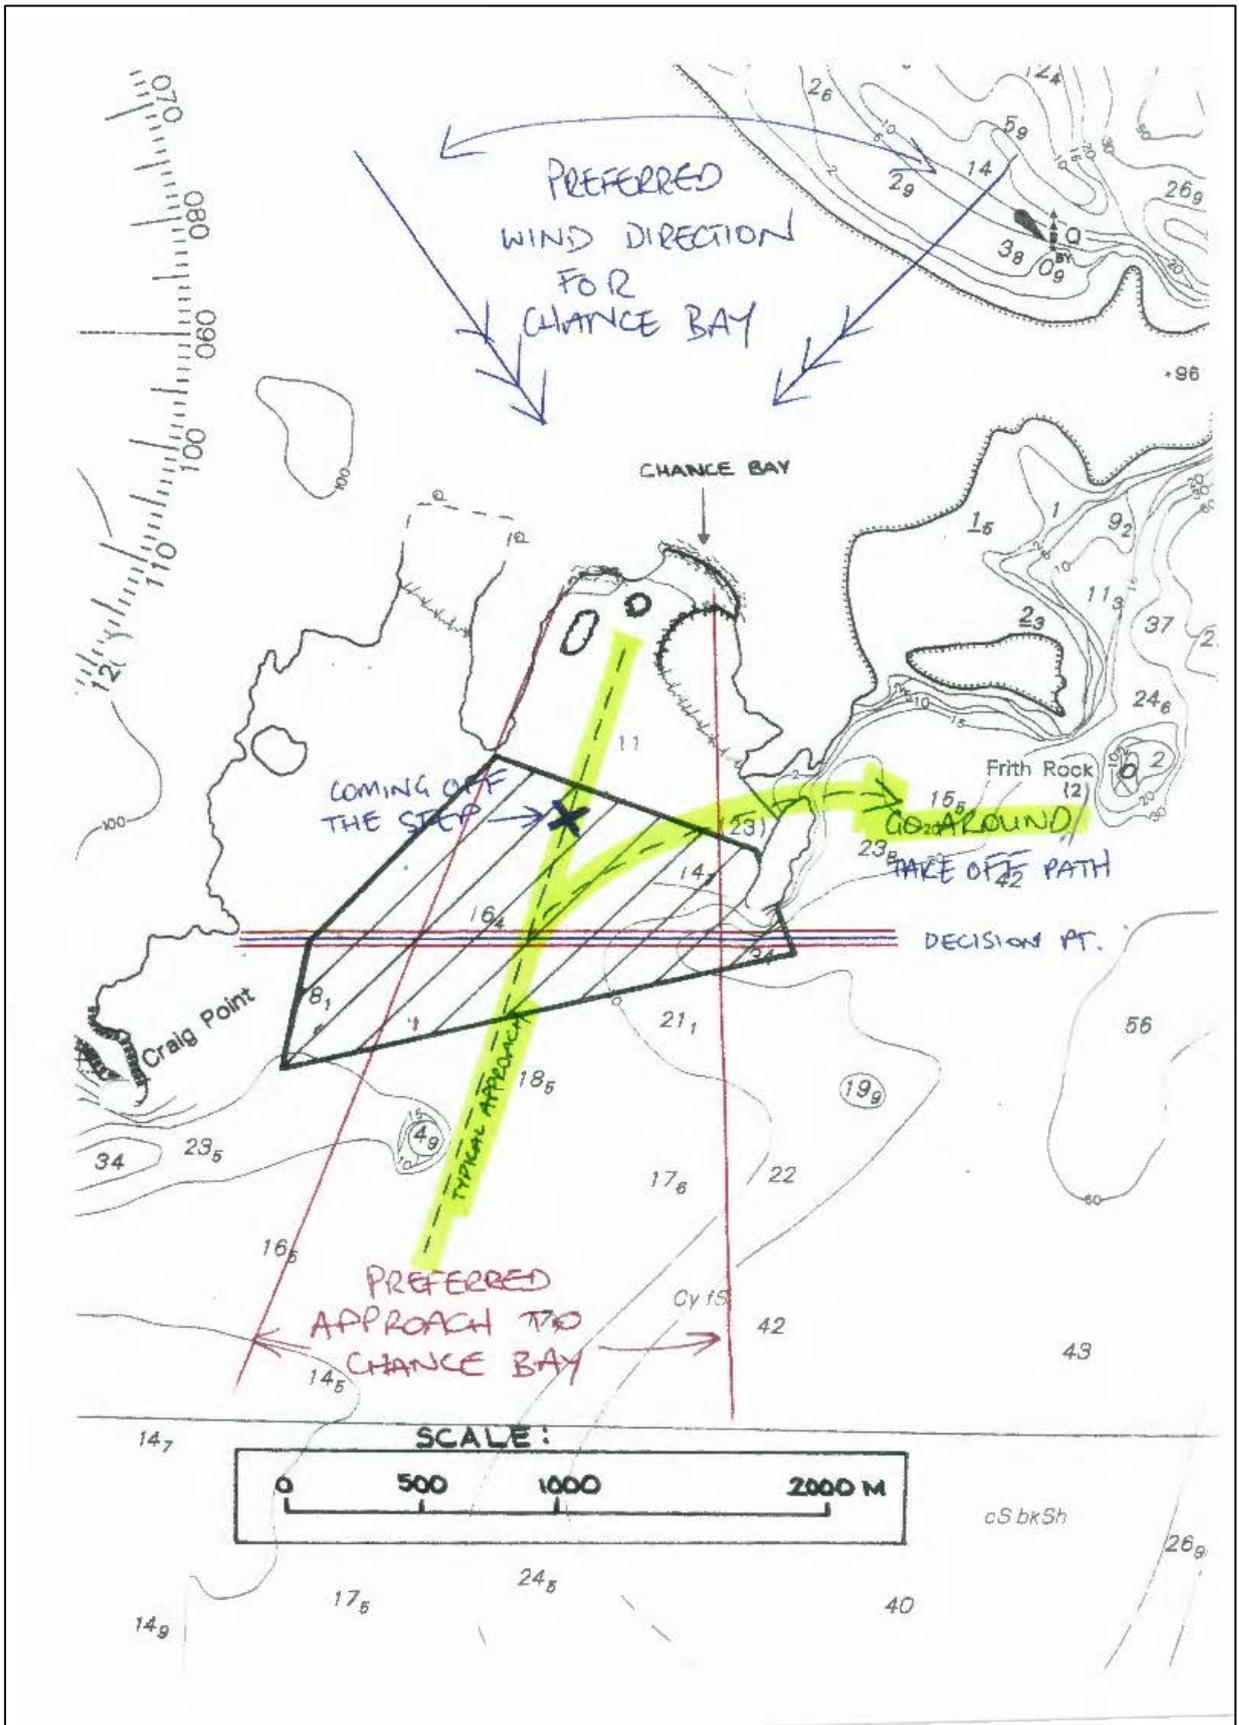
### Appendix B – Chance Bay ALA additional guidance

<b>SEA SWELL :</b>	LARGE RESIDUAL SWELL CAN BE EXPECTED. THERE WILL BE MANY OCCASIONS WHEN PARALLELING THE SWELL AND ACCEPTING A COMPONENT OF CROSS WIND WILL BE REQUIRED.
<b>BEACHING :</b>	BOTH BEACHES ARE OK FOR BEACHING ( Refer Tidal effect)
<b>SPECIAL NOTES :</b>	<b>CAUTION - BEWARE CORAL REEFS AND BOMMIES.</b> CHANCE BAY CAN BE VERY DIFFICULT TO WORK OUT OF. ENSURE YOU FLY OVER THE AREA BEFORE LANDING. ALWAYS OBSERVE THE ALA LIMITS. ENSURE YOU ALWAYS ALLOW YOURSELF AN ESCAPE ROUTE. REMAIN WELL CLEAR OF ALL VESSELS. KEEP A WATCH FOR BOAT SWELL COMING IN FROM THE SOUTH, ALWAYS ALLOW YOURSELF AMPLE ROOM FOR TAKEOFF AND LANDING. <b>NOTE : VERY IMPORTANT TO SET UP AN UNDERSHOOT APPROACH &amp; PLAN AN ESCAPE ROUTE AT THIS LOCATION.</b>
