AIRCRAFT ACCIDENT REPORT AND EXECUTIVE SUMMARY

Reference:	CA18/2/3/9494	
Aircraft Registration	ZS-OAA	Date of Accident	26 October 2015		Time of Accident	9:54Z
Type of Aircraft	Boeing 737-400		Type of Operation		Commercial Part 121	
Pilot-in-command Licence Type	ATPL	Age	49	Licence Valid	Yes	
First Officer Licence Type	ATPL	Age	40	License Valid	Yes	
Pilot-in-command Flying Experience	Total Flying Hours	9186.1		Hours on Type	2899	
First Officer Flying Experience	Total Flying Hours	5817.1		Hours on Type	480.5	
Last point of departure	Port Elizabeth International Airport (FAPE)					
Next point of intended landing	O.R. Tambo International Airport (FAOR)					
Location of the accident site with reference to easily defined geographical points (GPS readings if possible)						
On runway 03R during landing at O.R. Tambo International Aerodrome						
Meteorological Information	Wind direction: 034°, Wind speed: 10kt; Wind Temp: 26°C; Visibility: 9999; Cloud cover: Few; Cloud base: 4500ft; Dew Point: 04°C

Name of Owner : Comair Limited
Name of Operator : Comair Limited
Manufacturer : Boeing Aircraft Company
Model : 737-400
Nationality : South African
Registration Marks : ZS-OAA
Place : O.R. Ta

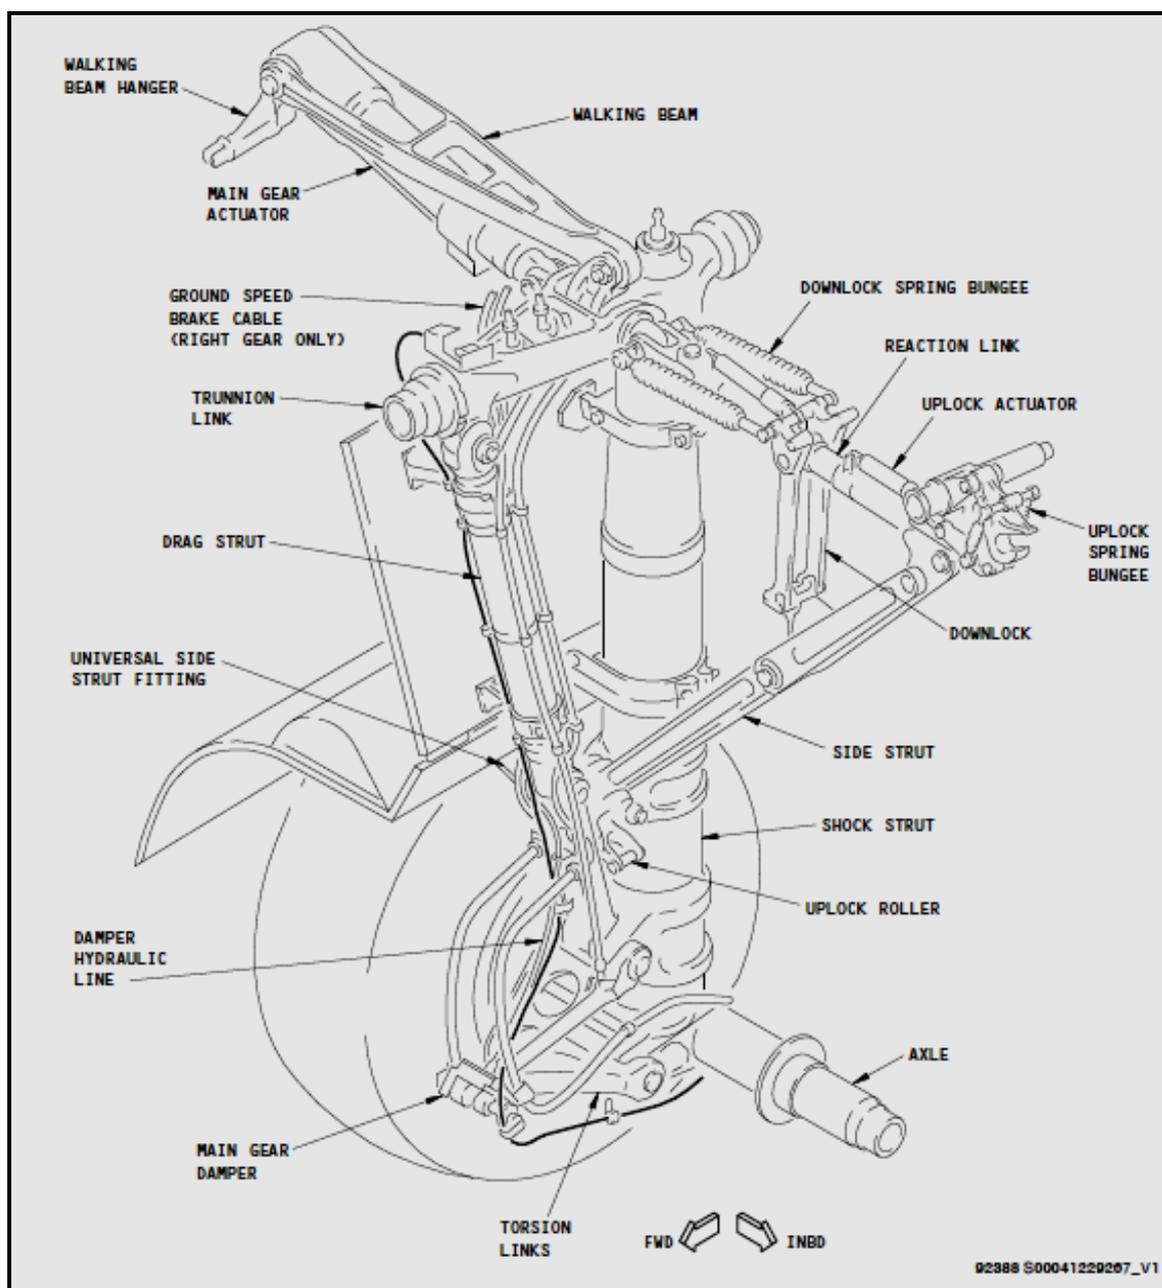
Figure 2: Main landing gear components

Each main gear consists of a trunnion link, a shock strut, a drag strut, torsion links, a damper, a side strut, and a reaction link. In addition, the right main gear carries ground speed brake-operating rods and cable. The shock strut assembly is attached to the trunnion link by a pin joint and the two are mounted between the rear wing spar and a trunnion support beam. The shock strut is charged with oil and compressed nitrogen to provide a shock absorbing medium. The main gear axles and the shock strut inner cylinder are machined from a one-piece forging. Replaceable sleeves are assembled over the axles to provide a mounting for wheel bearings and to protect the axles from damage. The reaction link is connected to the shock strut and to the upper end of the side strut.

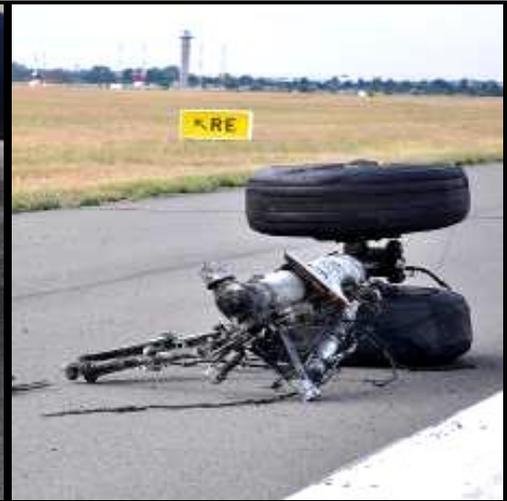
Figure 8: Landing gear

1.12.4 The damage to the trailing edge of the left wing, towards the wing root, was caused by the landing gear as it detached from the main assembly points. The inner flaps were also damaged by the landing gear. The trunnion forward-bearing bolt is designed to fail if the landing gear receives a severe impact. The observations revealed that the fuse lugs on the trunnion link gave a positive reaction characteristic with regard to design failure as it prevented damage to the left wing

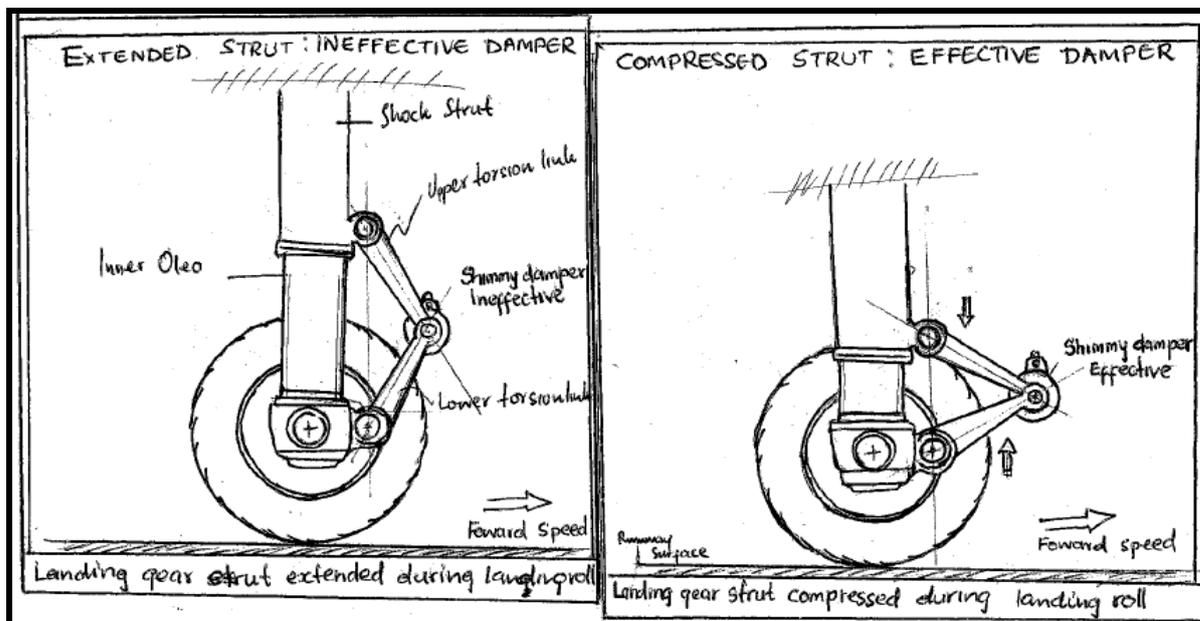
Figure 10: Demonstrate the conditions of extended and compressed strut during landing

- *Due to the geometry of the torsion links, the shimmy damper is most effective when the landing gear strut is compressed in the ground mode. Lower touchdown descent rates increase the likelihood of a shimmy damper failure. It is important to note, however, that proper maintenance of the gear components is the best way to prevent shimmy damper failures. The possibility of landing gear shimmy events is greater at high altitude airports. (Refer to Figure 10 below for illustration)*

Note: Figure 10 above is used for illustration of the geometric of the torsion links as discussed above with regard to the effectiveness of the shimmy damper with given conditions during landing roll phase.

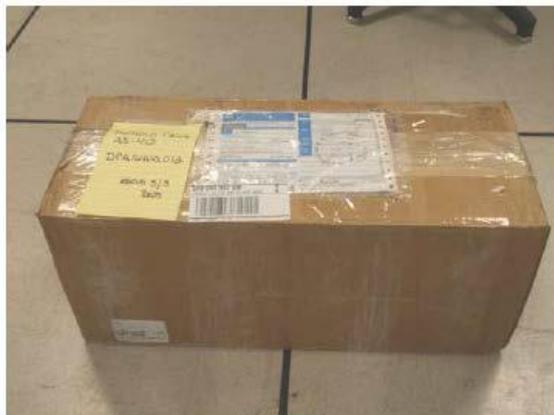
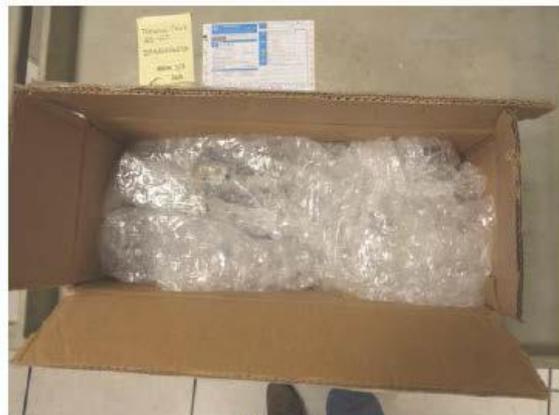
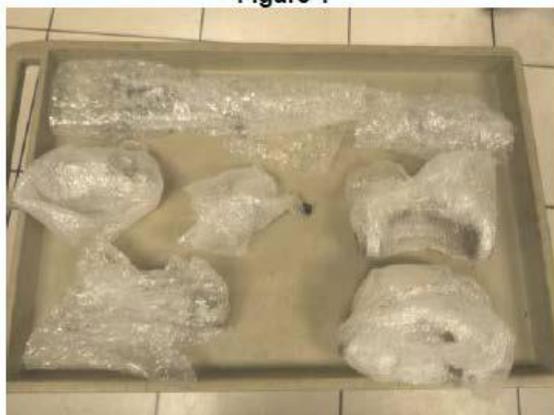
The parts delivered to the Boeing Equipment Quality Analysis (EQA) group by the NTSB representative were photographed as received; see Figure 1 through to Figure 4.

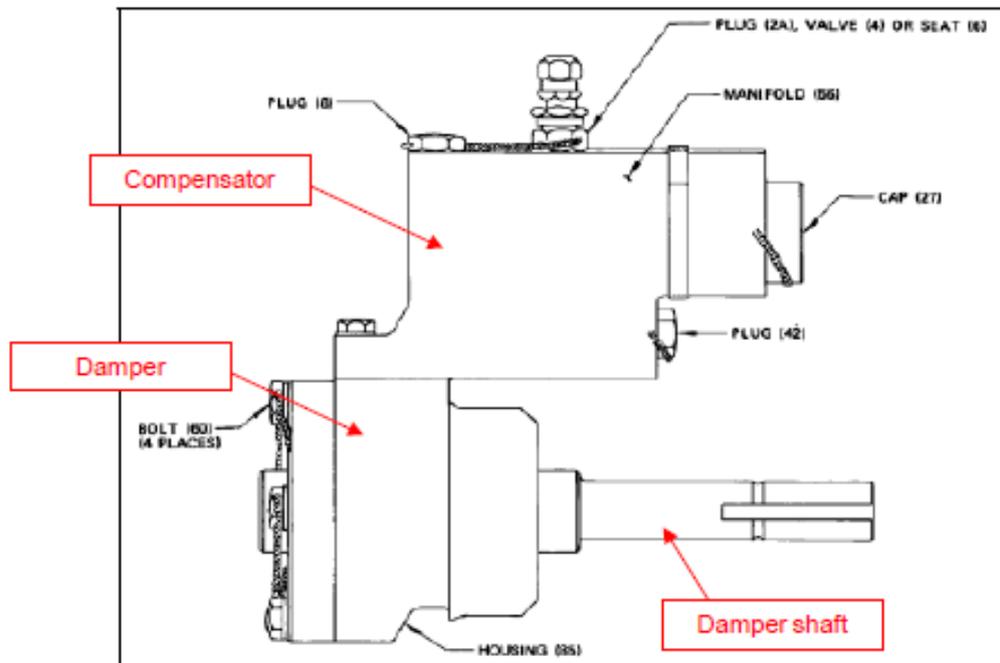
Figure 5 – Excerpt from Reference (a)

Initial examination showed that the damper assembly was separated into two sections, as seen in Figure 4. Figure 5 shows the main gear damper assembly in its normal assembled configuration.

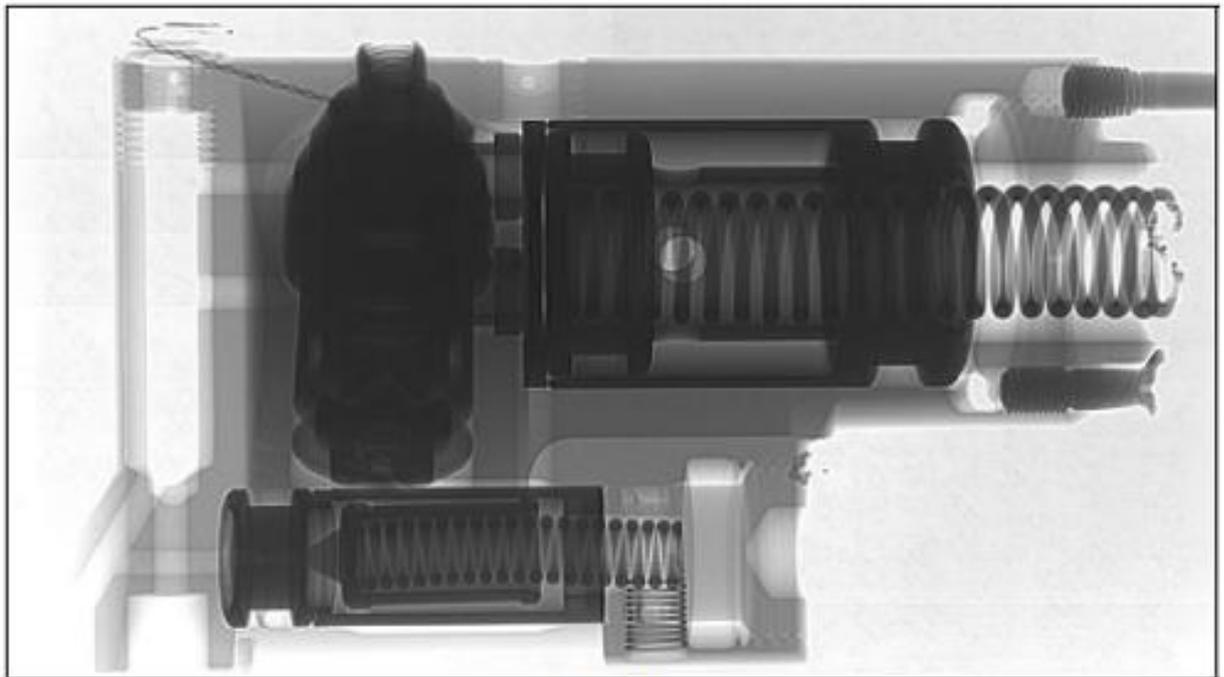
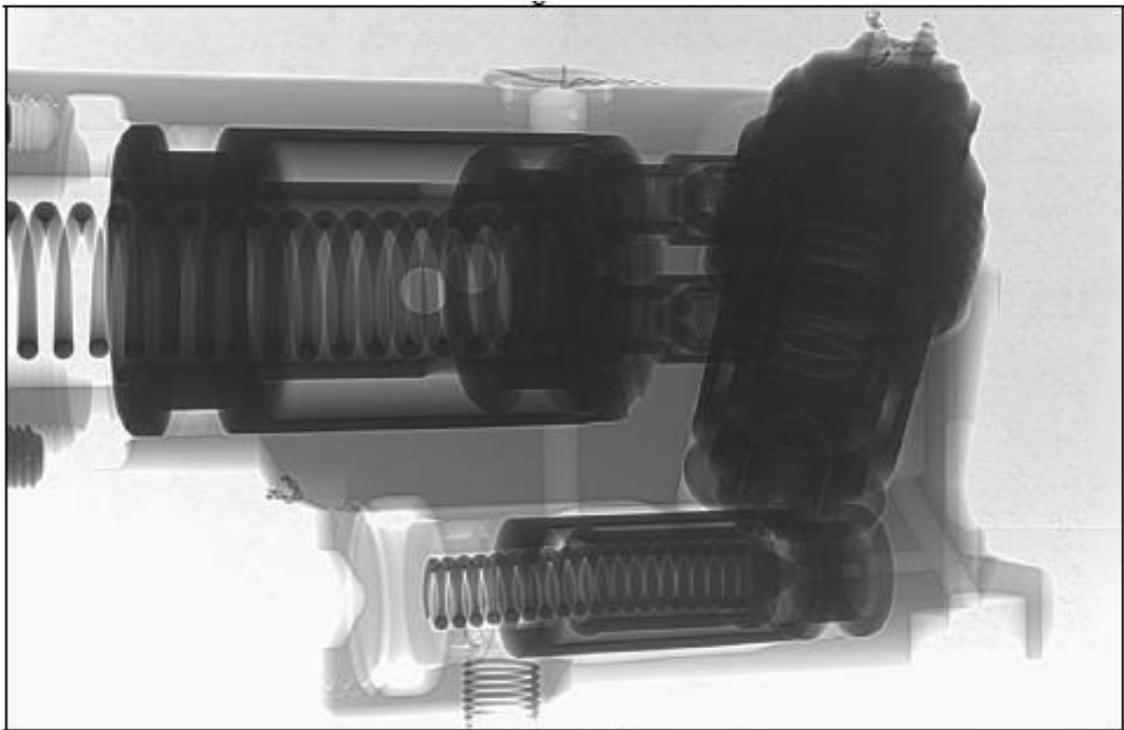
The compensator portion of the damper assembly was analysed using digital radiography (DR) imaging; see Figure 14 and Figure 15. No anomalies were found.

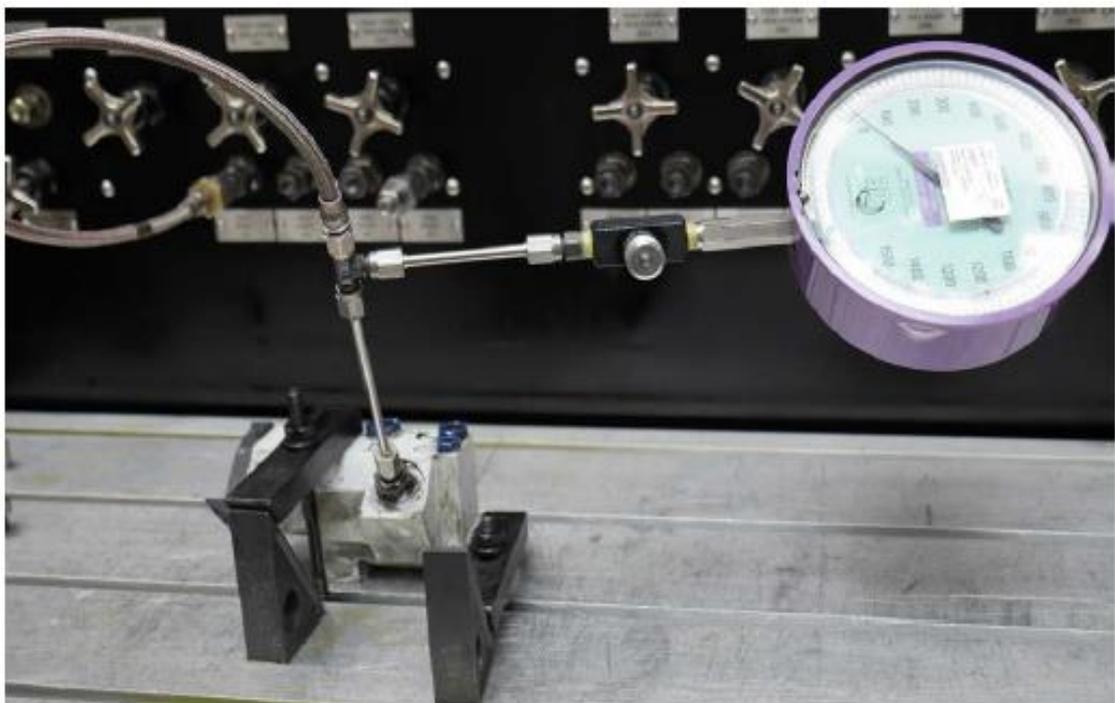
Figure 16

The compensator was then set up for hydraulic testing. Normally, the compensator and damper are tested as one unit. Due to the noted damage, two aluminium test plugs were installed at the normal interface between the compensator and damper, and the compensator was clamped to the hydraulic test bench so the compensator could be tested independently; see Figure 16. Tests were selected from reference (a) that applied to the compensator and were modified as needed to adjust for the damper not being attached.

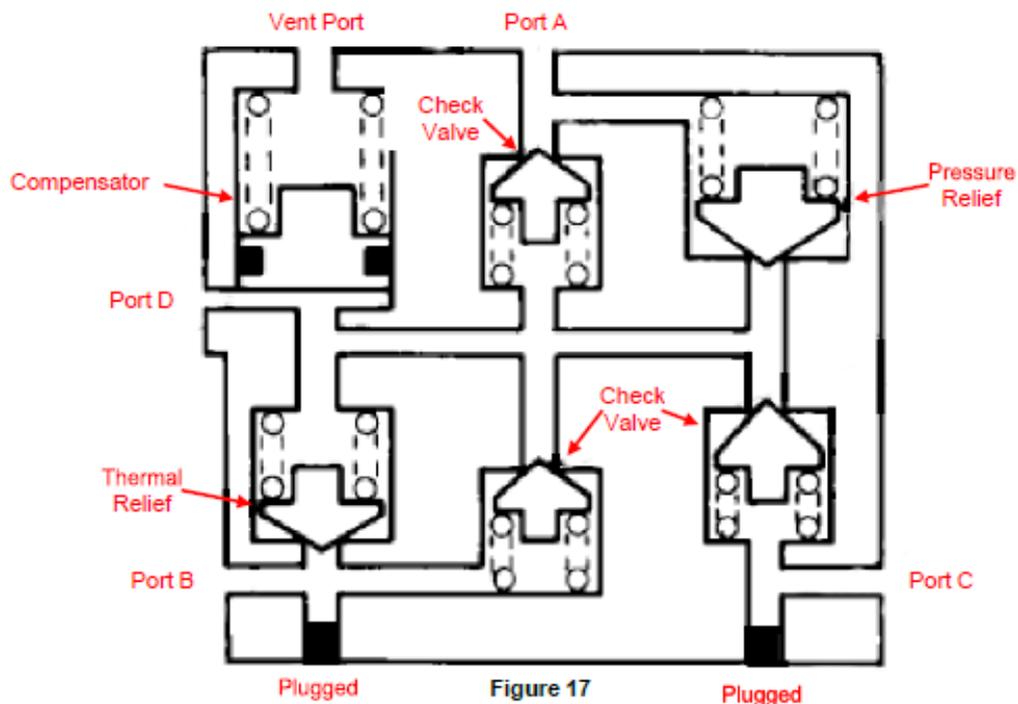
This test is to check if check valve B, check valve C and the thermal relief valve are sealing within an acceptable range; see the hydraulic schematic circuit of the compensator in Figure 17.

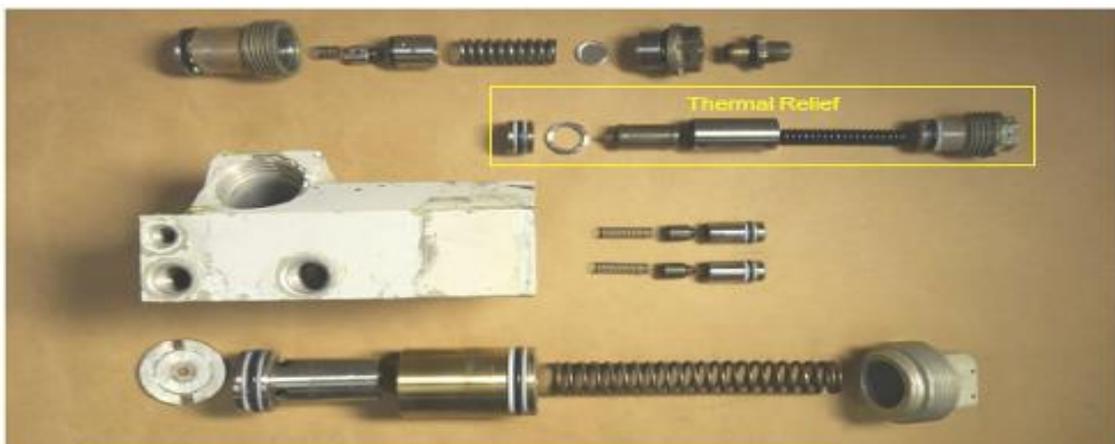
Figure 18

The compensator portion was disassembled; see Figure 18.

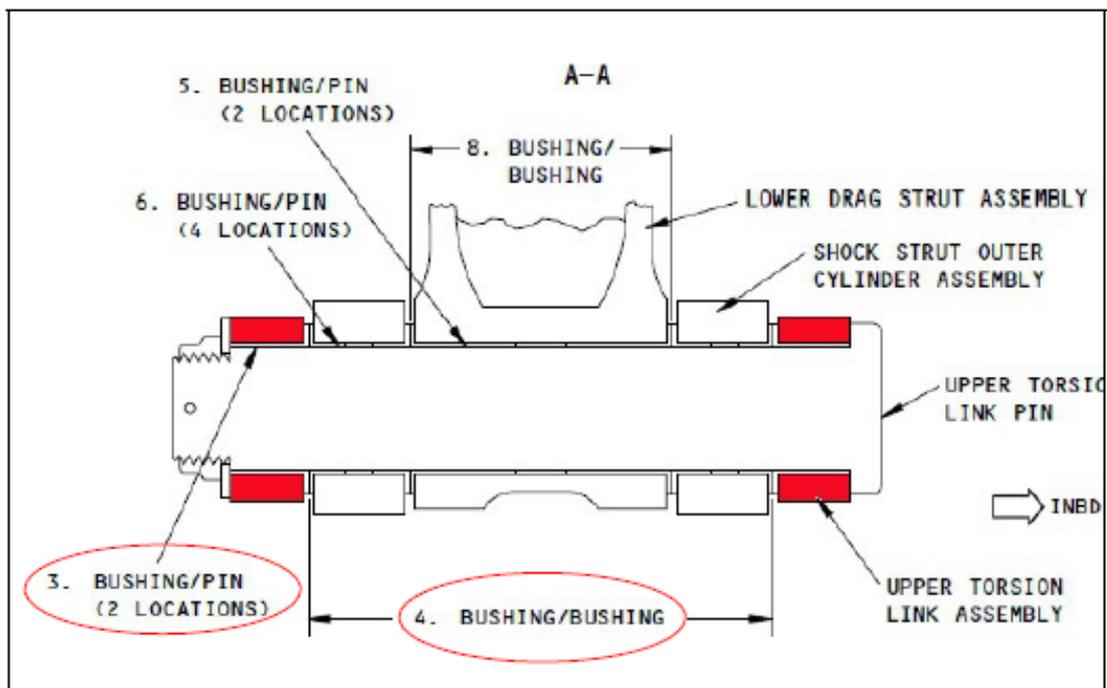
Measurements identified by numbers 3 and 4 in Figure 26 were taken from the bushing end of the fractured upper torsion link; see Figure 27.
