## Report A-043/2016

Accident involving a  
Beechcraft E90 aircraft,  
registration N-79CT, in Sotillo  
de las Palomas (Toledo, Spain)  
on 4 December 2016

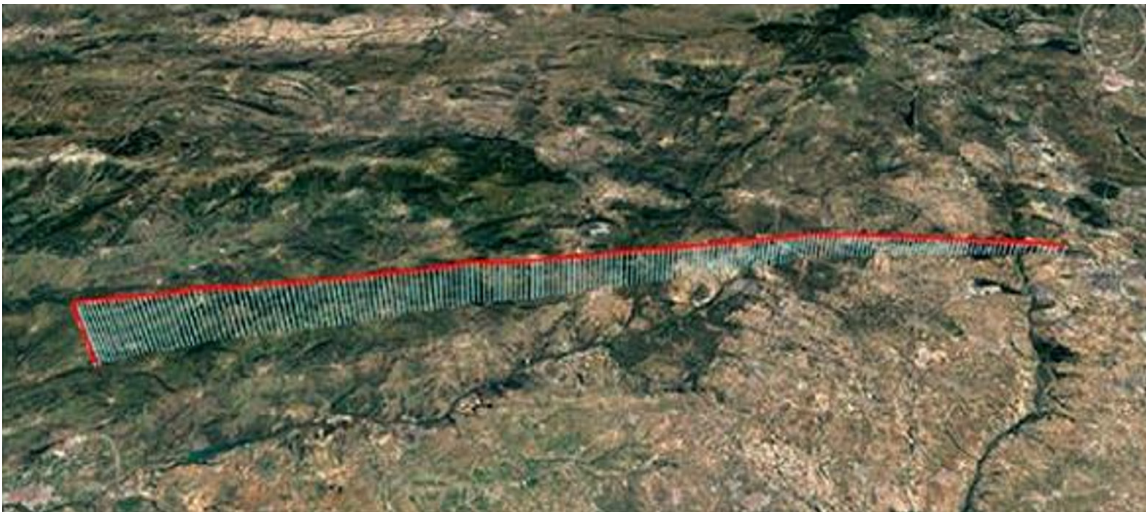
Illustration 1: Aircraft's flight path until the time of the ground impact

At 16:15:57, the aircraft was climbing to its authorized cruise level at FL210. Moments later, as the radar data show, there was a yaw to the left, and the aircraft started to describe a downward trajectory rotating in that direction and lose altitude suddenly.

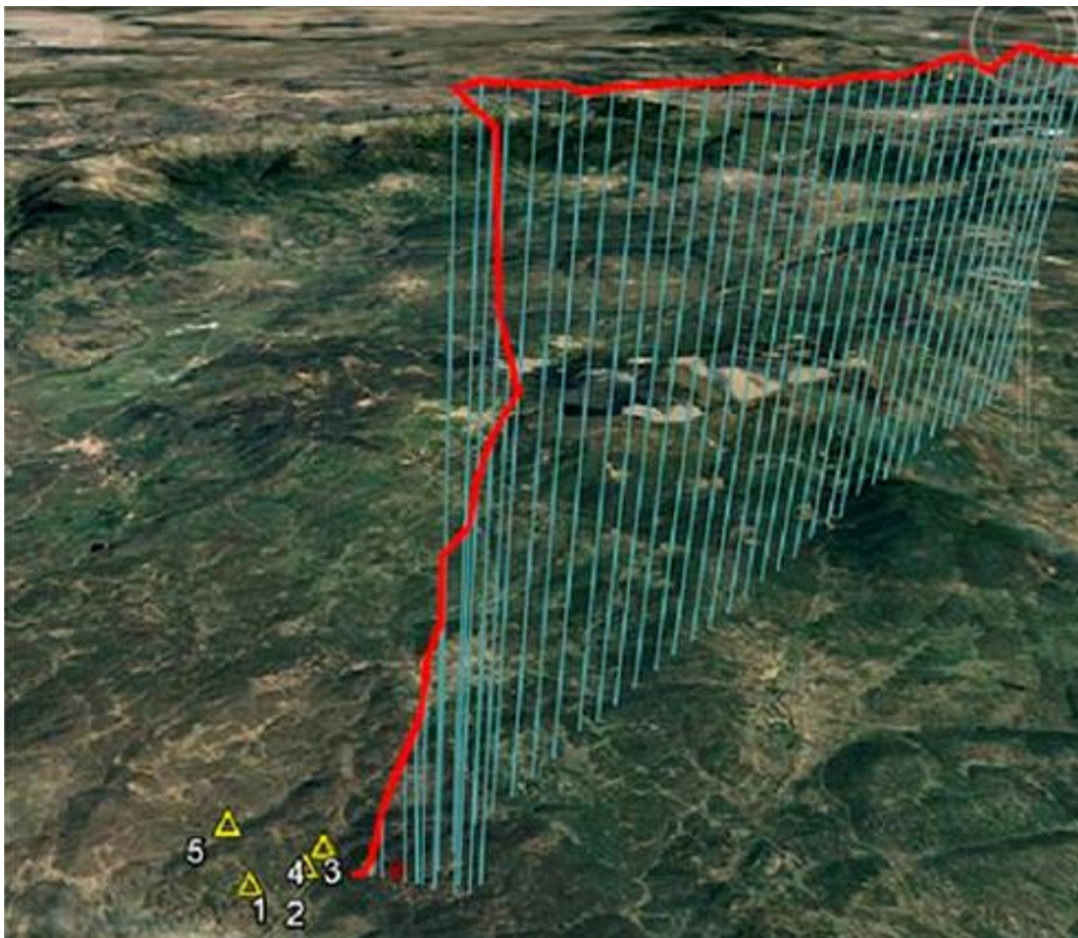
Illustration 2: Aircraft's flight path in the final moments before the ground impact

Following this event, the aircraft's speed fell quickly and gradually until its stall. The aircraft started to spin, a spin that after some time, turned into a flat spin.

During the uncontrolled descent, with the aircraft in a fully developed spin, loads were placed on the horizontal tail that were in excess of its design loads, which caused the in-flight fracture of the tail into five pieces before the impact with the ground.

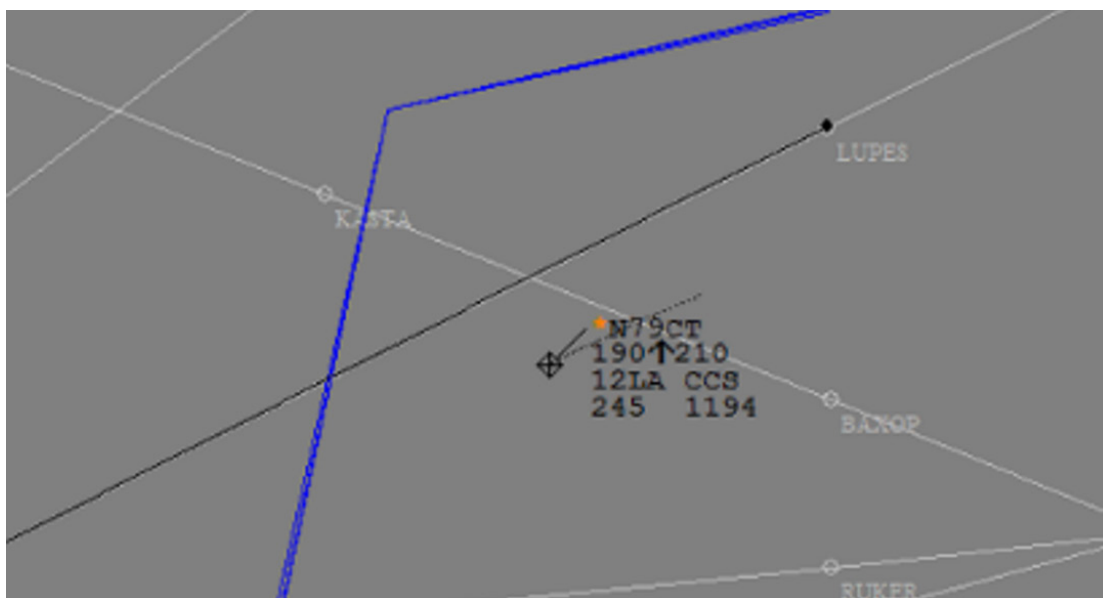
Illustration 7: Aircraft's position at 16:16:07 h

At 16:16:07, the aircraft was at FL190 and climbing to its cleared level of FL210. At that point, the aircraft's ground speed was 120 knots, it was on a heading of 245° and climbing at 1194 ft/min.

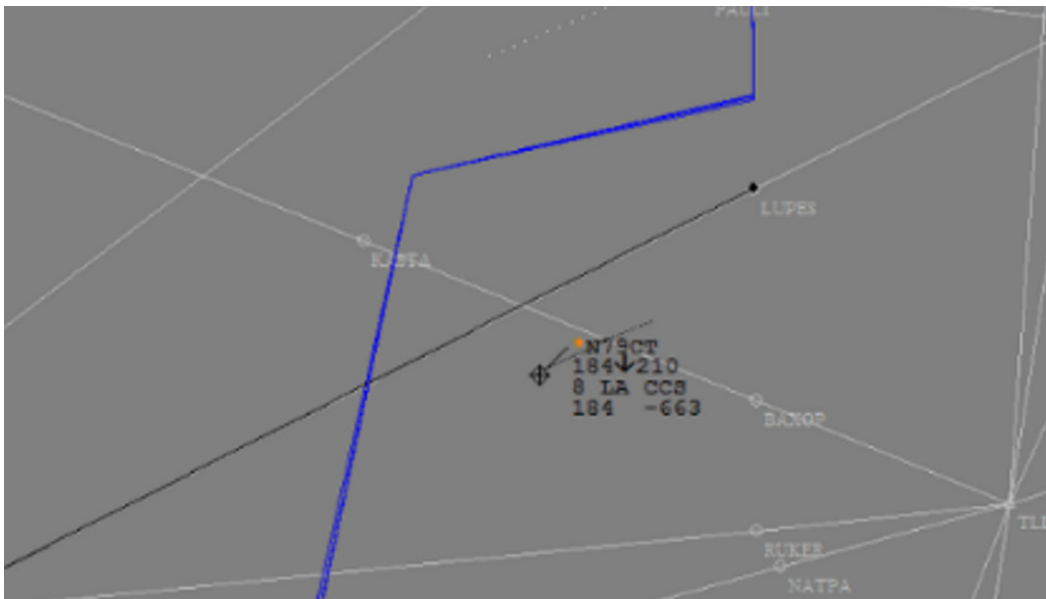
Illustration 8: Aircraft's position at 16:16:09

Two seconds later, the aircraft started to descend to FL190. At that point:

- The aircraft's ground speed fell to 80 knots.
- Its heading changed to 184°, meaning the aircraft turned 61° counterclockwise in 2 seconds, and
- Its descent speed was 663 ft/min.

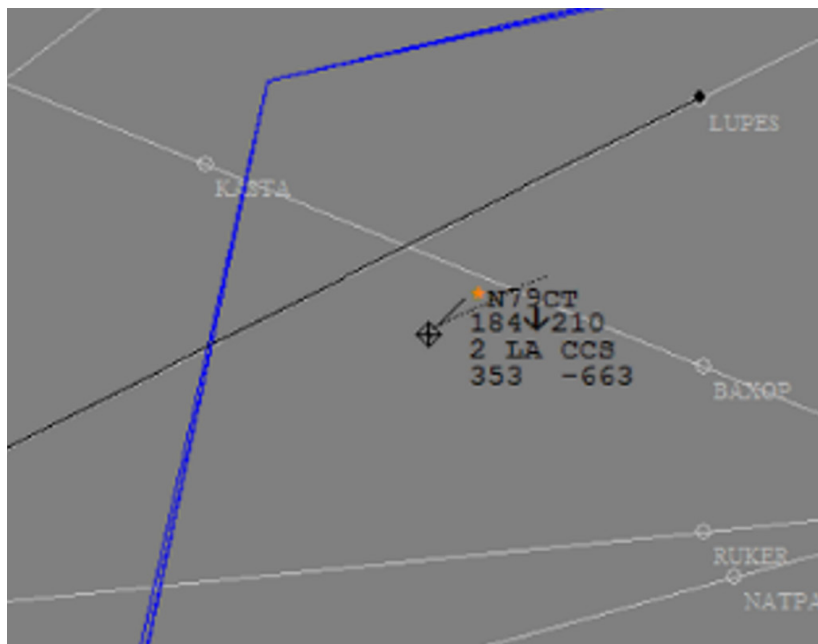
Illustration 9: Aircraft's position at 16:16:29

From 16:16:29, the aircraft's ground speed fell to 20 knots. Its descent speed was 663 ft/min and its heading changed to 353°.

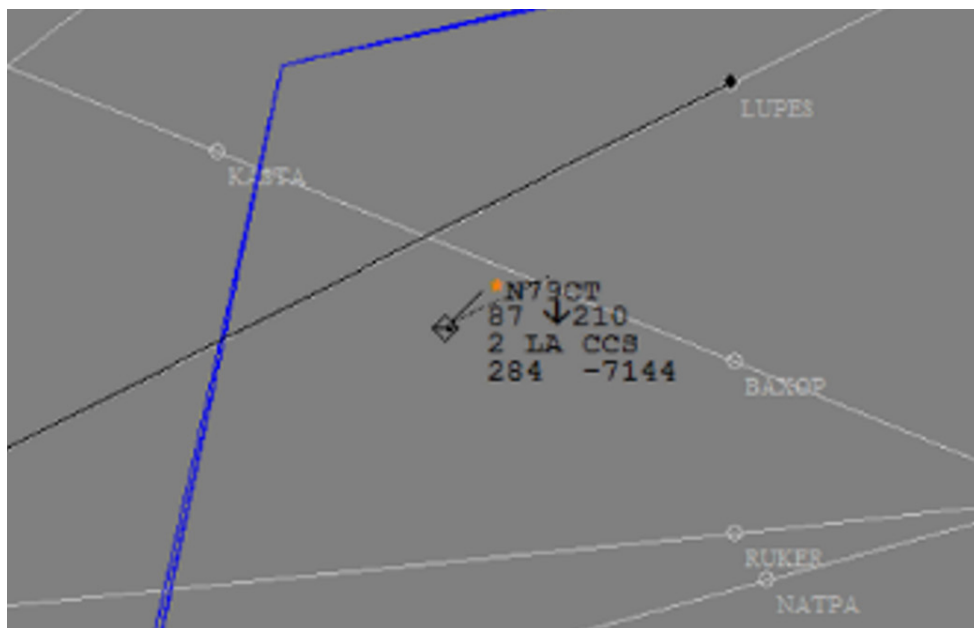
Illustration 10: Aircraft's position at 16:16:51

Later, at 16:16:51, there was an increase in the aircraft's descent speed, which at that time was 7144 ft/min.

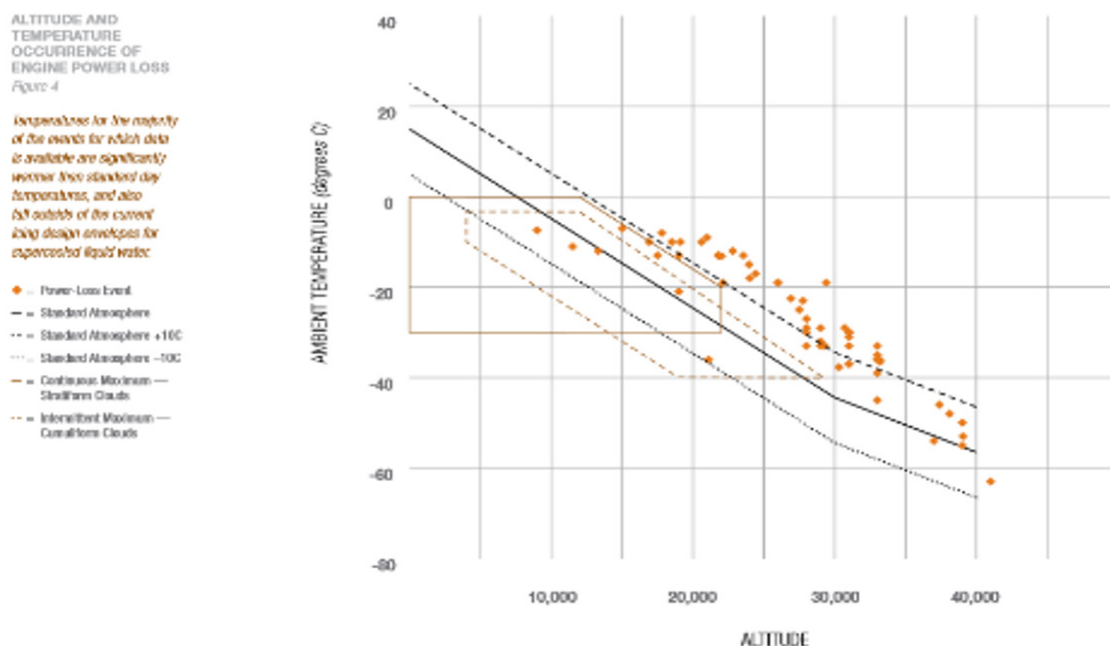
Ilustración 27: Engine power loss in icing conditions

1. Appearance of a significant yaw moment to the left, when the aircraft was climbing with wings level. In this case, two cases must be considered:
  - “Mechanical” failure of the left engine, producing a sudden power asymmetry at the same time as a 50% decrease in the available power. This is ruled out since after the inspection of the engines it was determined that both engines were producing the same power at the moment of the impact against the ground, although it has not been possible to determine the level of the same.
  - Possible “momentary malfunction of the left engine due to the transient effect of the presence of ice crystals in the air”. These power losses have been observed on several occasions, recovering the engine affected by itself, which-hypothetically-would explain why the two engines were working in this case.

This possible scenario can not be demonstrated (for the same reasons as all the others that have been considered) but it is not ruled out either.

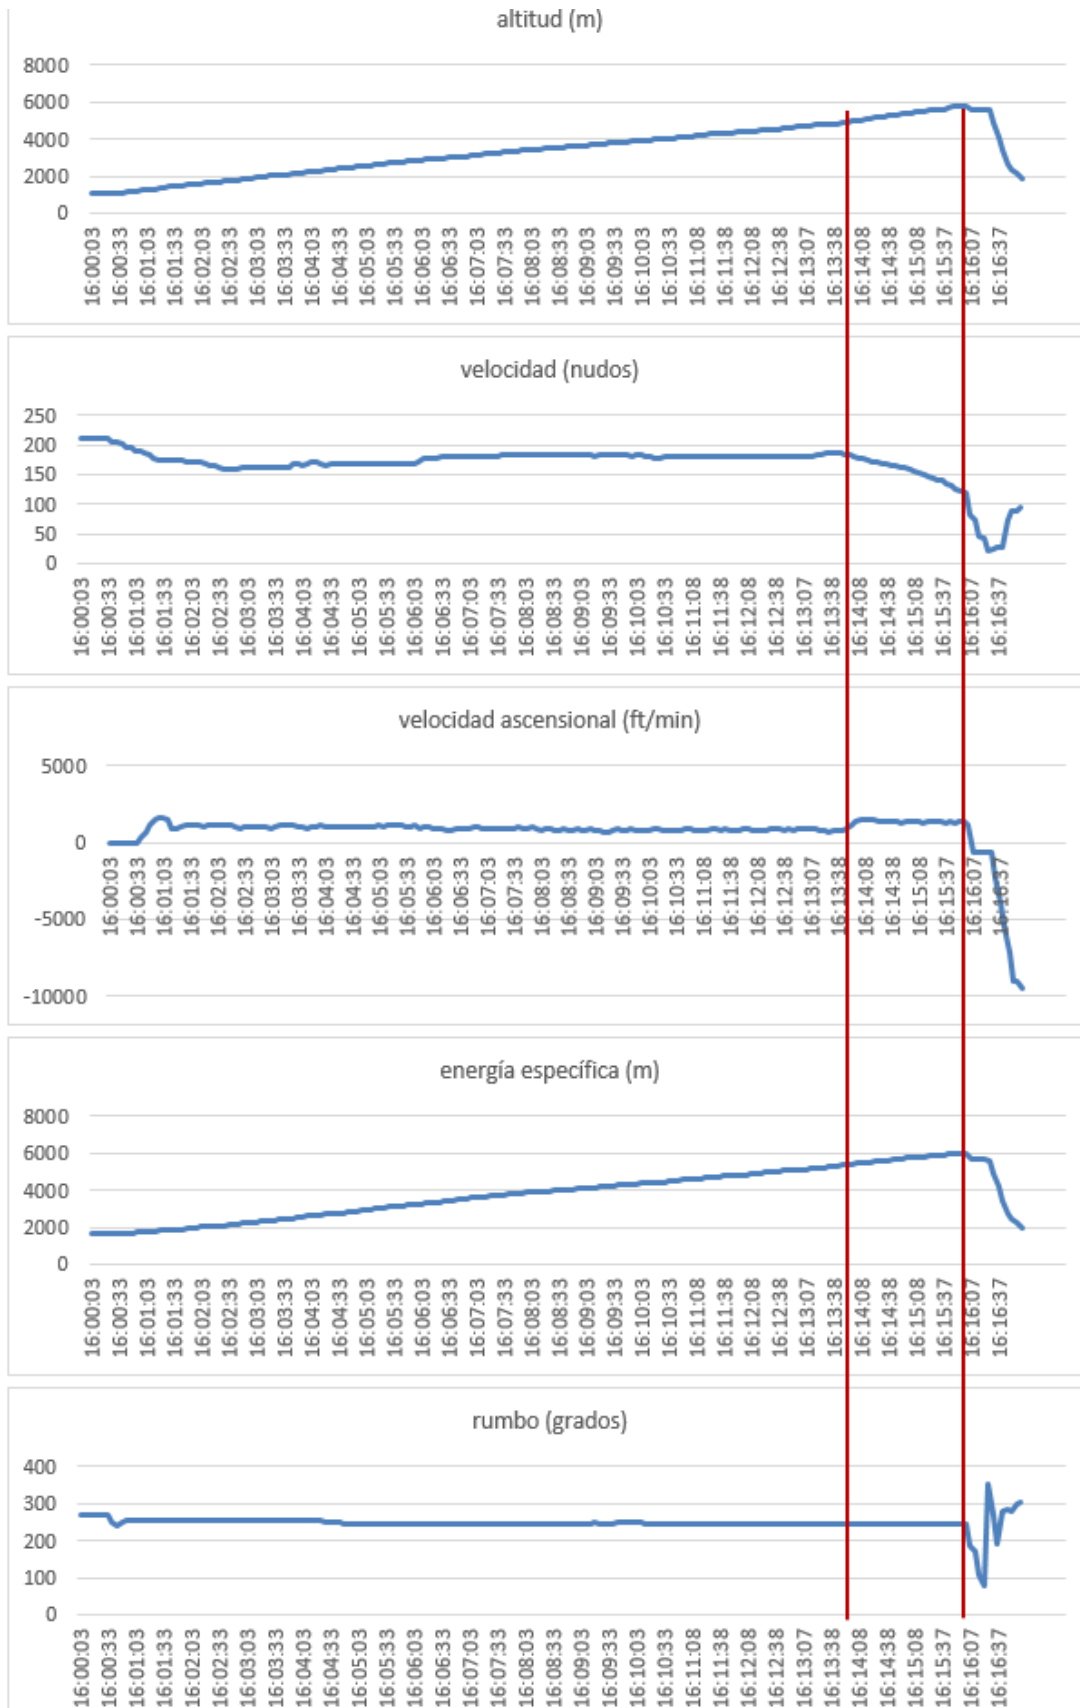
A 1 Altitud, velocidad, velocidad ascensional, energía específica y rumbo a lo largo del vuelo

Between the takeoff at 15:57 and approximately 16:13, the flight was uneventful as the aircraft climbed constantly toward its assigned cruise level (FL 210), as shown in Illustration 1, Aircraft's flight path until the time of the ground impact, and the figure below A.1, which shows the altitude, speed, climb speed, specific energy and heading between 16:00:03 and 16:17:02 (last reliable radar reading).

The following figure A.1 shows a stable speed once a constant climb rate to the cruise level is established, with a linear change in altitude, a noticeably constant climb speed and a heading of 245°. Given these flight conditions, the trend in specific energy over time shows a constant linear increase, indicative of normal conditions.

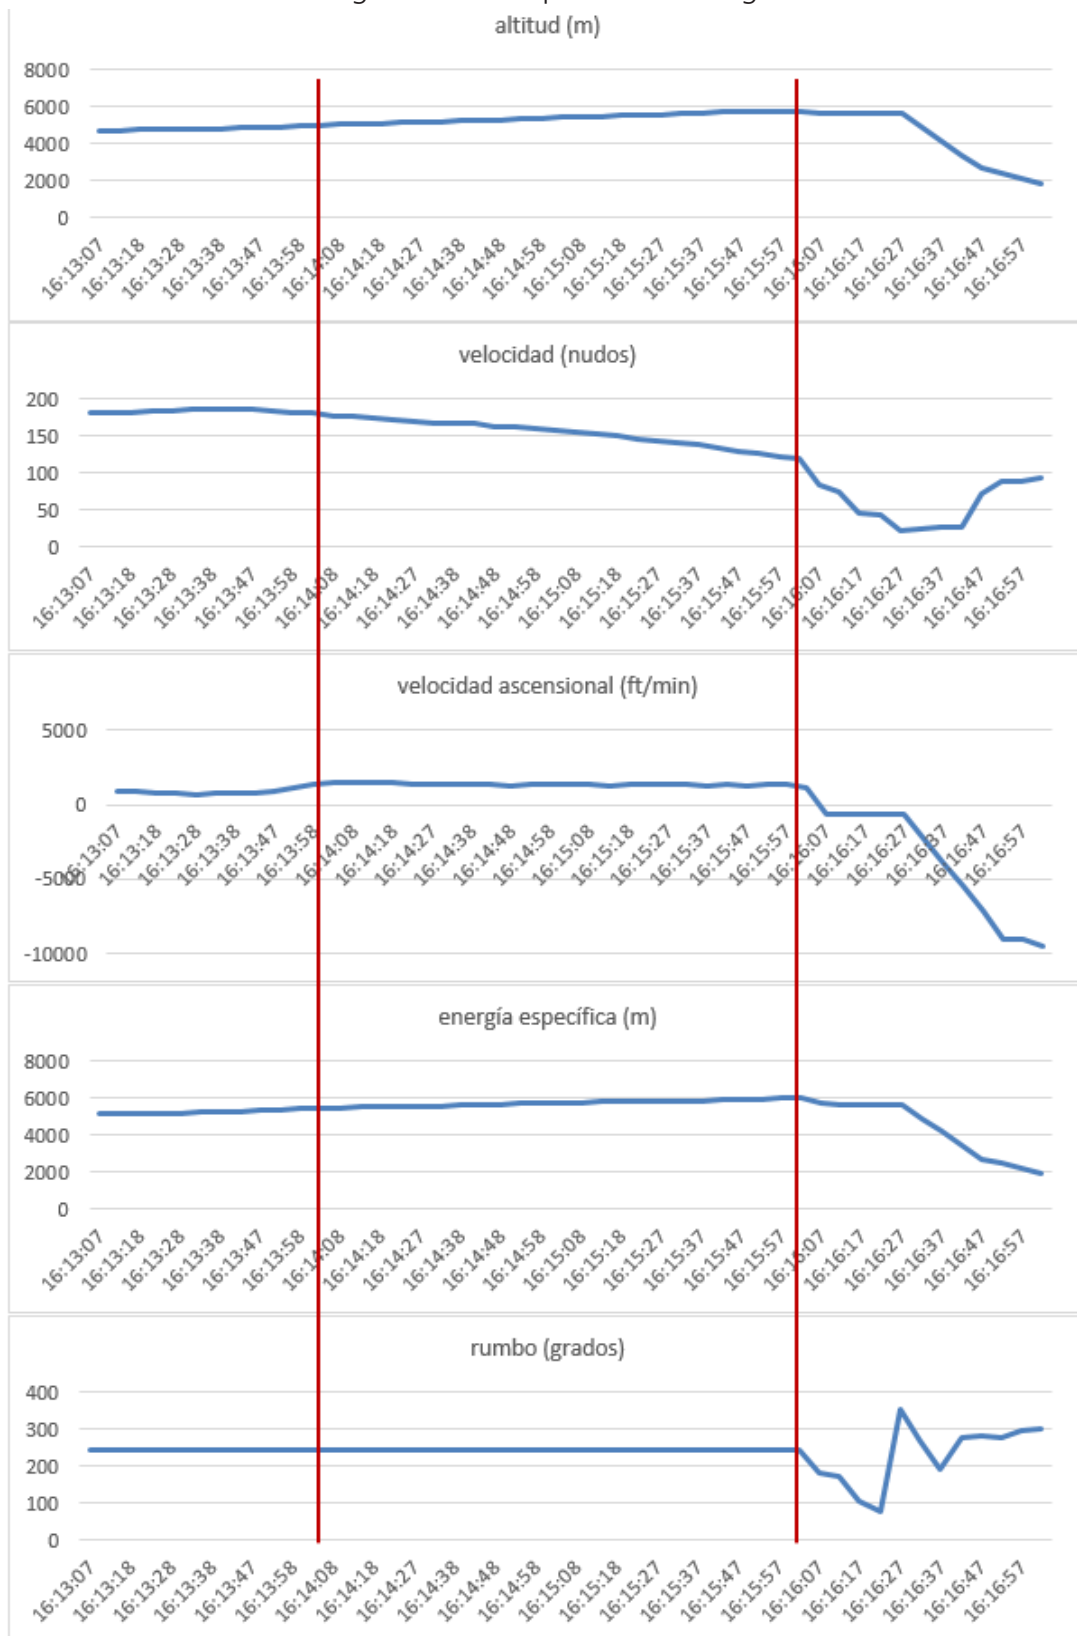
A 2 Altitud, velocidad, velocidad ascensional, energía específica y rumbo en los últimos minutos de vuelo

The final figure shows the altitude, speed, climb speed, specific energy and heading from 16:13:07 to 16:17:02, that is, in the final minutes of the flight for which reliable radar readings are available.

The heading,  $\psi$ , en route remained practically constant from shortly after takeoff, its recorded value being  $245\pm 1^\circ$  until 16:16:02, at which point there is a sudden left yaw that changes the heading  $61^\circ$  in 5 seconds (angular yaw rate  $r=-12.2$  degrees/s), until it reaches  $\psi = 184^\circ$ . The left yaw continues until  $\psi = 171^\circ$  at 16:16:12 ( $r=-2.6$  degrees /s);  $\psi = 106^\circ$  at 16:16:17 h ( $r=-13.0$  degrees /s);  $\psi = 77^\circ$  at 16:16:22 h ( $r=-5.8$  degrees /s);  $\psi = 352^\circ$  at 16:16:27 h ( $r=-17.0$  degrees /s);  $\psi = 268^\circ$  at 16:16:32 h ( $r=-16.8$  degrees /s);  $\psi = 190^\circ$  at 16:16:37 h ( $r=-15.6$  degrees /s). At that point it changes direction (now to the right), reaching  $\psi = 278^\circ$  at 16:16:42 h ( $r=17.6$  degrees /s). The right turn continues and at 16:16:47 the heading is  $\psi = 284^\circ$  ( $r=1.2$  degrees /s). The direction of rotation changes once more (to the left again), with the heading again returning to  $\psi = 278^\circ$  at 16:16:52 ( $r=-1.2$  degrees /s), at which time the aircraft again reverses its direction of rotation (again to the right), reaching  $\psi = 298^\circ$  at 16:16:57 h ( $r=4.0$  degrees /s) and  $\psi = 304^\circ$  at 16:17:02 h ( $r=1.2$  degrees /s). Since this is the last reliable radar reading,

as is the case with the other parameters, it was not possible to determine the trend in the aircraft's heading until the impact with the ground.
