FINAL REPORT
A-151/CENIPA/2018

| OCCURRENCE: | ACCIDENT |
| AIRCRAFT: | PR-TLZ |
| MODEL: | HA-420 |

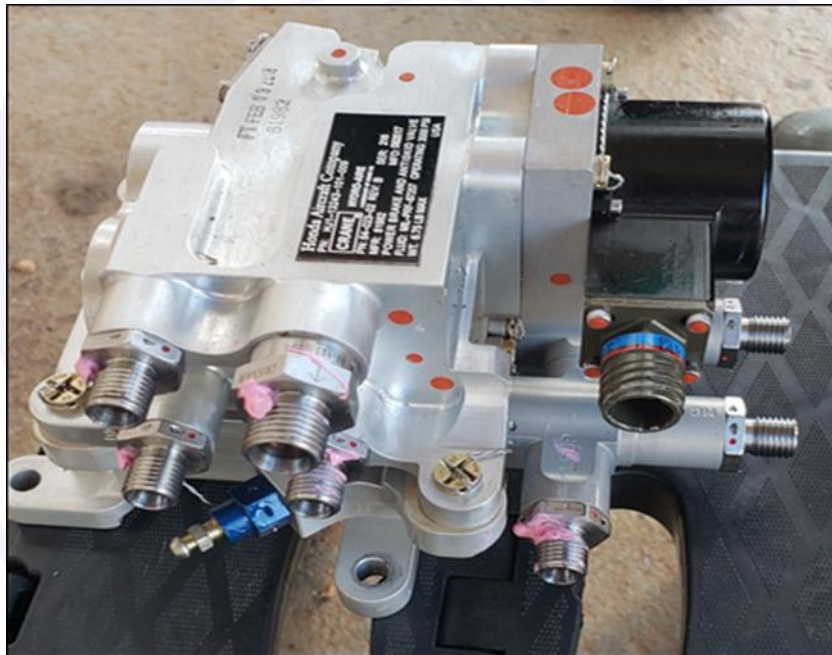
Figure 4 - Power Brake Valve (PBV).

Due to the history of asymmetric braking reports involving some HA-420 model aircraft, an AD (2018-06-10) had been issued in March 2018, which mandated the replacement of PBVs that were defective.

The investigation found that this AD had been complied with prior to the accident and that the latest version of the PBV (PN HJ1-13243-101-009) was properly installed on the aircraft.

Additionally, specific tests of the PBV were performed at the component manufacturer's headquarters, where the hydraulic pressure was measured and the results found were in accordance with the recommended for normal operation of the aircraft.

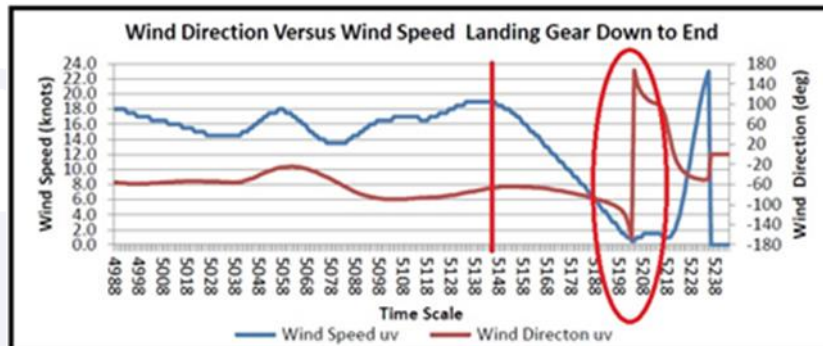
Figure 11 - Wind Direction x Speed during approach.

Just prior to touchdown, there was a 40 second time period where the wind intensity decreased from 19kts to 6.5kts.

These variations are represented graphically. The point of wind speed variation comprises the interval 5146 to 5186 on the figure time scale, while the variation in its direction can be observed at the time of landing, on time scale 5203 (Figure 11).

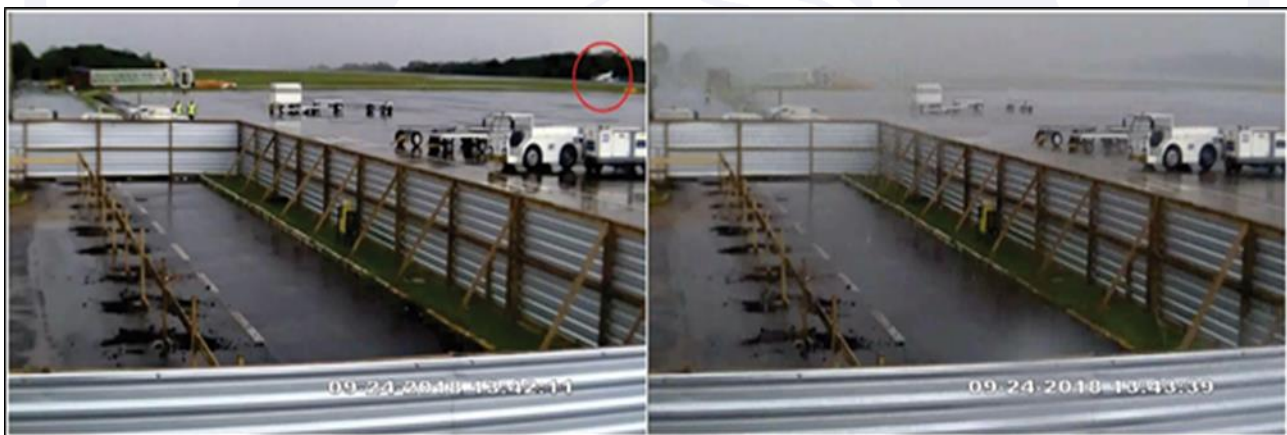
In Figure 12 it is possible to see the weather conditions recorded by a security camera of the Aerodrome in two moments: on the left, with the aircraft on the runway, it is possible to see the precipitation over threshold 14; on the right, 1 minute and 28 seconds after the first recording, it is possible to see a heavy rain over the Aerodrome.

Figure 12 - Comparison of images from threshold 14 at two moments: 13h42min11s (Local Time) (aircraft over the runway) and 13h43min39s (Local Time) (rain over the Aerodrome).

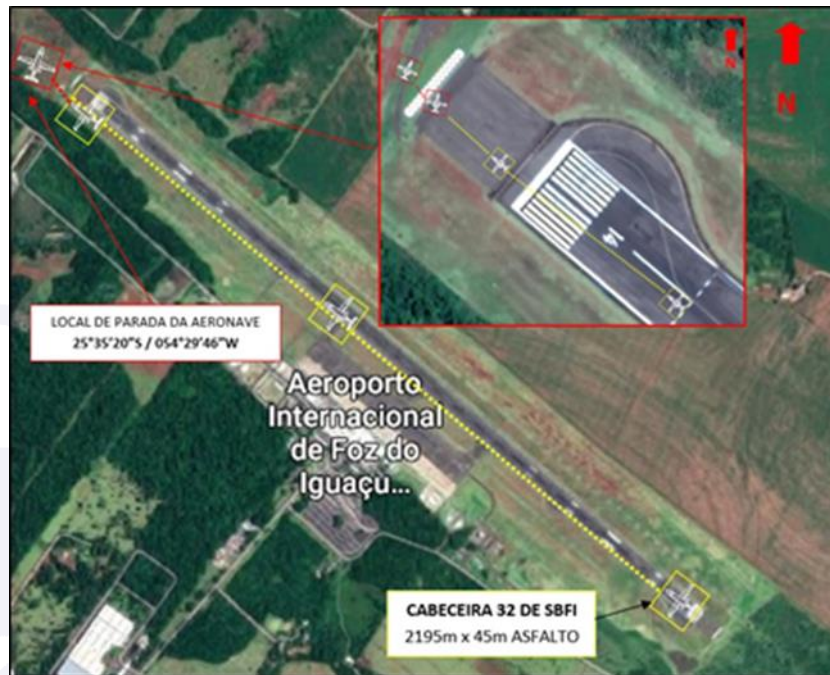
Figure 16 - Aircraft trajectory.

The aircraft exceeded the limit of runway 32, crossing the opposite threshold (14) and the stopway.

When realizing he was about to leave the runway, the pilot commanded a right turn, stopping at 90° in relation to the runway (Figure 16).

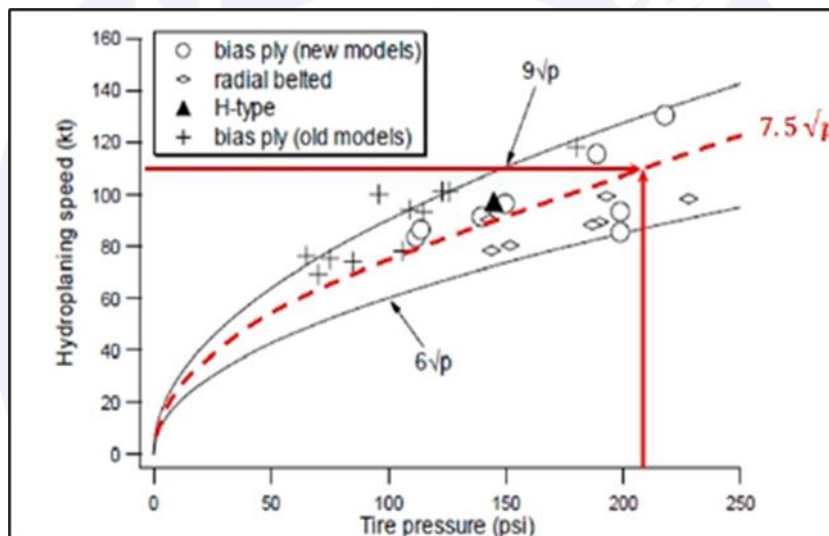
Figure 21 - Experimental hydroplaning speeds as a function of tire pressure for the HA-420 aircraft.

The Honda Aircraft Company Flight Science Department developed the $7.5 \sqrt{p}$ curve to model the predicted hydroplaning for the HA-420 aircraft with the normal main tire pressure of 215 PSI. The result of this curve corresponded to an estimated hydroplaning speed of 110 kt (Figure 21).

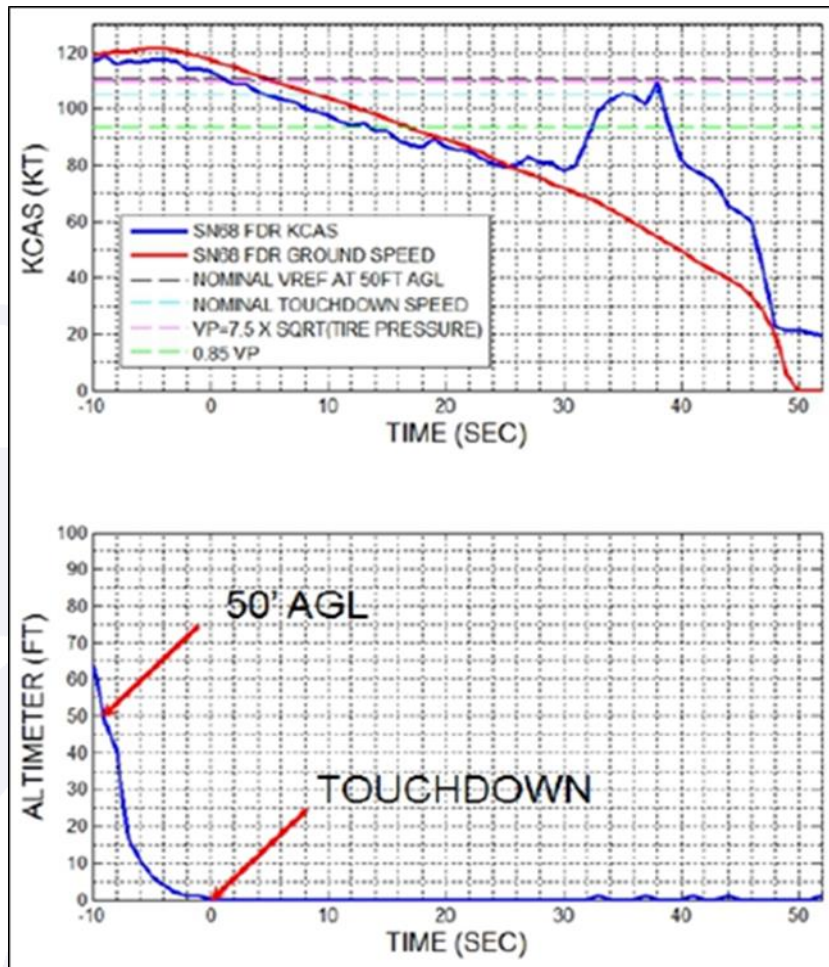
Figure 22 - Velocity and height (AGL) vs Time, Touchdown at T=0.

Figure 22 shows the Calibrated Airspeed (CAS), and ground speed of the aircraft over time, with Time 0 (start time) set as the estimated touchdown point. The speed reference lines are included values for Nominal VREF, Nominal Touchdown Speed, estimated hydroplaning speed (tire pressure $7.5 \times \text{SQRT}$) and 85% of hydroplaning speed.

The first graph shows that the ground speed was greater than the CAS during the first 26 seconds of the landing, indicating a tailwind. The CAS becomes greater than ground speed during the rapid increase in the CAS starting 30 seconds after the touchdown (Figure 22). The graph also shows that at 50ft AGL, the CAS was approximately 117kt.

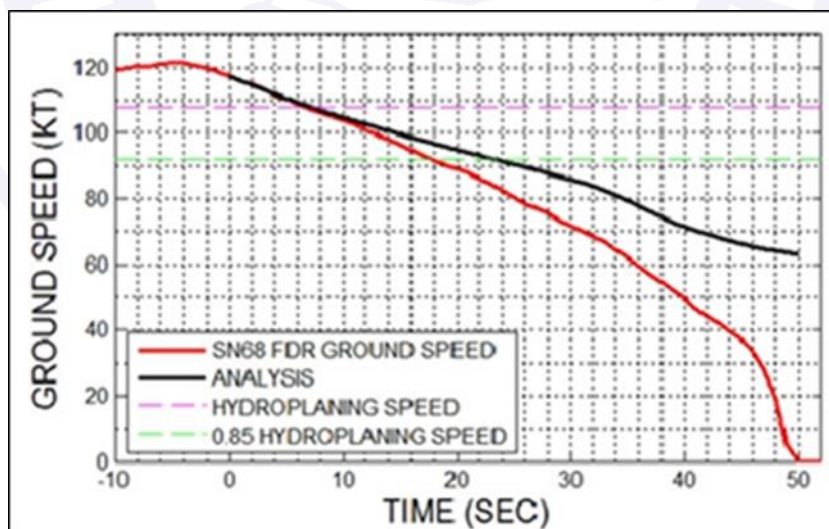
Figure 23 - Aerodynamic drag model (black line) and deceleration curve relative to the ground (red line).

Figure 23 shows the aircraft deceleration recorded after the touchdown (red line) compared to a Honda Aircraft aerodynamic model curve showing the predicted aerodynamic drag deceleration (black line, no aircraft brakes applied). It is evident from the figure that forces, other than aerodynamic drag, acted to decelerate the aircraft after the touchdown.

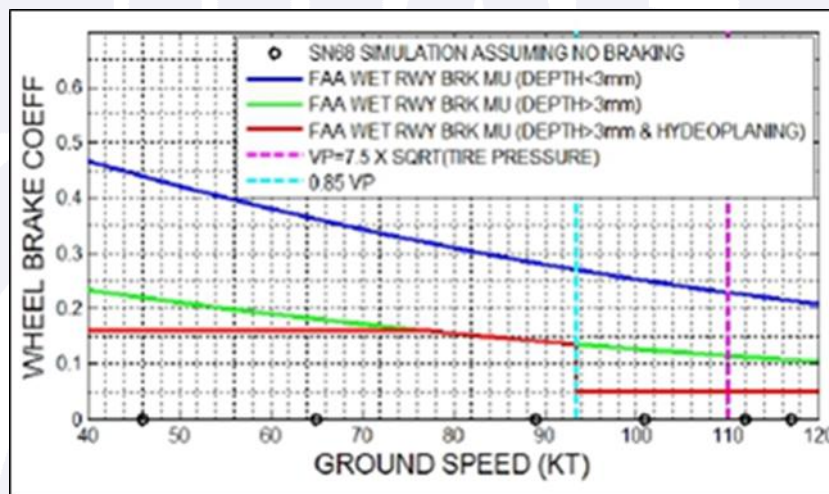
Figure 24 - Aerodynamic drag only (black circles, brake coefficient = 0 for all speeds) data points compared to the FAA model braking curves for a wet runway with various water depths.

The solid horizontal lines depict conditions of a wet runway (FAA WET RWY BRK MU - DEPTH<3mm), a very wet runway (FAA WET RWY BRK MU - DEPTH>3mm), and a very wet runway with hydroplaning (FAA WET RWY BRK MU - DEPTH>3mm&HYDROPLANING). Any data point below the red line indicates a potential for hydroplaning.

The simulated braking coefficient for the PR-TLZ, assuming a value of "0" for all speeds, is mapped in Figure 24 (black circles). This equates to no braking and that the expected deceleration would correspond to the black line shown in Figure 23 (aerodynamic braking only).

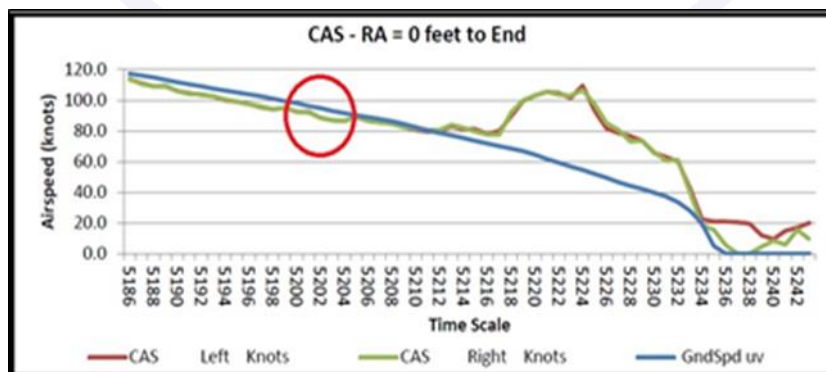
Figure 31 - Calibrated speed x ground speed.

According to the data obtained through the CVFDR transcription, it was possible to verify that, at the time of the aircraft landing (time scale 5203), the speed in relation to the ground was 3.5kt higher than the calibrated speed. Therefore, it was assumed that there was a tailwind component, with intensity of 3.5kt (Figure 31).

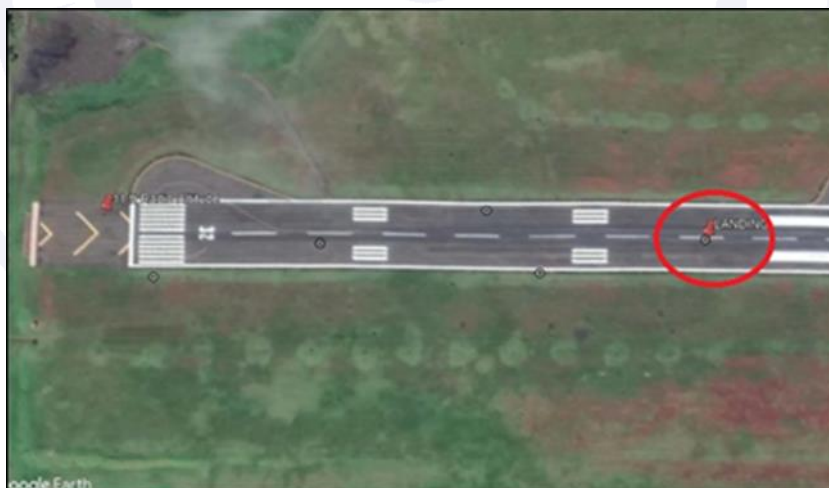
Figure 32 - Touching point on the runway in relation to threshold 32.

The representation of the data obtained from the CVFDR transcription indicated that the touchdown on the runway occurred in the Touchdown Zone (TDZ), about 70m before the 1,000ft mark, as illustrated in Figure 32.

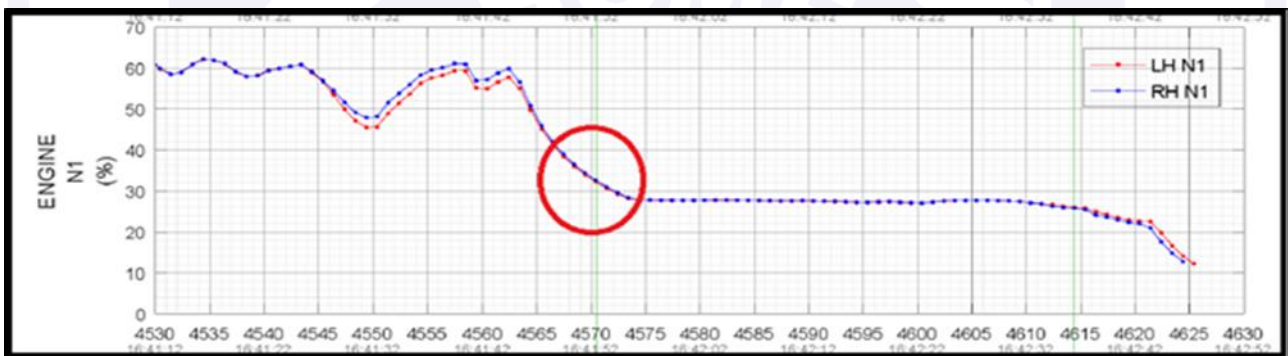
Figure 34 - Variation of N1 of the aircraft engines.

As observed in Figure 34, during this event, there was no increase in the power developed by the aircraft engines. The area circled in red indicates the moment of the aircraft touchdown on the runway (16:41:52). Also, there was no change in the engine speed (% N1) during the run after landing.

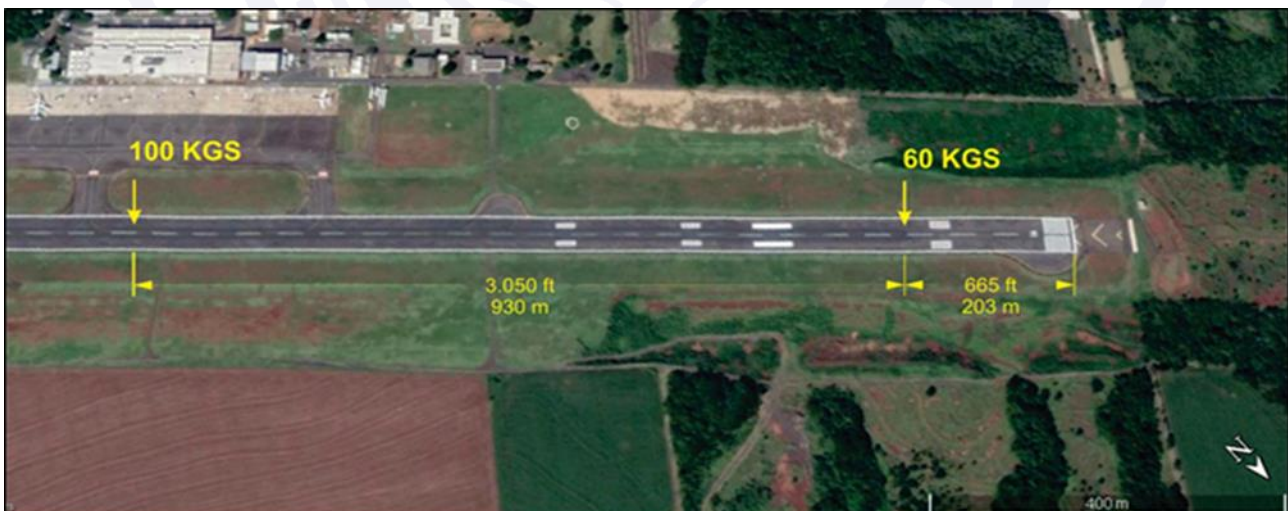
Figure 35 - Representation of the distance traveled by the aircraft from the point of 100 KGS to 60 KGS.

Through flight data obtained from the CVFDR transcription, it was possible to illustrate the deceleration of the aircraft from 100kt to 60kt (Figure 35).

The aircraft's flight data recorders indicated that the emergency brake was applied when there was 500ft left to the end of the runway.
