Loss of control and collision with water involving Grumman American Aviation Corp G-73, VH-CQA

10 km west south west of Perth Airport, Western Australia | 26 January 2017

ATSB Transport Safety Report
Aviation Occurrence Investigation
AO-2017-013
Final – 19 November 2019

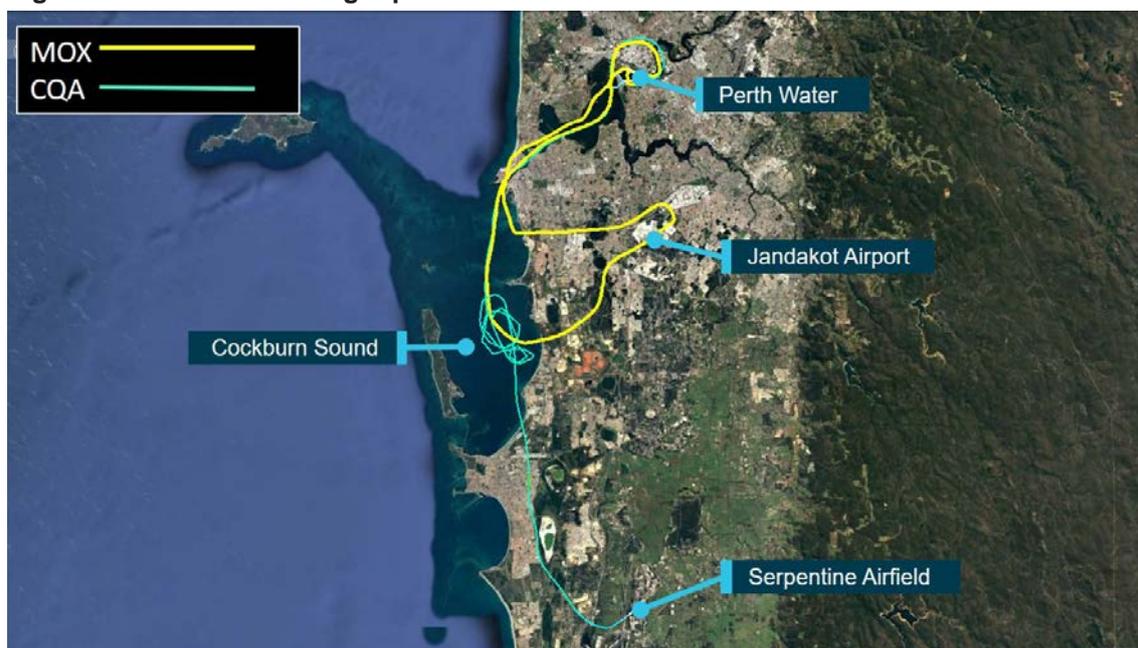
Figure 1: CQA and MOX flight path

The pilot of CQA planned on flying 'in company' (see the section titled *Procedure for fly-bys*) with a Cessna Aircraft Company C208 'Caravan' amphibian, registered VH-MOX (MOX) during the air display. The pilot of MOX received a text message from CQA's pilot, advising that he would not be landing at Jandakot Airport as previously discussed and requested that they meet up overhead the agreed alternative location of Cockburn Sound (Figure 1). MOX departed from Jandakot at about 1645 and met up with CQA over Cockburn Sound.

Upon meeting up, the pilot of CQA assessed that MOX's speed was too high for the two aircraft to travel together and requested that the Caravan pilot slow his aircraft down. The pilot of MOX agreed to slow down with a request that CQA 'didn't get too close'. Both aircraft then flew the prescribed route to Perth Water, the location of the air display. The weather was fine with a recorded wind of about 20 km/h from the south-west and a temperature of about 39°C.

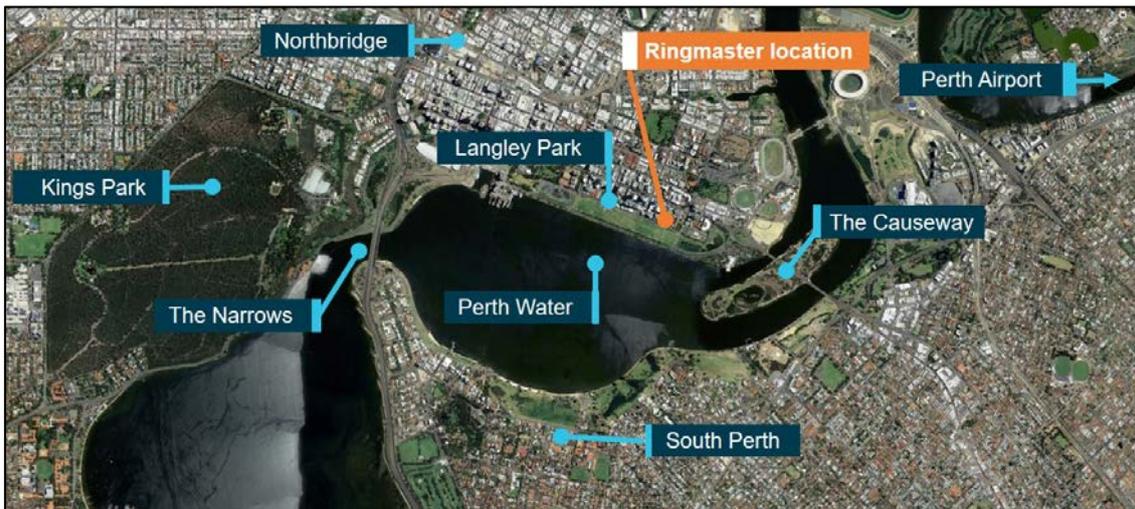
Figure 6: Perth Water

The City of Perth (CoP) managed the Australia Day Skyworks (Skyworks), which consisted of a series of events on 26 January each year, culminating in a fireworks display from barges moored in the centre of Perth Water (Figure 6). Perth Water is located on the Swan River between Langley Park and the South Perth shoreline, the Narrows Bridge in the west and Causeway in the east. Events included various activities on the Langley Park foreshore and the South Perth foreshore, which was coordinated by the City of South Perth. Water-based events and the air display were managed on behalf of CoP by a contracted events management company. Up to 300,000 people attended each year.

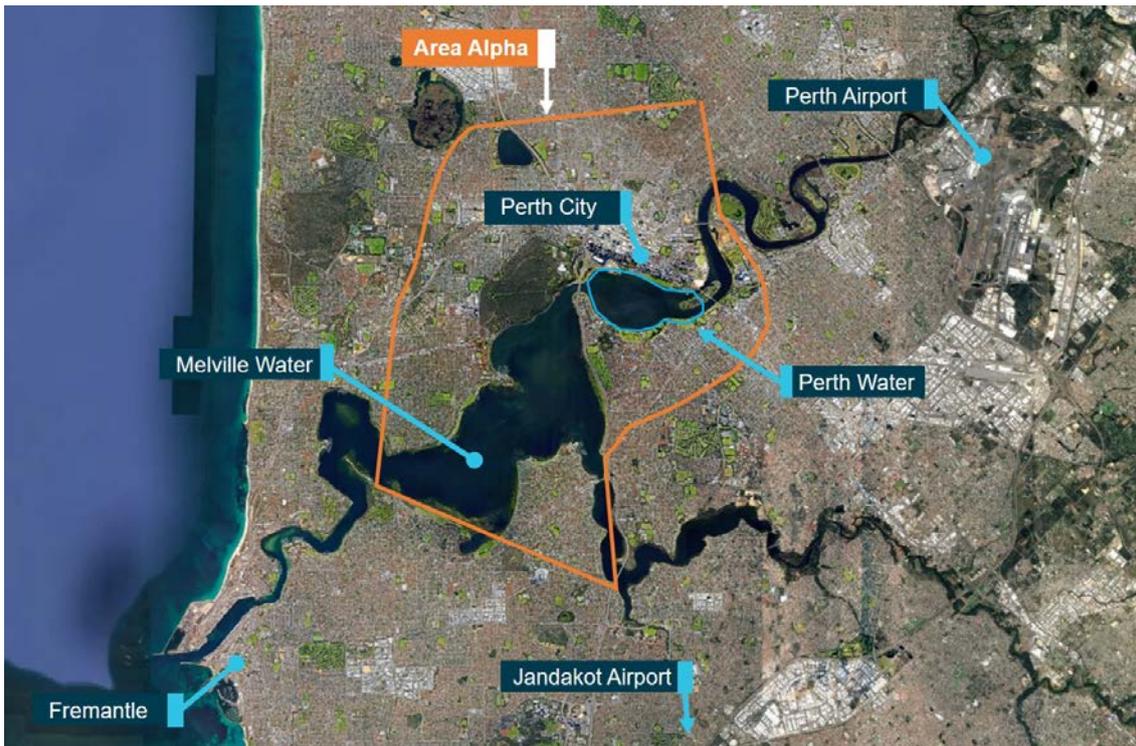
Figure 7: Google Earth image showing approximate location of Perth Water within Area ALPHA.

Perth Water is located about 10 km west-south-west of Perth Airport, in class C airspace. A temporary danger area (TDA)¹³ 'Area ALPHA' (Figure 7) was established by Airservices Australia for the duration of the air display, from surface up to 1,500 ft AMSL.¹⁴ This allowed air display aircraft to operate in Perth Water without the need for specific air traffic control (ATC) clearance. A central point of contact - the Ringmaster - was required to maintain two-way communication with Perth ATC and coordinate aircraft access into Area ALPHA on a specified frequency. Standard airspace procedures were required for operations outside of Area ALPHA.

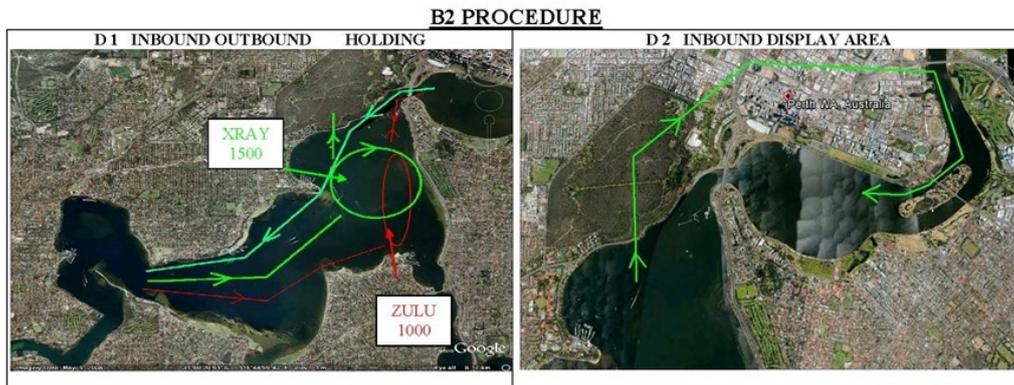
Figure 8: Extract of the CASA-authorized B2 display procedure supplied to all participants

The procedures for approach and departure from the display area were detailed in 'display procedure B2' (Figure 8). Once aircraft had entered Area ALPHA they were to track toward the holding area XRAY at an altitude of 1,500 ft (D1 INBOUND OUTBOUND HOLDING). If holding

For all non-aerobatic aircraft, the standard inbound route to the display area (Perth Water) was to fly over Kings Park then Northbridge (to the north of Perth City) and via the Graham Farmer freeway toward the East Perth power station (D2 INBOUND DISPLAY AREA). Aircraft descended to 1,000 ft while flying over the Swan River toward the Causeway and Perth Water. Departure from the display area was via the Swan River at 1,000 ft toward Fremantle, until clear of Area ALPHA.

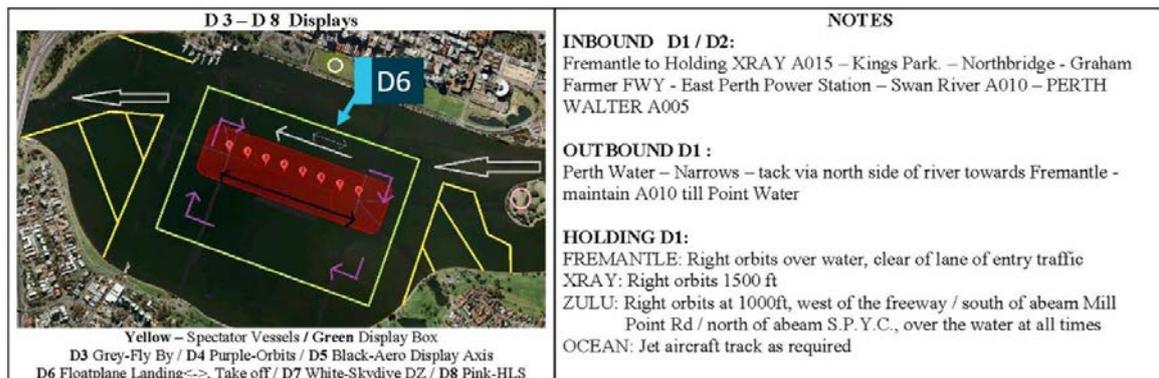
Figure 9: Extract from the ‘display procedures – B2’ diagrams, showing the arrow that indicates the direction and location of the float plane landing area

Fly-bys (procedure D3, Figure 9) were to be performed by groups of aircraft flying ‘in formation’ or ‘in company’. The program noted that ‘formation rated and current pilots [are to] only [fly] in formation groups up to maximum of 6. Other aircraft [including those operating in company] were to maintain 600 metre separation between each other’.

Following the standard approach and departure procedure, aircraft conducting fly-bys were to descend from 1,000 ft to not below 500 ft over the channel of water between the pyrotechnic barges (red rectangle, Figure 9) and Langley Park foreshore. The aircraft were to depart over the Narrows Bridge (Figure 6) and track over the Swan River at 1,000 ft, back toward Jandakot Airport.

The B2 display procedure included the 'D6 Floatplane Landing' (Figure 9) location at the northern edge of the display box.
