# VFR into IMC and controlled flight into terrain involving Pilatus Britten-Norman BN2A, VH-OBL

101 km west-south-west of Hobart, Tasmania, on 8 December 2018

**ATSB Transport Safety Report**

AO-2018-078

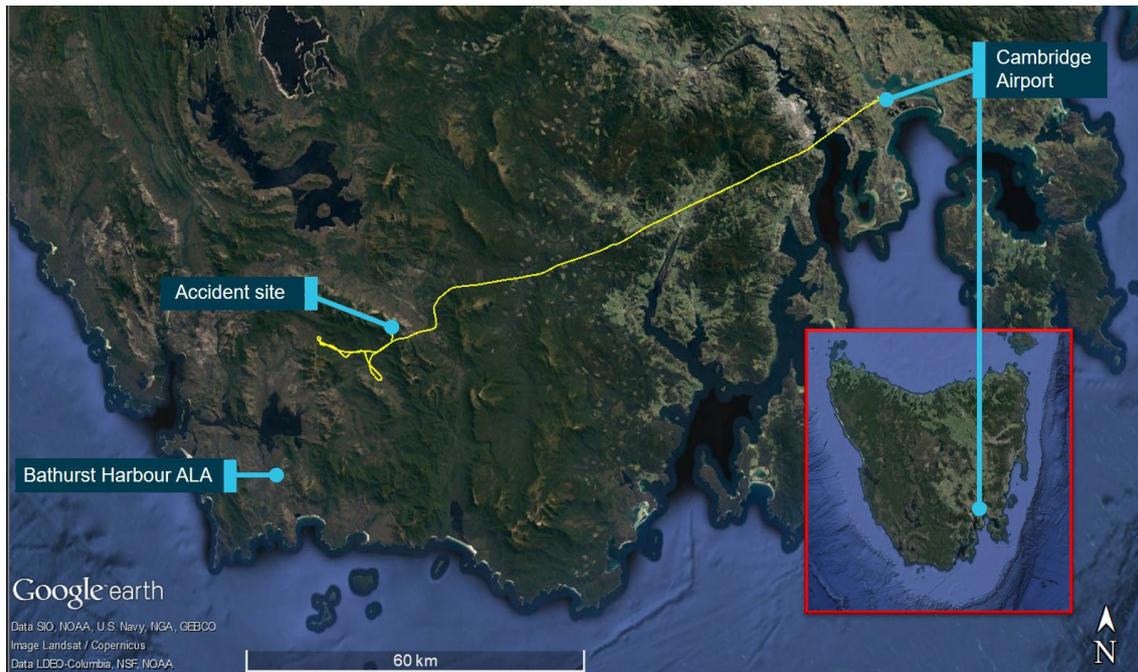
Automatic dependent surveillance broadcast (ADS-B)<sup>3</sup> position and altitude data (refer to the section titled *Recorded information*) showed the aircraft tracked to the south-west towards Bathurst Harbour (Figure 1). At about 0816, the aircraft approached a gap in the Arthur Range known as 'the portals'. The portals are a saddle (lowest area) between the Eastern and Western Arthur Range, and was an optional route that Airlines of Tasmania used between Cambridge and Bathurst Harbour when the cloud base prevented flight over the mountain range. After passing through the portals, the aircraft proceeded to conduct a number of turns below the height of the surrounding highest terrain. The final data point recorded was at about 0828.

**Figure 1: Track of VH-OBL from Cambridge Airport towards Bathurst Harbour, showing the accident location**

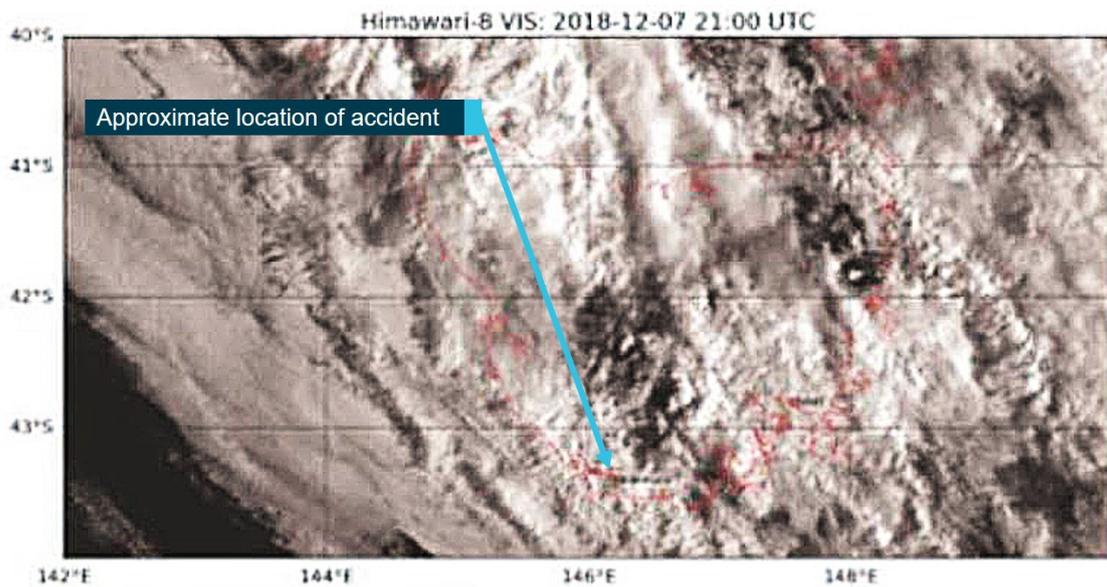
The satellite images showed that there was an ‘extensive layer of middle and high cloud associated with the passage of the trough’. Similarly, high-resolution images also indicated the presence of low-level cloud in the area, including the accident location (Figure 4).

**Figure 4: Visible satellite image at 0800 showing the approximate accident location**

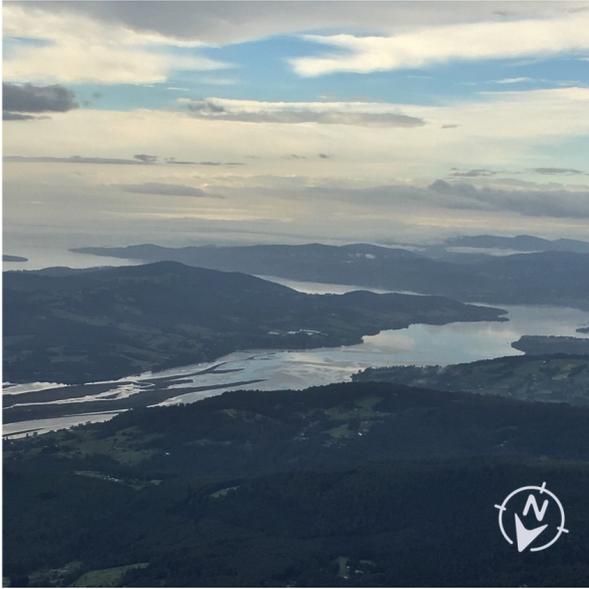
Early in the accident flight, the pilot took a photograph as the aircraft passed near Huonville (about 40 NM (74 km) south-west of Cambridge Airport) and sent this to a colleague. Another company pilot viewed the photograph and reported that there was a ‘little bit of low-lying stratus cloud around, but it was blue skies’ (Figure 5).

**Figure 5: Photograph captured by the pilot as the aircraft passed near Huonville**

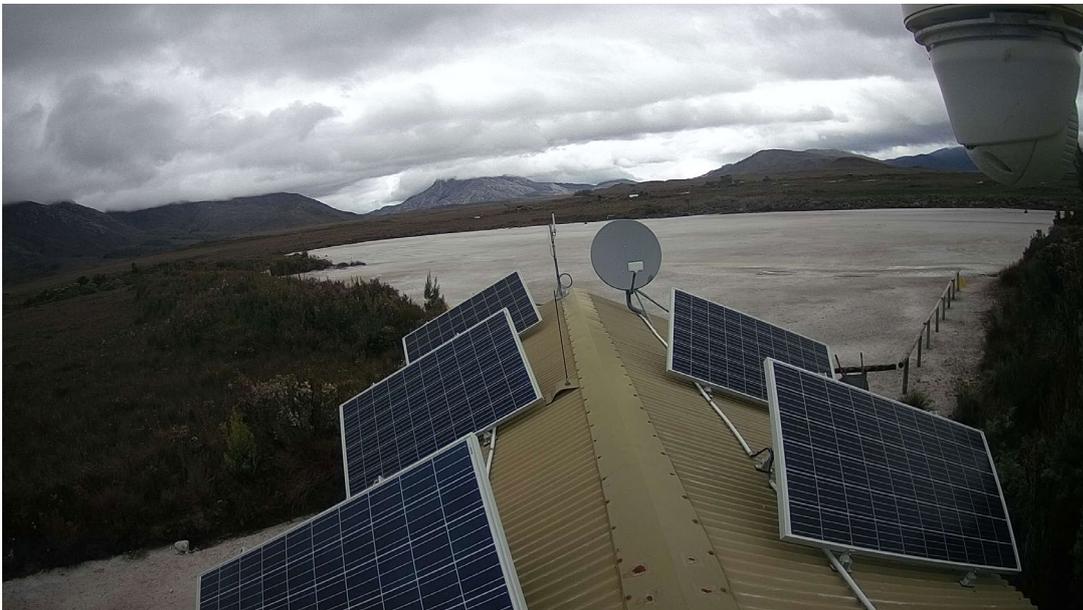
Following the accident, the chief pilot accessed the cameras and recorded a number of images. The images during the earlier part of the day were not saved by the camera. Figure 7 was taken from the south facing camera at 1020 on 8 December 2018, looking out toward the landing area.

**Figure 7: Web camera image from Bathurst Harbour**

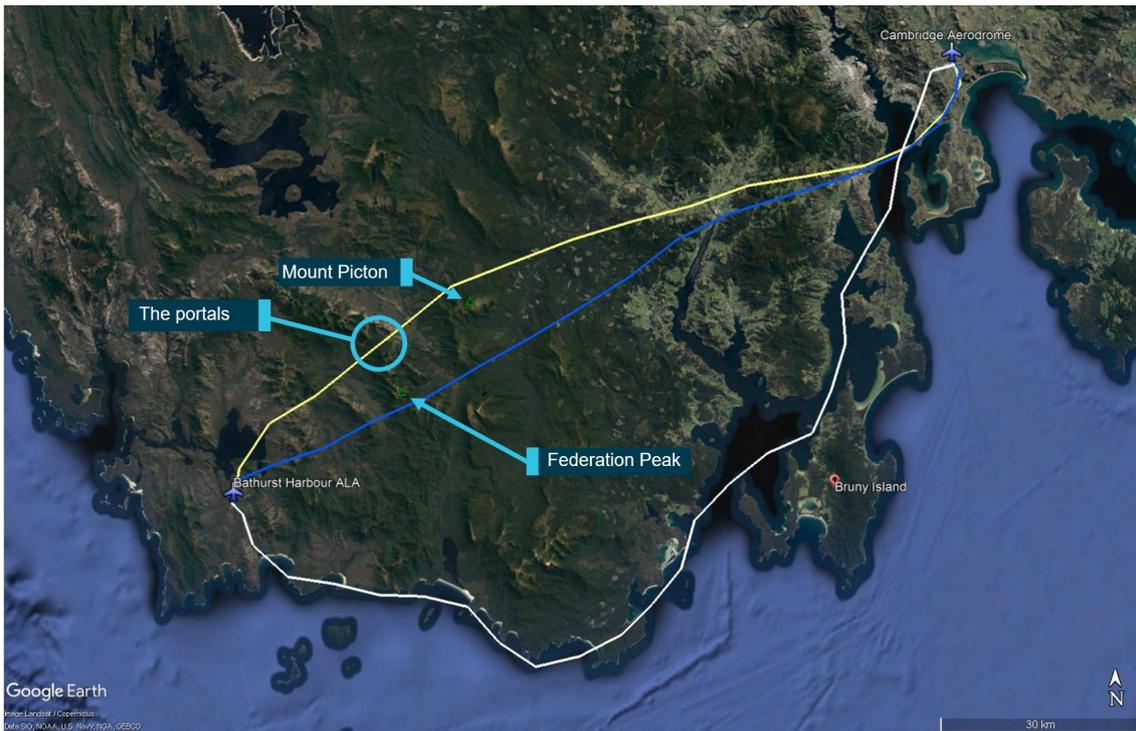
**Figure 11: Routes commonly used between Cambridge and Bathurst Harbour**

Note: The white track is the coastal route, the blue track is the direct route in high cloud conditions and the yellow track is in lower cloud conditions via the portals.  
 Source: Google earth and Spidertracks, annotated by the ATSB

The route selected was at the pilot’s discretion based on their assessment of the weather and type of flight being performed. For the sightseeing tours, it was reported that, weather permitting, the pilot might fly coastal one way, and direct on the return flight to provide the optimum tour experience for the passengers. However, if it was a charter for transporting passengers and/or freight to Bathurst Harbour, normally the direct route was chosen. The accident pilot had selected the direct route, and the flight track showed that the aircraft had passed through the portals, which indicated that the cloud base was not high enough to pass directly over the mountain range.
