# **FINAL INVESTIGATION REPORT**

***ACCIDENT INVOLVING  
M/S AIR INDIA EXPRESS LIMITED  
B737-800 AIRCRAFT VT-AXH  
ON 07 AUGUST 2020 AT KOZHIKODE***

**AIRCRAFT ACCIDENT INVESTIGATION BUREAU  
MINISTRY OF CIVIL AVIATION  
GOVERNMENT OF INDIA**

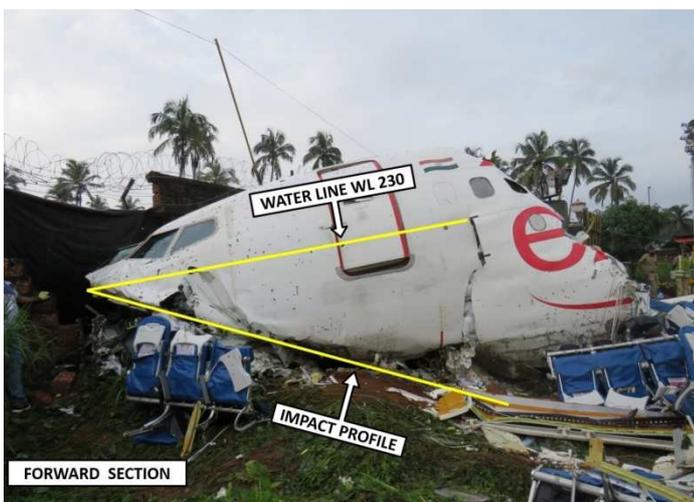
Figure 28: Forward Section Impact Profile.

The impact profile observed on the forward section was at an angle of 30° to the corresponding water line. The initial impact severely damaged the forward section and all the structural members including forward pressure bulk head, floor

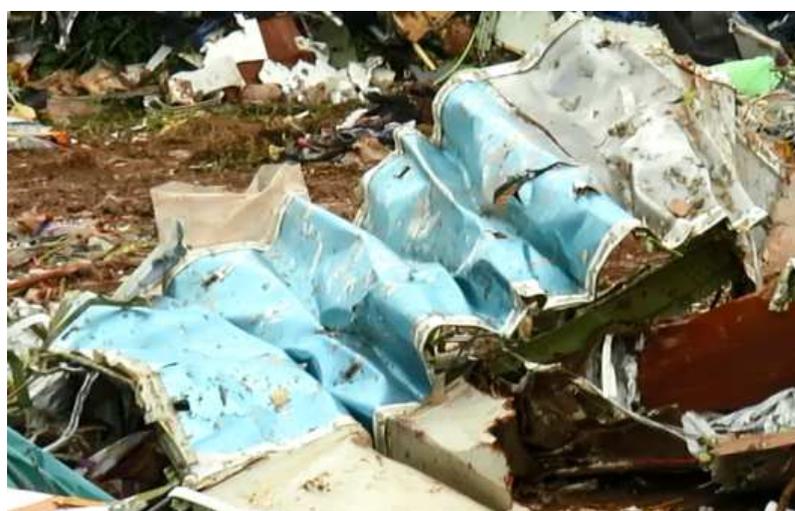
Figure 32: Centre Section Debris

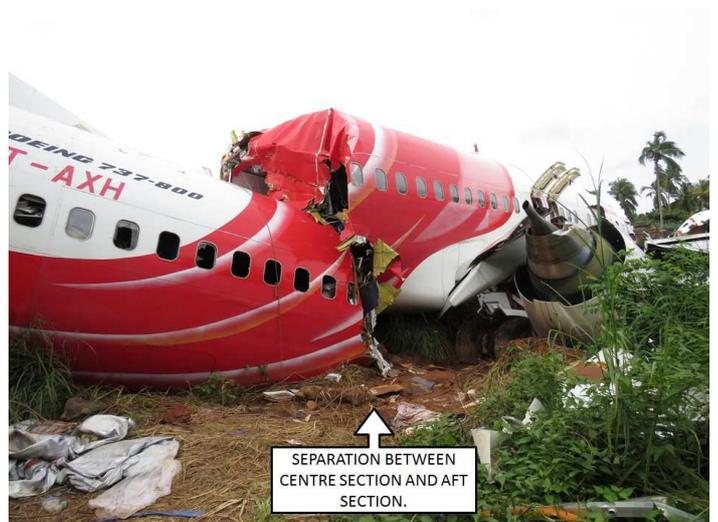
Figure 35: Separation Between Centre and Aft Section

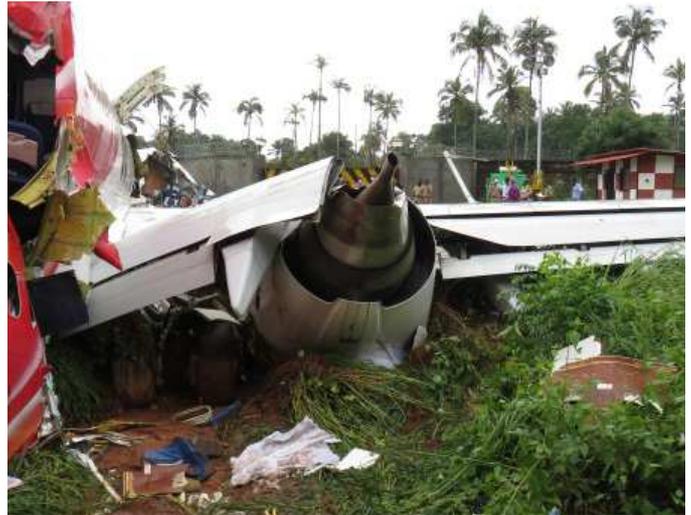
Figure 37: Right Engine

Engines ingested lot of debris, mud and a portion of the air-intake which had crushed on impact. The pieces from crushed section got stuck beneath the fan blade tips. This along with the ingested debris resulted in the arresting of engine rotation. Nacelles of both the engines were also destroyed.

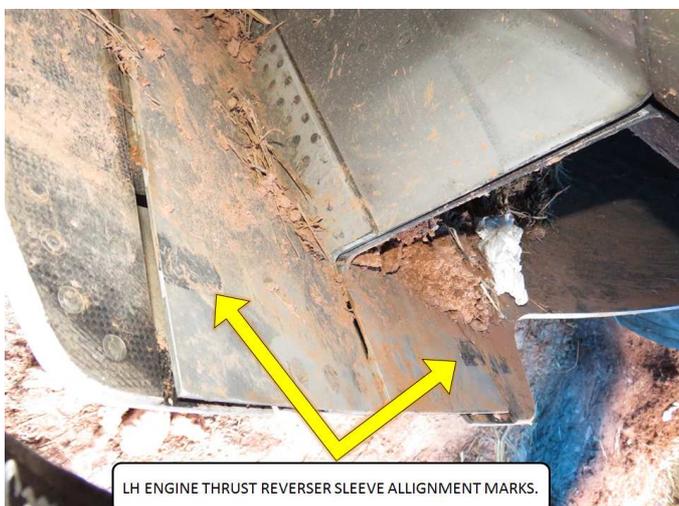
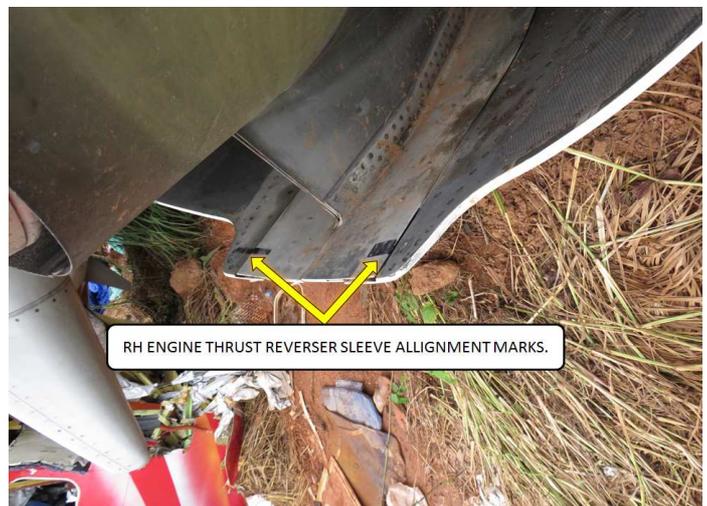
Figure 38: Engine Thrust Reverser Sleeve Alignment Marks

Both Engines had the thrust reverser actuators retracted, and the translating cowls of both were in the stowed position, indicating that the thrust reversers were stowed before impact. This information conforms to the recorded DFDR data. There was no evidence of pre-impact anomalies noticed during the examination.

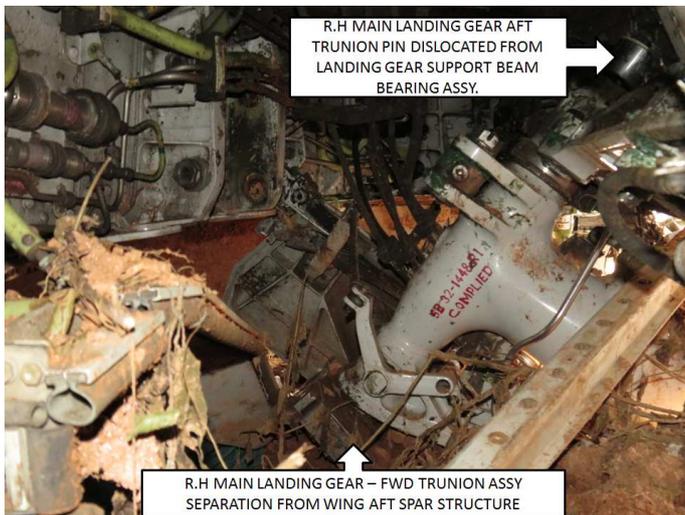
The right main landing gear folded back under the right inboard flap. It separated from forward trunnion pin assembly and side beam hangar fitting with a dislocation from the aft trunnion pin. It did not separate cleanly and was covered by debris and partially submerged in water. The DFDR indicated that the right main landing gear was down and locked before impact.

*Figure 40: Right Main Landing Gear Separation*

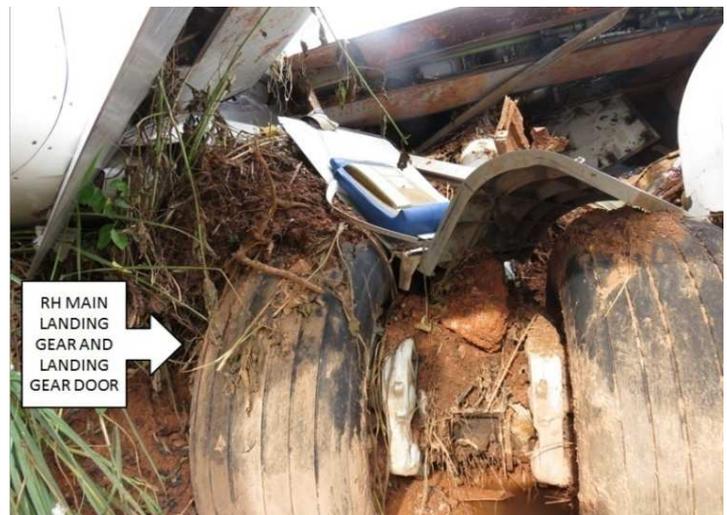
*Figure 41: Right Main Landing Gear*

The wear on the tyres was typical of in-service tyres. They showed signs of abrasions on the side walls sustained during their contact with concrete base structures in RESA. The outboard tyre had circumferential cracks on the sidewall due to impact and was deflated. The inboard tyre was intact and the tyre pressure recorded was 210 psi. Both the brakes were intact and no damage was observed. No hydraulic leaks were observed at the brake pistons. Examination of brakes and its associated hardware was carried out; no pre-impact anomalies were noticed during the examination.

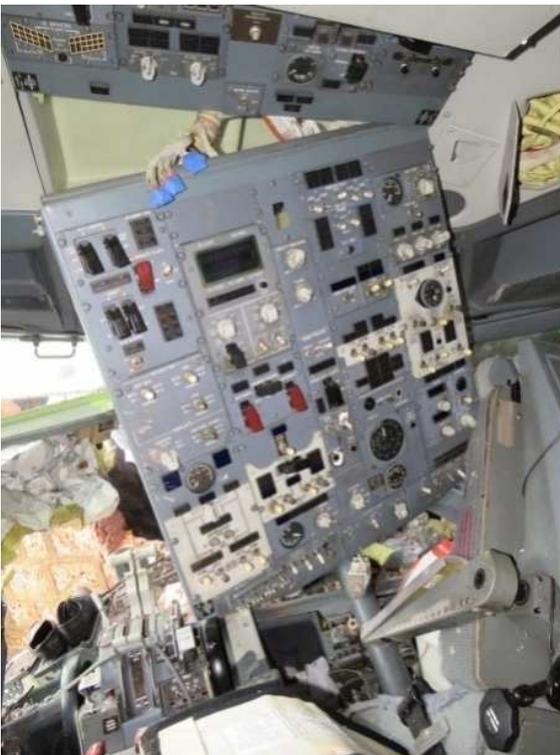
*Figure 42: Control Cabin P5 Fwd Overhead Panel*

The flight deck suffered extensive damage during the initial impact. The forward pressure bulkhead, the sidewall frames and the skin were fractured/deformed. The cockpit floor beams had cracked and the flight deck floor was buckled upwards. There was a separation in the floor forward of the cockpit door.

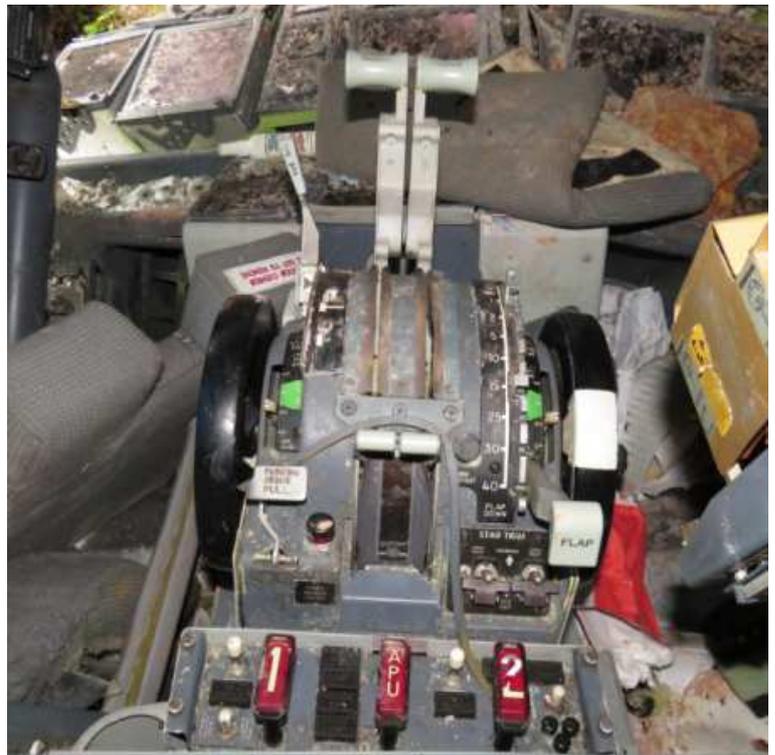
*Figure 43: Control Stand*

Figure 43 shows the image of Control Stand P10 as observed during the wreckage examination.

The throttle lever position did not correspond to the last recorded position in the DFDR data before impact. The Engine Throttle Levers were found jammed at the full forward position with the stop plate bent forward. This was attributed to impact damage sustained by the Thrust Lever Resolver Assemblies and Control Rods causing it to move back thereby forcing the throttle lever forward with such a force that it resulted in bending the stop plate. Both the throttle levers were jammed and could not be moved.

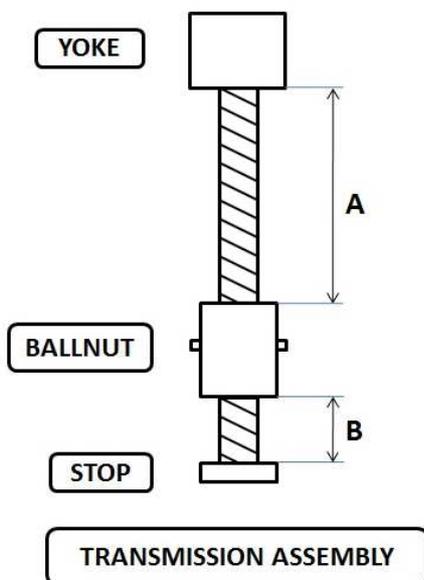
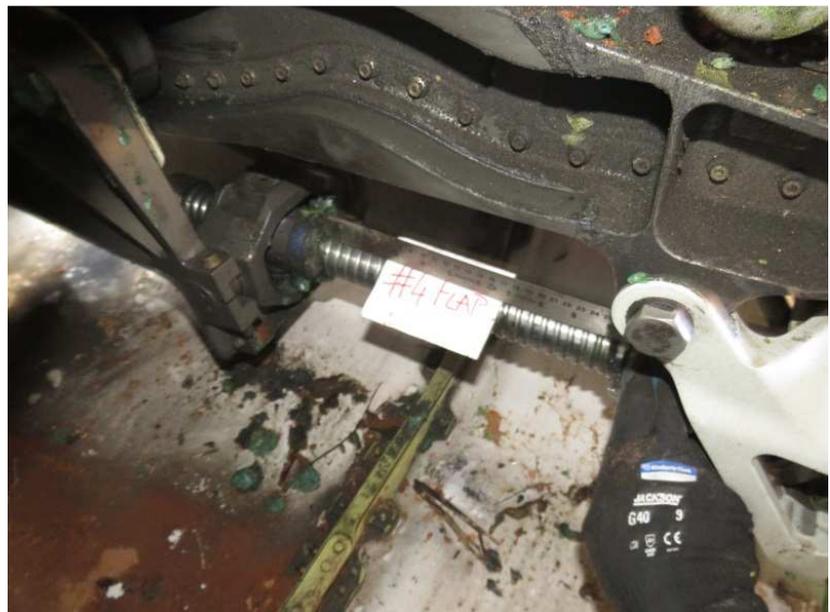
Figure 46: Trailing Edge Flap Jack Screw Measurement

The Flap lever was found to be at Flap 40 selection and free to move without any frictional load. This position did not corroborate with the Flap 30 selection last recorded in the DFDR. The actual Flap position was confirmed by physically measuring the flap jack screw length which is shown in the following figure and table. The measured length corresponds to the Flap 30 selection as in DFDR.

MEASUREMENT AS PER BOEING DESIGN DIAGRAM FOR FLAP AT 30 DEGREE POSITION				
FLAP POSITION	STANDARD DIMENSION 'A'	MEASURED DIMENSION 'A'	STANDARD DIMENSION 'B'	MEASURED DIMENSION 'B'
1	8.33"	8.31"	1.72"	1.75"
2	9.73"	9.56"	2.02"	2.06"
3	10.69"	10.75"	2.17"	2.12"
4	10.69"	10.62"	2.17"	2.31"
5	10.69"	10.62"	2.17"	2.12"
6	10.69"	10.68"	2.17"	2.25"
7	9.73"	9.68"	2.02"	2.06"
8	8.33"	8.31"	1.72"	1.75"

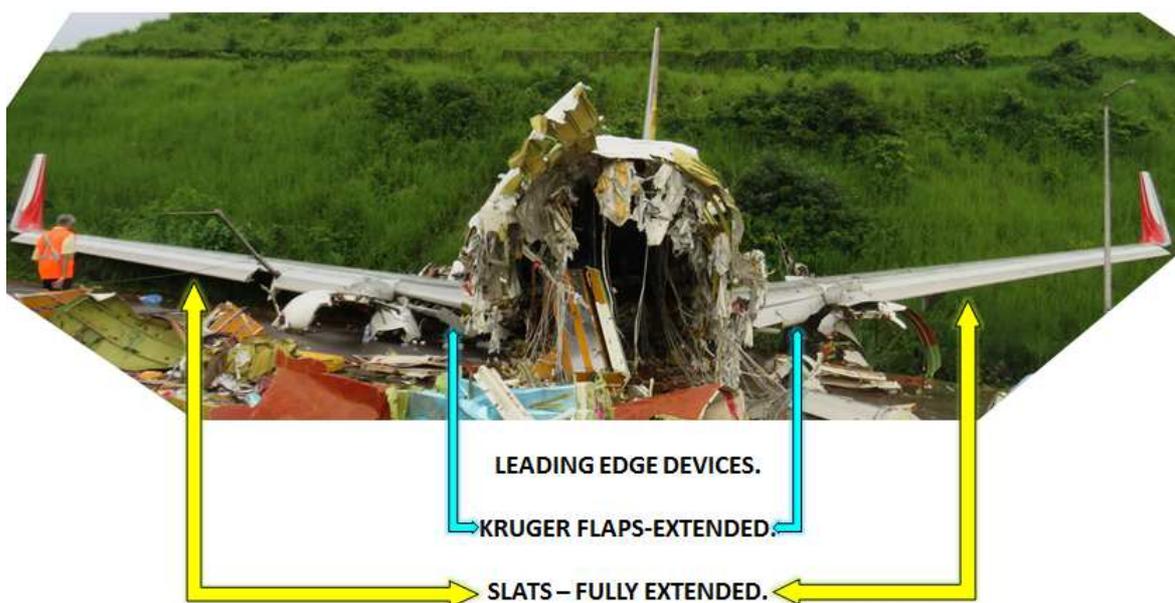
Figure 47: Leading Edge Devices

Leading edge flaps were found to be in extended position and slats were found to be in “full extend” position. The kruger flaps were damaged and leading edge slat #5 on the right wing impacted a light pole resulting in separation of a 30 inch piece from the outboard end.

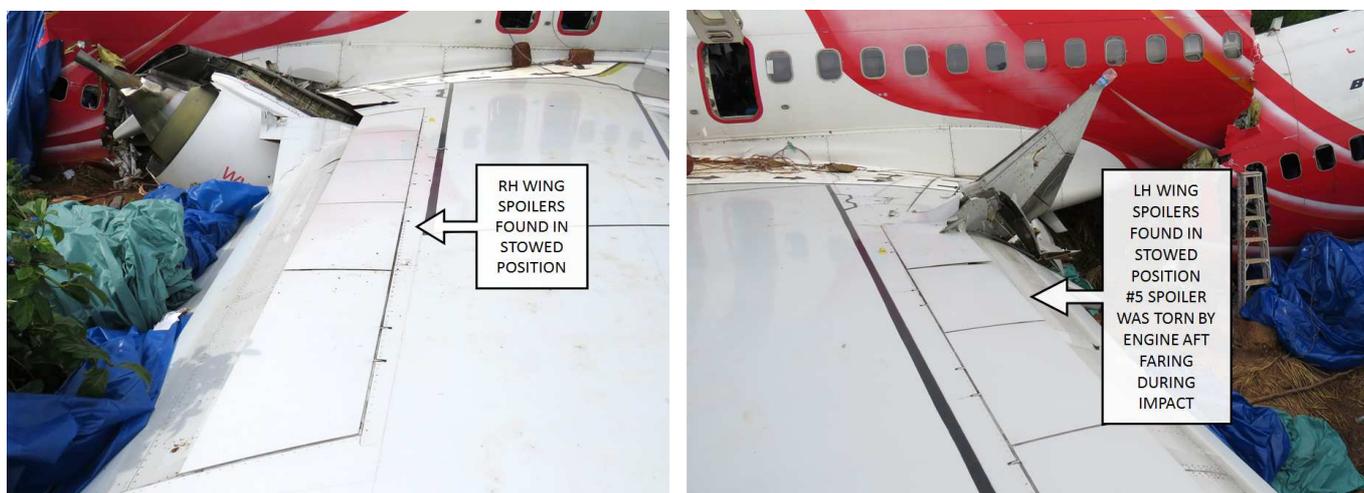
Figure 49: Spoilers

Physically all spoilers were found in the stowed position, corresponding to the recorded position in the DFDR before impact.

Flight spoiler # 5 was hit by the LH Engine Aft fairing which broke apart during Engine separation. The spoilers were stowed and pressurised at this point, as indicated by the damage pattern on the spoiler.

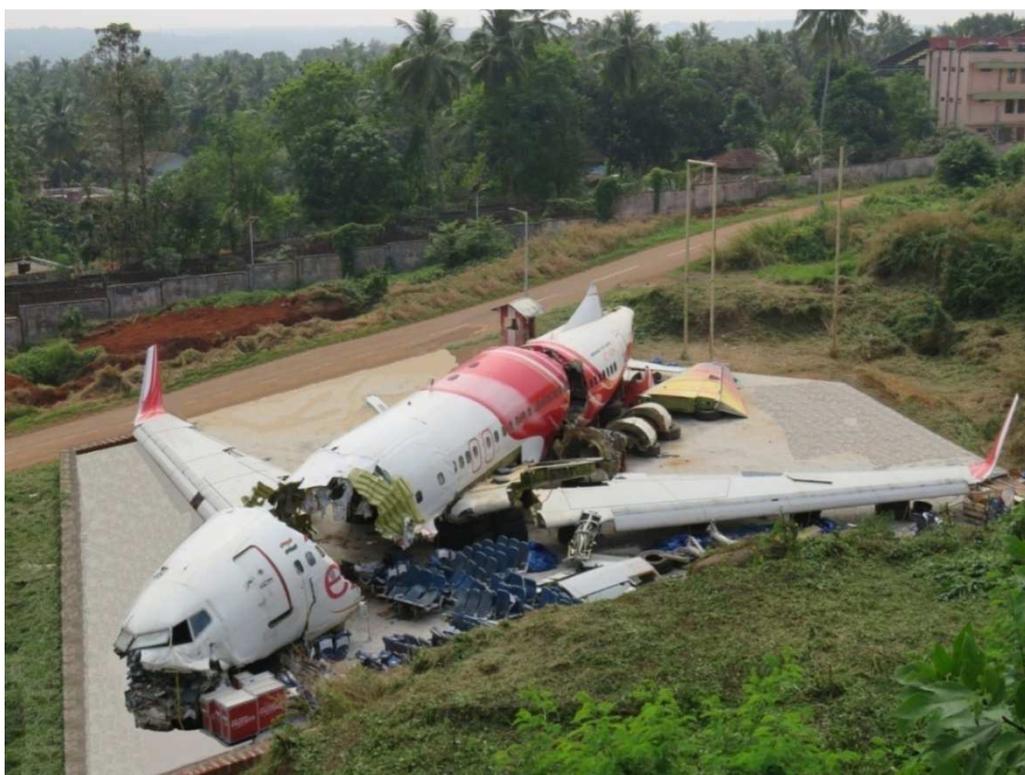
*Figure 50: Rearranged Wreckage*

The wreckage from the crash site was shifted to a secure area within the Kozhikode airport. The wings were cut and stabilizers removed for transporting the wreckage. It was rearranged resembling an actual aircraft for investigation. The re-arranged wreckage is shown in the figure below.

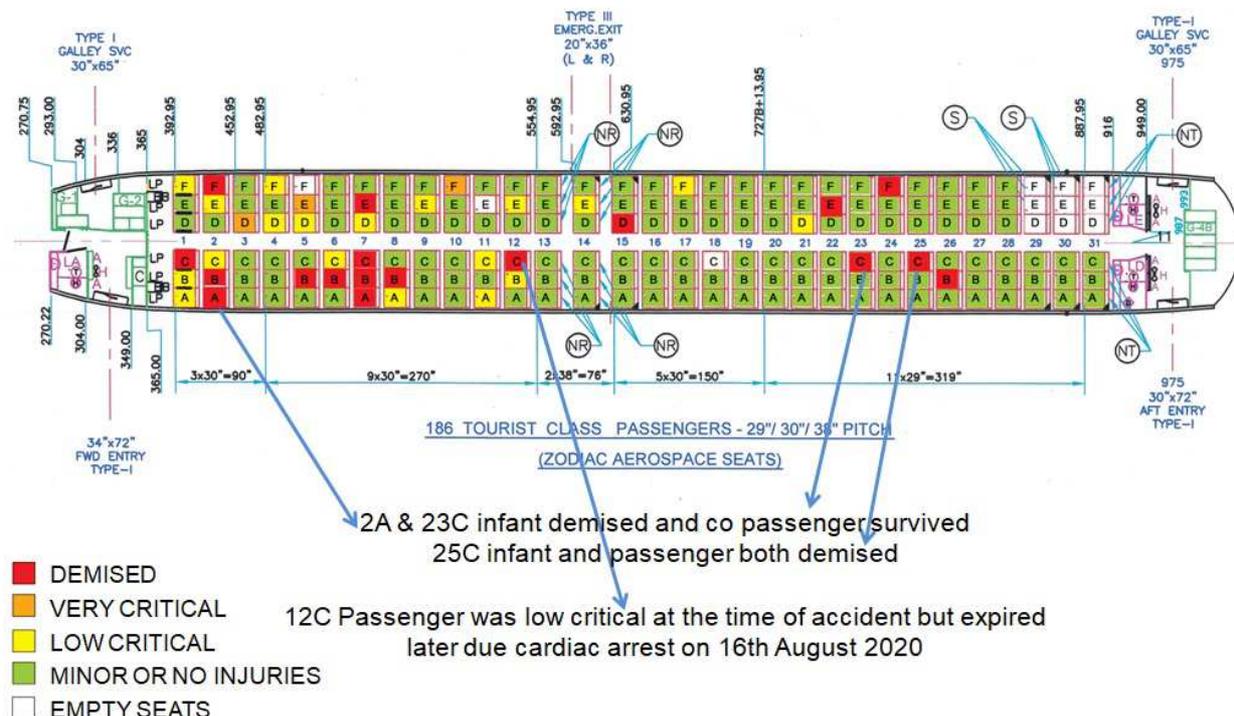
Figure 51: Fatalities and Injuries to passengers depicted on Seat Layout

The injuries (mainly fractures) of the lower limbs occurred due to direct impact and compaction between the passenger seats that moved forward due to frontal impact. Most of the passenger seats were dislodged from the floor mounting. Head injuries were caused most likely due to impact from the loaded overhead baggage stowage bins that separated and fell on the seats with a forward momentum. In addition, some injuries were caused due to the head and face hitting the aircraft structures due to inertial movement of trunk and head due to frontal impact. Also, the aircraft experienced significant damage between seat row numbers 2 to 10, following the impact and separation of the nose portion of the aircraft. Almost all the passengers seated in this area (54 passengers) suffered serious or

fatal musculoskeletal injuries and head injuries except passengers on 3C, INF/3C, 3E 5A, 8F and 9E (six passengers) who sustained minor injuries. Also, the rows 22 to 26 suffered extensive damage due to the fact that the aircraft split up around this location. 05 out of 30 passengers seated in the area suffered fatal injuries and one suffered serious injuries. Remaining 24 passengers suffered minor injuries.

The injury pattern analysis of the deceased passengers reveals that, these 19 passengers were distributed in two clusters, each in the vicinity the aircraft fuselage breaks i.e. from row numbers 2 to 10 and 22 to 26. Figure 51 depicts the injuries to the passengers as per seat layout.

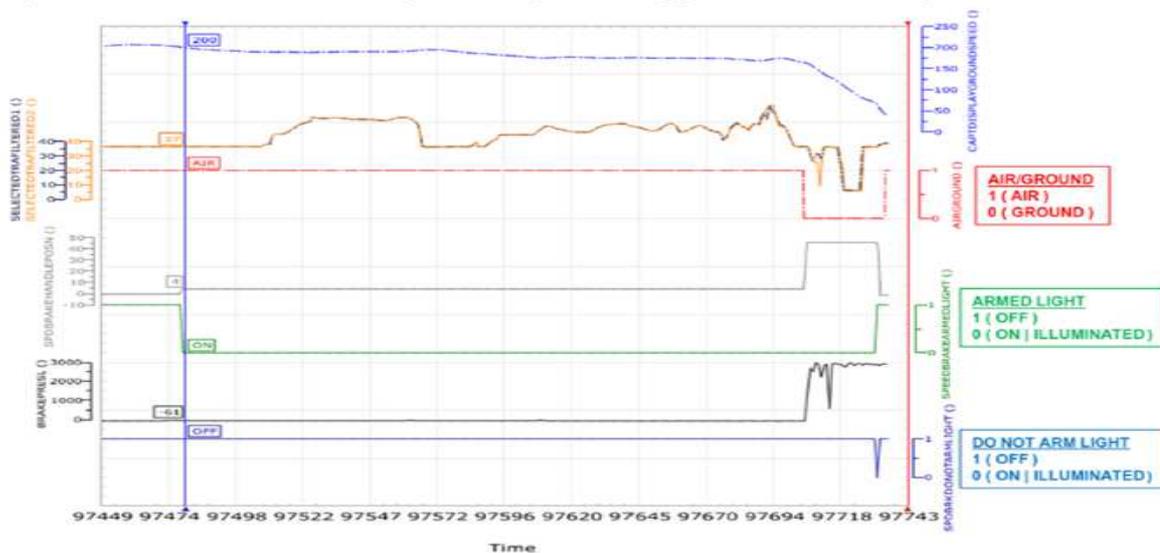
Figure 59: SBDNA and SBA Lights Graph (above 70 Kts)

It can be seen from the Figure 59 that the SBA light was recorded to illuminate when the speed brake lever was set to ARM on approach. The SBA light remained illuminated until after the aircraft landed and decelerated below 70kt ground speed. Based on this observation, it can be inferred that multiple wheels (at least one even number wheel and one odd number wheel) were sensed to rotate greater than 60 knots within four seconds of landing and remained that way during deceleration through 70 knots of the PIC side recorded ground speed.

The behaviour of the SBDNA light as seen in the figure 59 indicates that SBDNA light was recorded on the DFDR to be OFF on the event flight until the aircraft was below 70 knots groundspeed. The recorded state of the SBDNA light indicates that the paired wheel spin determinations (Greater than 60 knots sensed on one or both wheels within the pairings) were in agreement following touchdown and while above 70 knots groundspeed during the landing deceleration.

From the recorded behaviour of the SBDNA and SBA lights, for Ground Speed above 70 knots, it can be concluded that multiple wheels were sensed to be spinning greater than 60 knots and that there was no disagreement between the paired wheel speed determinations for the majority of the landing roll. Due to a four second time delay in the SBA and SBDNA logic after touchdown, no conclusions about wheel speed during the first four seconds after landing can be drawn from the behaviour of the lights.

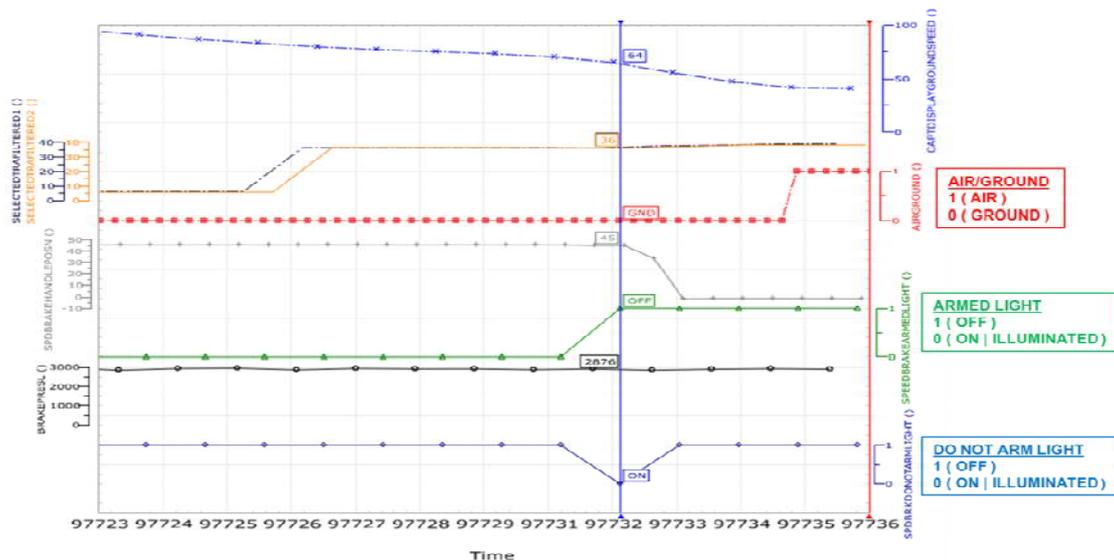
Figure 60: SBDNA and SBA Lights Graph (below 70 Kt)

The SBDNA light was recorded to be illuminated for one FDR data frame with the aircraft position: Latitude 11.13327, Longitude 75.969257. The aircraft recorded ground speed was 66 knots at the time and the recorded position is approximately 105 feet beyond the runway hard surface. Below 70 Kt ground speed The SBDNA light would have illuminated in a scenario where there is disagreement between the sensed wheel speeds (i.e. Wheel speed greater than 60 knots sensed on one wheel of a pair, with both wheels on the opposite pair sensed at less than 60 knots).

This scenario is considered likely reason for SBDNA light behaviour as the aircraft was on a soft surface and ground speed was approaching 60 Kt at the time the SBDNA light was recorded. The speed brake lever was stowed shortly after the SBDNA light was recorded. The SBDNA light was turned OFF after the speed brake lever was stowed consistent with expected system behaviour.

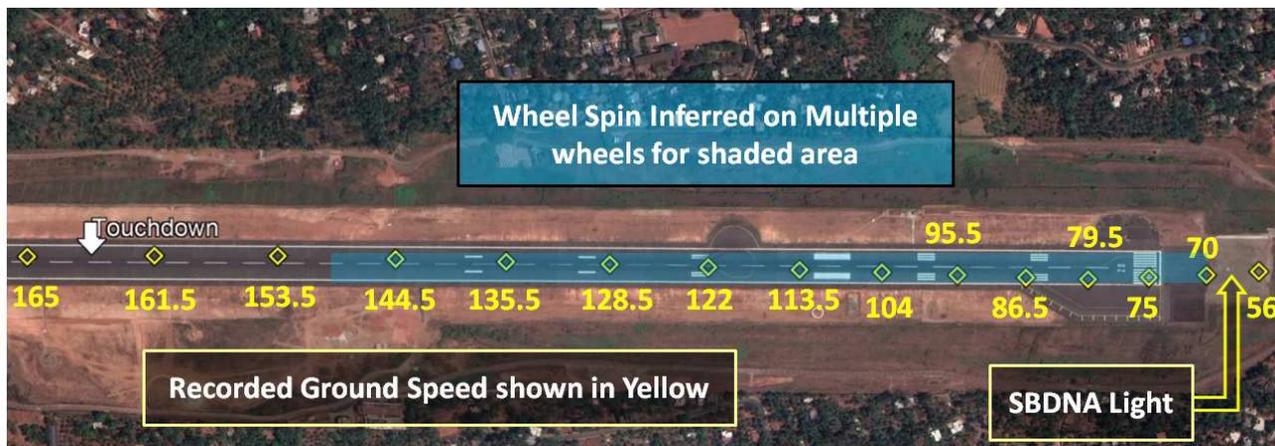
Figure 61: Wheel Spin Analysis

The behaviour of SBA and SBDNA lights during the previous flights was also studied and was observed to be consistent with expected system behaviour. The runway length over which multiple wheels (at least one even number wheel and at least one odd numbered wheel) were inferred to be spinning during the event landing based on behaviour of SBA and SBDNA lights is shown in the figure 61.

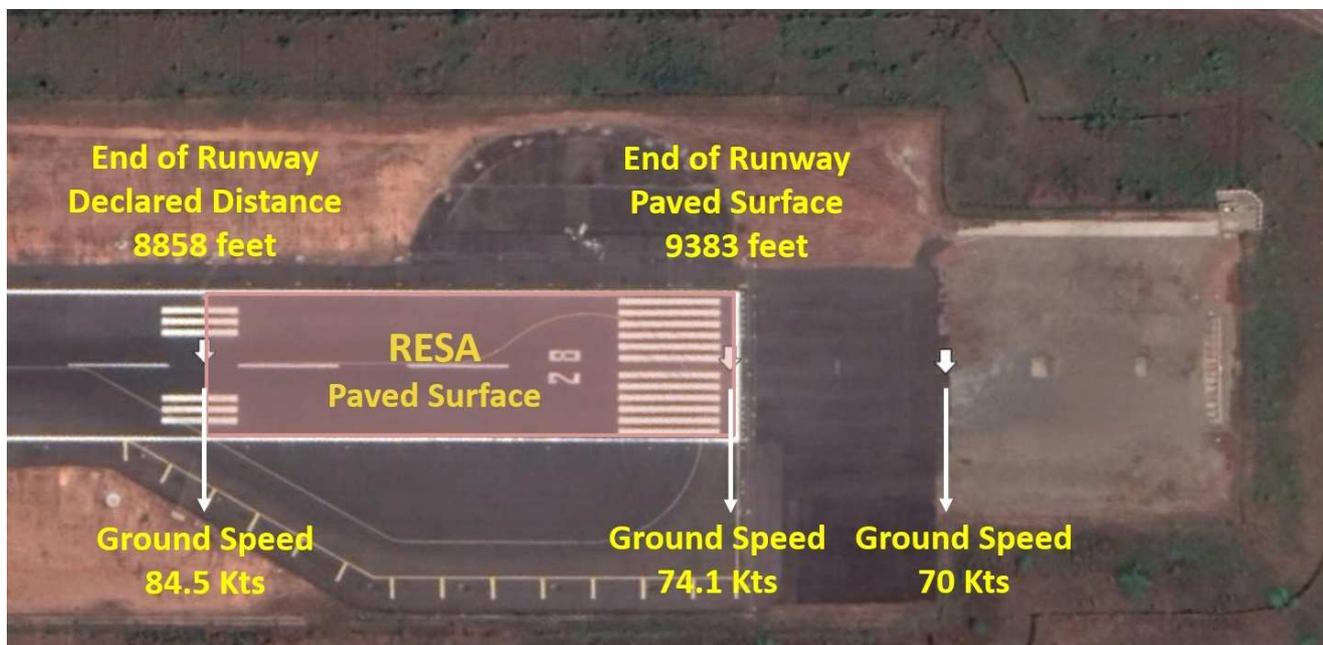
Figure 62: Ground Speed of the Aircraft with reference to RESA

During the visit of Investigation Team it was observed that concrete slabs on which the frangible light fittings and ILS localizer antenna are installed, are protruding above the ground which would adversely affect the aircraft deceleration. In addition, wild vegetation was also seen growing on the soft ground portion of RESA. The poor maintenance of Soft Ground portion of RESA will adversely affect the desired deceleration of the aircraft.

The Soft Ground portion of RESA provided an average longitudinal deceleration of -0.40 G with peaks of up to -0.64 G as calculated from the DFDR data. However, it was not enough to stop the aircraft as the aircraft crossed the declared end of runway 10 at a ground speed of 84.5 kt and entered the soft ground portion of RESA at a ground speed of 70 Kt. (Figure 62)
