# Investigation Report

Type of Occurrence: Accident

Location: Gransee

Type: C 208 Caravan

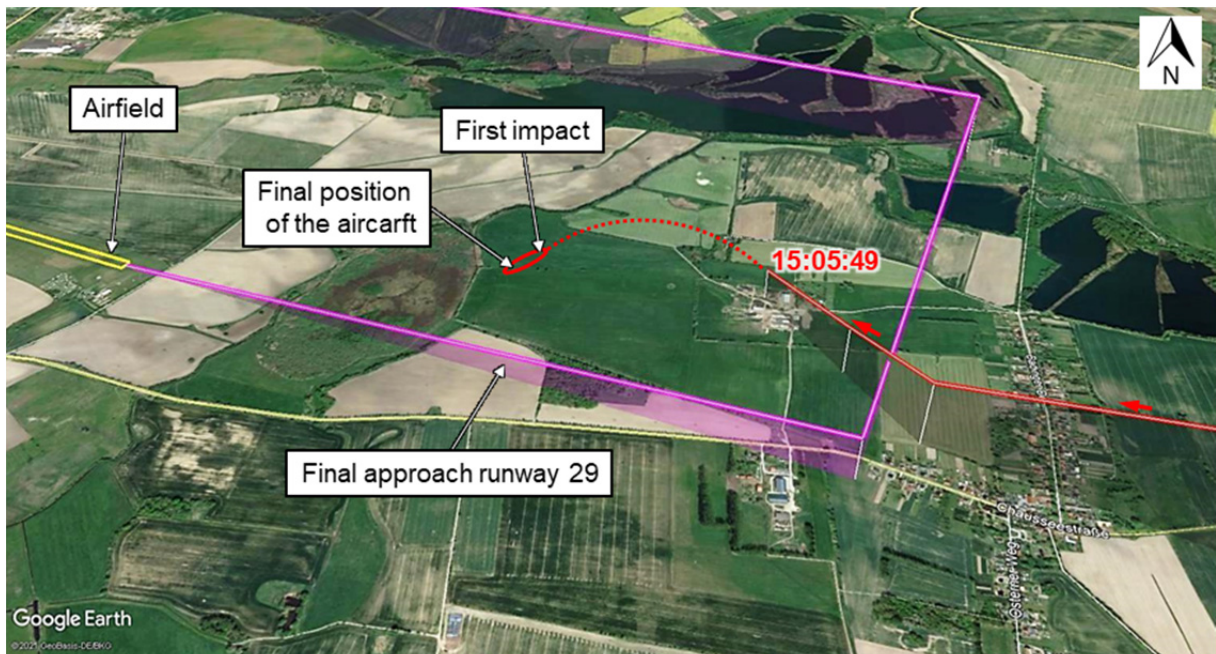
Fig. 6: Location of the accident site

The accident site was located 1,250 m east of the threshold of runway 29 of Gransee Special Airfield and about 530 m north or to the right of the extended centre line, respectively, at approximately 50 m NHN on an area with low vegetation (Fig. 6).
