Bundesstelle für Flugunfalluntersuchung

Investigation Report

Type of Occurrence:	Accident
Date:	24 April 2019
Location:	Siegerland Airport
Aircraft:	Airplane
Manufacturer:	Cessna Aircraft Company
Туре:	551 Citation II/SP
Injuries to Persons:	No injuries
Damage:	Aircraft substantially damaged
Other Damage:	Asphalt of the runway damaged

BFU19-0411-3X

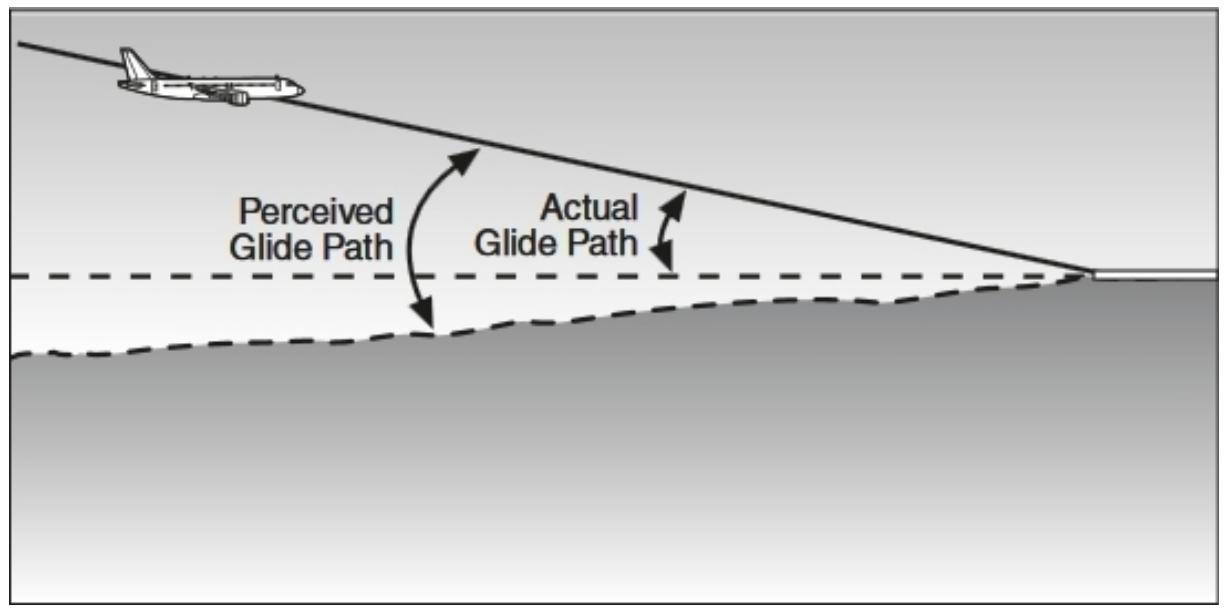
Fig. 11: Visual perception of the approach angle with rising terrain ahead of the runway Source: Flight Safety Foundation / ALAR Briefing Note 5.3 - Visual Illusions

Rising terrain ahead of the runway can suggest that the aircraft is too high during the approach and/or that the approach angle is too steep (Fig. 11). A possible reaction of the pilot could be to increase sink rate. The result would be an approach angle which is too low; below the approach angle of the approach chart.¹⁶
