COMANDO DA AERONÁUTICA
CENTRO DE INVESTIGAÇÃO E PREVENÇÃO DE
ACIDENTES AERONÁUTICOS

FINAL REPORT
A - 153/CENIPA/2019

OCCURRENCE:	ACCIDENT
AIRCRAFT:	PP-BSS
MODEL:	C90GT
DATE:	02DEC2019

This is the Final Report of the 02DEC2019 accident with the C90GT aircraft model, registration PP-BSS. The accident was classified as “[CFIT] Controlled Flight Into Terrain”.

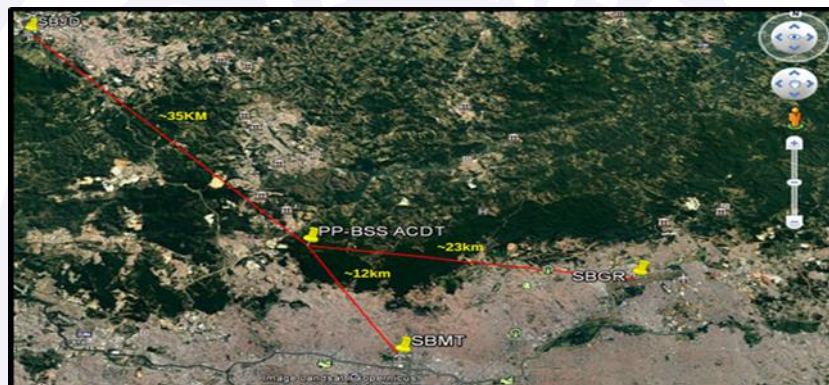
Figure 1 - Image showing the position of the Aerodromes closest to the accident site.
Source: Adapted from Google Earth.

It was found that conditions were not favorable for visual flight, with visibility restrictions and clouds based close to 1,000 ft in height.

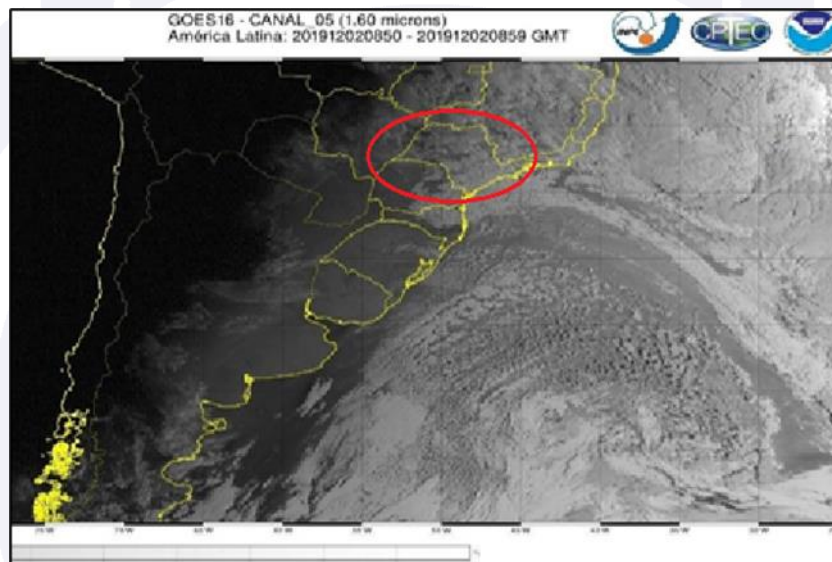
Figure 2 - Image of the GOES 16 satellite at 08:59 (UTC) on 02DEC2019.

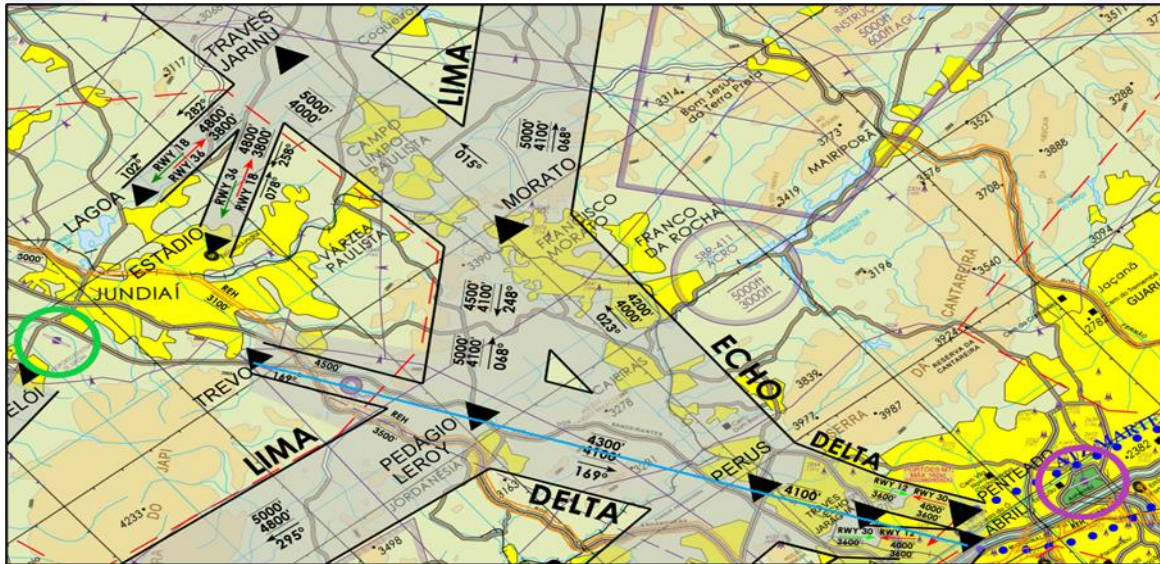
Figure 14 - Special Aircraft Routes at the TMA-SP 2. Highlights for SBJD (green circle), the route via REA DELTA (blue line) and SBMT (purple circle).

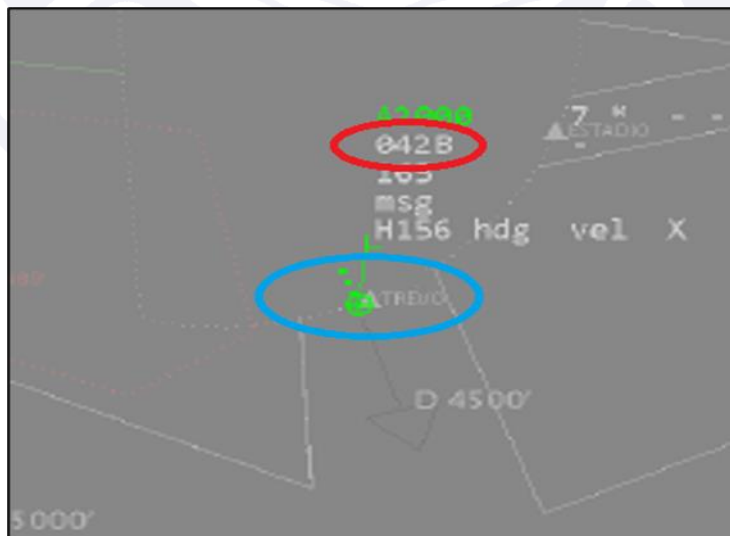
Figure 16 - Synthesis of the ATC RADAR at 08:54:33 (UTC). In the red and blue highlights, the altitude in hundreds of feet and the plot of the aircraft over the TREVO position, respectively.

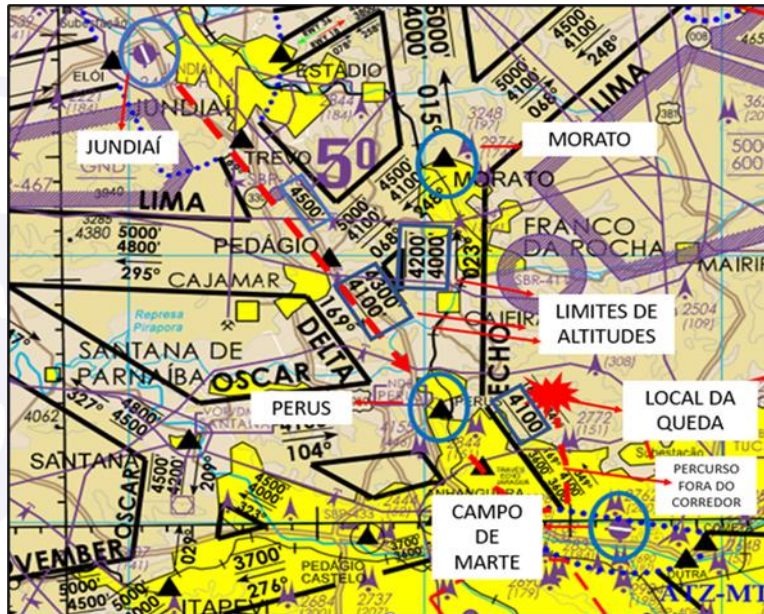
Figure 19 - Cutout of the Visual Corridors Chart - Special Aircraft Routes in the TMA-SP 2 showing the REA DELTA visual corridor and the route taken by the plane.
