Controlled flight into terrain involving Cessna 404, VH-OZO

6 km south-east of Lockhart River Airport, Queensland, on 11 March 2020

ATSB Transport Safety Report

AO-2020-017

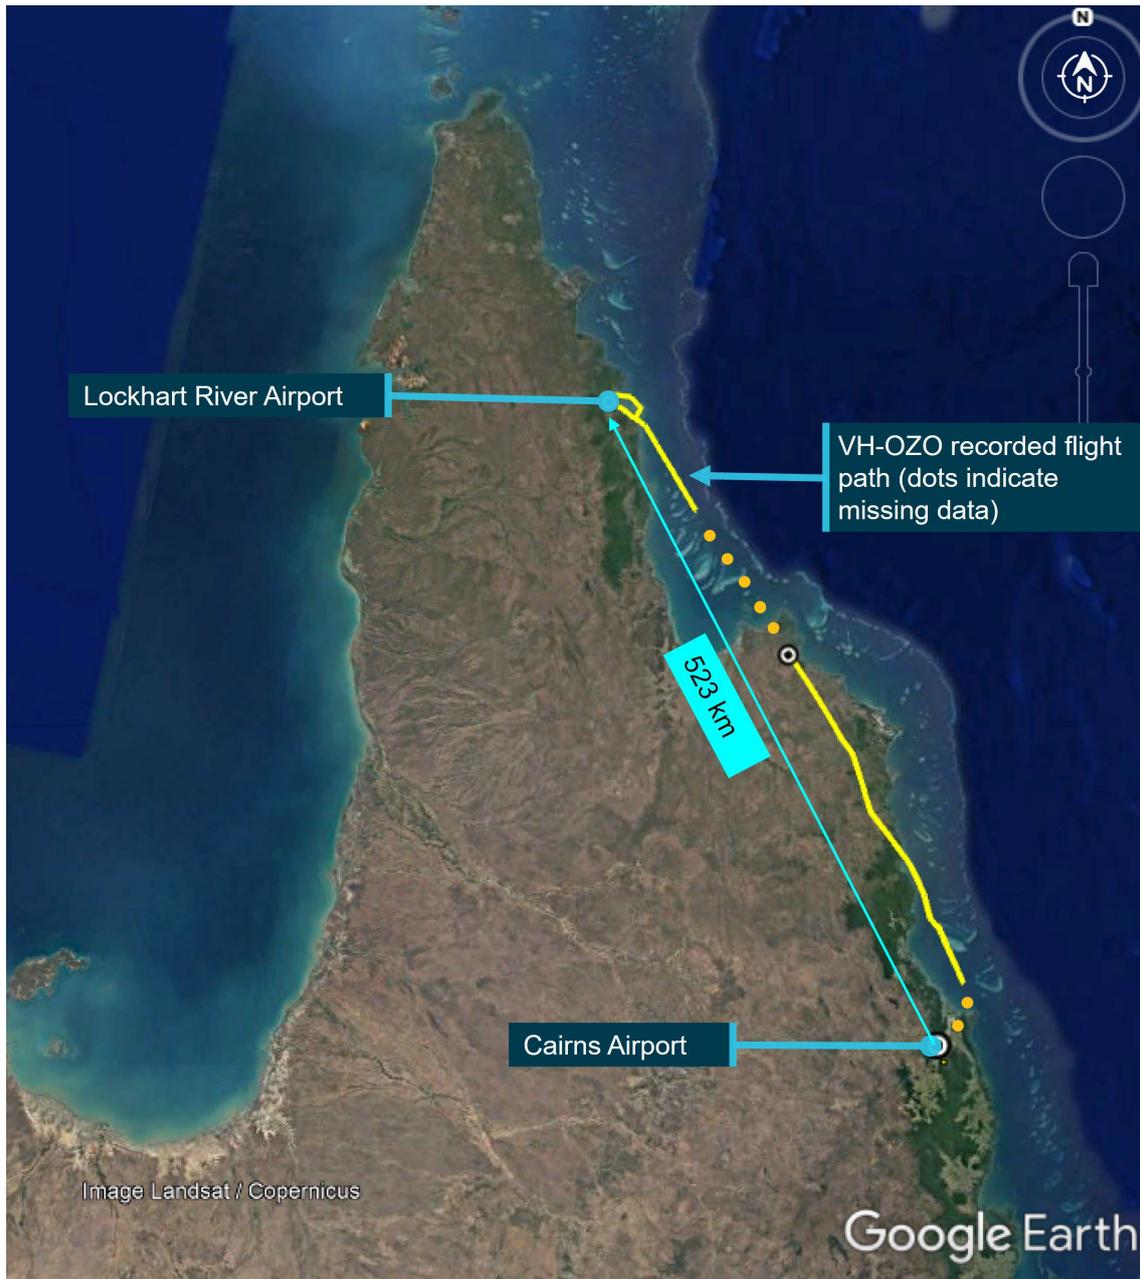
Figure 1: VH-OZO recorded flight path from Cairns to Lockhart River, Queensland

The aircraft departed Cairns at 0719 and tracked for the first planned waypoint on climb to its cruise level of 10,000 ft above mean sea level. Based on the forecast winds, the estimated time of arrival at Lockhart River was 0852. As the flight progressed, the pilot amended the estimated time of arrival to 0904. The aircraft's track during the flight is shown in Figure 1.

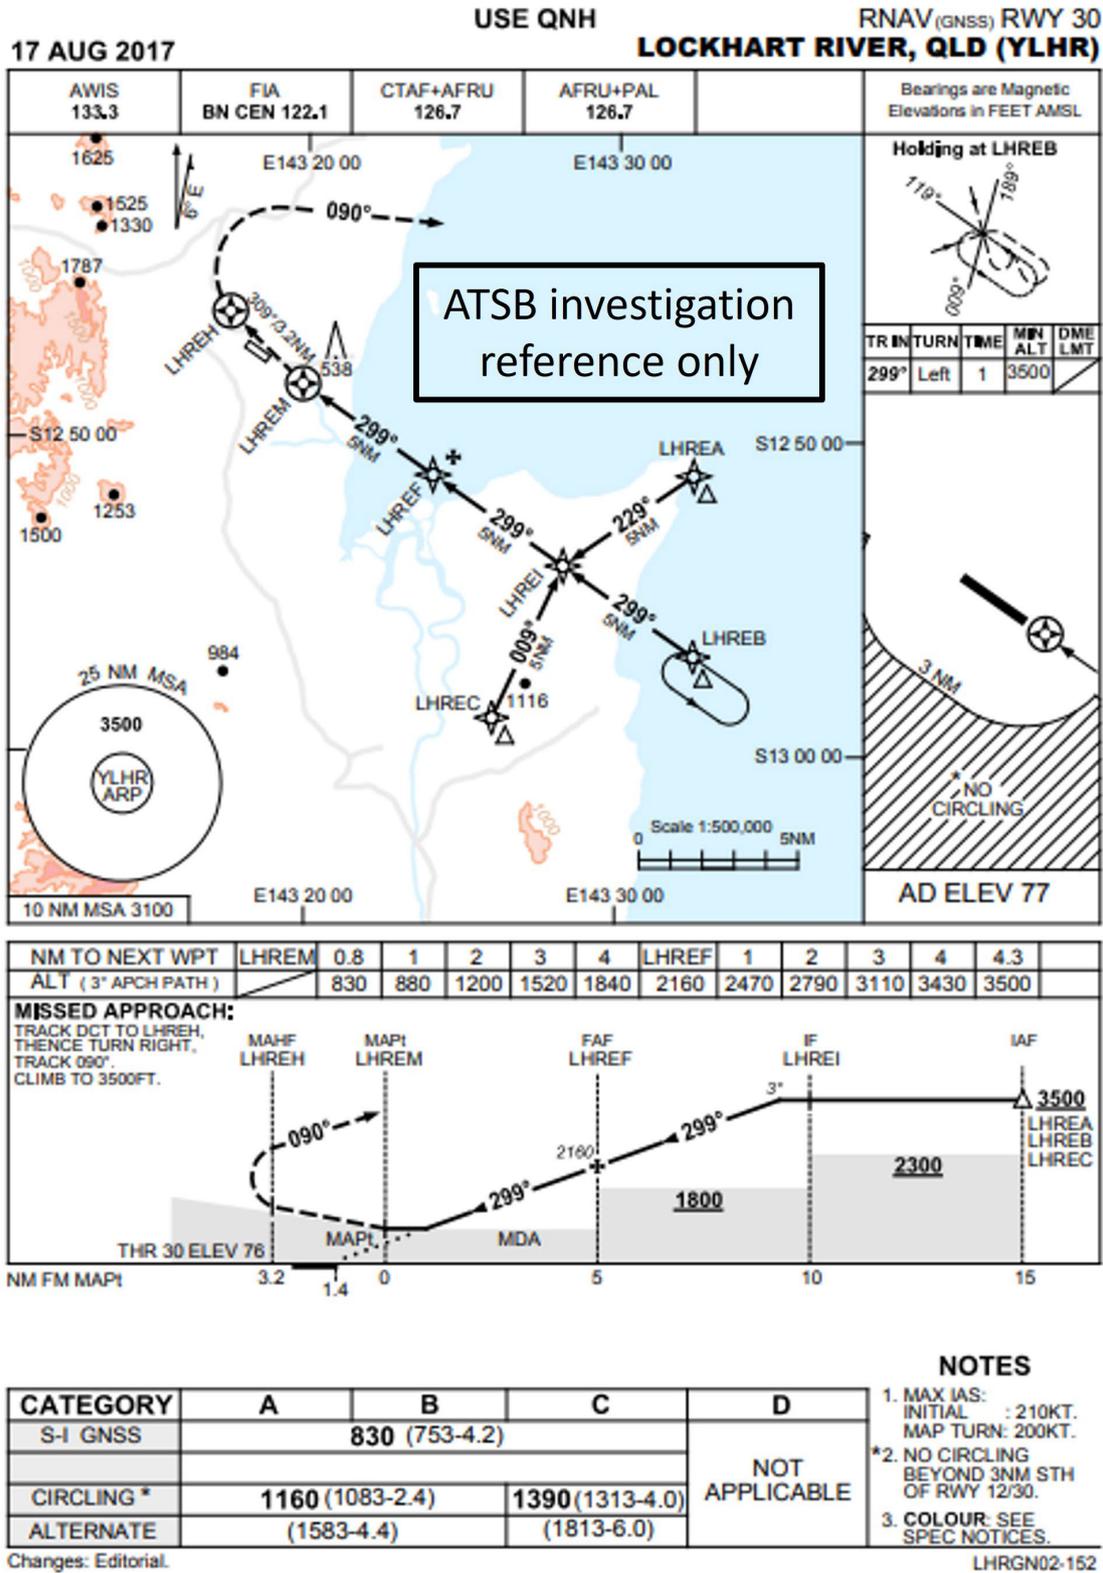
Figure 2: Lockhart River RNAV GNSS runway 30 approach chart

At about 0857, the aircraft levelled off at 5,500 ft. At this time the aircraft was heading to waypoint LHREB, one of 3 initial approach fixes (IAFs) for the RNAV GNSS instrument approach to runway 30 (Figure 2). The weather information indicated that the conditions were better than the landing minima (which were a cloud ceiling of 730 ft and visibility 4,200 m).⁵

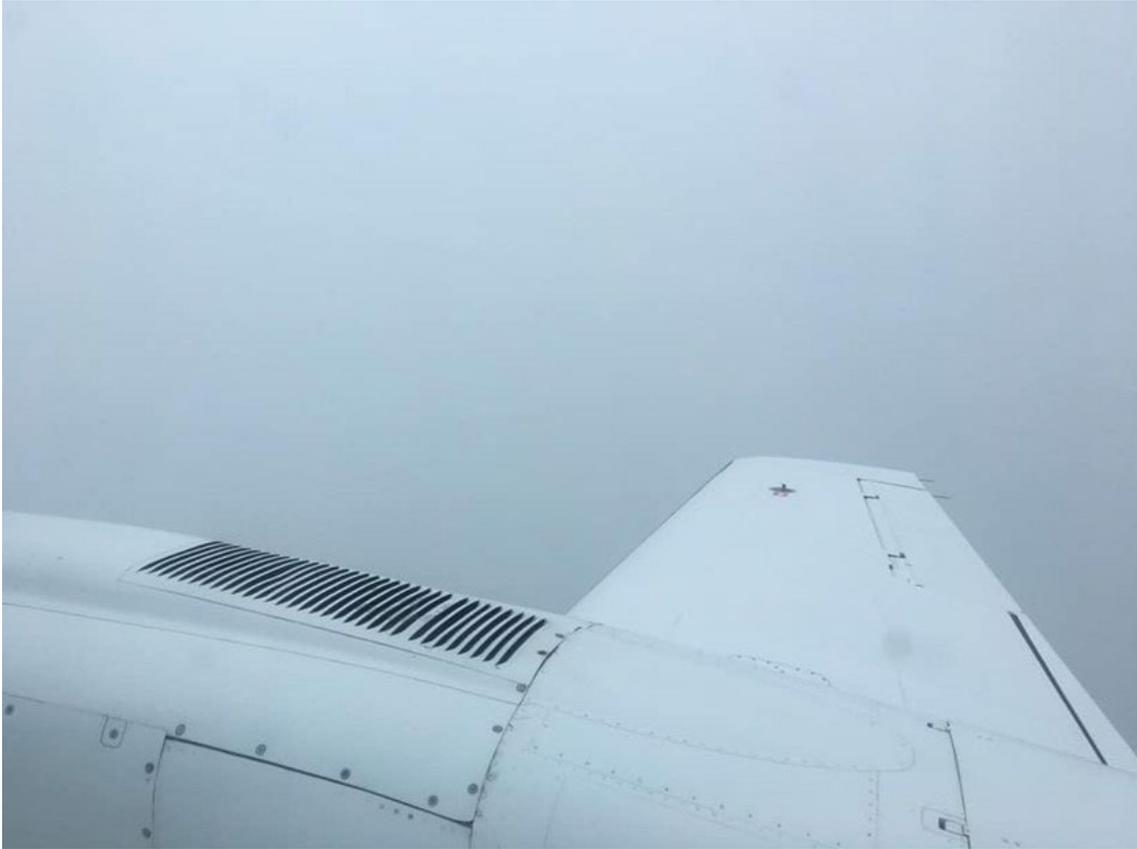
Figure 6: Image recorded by a passenger looking over the right wing and uploaded to social media at 0914

At about 0914:43, when about 2.7 NM from LHREI, the aircraft started descending from 3,500 ft. At this time, the aircraft was tracking towards the initial approach track between LHREA and LHREI (Figure 5).

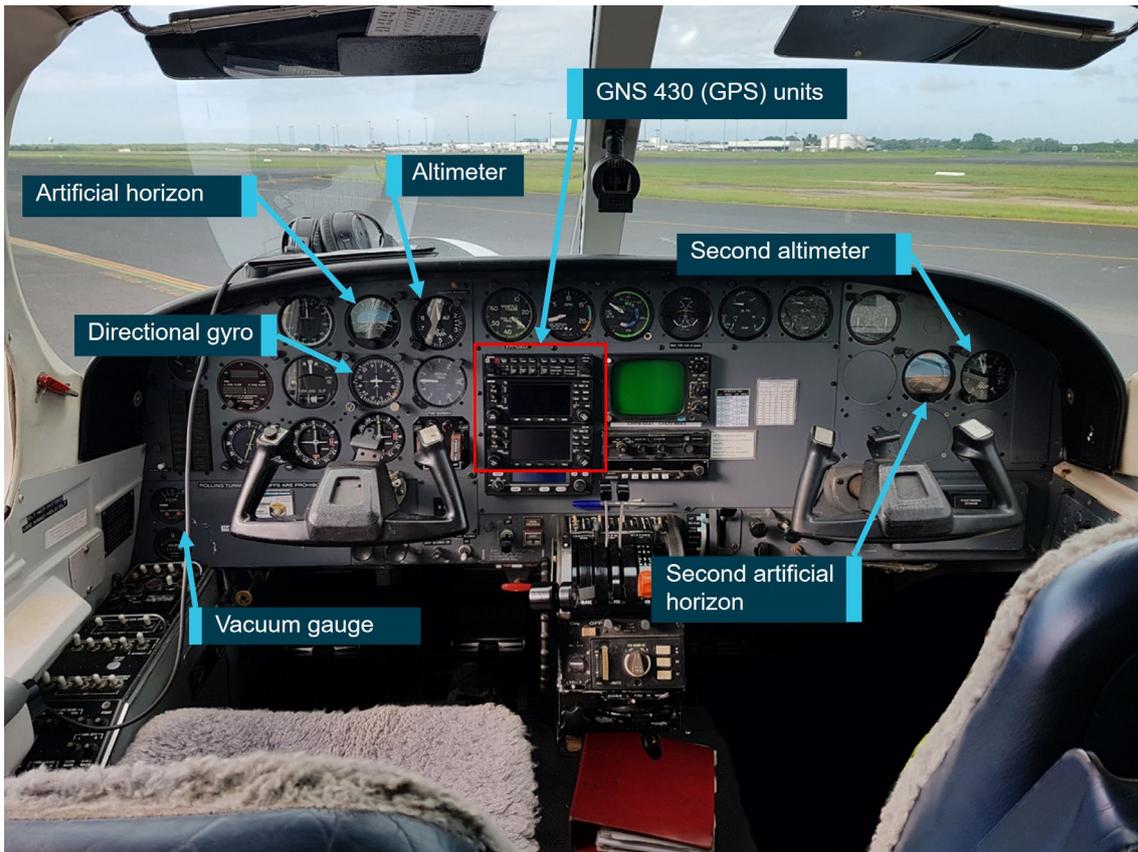
Figure 7: VH-OZO instrument panel

The aircraft was fitted with the instrumentation required for operations under the IFR. These flight instruments were conventional analogue indicators and reflected the original specifications for the aircraft. The second artificial horizon/attitude indicator and altimeter were located on the right side of the co-pilot panel (far side of the instrument panel relative to the pilot) (Figure 7).

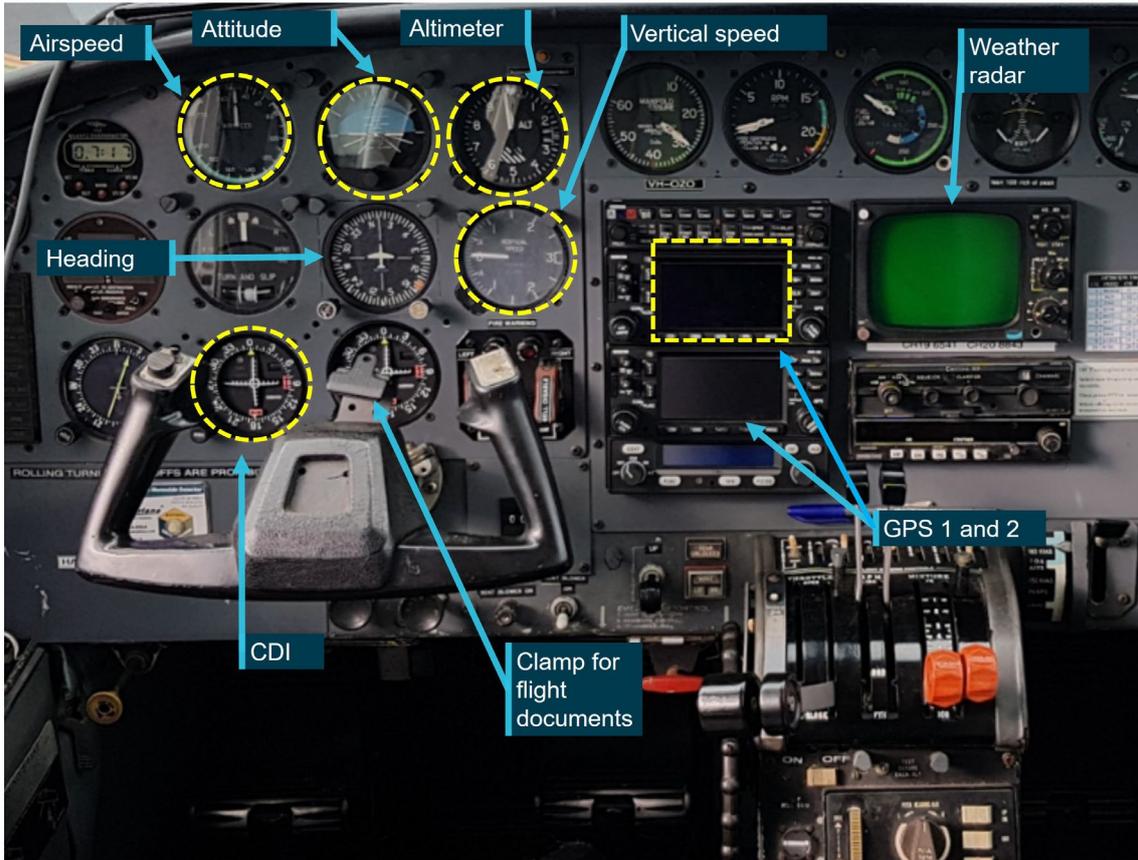
Figure 8: Instrument panel of VH-OZO

A closer view of the instrument panel is depicted in Figure 8. It had the standard 6 flight instruments directly in front of the pilot's seat on the left. These include the attitude indicator, which depicts the aircraft's basic roll and pitch attitude, and the primary performance instruments – altimeter, airspeed indicator and vertical speed indicator (VSI). Below those were 2 (GI-106A CDI) instruments¹⁷ that provided course deviation indication provided either by the GNS 430's digitally-tuned VOR/localiser and glideslope receiver or GPS input to conduct an RNAV GNSS approach. One CDI instrument was coupled to the aircraft's number-1 GNS 430W GPS unit and the other to the number-2 GPS unit.

¹⁷ Second CDI is partially hidden behind control column and clamp in Figure 8.

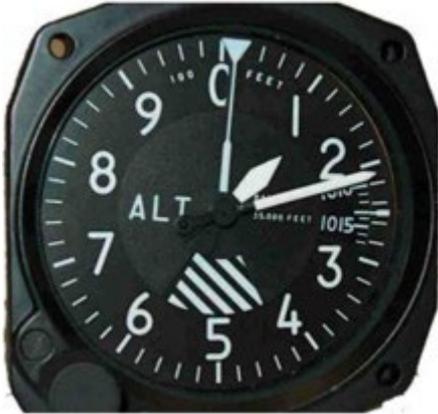
Figure 9: Example of the 3-pointer type of altimeter fitted in VH-OZO

VH-OZO was equipped with two 3-pointer altimeters (Figure 9), including one directly in front of the pilot. They had a 100-ft pointer (long and narrow), 1,000-ft pointer (short and wide) and 10,000-ft pointer (long and thin with a triangle at the end). The diagonal hashing indicated when below 10,000 ft and was gradually covered above that height.

This altimeter shows an altitude of 1,210 ft (10,000 ft pointer indicating 0, 1,000 ft pointer indication 1,000 ft and 100 ft pointer indicating 210 ft.

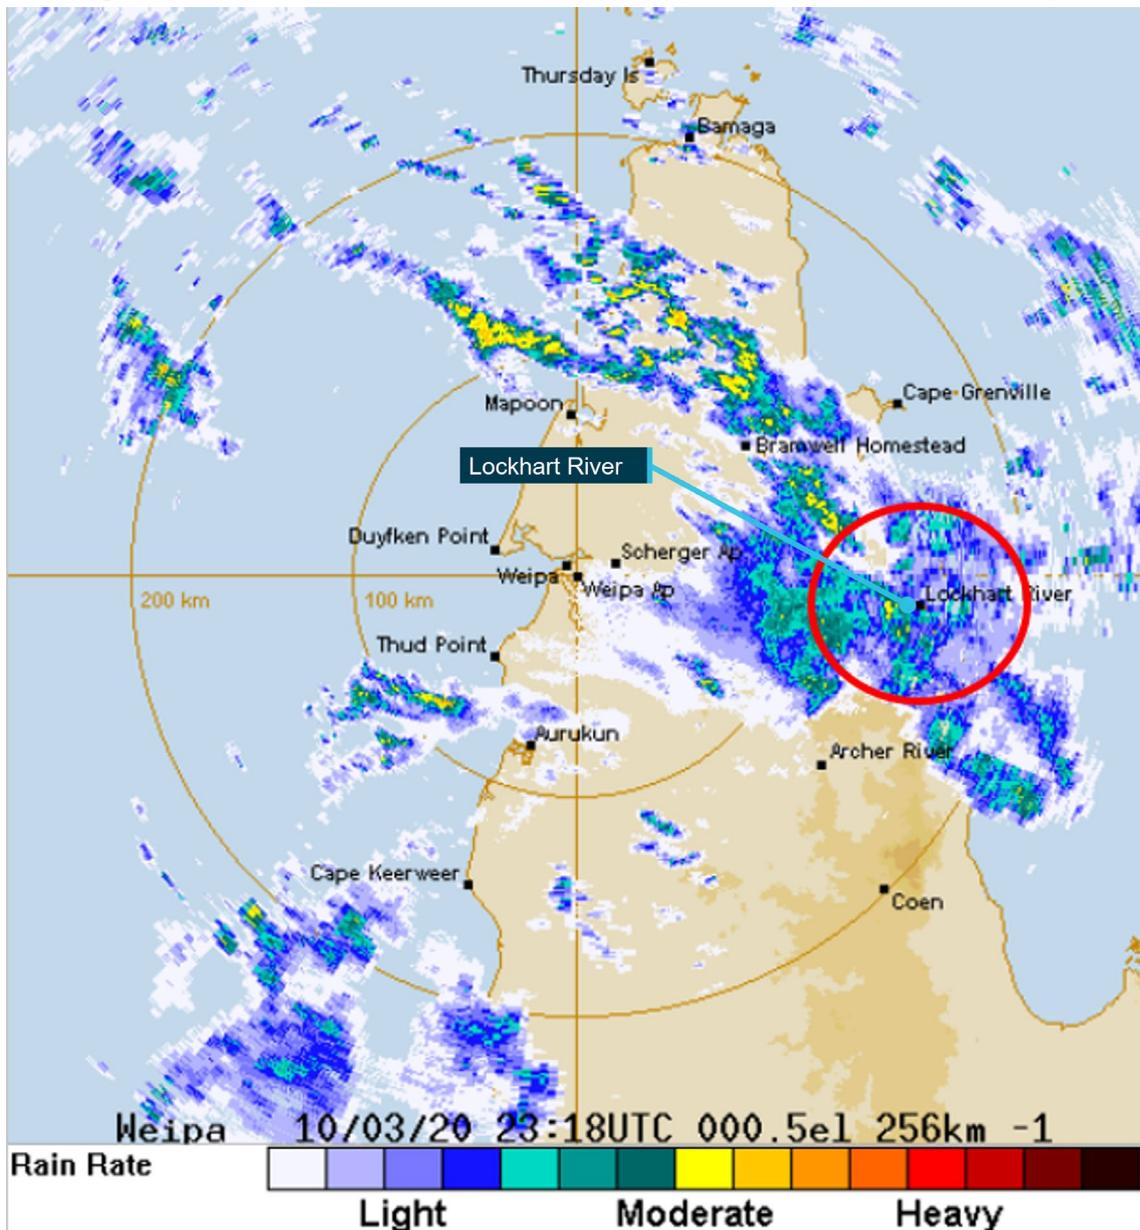
Figure 11: Weipa radar image at 0918 EST (about 2 minutes prior to the accident) showing weather in Lockhart River area (circled, approximate radius 25 NM/46 km)

Figure 11 provides an indication of the weather around Lockhart River at 0918 on the morning of the accident (during the second approach), with Figure 12 displaying an extract of radar images from the time of the first approach and the time of the accident. The weather radar depicted areas of moderate precipitation in the vicinity of Lockhart River. In addition, an analysis of a sequential series of images showed precipitation moving through the area at a speed of about 30 kt (55 km/h) from the north-west.

The minute-by-minute data from the AWS around the time of the accident (see *Automatic weather station* and Table 3) recorded no significant surface wind. However, there was a short period of rainfall between 0910 and 0916, including moderate to heavy rainfall between 0912 and 0914. If this rainfall persisted and continued moving in a direction/speed consistent with the observed radar returns, it would have been in the vicinity of the accident site about the time of the accident.

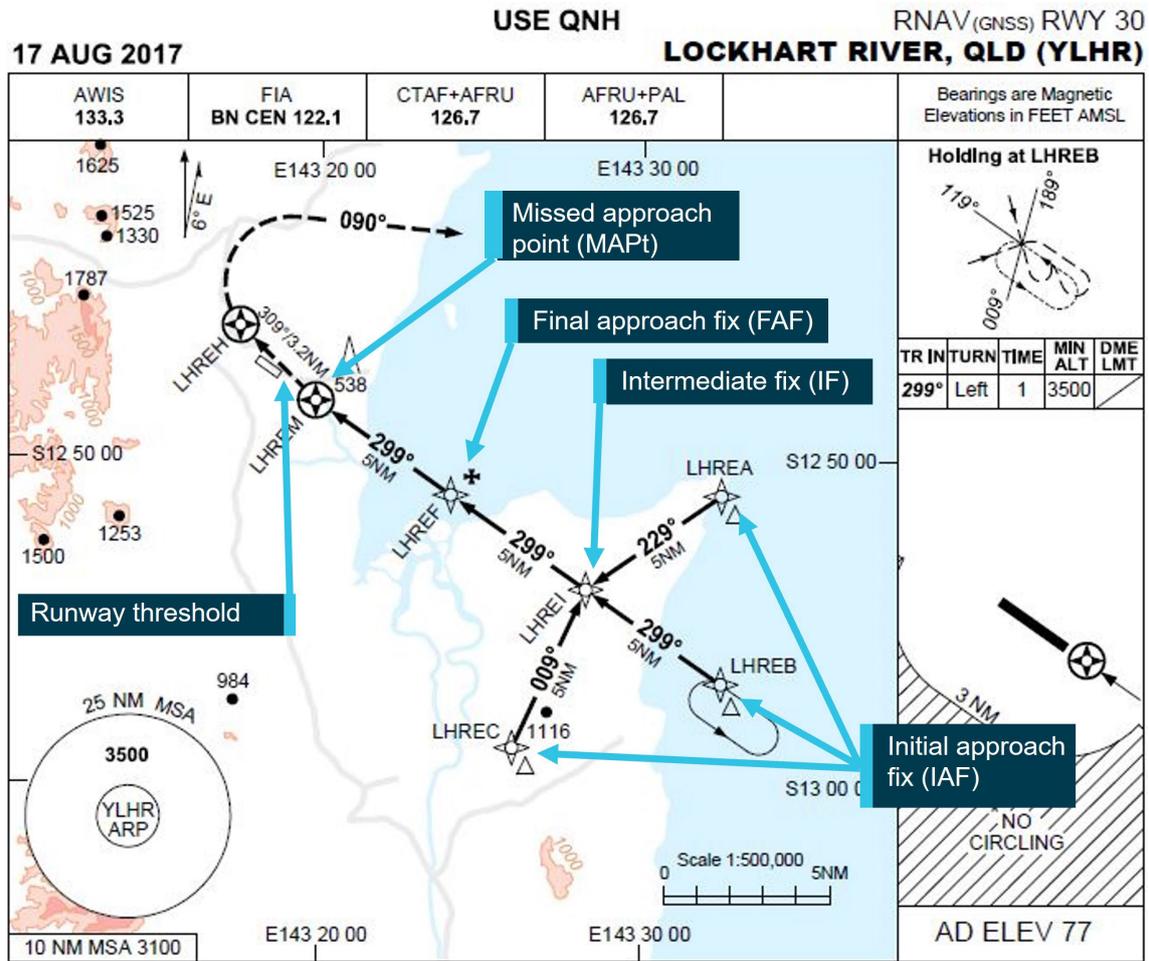
Figure 13: Extract from Lockhart River RNAV GNSS runway 30 approach chart showing layout of waypoints

RNAV GNSS approaches in Australia have a Y-pattern, runway-aligned design. The Lockhart River runway 30 RNAV GNSS approach uses this typical layout, as shown in Figure 13.

The approaches have 3 initial approach fixes (IAFs, in this case, LHREA, LHREB and LHREC), followed by an intermediate fix (IF, LHREI), final approach fix (FAF, LHREF) and missed approach point (MAPt, LHREM).

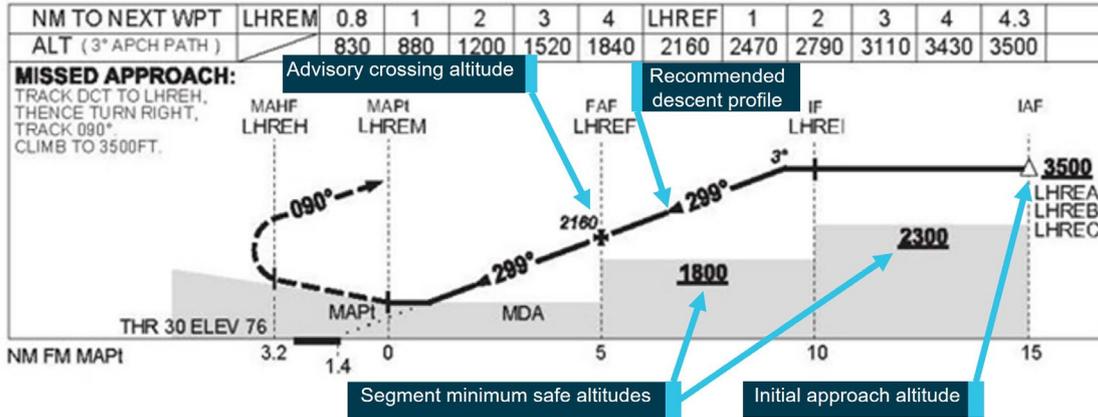
Figure 14: Excerpt from Lockhart River RNAV (GNSS) runway 30 approach chart showing recommended vertical profile and segment minima safe altitudes

For example, the approach chart for the Lockhart River runway 30 approach (Figure 14) had an initial approach altitude of 3,500 ft leading to an approach path angle of 3°, which commenced 0.8 NM after the IF (4.2 NM prior to the FAF and 9.2 NM prior to the MAPt).

If the recommended descent profile starts prior to the FAF, the RNAV GNSS approach chart includes an advisory crossing altitude (or procedure height) at the FAF (and if required the IF) to assist pilots with maintaining the recommended descent profile (for example, 2,160 ft at the FAF in Figure 14). In addition, a pilot is provided with a distance/altitude scale on the approach chart that provides guidance for the recommended descent profile (see top of Figure 14). The distance specified is the distance to the next waypoint.

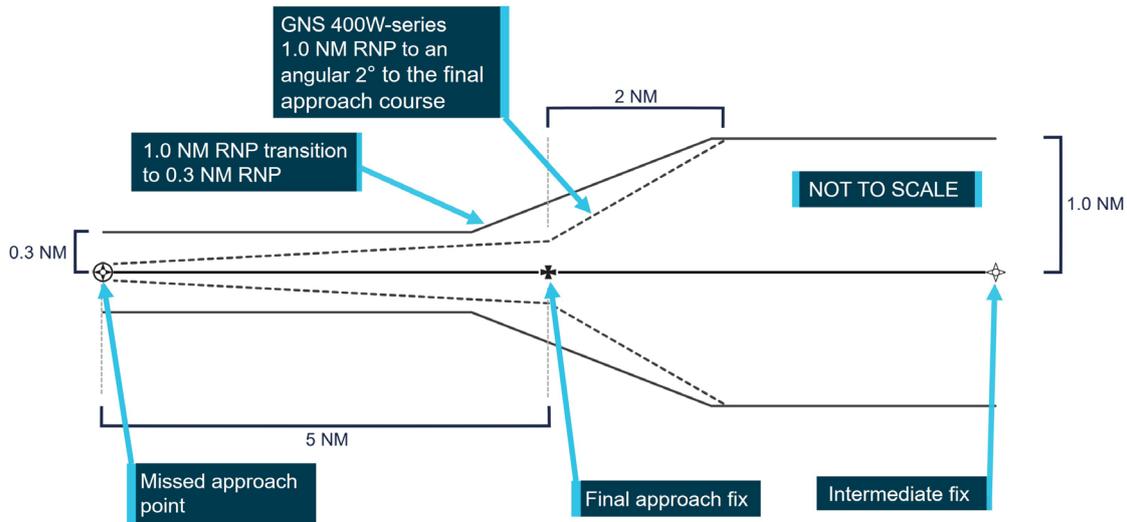
Figure 16: Conventional transition from RNP 1.0 to RNP 0.3 NM during final approach segment (represented by full-scale CDI deflection) compared to the full-scale CDI deflection provided by the GNS 400W-series GPS

intermediate segment, then transitioning from about 2 NM (3,704 m) prior to the FAF to a 0.3 NM displacement being full-scale deflection about 1 NM after reaching the FAF (Figure 16).

The GNS 400W-series manual indicated that the CDI full-scale deflection varied during the final approach segment.⁴⁸ When conducting an RNAV GNSS approach using a GNS 400W-series unit, the full-scale deflection was 350 ft (0.06 NM or 107 m) at the MAPt, diverging back to the FAF at an angle of either 2° to the final approach track, or an angle such to achieve 0.3 NM full-scale deflection at the FAF, whichever was less (Figure 16).⁴⁹ For 5 NM final approach segments, the angular 2° would always be less than the lateral 0.3 NM CDI full-scale deflection at the FAF.

For the 5 NM final approach segment for the runway 30 approach at Lockhart River, an angular 2° to the final approach track displaced 350 ft (107 m) at the MAPt equated to 0.23 NM (430 m) at the FAF. The transition from 1.0 NM full-scale deflection during the intermediate segment to the 2° automatic rescaling full-scale deflection for the final approach segment commenced 2 NM prior to reaching the FAF and was completed by the FAF. In other words, during the final approach segment, GNS 400W series units presented CDI full-scale deflection that was less than the lateral tracking limit specified in CAO 20.91 for the final approach segment. This difference was relatively minor at the FAF (0.3 NM versus 0.23 NM) but increased significantly as the aircraft got closer to the MAPt.

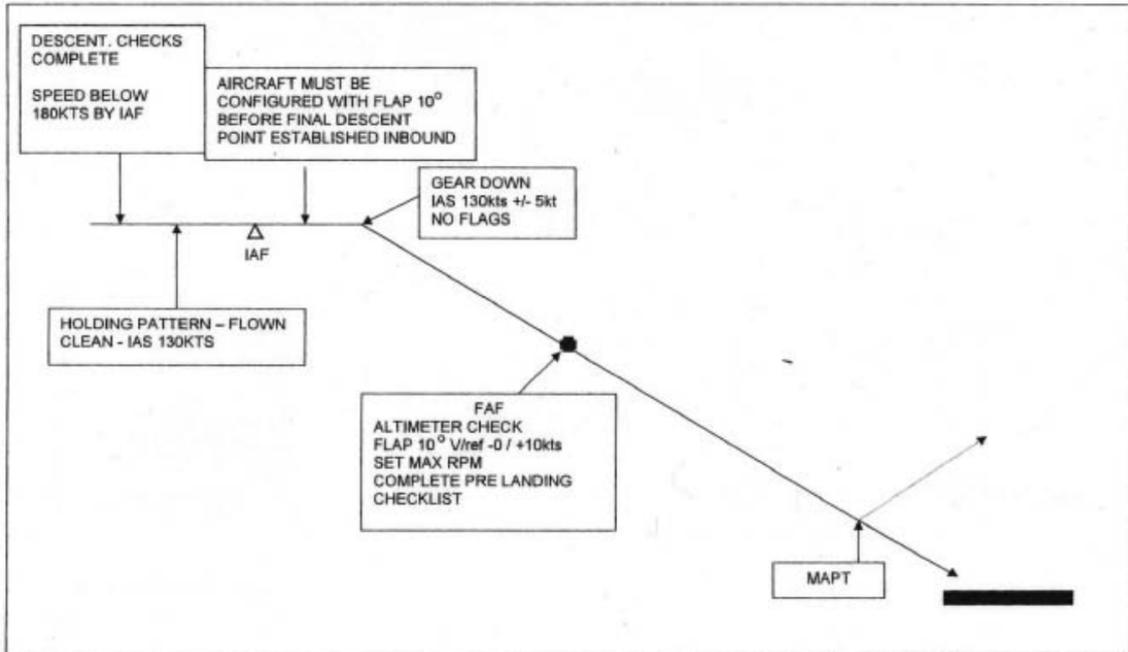
Figure 19: Flight profile for Cessna 404 RNAV GNSS approach

The operator's operations manual included flight profiles to be used for various situations for the Cessna 404, and stated that the profiles were required to be used for all operations. The prescribed flight profile for an RNAV GNSS approach (and other straight-in instrument approaches) is shown in Figure 19.

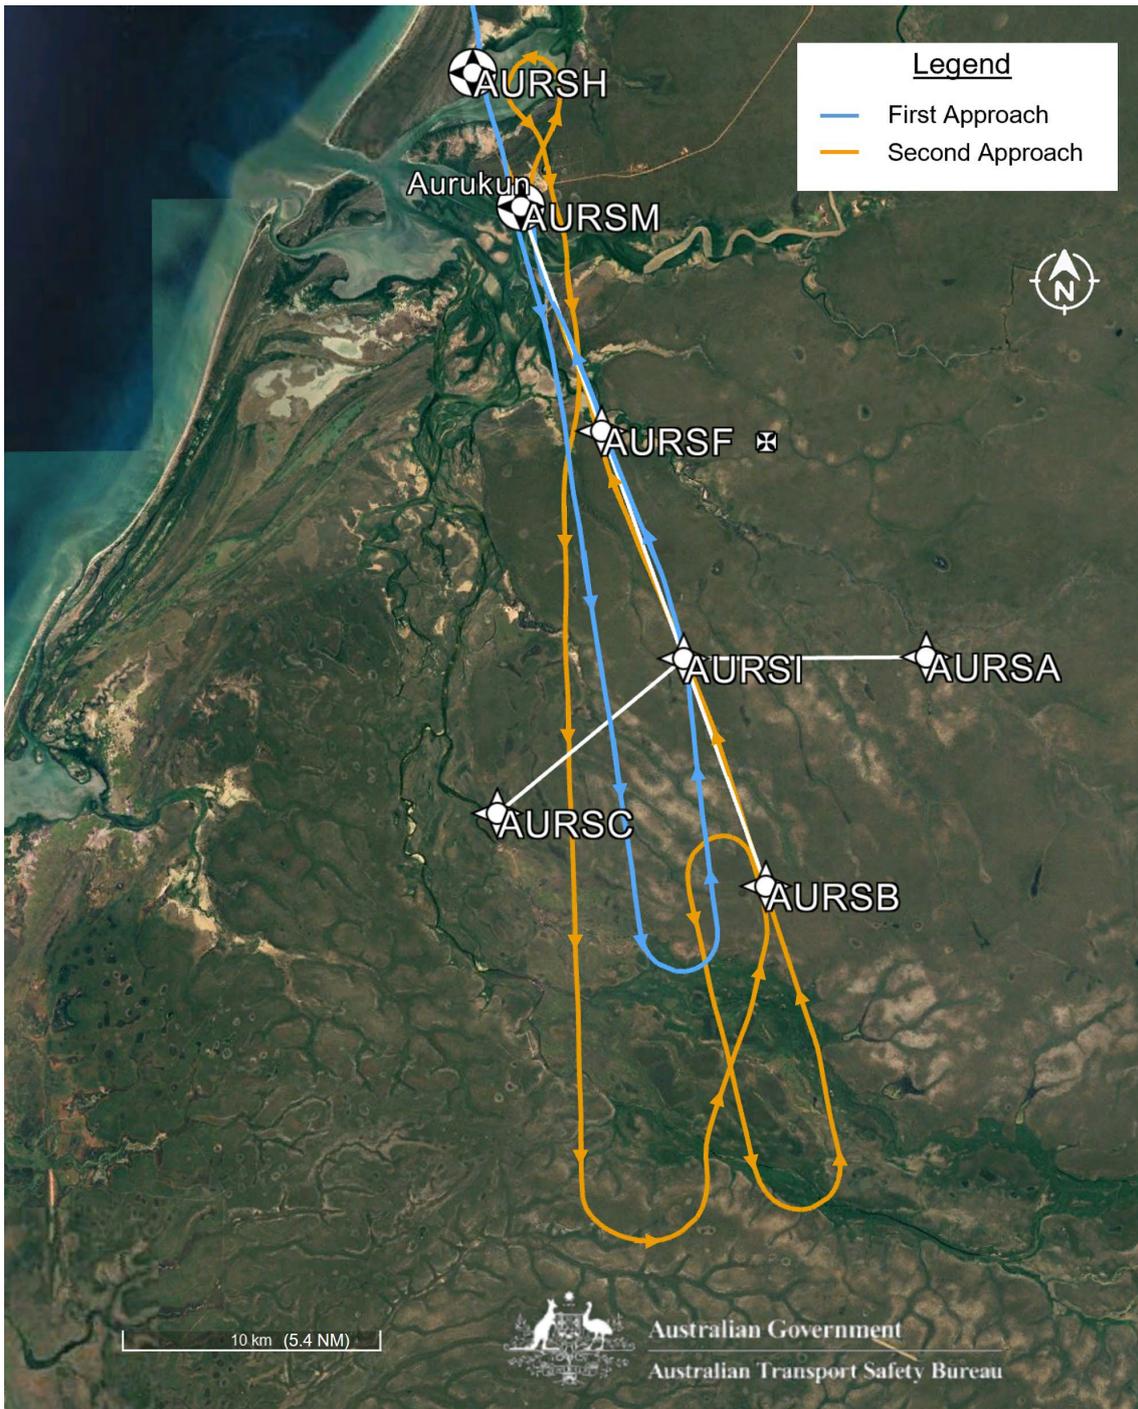
Figure 24: VH-OZO recorded data 22 January 2020 at Aurukun, Queensland

The ATSB analysed OzRunways GPS data from the 2 approaches and the missed approach (Figure 24). The data was recorded at 5-second intervals. Recorded altitude, lateral position and groundspeed data for the 2 approaches from the initial approach fix (IAF) to the missed approach point (MAPt) is shown in Figure 25.
