# Aviation Investigation Final Report

<b>Location:</b>	Honolulu, Hawaii	<b>Accident Number:</b>	DCA21FA174
<b>Date &amp; Time:</b>	July 2, 2021, Local	<b>Registration:</b>	N810TA
<b>Aircraft:</b>	Boeing 737-275C	<b>Aircraft Damage:</b>	Destroyed
<b>Defining Event:</b>	Loss of engine power (partial)	<b>Injuries:</b>	1 Serious, 1 Minor
<b>Flight Conducted Under:</b>	Part 121: Air carrier - Non-scheduled

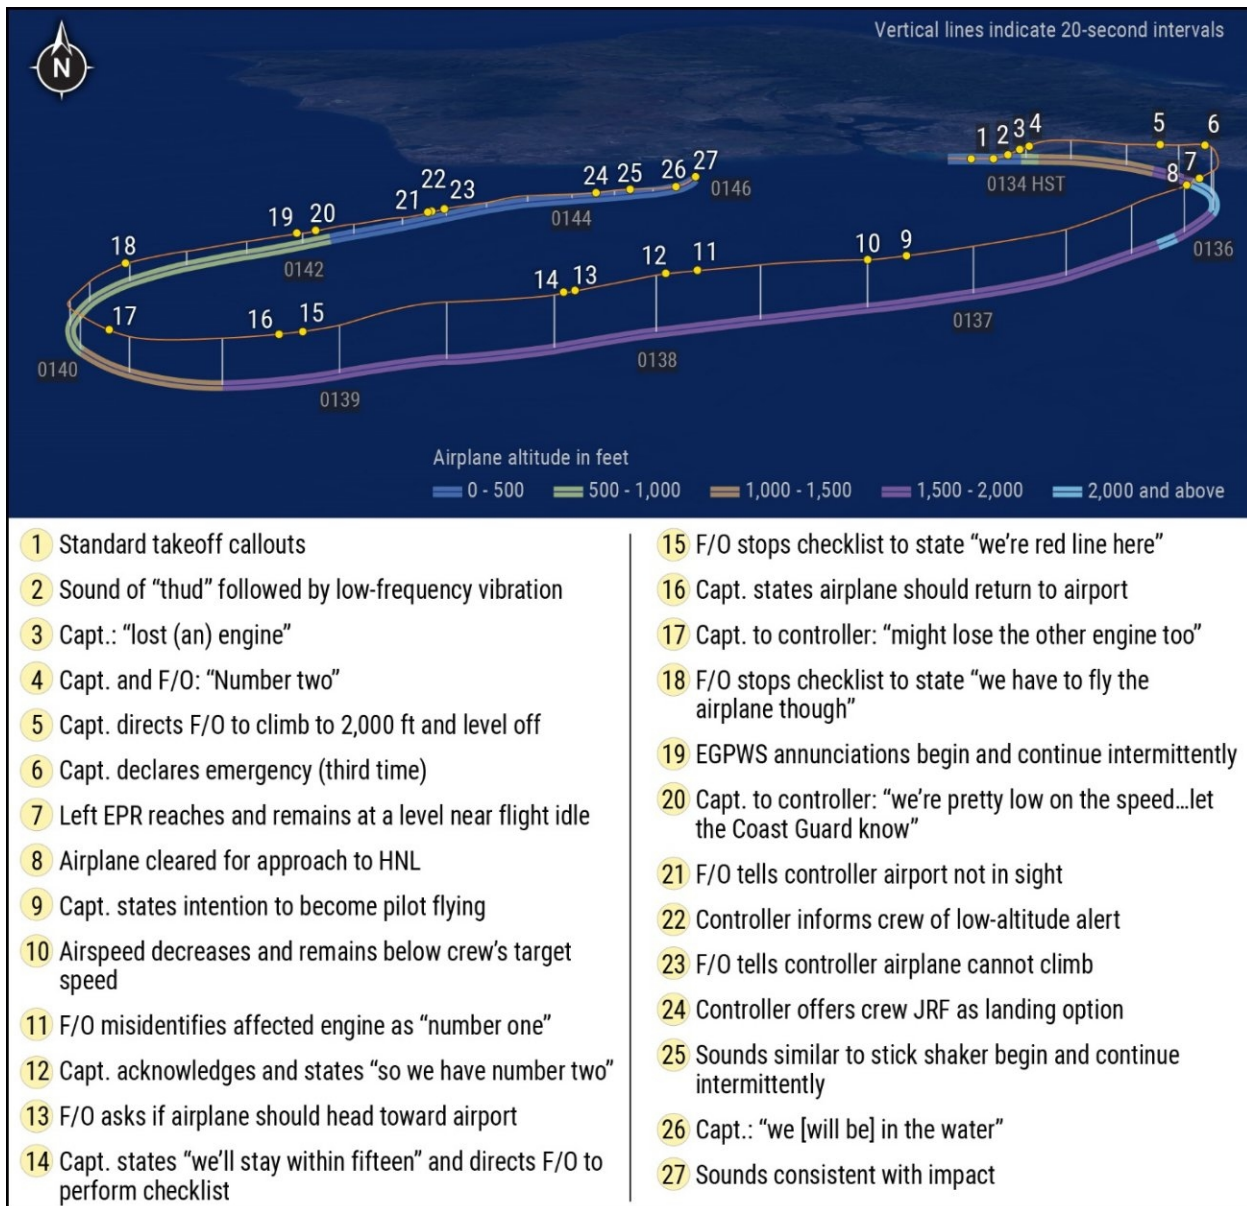
Figure 1 shows the airplane’s flightpath along with key transmissions and events. Figure 2 shows the EPR values during the flight. Figure 3 shows the location of the EPR gauges in the cockpit of the accident airplane. The evacuation and emergency response are discussed in the Survival Aspects section of this report.

**Figure 1.** Airplane flightpath with pertinent transmissions and events overlaid.

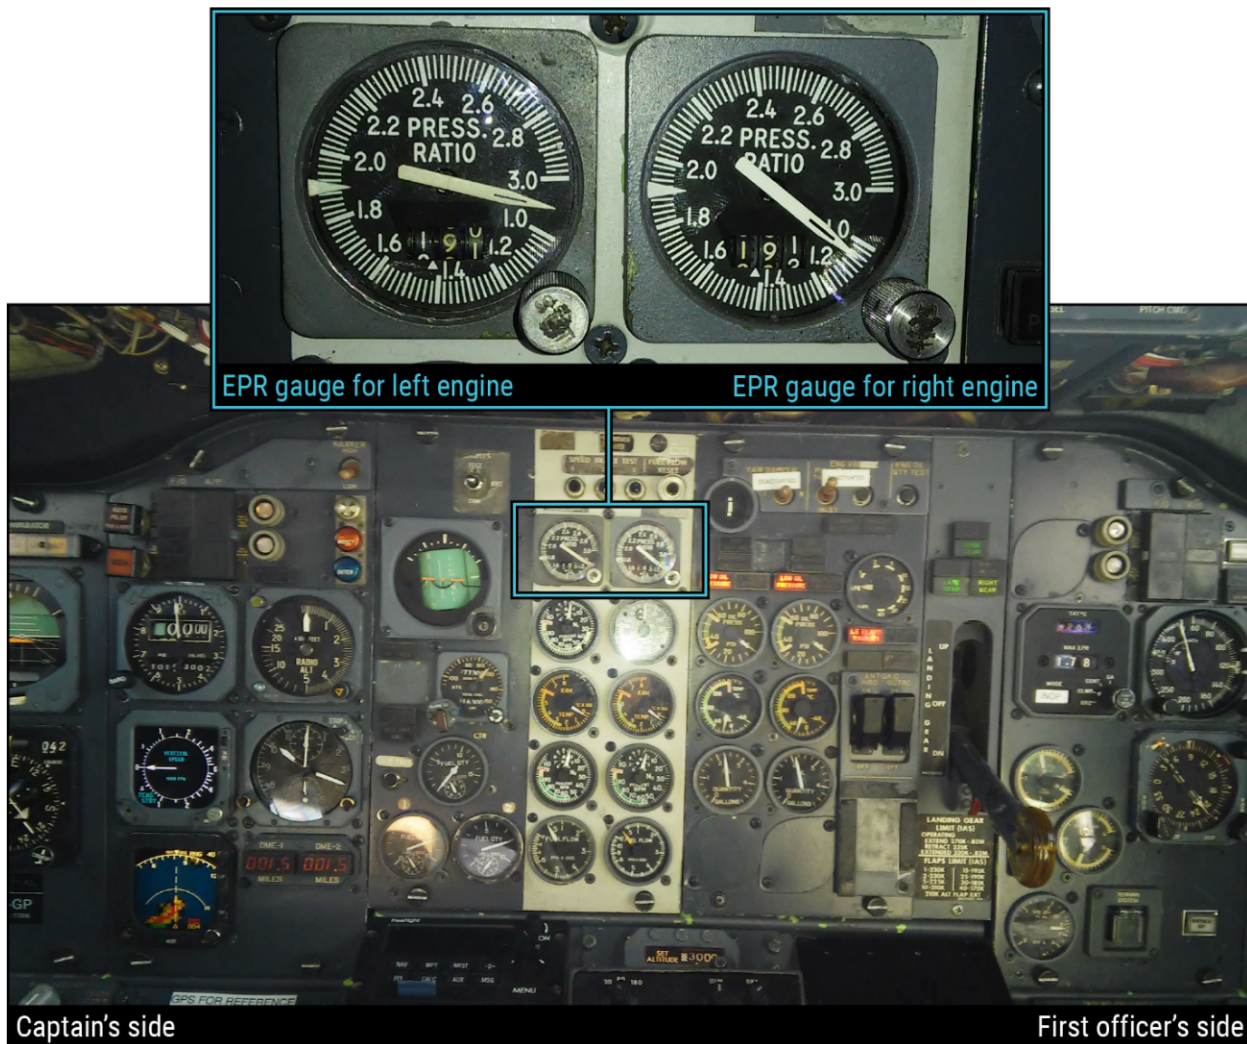
**Figure 3.** EPR gauges on the accident airplane's center instrument panel (Source: Transair).

Note: This photograph was taken in March 2016.
