# AIRCRAFT ACCIDENT INVESTIGATION AND INQUIRY BOARD

## FINAL REPORT

### HL7525 AIRBUS A330-322

***PLACE OF OCCURRENCE: MACTAN-CEBU INTERNATIONAL  
AIRPORT, LAPU-LAPU CITY, CEBU, PHILIPPINES***

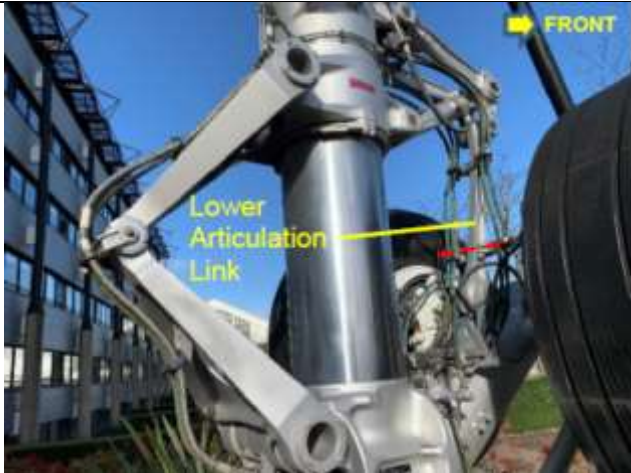
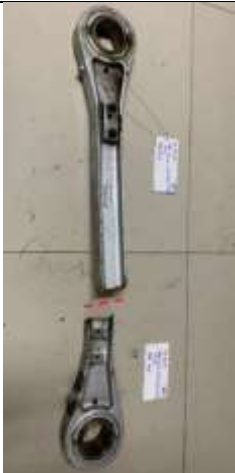
IMAGE No.	DESCRIPTION	LOCATION	P/N
1	R/H MLG Lower Articulation Link (2 parts)	Front side of the bogie	201589208
2	R/H MLG Pitch Trimmer (2 parts)	Front side of the bogie	114258004-070
3	2M electrical harness	Front side of the bogie	201655084
4	R/H MLG NORMAL BRAKING bogie beam bracket/manifold (2 parts: a, b) + GREEN hydraulic hose (rigid): c + part of lower torque link bracket: d + BLUE hydraulic hose (flexible): e + BLUE hydraulic hose (rigid): f	Aft side of the bogie	201274608
5	Two (2) ALTERNATE BRAKING hydraulic hoses + Upper part of 1M electrical harness	Aft side of the bogie	Hose 1 (middle): 201042298 Hose 2: 201042299 Harness: 701114502
6	Lower part of 1M Electrical Harness	Aft side of the bogie	201042731

The laboratory investigation found significant evidence that the RH LAL was fractured in a manner consistent with ductile overload, with no specific crack initiation site or other fracture morphologies observed. This suggests that there was no prior defect present in the part and the fracture was purely a result of a tensile overload.

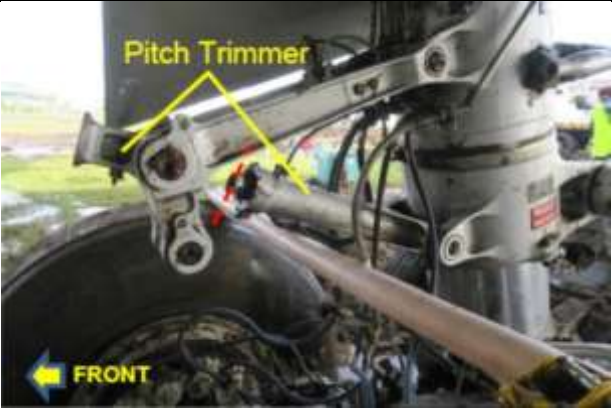
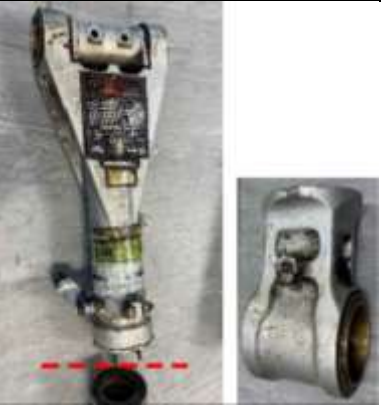
With the RH MLG Bogie Pitch Trimmer Rod End disconnected due to the lower articulation link fracture, it was possible for contact to occur between the BPT cylinder and the pitch trimmer proximity sensor brackets as the release of energy swung it upwards. This matched damage was seen on the RH MLG proximity sensor 31GA2 harness that was completely torn out and disconnected. The proximity sensor 31GA1 harness was also partially torn out.

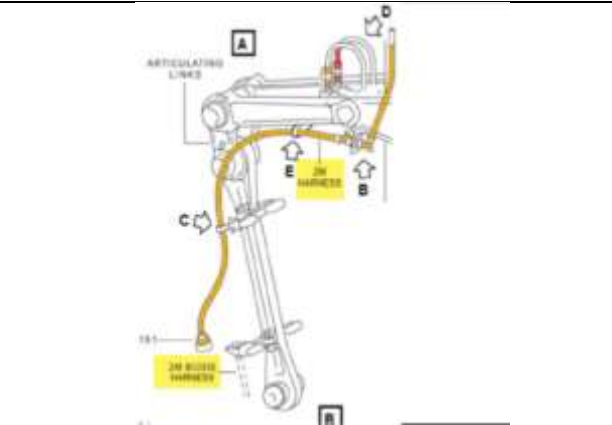
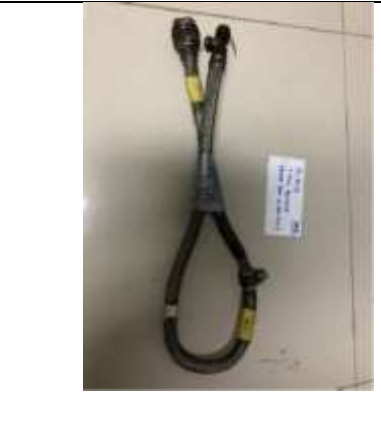
The site investigation further shows that the RH MLG lower articulation link was broken. Moreover, as a consequential event of the step impact, the rupture of the RH MLG led to tearing off the 2M electrical harness. All the sensors (L/G position, brake temp, tire pressure, etc.) and tachometers (wheelspeeds) of the MLG are powered through two electrical routes: 1M and 2M. For LGCIUs, 1M supplies sensors are dedicated to LGCIU1, and 2M supplies sensors are dedicated to LGCIU2. The loss of the 2M electrical route resulted in losing half of the proximity sensors of the RH MLG (i.e., tachometers, bogie trail proximity sensors, pitch-trimmer proximity sensors, and tire pressure indication system (TPIS) sensors).

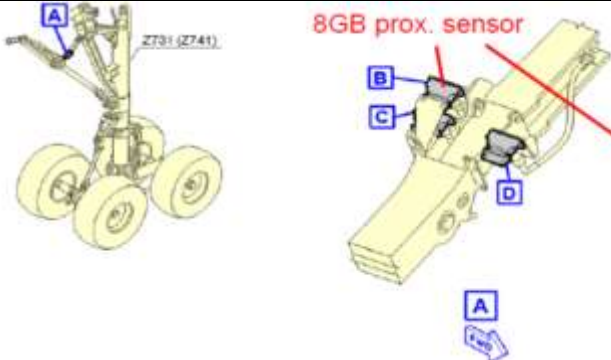
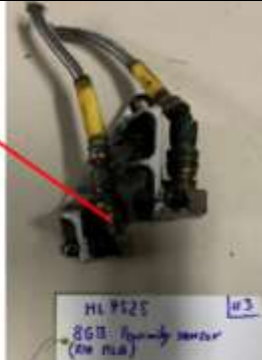
Additionally, 8GB sensor was sent to the BEA to give details of the fault transmitted through ACARS. This part was sent to Safran Landing System in Gloucester, UK, then to the manufacturer Crane Aerospace in Lynnwood, USA, and finally back to Gloucester.

IMAGE No.	DESCRIPTION	LOCATION	P/N
7	Proximity Sensor 8GB (downlock) with its connector and 15cm of harness	R/H MLG lock link (side stay assembly)	C13502-08

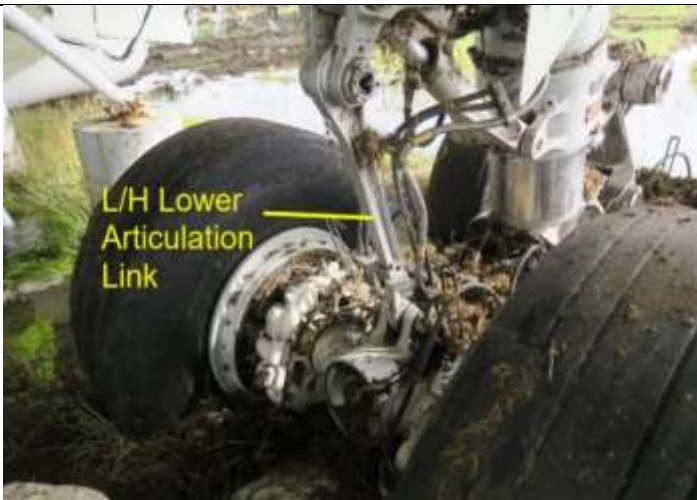
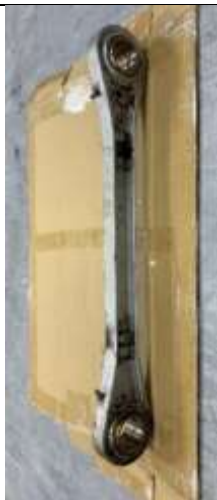
IMAGE No.	DESCRIPTION	LOCATION	P/N
8	L/H MLG Lower Articulation Link	Front side of the bogie	201589208

On the other hand, there was no fracture of the LH MLG LAL. Physical measurements of key dimensions were performed and found to be within drawing tolerance. A 3D scan was also performed, with the resulting model compared with a nominal model. This showed that the two models concurred with each other, demonstrating that no permanent deformation had occurred.

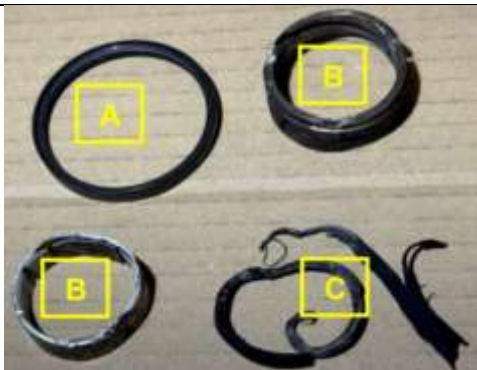
During on-site observation of RWY22 threshold, some parts were found on the ground. They were collected and sent to the BEA for identification. These parts were sent to Safran Landing System in Gloucester, UK.

IMAGE No.	DESCRIPTION	IMAGE OF PART
9	<ul style="list-style-type: none"> <li>1 seal - A</li> <li>2 pieces of electrical connectors - B</li> <li>2 pieces of rubber - C</li> </ul>

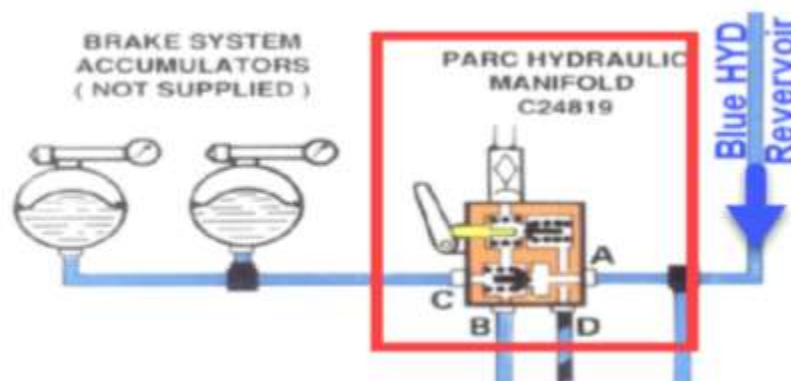
Figure 34 A - The Park Hydraulic Manifold Schematic

All these components were tested as per CMM and all were found No Fault Found (NFF) except the Park Hydraulic Manifold, where an internal leakage was found on the Pressure Release Valve (PRV) as shown in figure 34 A and B.

During the examination, as indicated in the above schematics, the normal cracking pressure of the PRV (i.e., the pressure at which the valve is supposed to open) is between 237 and 245 bar. However, the following behavior of the PRV was observed during the examinations: By increasing the service pressure (port B), a leakage (continuous flow) was observed at port D. When the pressure was increased above 207 bar, a leak rate of 500 cc/min was reached at around 210 bar. The leakage stopped (i.e., dripping at 5 cc/min) when the pressure was decreased down to around 140 bars, wherein it fully stopped below 59 bars.

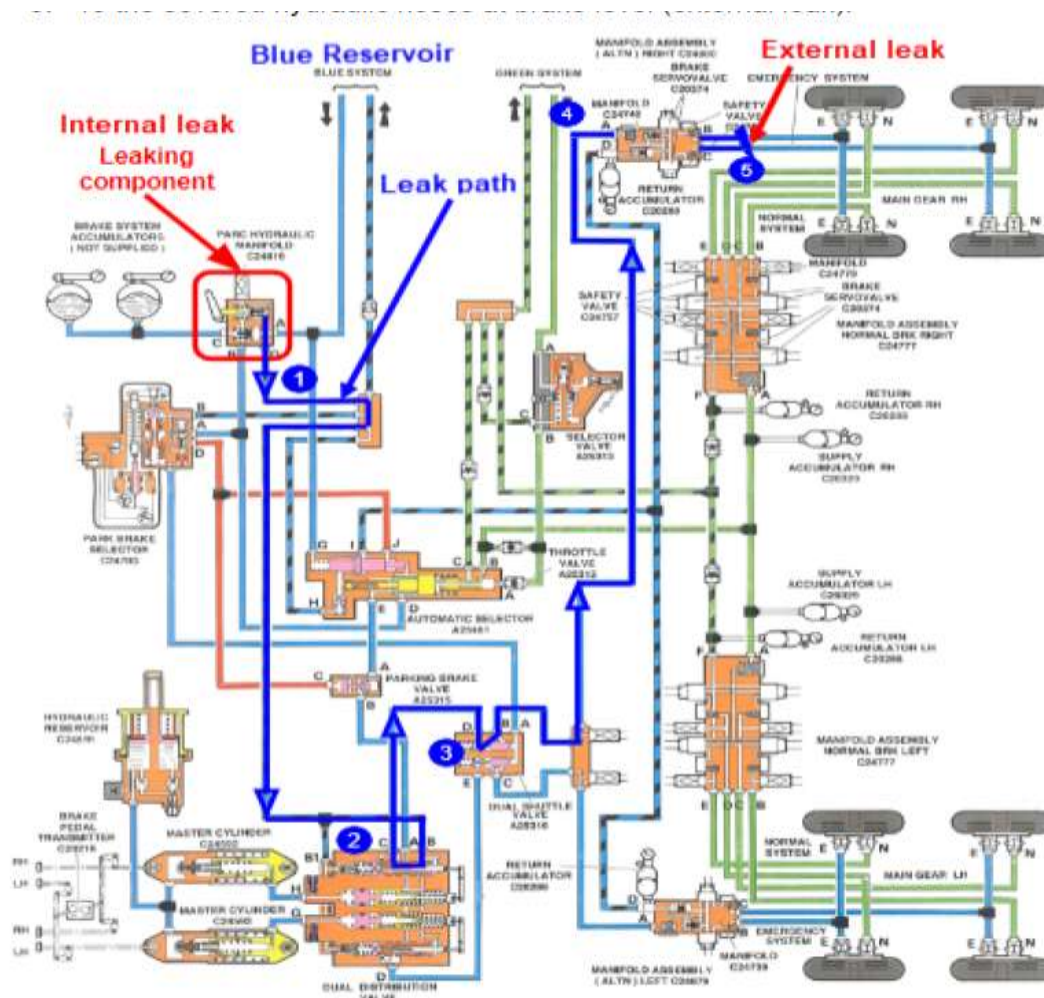
Figure 37 A - Hydraulic "Blue Line".

Coming back to the event, the leak path was the following diagram shown below (cf. blue line, figure 37-a):

1. From the blue hydraulic reservoir through the PRV (internal leak) of the Park Hydraulic Manifold (D port) and the return lines, then;
2. Through the BDDV (without any pedal deflection port B is opened to ports C and D), then;
3. Through the Dual Shuttle Valve (fully opened since parking brake was not operated during flight) and then;
4. Through the RH Alternate Brake Servo Valve Manifold (which is opened when in Alternate Braking mode);
5. To the severed hydraulic hoses at brake level (external leak).

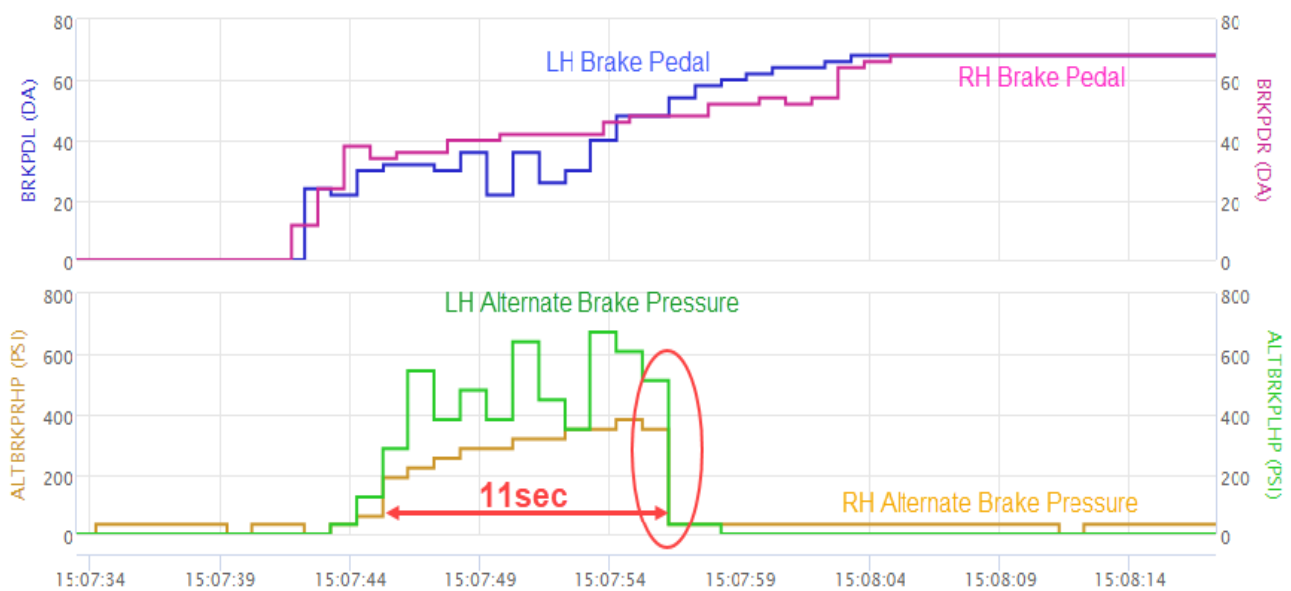
Figure 37 B - RH and LH alternate brake pressures.

This loss of hydraulic fluid in the accumulators decreased the pressure of the accumulators. Therefore, at the brake pedal application during landing (15:07:42 UTC), the pressure of the accumulators was below the nominal pressure (i.e. 3000 PSI) which explained why the safety valves did not activate (not enough flow rate). The safety valves were actually tested and found working properly (i.e. as per CMM). This is highlighted by the simultaneous and abrupt drop of the RH and LH alternate brake pressures at 15:07:56 UTC (once the accumulators were fully emptied). As a reminder, the purpose of safety valves is to isolate a possible downstream braking line leakage during brake operations in order to preserve system from a global loss of hydraulic fluid. There is one safety valve per braking line (Figure 37-b).

Following this event, Airbus has launched a study to enhance the A330 reverser logic in order to keep thrust reversers (most important benefit in terms of landing performance) in the conditions of this event. With regard to the “dormant” failure on the alternate braking system, Airbus is investigating improvements of the maintenance documentation in order to better detect such an internal leakage (Reference: Airbus Contribution Report dated February 16, 2024).

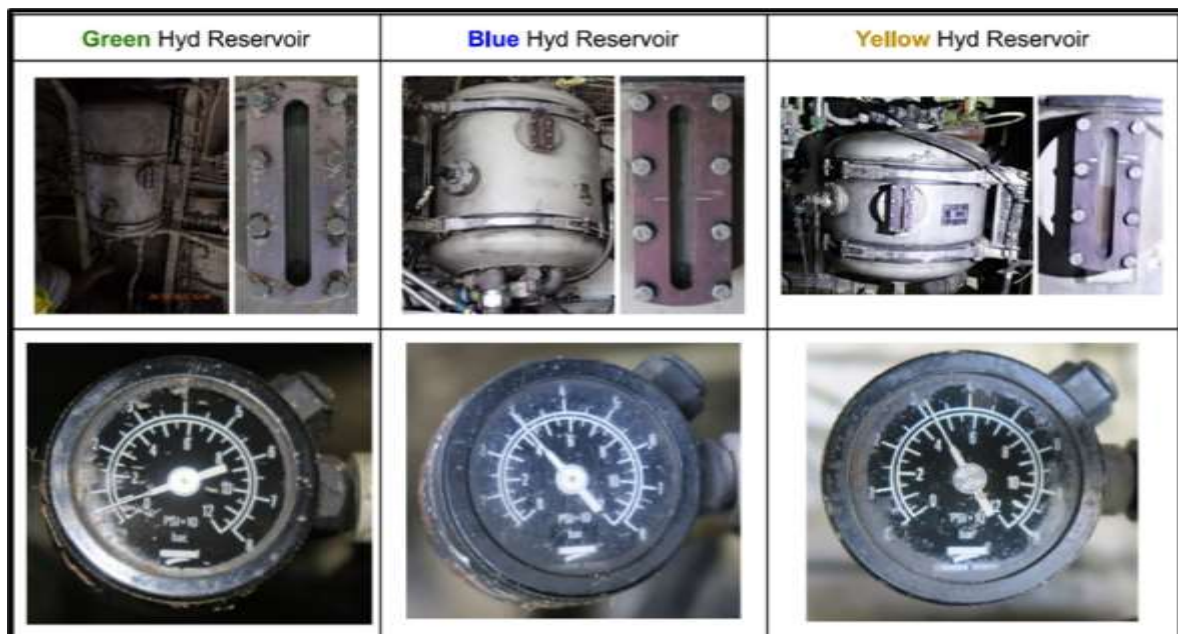
Figure 38 - The hydraulic reservoir and their specific accumulator

The Green reservoir was found empty. It is assumed that the Green hydraulic fluid leak happened due to the damages to the NLG supply green hydraulic system pipes after the NLG collapsed. Air Pressure in the Green reservoir was found at zero (0). The Yellow reservoir was found closed to normal level. Air Pressure in the Yellow reservoir was found nominal about three (3) bars. The A330 hydraulic reservoir and respective gauges are shown (Figure 38).

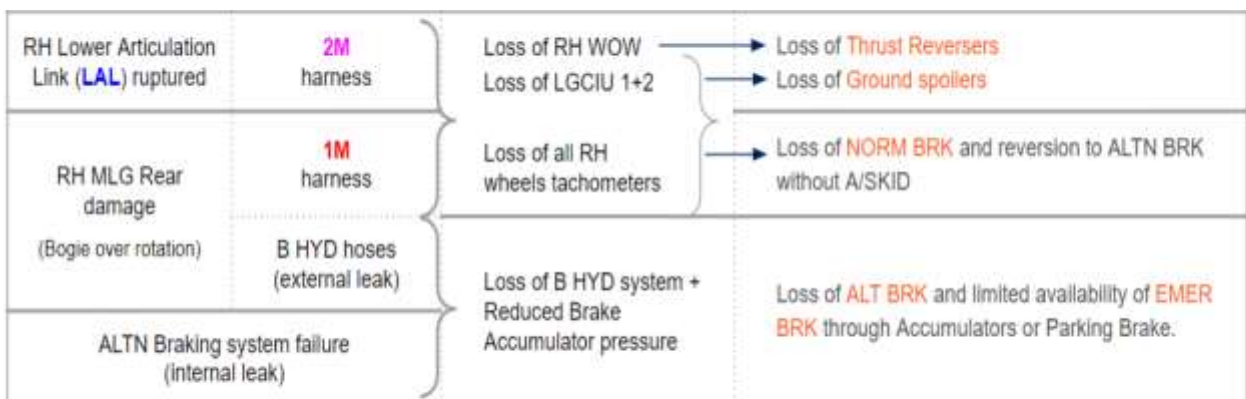
- Thrust reversers: Weight-On-Wheel (WOW) discrepancy between the two MLGs (in that case, "Flight" condition is taken by default in order to prevent thrust reversers deployment in flight).
- Ground spoilers: Loss of both LGCIUs and all RH MLG wheel tachometers.
- Normal braking: Loss of all RH MLG wheel tachometers.
- Alternate & Emergency braking: Blue hydraulic system and accumulator pressure loss due to the combination of an internal leakage at Park Hydraulic Manifold PRV (dormant" failure) and an external leakage (severed blue hydraulic hoses at RH MLG brake level).

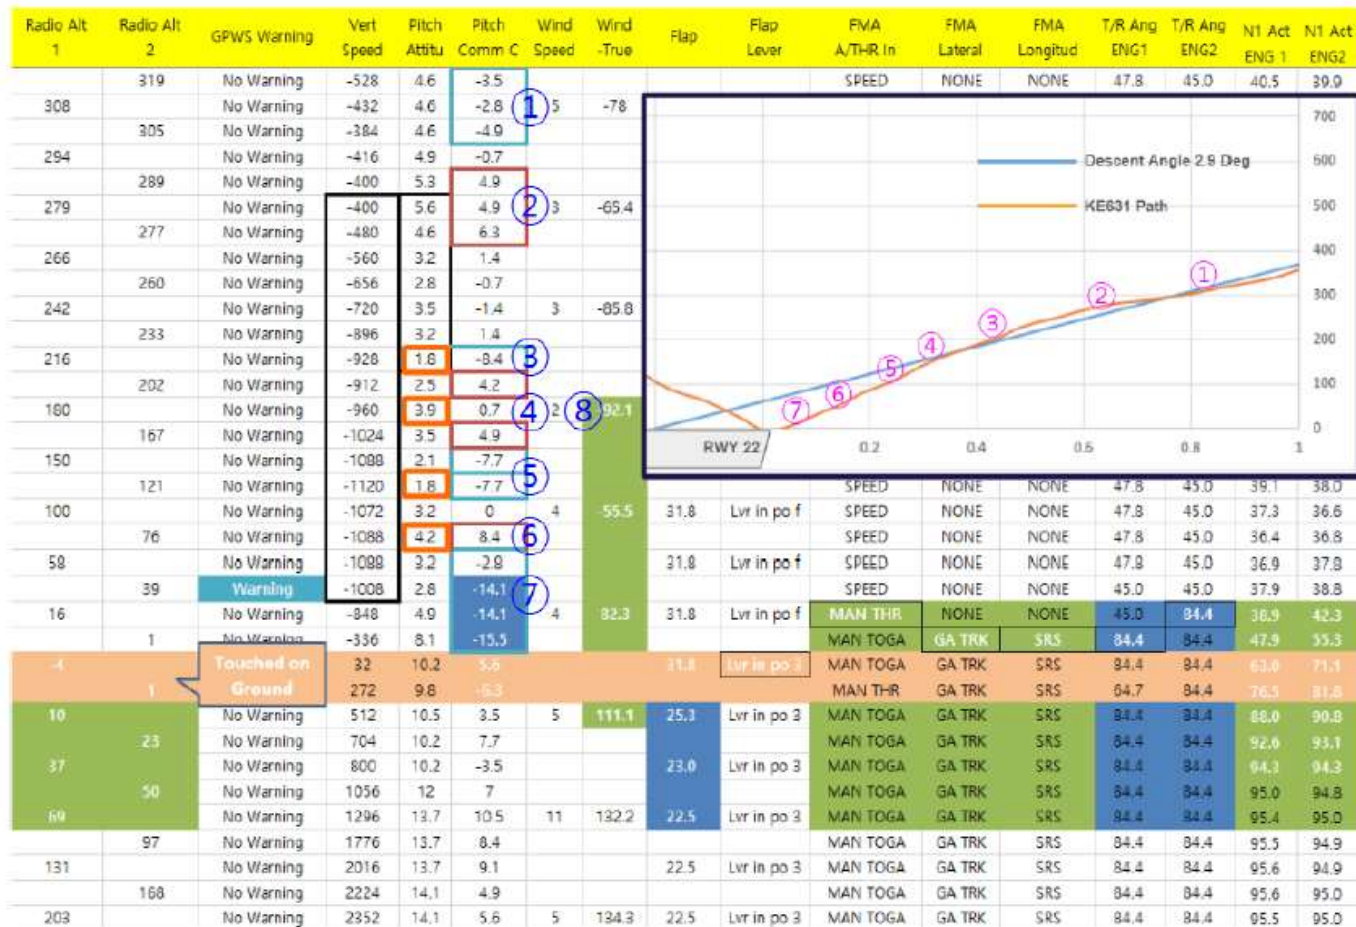
Figure 40 - DFDR Analysis

8. From RA 180 ft to the ground contact, the wind direction changed from a right crosswind to a side tail wind by approximately 180 degrees. During this period, the captain made at least three (3) attempts to reduce the descent rate, yet the aircraft's descent rate remained unchanged due to uncontrollable factors. Additionally, this timing coincided with the captain's statement regarding sensing strong downdrafts, and it aligns with the analysis indicating the presence of Vertical Wind Factor (Multiple downdrafts).

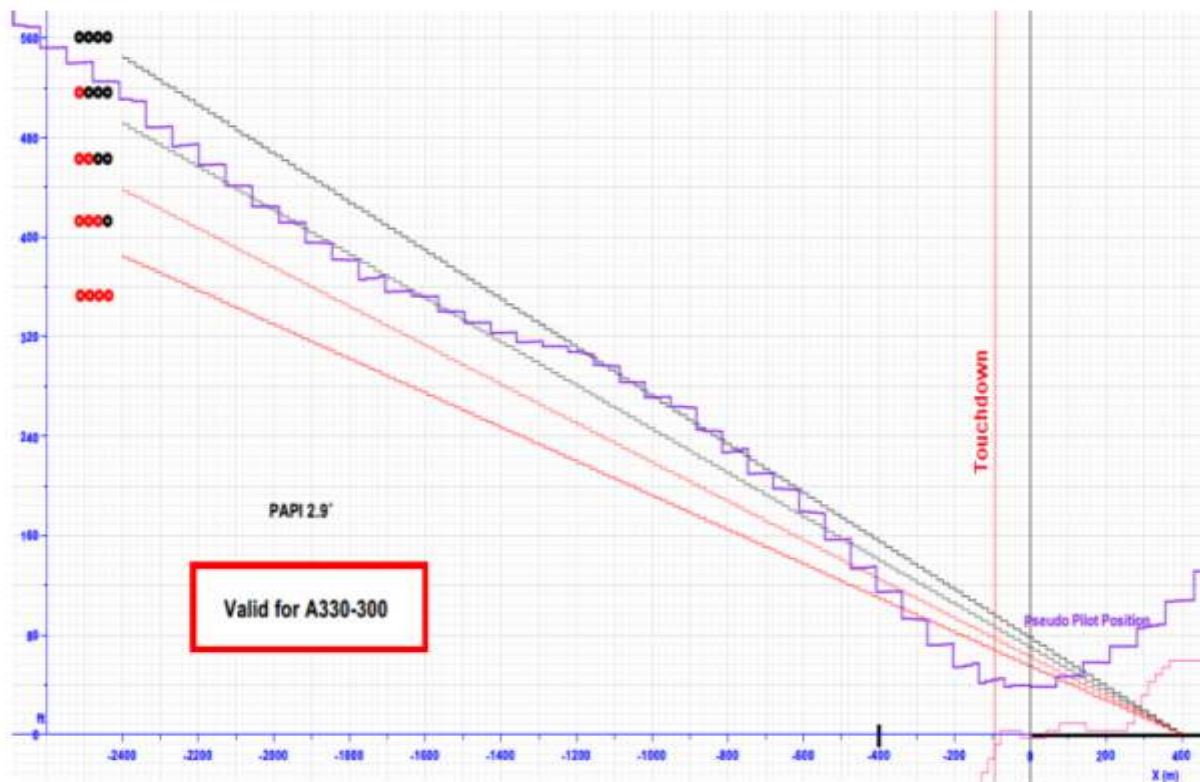
Figure 41 - The vertical flight path.

As mentioned, between 14:26:06 UTC (300 ft RA) and 14:26:22 UTC (70 ft RA), there was high-pitch sidestick activity and high roll sidestick activity. The calibrated airspeed (CAS) remained stable around speed target (Vapp) and the aircraft passed durably below the 3° flight path at 150 ft RA. In these regards, the aircraft vertical flight path versus the PAPI profile (2.9°) during the last 400 ft AGL was reconstructed as shown (Figure 41).

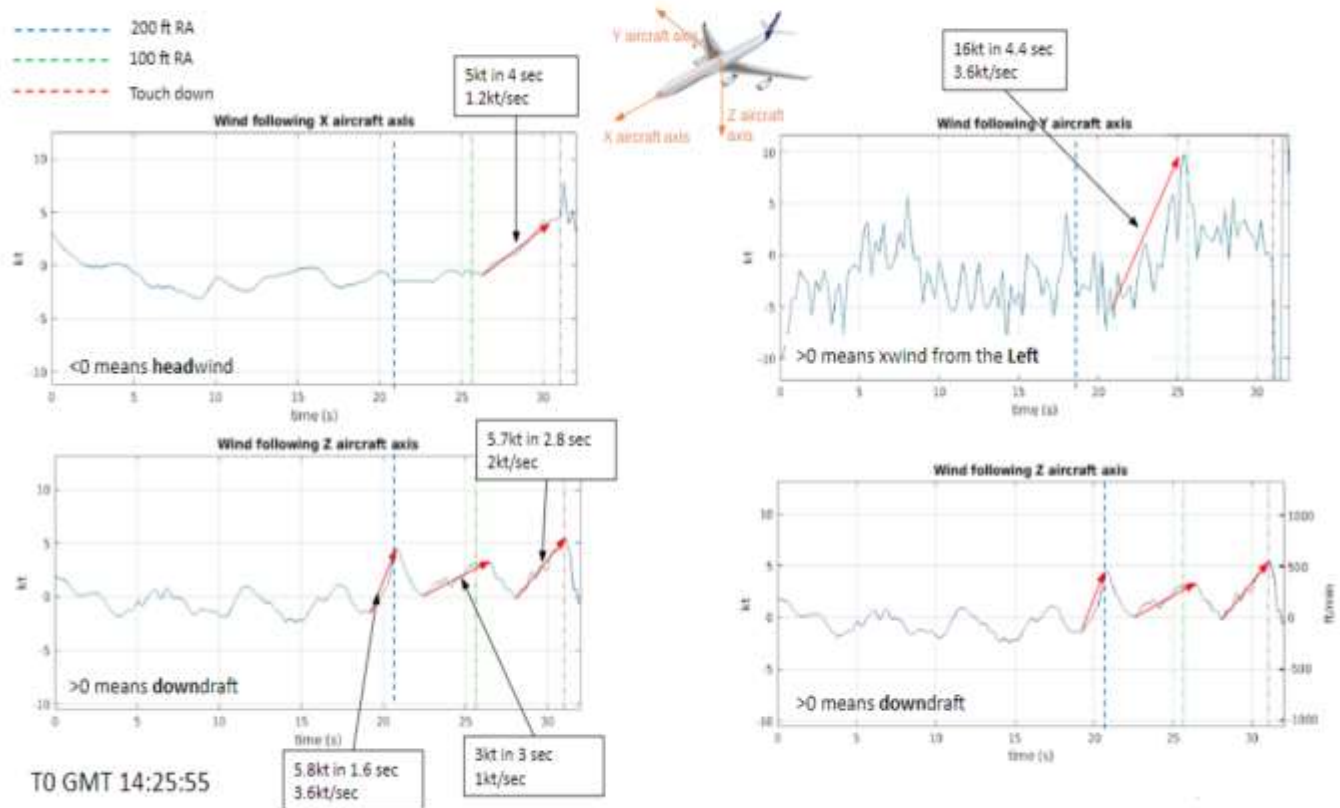
Figure 42 - The wind re-computation.

Based on these results, it can be concluded that the aircraft experienced:

- On longitudinal (X axis), a 5kt tailwind increase just before and during the flare leading to CAS and lift decrease.
- On lateral (Y axis), a significant left wind gradient (16kt in 4.4sec) just before and during flare.
- On vertical (Z axis), multiple downdrafts around 200ft (max 500ft/min), 100 ft RA and during the flare which contributed to increase the vertical speed.

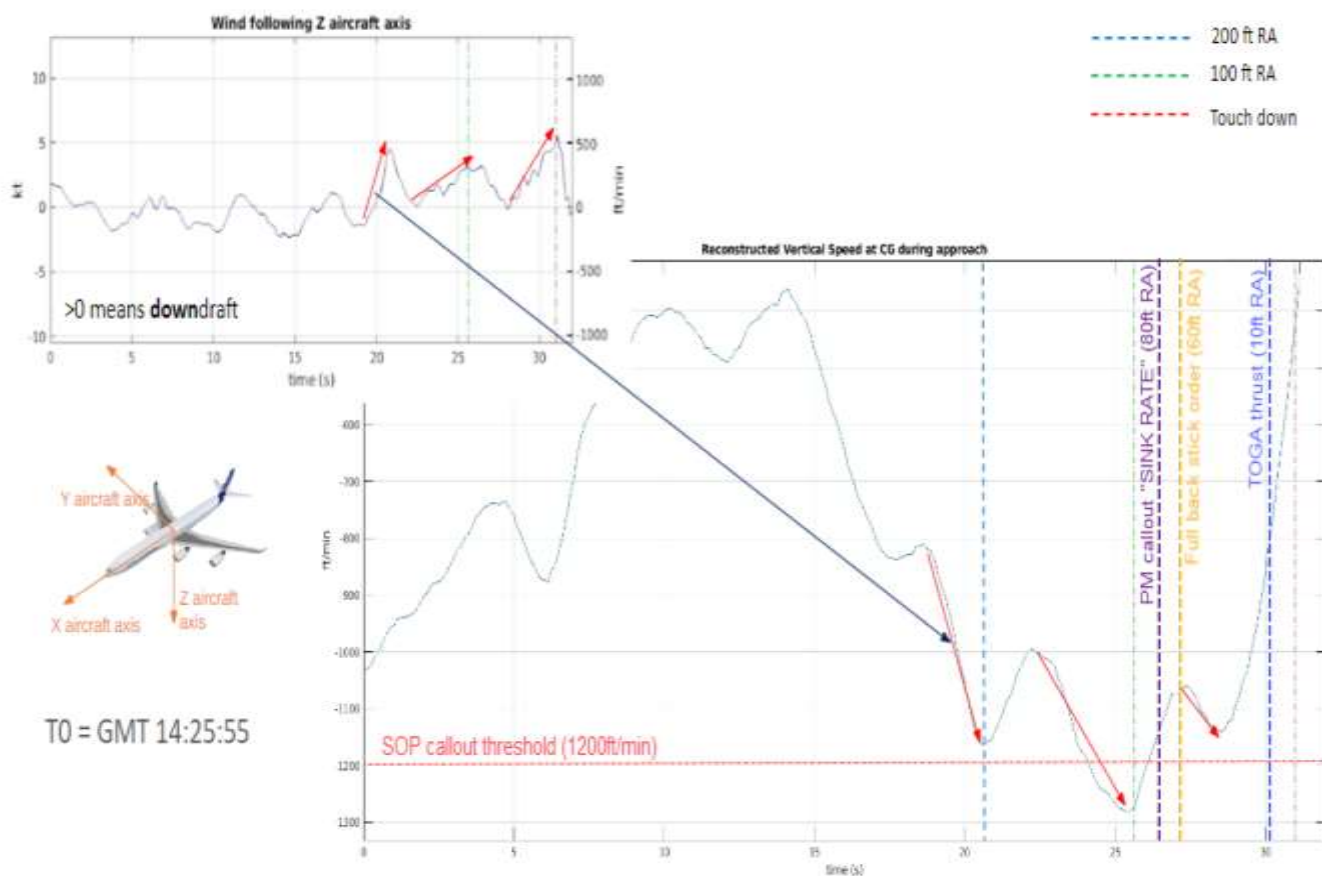
Figure 43 - Vertical Speed re-computation

This vertical speed re-computation shows that the two first downdrafts increased the Vz from 800ft/min to almost 1300ft/min reached at 100 ft RA. The PM callout occurred about 2sec after the Vz increased above 1200ft/min.

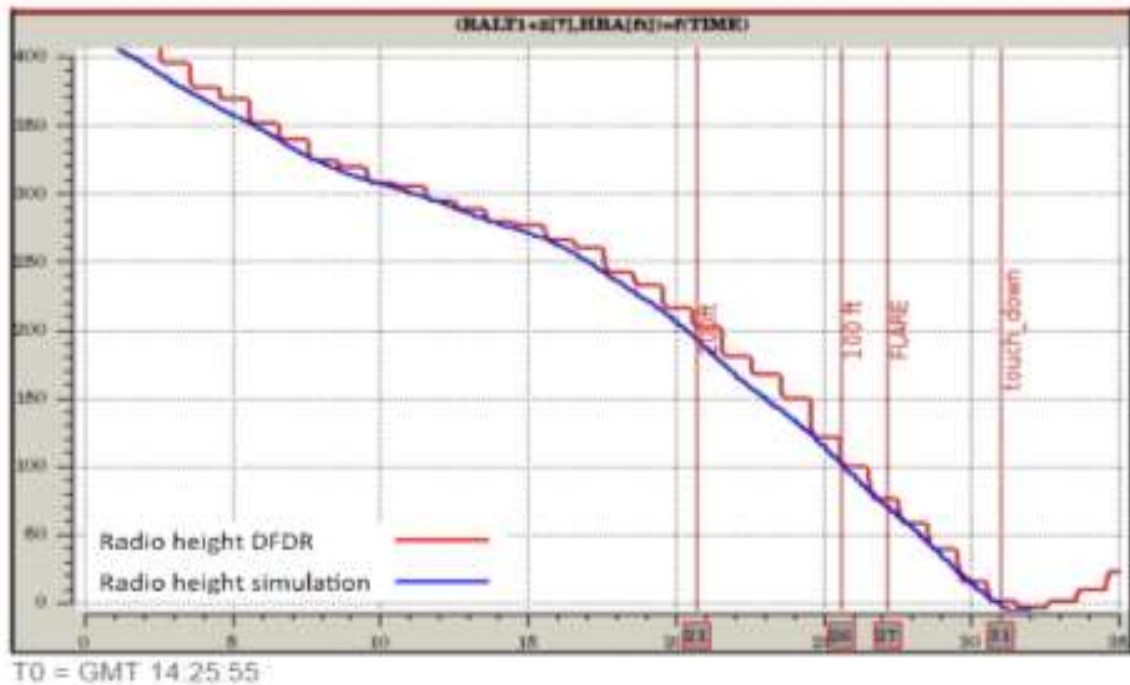
Figure 44 - Sidestick input

This shows that this simulation matches pretty well the event validating the settings of the computation.

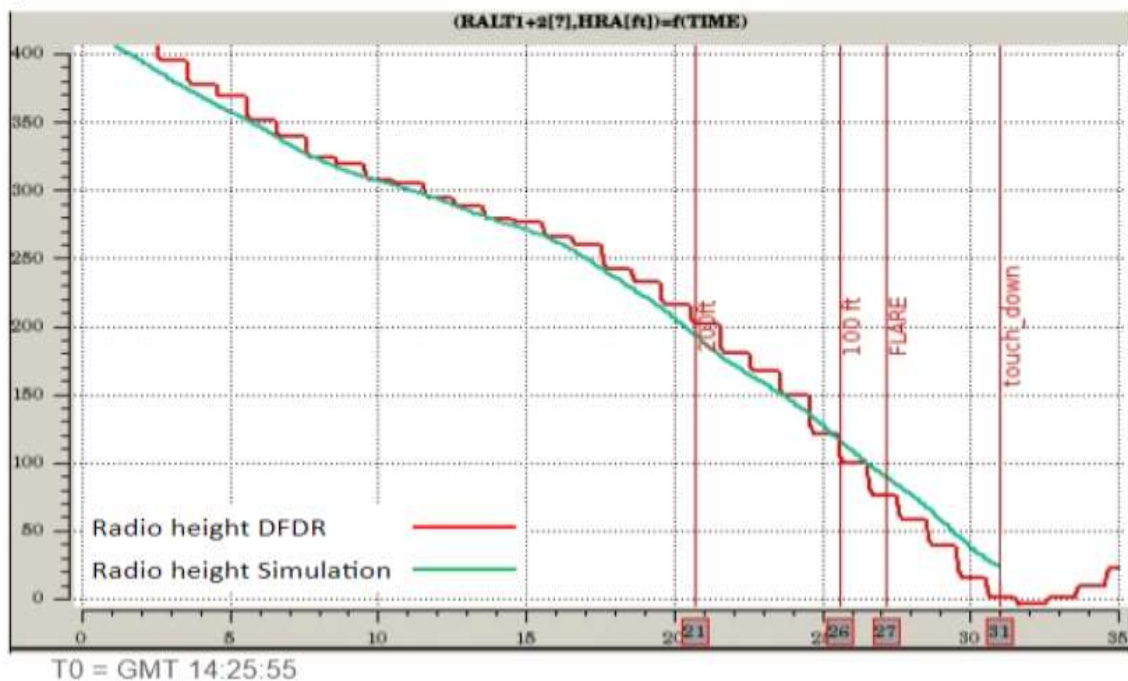
Figure 45 - Sidestick input with no wind.

This simulation shows that the wind was a contributing factor that led the aircraft flying below the correct fly path in the last 100 ft RA (25 ft RA at event touchdown).

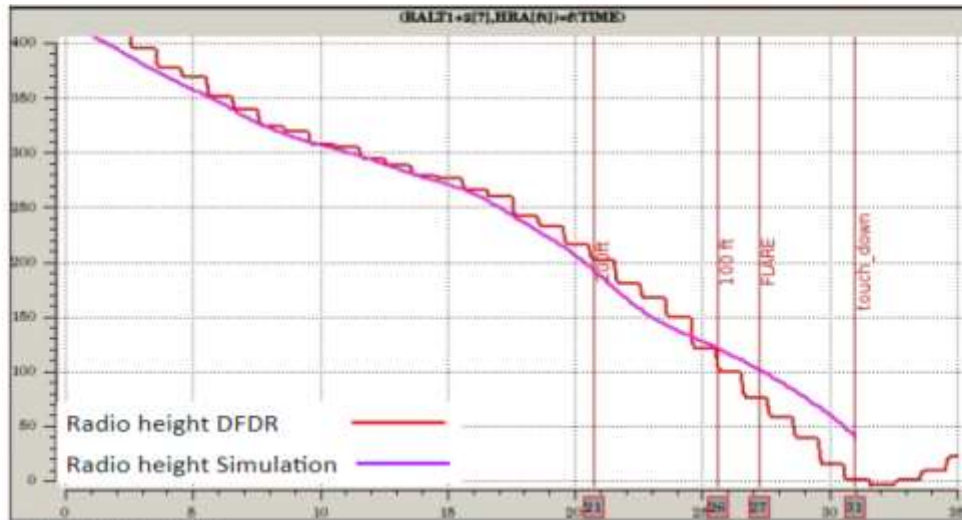
Figure 46 - Sidestick with wind.

The simulation shows that the pilot sidestick input was also a contributing factor with a higher impact on the trajectory than the wind: 40ft RA (iso 25ft RA) at event touchdown. The following simulations were done to assess when the G/A should have been performed to avoid the touch with the ground:

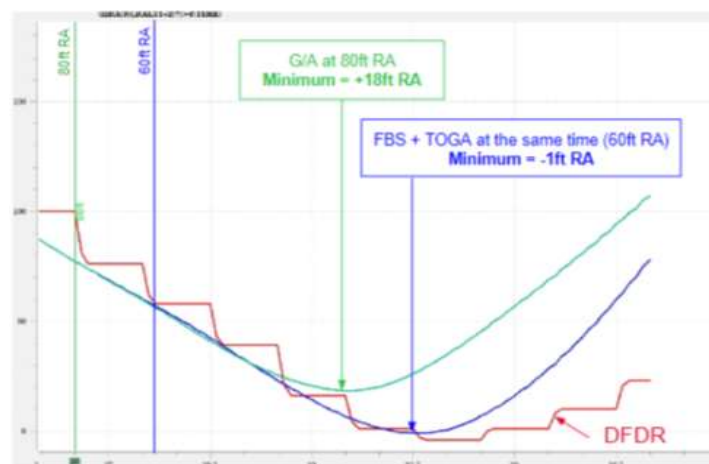
Figure 47 - Graph 1.

- A simulation with TOGA thrust applied at the time of the Full Back Stick (FBS) input (i.e. 60ft RA) as requested by the Go-Around Standard Operating Procedure (vs event where TOGA was applied about 3sec after the FBS order).
- A simulation with a G/A initiated at 80ft RA (i.e. ~1sec before the actual initiation).
