Air Accident Investigation Unit Ireland

FORMAL REPORT

**Partenavia P68, F-HIRD
Near Carnsore Point, Co. Wexford**

AAIU Report No: 2025-001

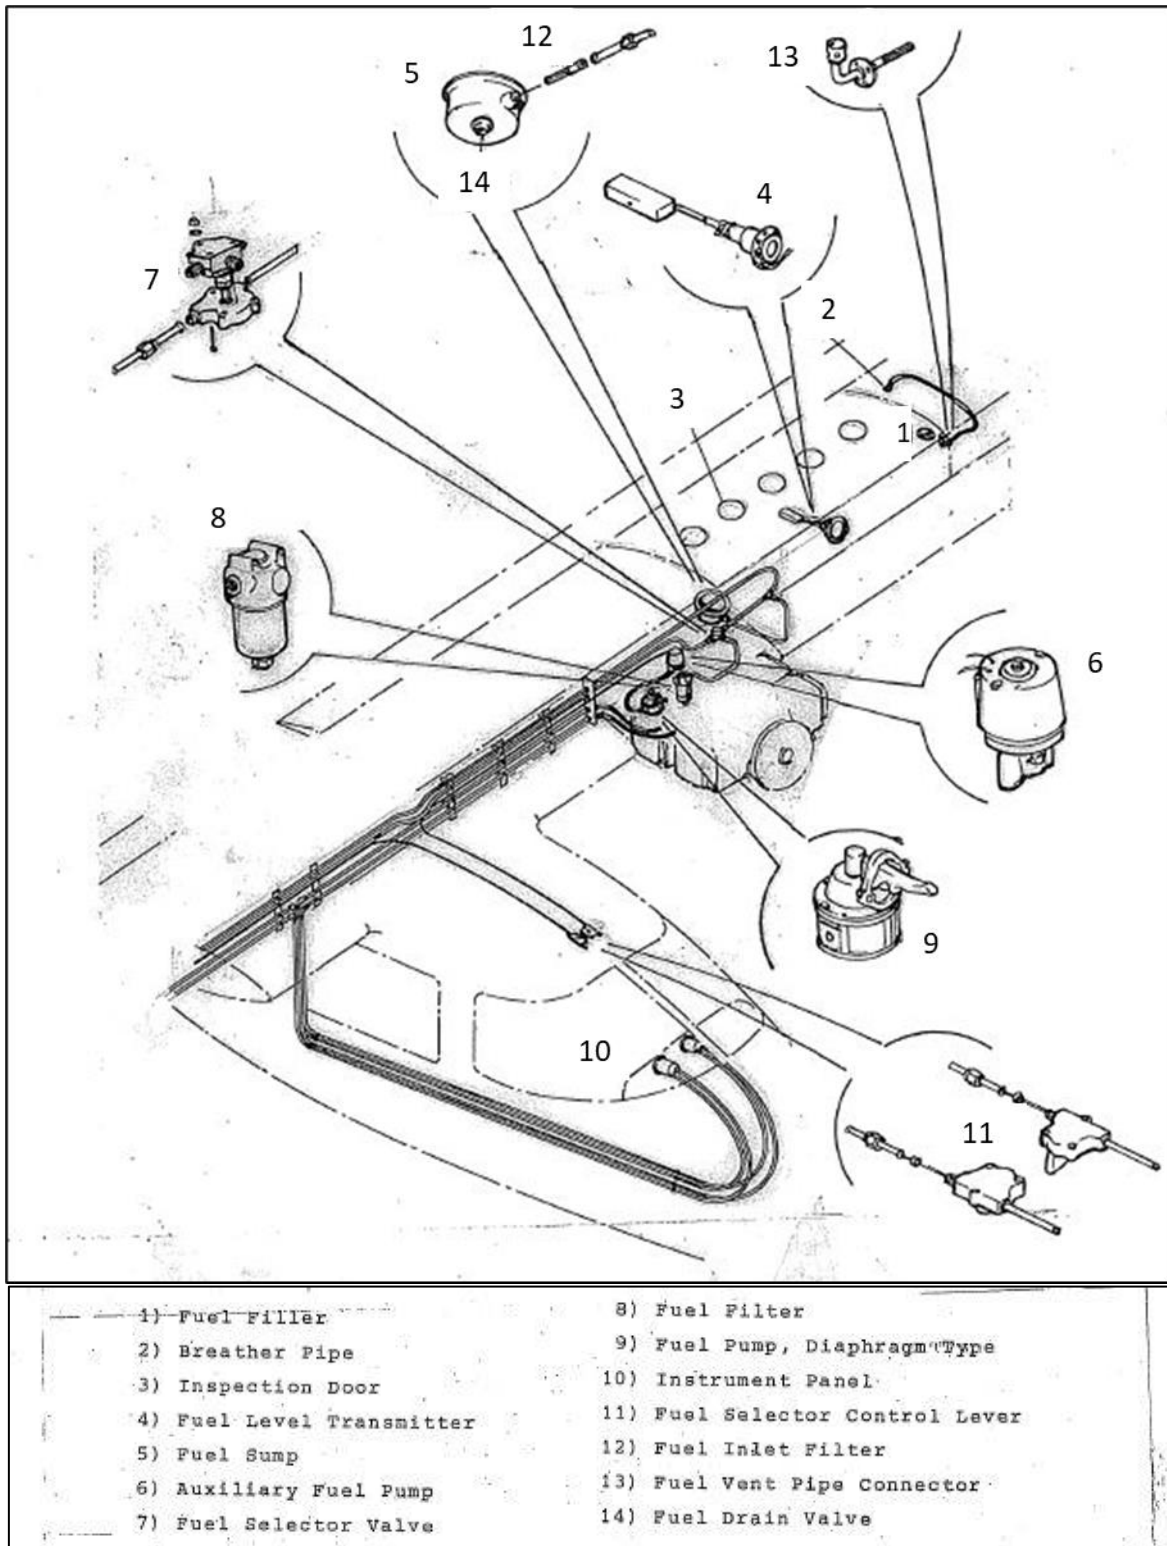
Figure No. 1: Aircraft Fuel System (Manufacturer's Maintenance Manual)

During the inspection of the crossfeed system, the Investigation observed that a fitting on the crossfeed pipe (**Figure No. 1** in **Section 1.6.2**) where it connected to the right-hand fuel transfer valve, was loose, and that the pipe could move in and out along the longitudinal axis of the pipe and fitting. The Investigation disassembled the fitting and found significant damage to the olive fitting (**Figure No. 12a** and **12b**) and o-ring (**Figure No. 12c**). The damage did not appear to be recent.

Each fuel tank of the aircraft contained a fuel sump (Item No. 5 in **Figure No. 1** in **Section 1.6.2**) which was located towards the front edge of each fuel tank. The fuel feed from each tank was located at the bottom of the fuel sump. The aircraft Type Certificate states that the unusable fuel in each tank is 9.5 litres. The Investigation explored the possibility that the unusable fuel as stated in the aircraft Type Certificate could be incorrect and that the fuel system may have been susceptible to unporting²⁵.

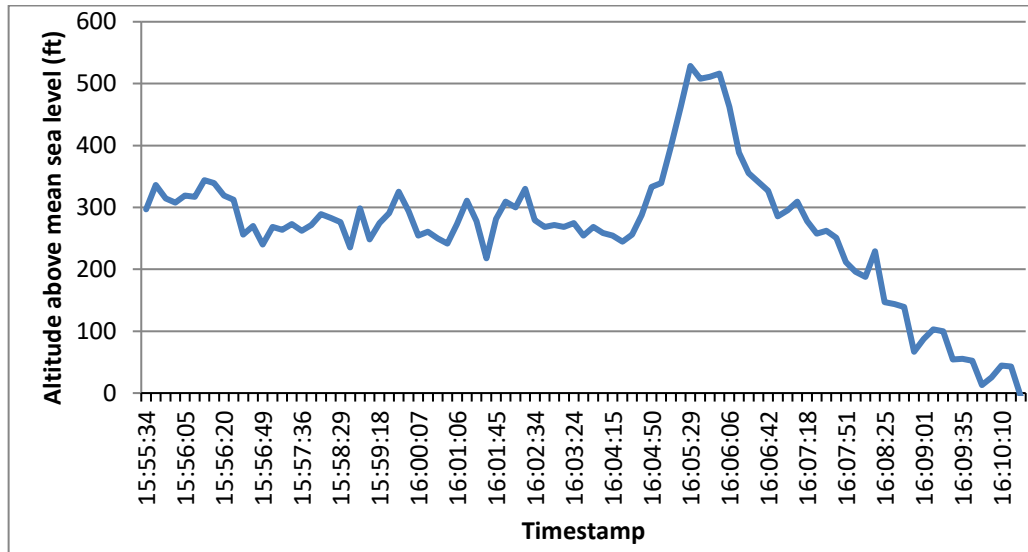
Figure No. 6: Calculated Altitude Data¹⁷ Recorded by the aircraft Garmin Aera 796

Figures No. 6 and 8, show altitude data recorded by the Garmin and Spidertracks devices during the final survey line. Both plots indicate that there was some variability in the altitude of the aircraft during the survey line, but the most significant change occurs at approximately 16:04 hrs when the aircraft initiates a significant climb. The aircraft speed just prior to the climb was approximately 105 kt. The Pilot also recalled that the aircraft was flying at 105 kt when the right engine symptoms started, after which he commenced a climb.

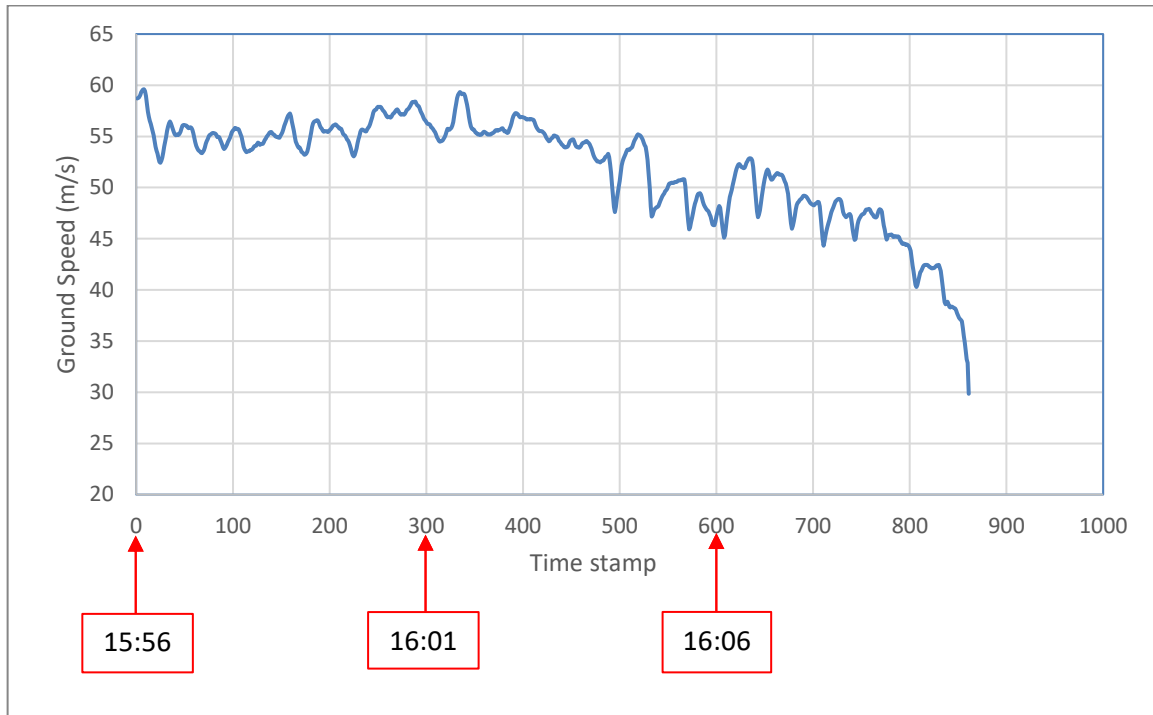
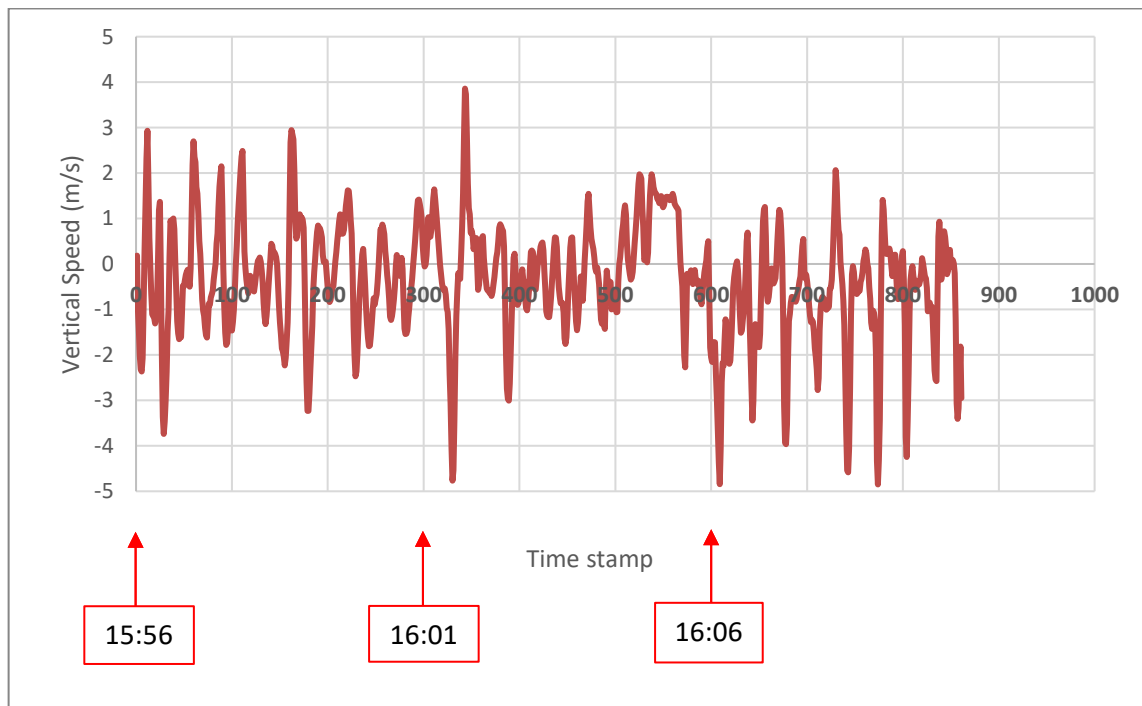
Data recorded by the Spidertracks device (**Figures No. 9 and 10**) showed that throughout the flight there was variability in the recorded parameters when the aircraft was established on a survey line. This is not unexpected as the flight was flown using manual control for many hours which would have required the Pilot to make constant flight control inputs. However, in this scenario, it may be possible for the flight to briefly become uncoordinated, which at lower fuel levels has the potential to cause temporary interruption(s) to engine fuel supply. Even a short interruption to engine fuel supply could introduce air into the fuel and cause problems with engine operation. When interviewed after the accident, the Pilot described the right engine symptoms as *'like when there is air in the fuel'*.
