REPORT # H80003  
AIRCRAFT ACCIDENT  
AIRWEST AIRLINES LTD  
DE HAVILLAND DHC6-200 (FLOATS)  
REGISTRATION CF-AIV  
VANCOUVER HARBOUR, BRITISH COLUMBIA  
00:42 GMT, SEPTEMBER 3, 1978

#### SYNOPSIS

A visual approach was being made to Vancouver Harbour. When at 175 ft above the surface and approximately 2500 ft from the intended landing area, the aircraft suddenly rolled left and plunged into the water.

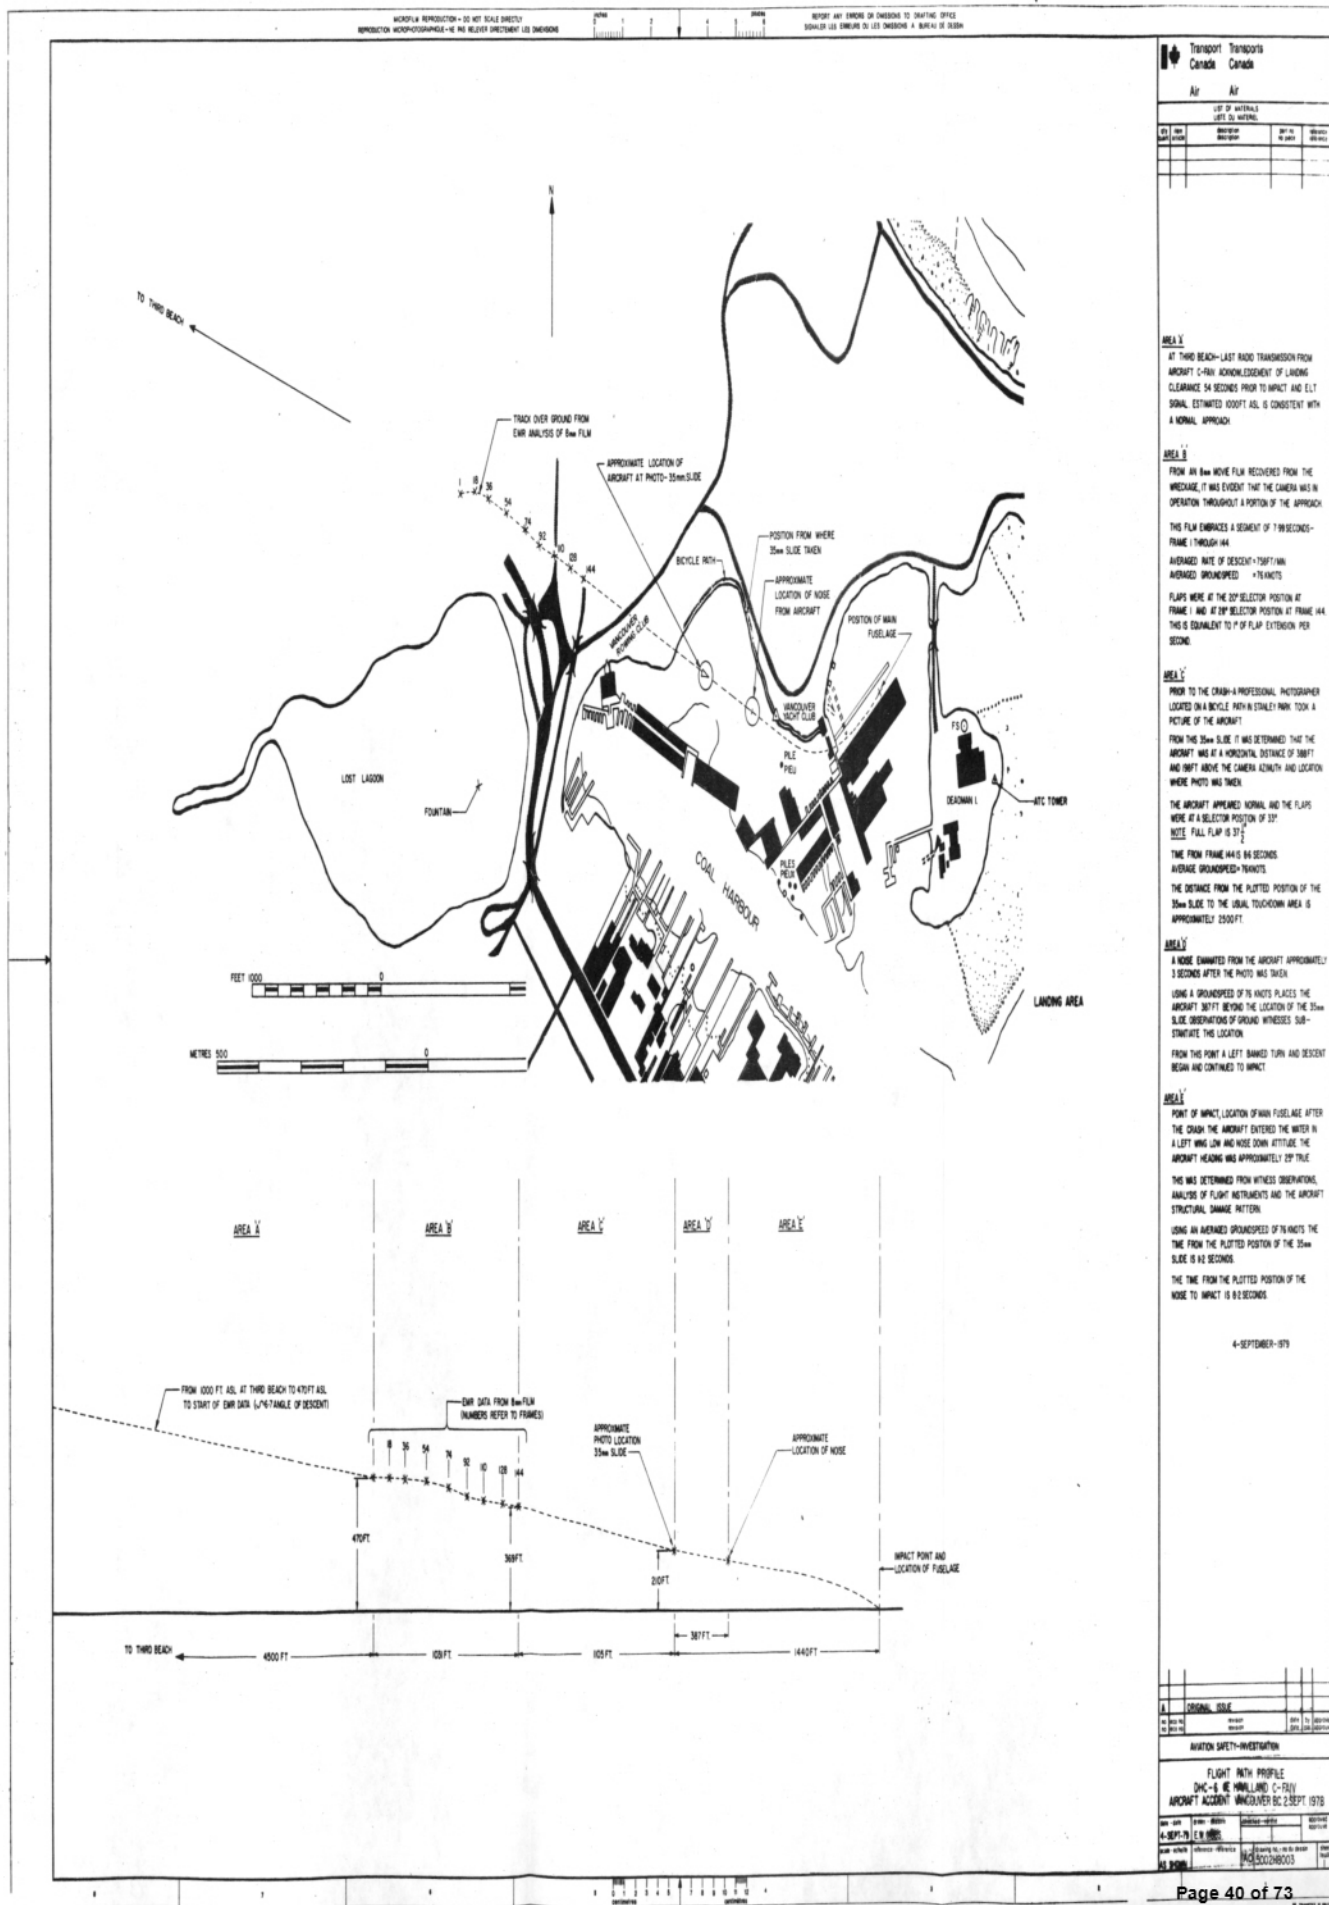
FIG-1

From the cine camera data it was calculated that 29 seconds later the aircraft was over position "1", (as indicated on Figure 1) and that the flap at that time had been extended to 20°.
