DIRECTORATE OF CIVIL AVIATION

**AIRCRAFT
ACCIDENT REPORT**

**ALEV
UNGARIAN AIRLINES**

MALEV 731 (REG. HA-MOC)
ACCIDENT IN ØRESUND
ON AUGUST 28, 1971.

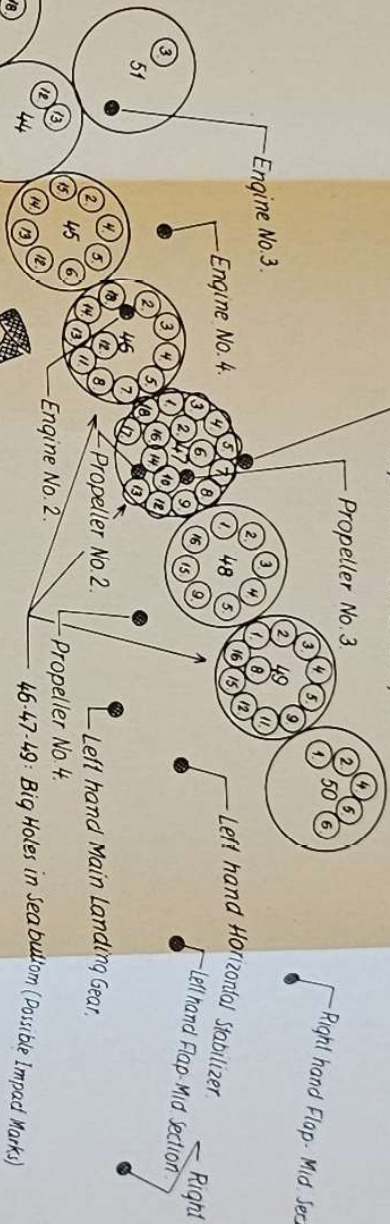
Sea depth: Average 4.5 Metres
 Sea current: 0.5 kts. Southward (reversing).
 W/V: 240°/20kts.

- ① Nose Gear Parts.
 - ② Nose Section Parts.
 - ② Radar (Radome) Parts.
 - ② Cockpit Parts.
 - ③ Forward Cabin Parts.
 - ③ Forward Baggage Compartment Parts.
 - ③ Forward Toilet Parts.
 - ④ Main Landing Gear Parts.
 - ⑤ Wing Center Parts.
 - ⑥ Baggage Compartment Parts.
 - ⑥ Main & Rear Cabin Parts.
 - ⑦ Rear Cabin Parts.
 - ⑧ Tail Section Parts.
- (Hydraulic Jack Parts & Abu Parts)
- ⑨ Right hand Wing Parts.
 - ⑩ Left hand Wing Parts.
 - ⑪ Engine No. 1 Parts.
 - ⑫ Engine No. 2 Parts.
 - ⑬ Engine No. 3 Parts.
 - ⑭ Engine No. 4 Parts.
 - ⑮ Right hand Flap
 - ⑯ Left hand inboard Flap spindle Pa
 - ⑰ Left hand outboard Flap spindle Pa
 - ⑱ Passenger Seat Parts.

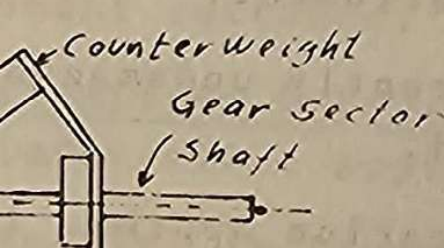
stigations after disassembly: Inspection of scale befo
 r ultrasonic cleaning revealed no pointer impressions
 ection of the mechanism showed that the gear sector co
 he pointer pinion gear had deflected the pinion shaft
 as the counterweight as shown on the
 The gear sector still meshed with th
 gear, and when rotated to maximum do
 deflection the pointer indi

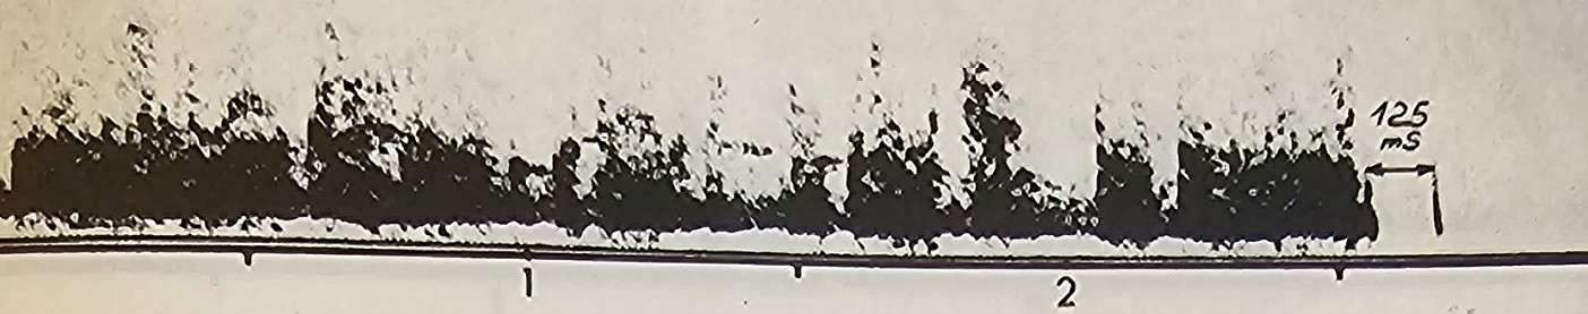
Sonagram no. 16.

The possibility, that the message at 185220 from MA 731 is or a receipt for permission to continue approach (e.g. "continue") do not seem to be confirmed by sonagram no. 16.

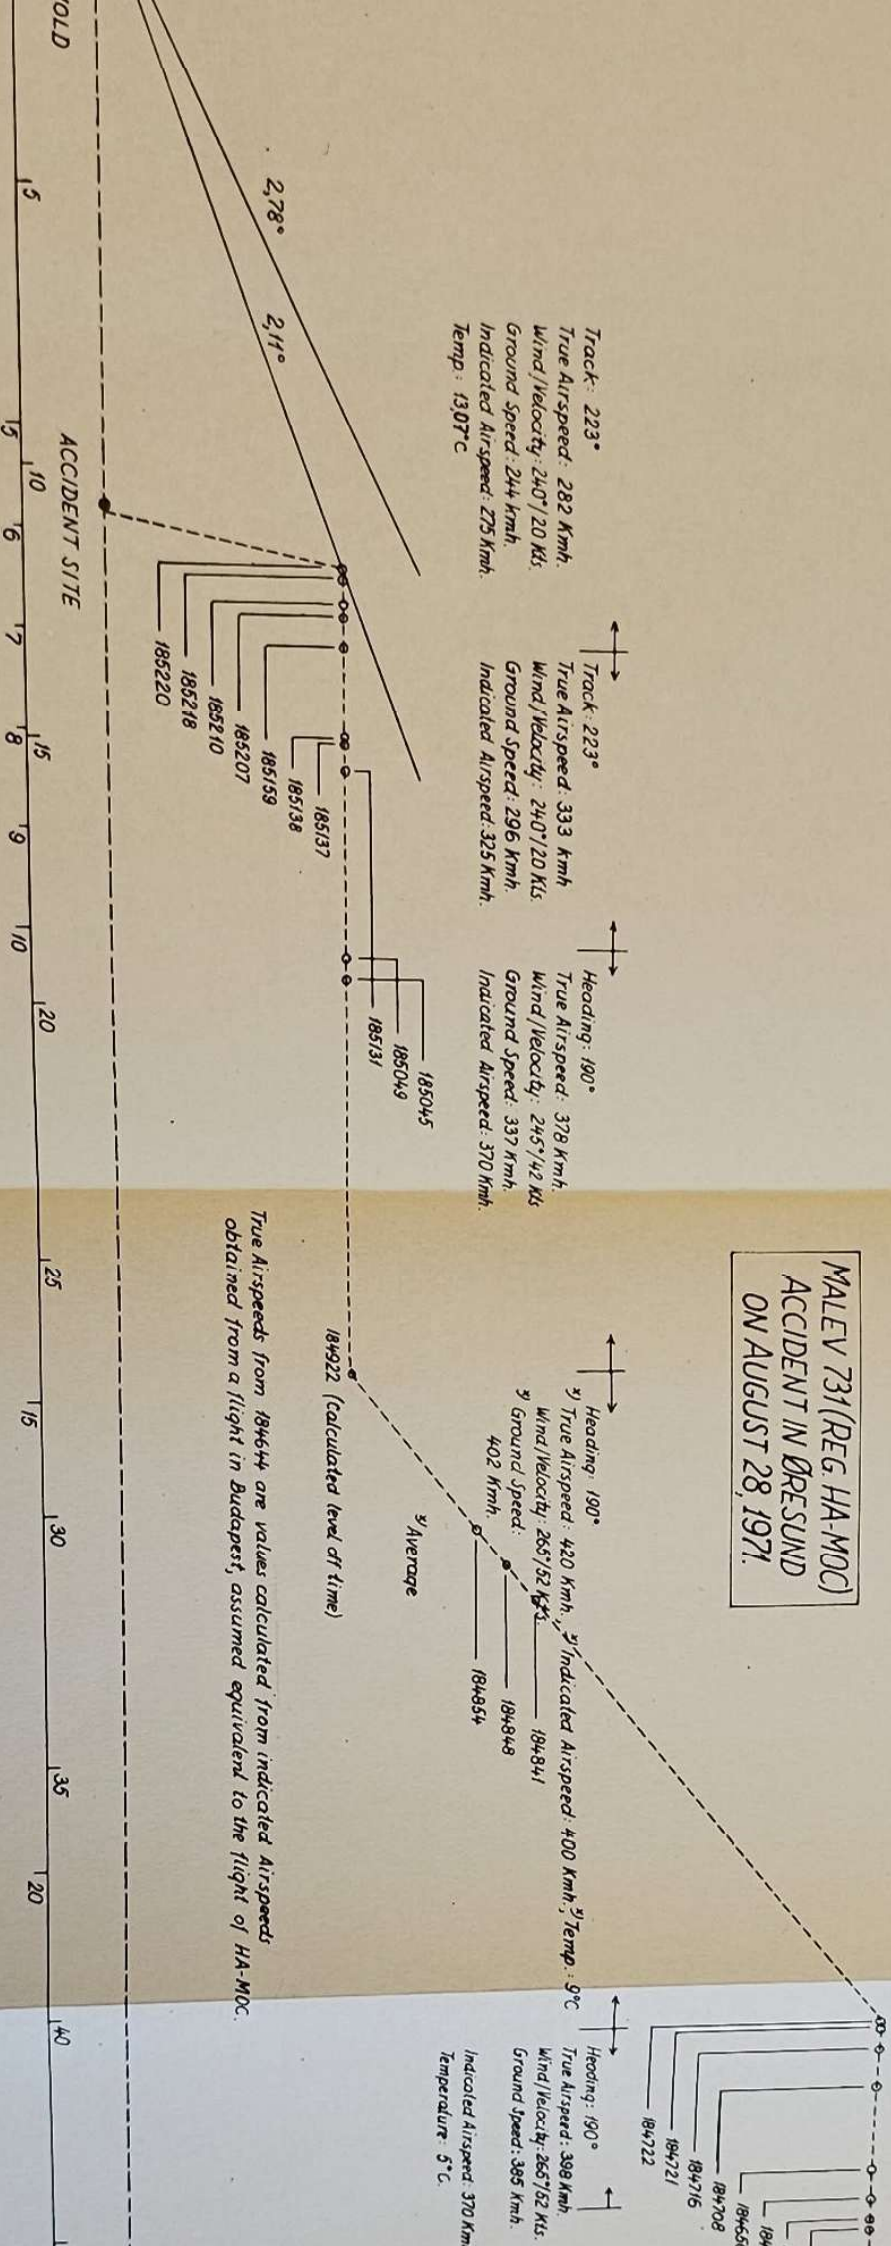
**MALEV 731 (REG. HA-MDC)
ACCIDENT IN ØRESUND
ON AUGUST 28, 1971.**

True Airspeeds from 184644 are values calculated from indicated Airspeeds obtained from a flight in Budapest, assumed equivalent to the flight of HA-MDC.
