AIRCRAFT ACCIDENT REPORT #H90002
TRANSPORT CANADA BEECHCRAFT 65-90
REGISTRATION C-FCAS
SHERRINGTON, QUEBEC
MAY 1, 1979

SYNOPSIS

On 1 May 1979 a Transport Canada King Air 65-90 was calibrating a radar antenna located at Dorval airport. While flying a 20 mile orbit at 1700', the right wing separated from the aircraft. The aircraft crashed in open farm land and was destroyed. Both occupants were killed.

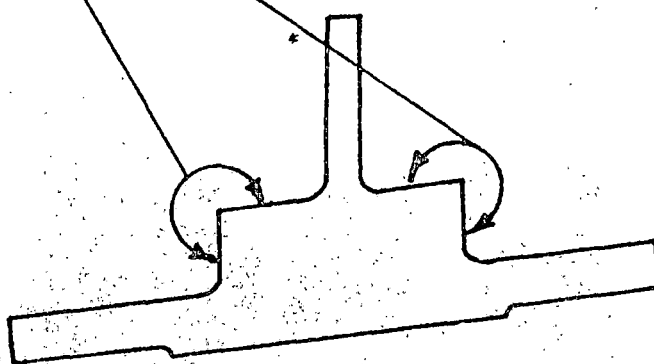
Figure 4. Spar Cap Cross Section

DYE PENETRANT INSPECT
SURFACE IN THESE AREAS

6. Inspect the lower forward spar cap within the fuselage. Access to the spar cap is gained by removing the forward cabin seats and the floorboard panels immediately forward and aft of the forward spar. Use dye penetrant procedures as outlined in AC43.13-1 to inspect the forward shoulder areas (see figure 4) of the
