AIRCRAFT ACCIDENT REPORT

**NORTH AMERICAN ROAD LTD.
MITSUBISHI MU-2B-35, C-GLOW
EDMONTON, ALBERTA
6 DECEMBER 1981**

REPORT NUMBER 81-W10137

SYNOPSIS

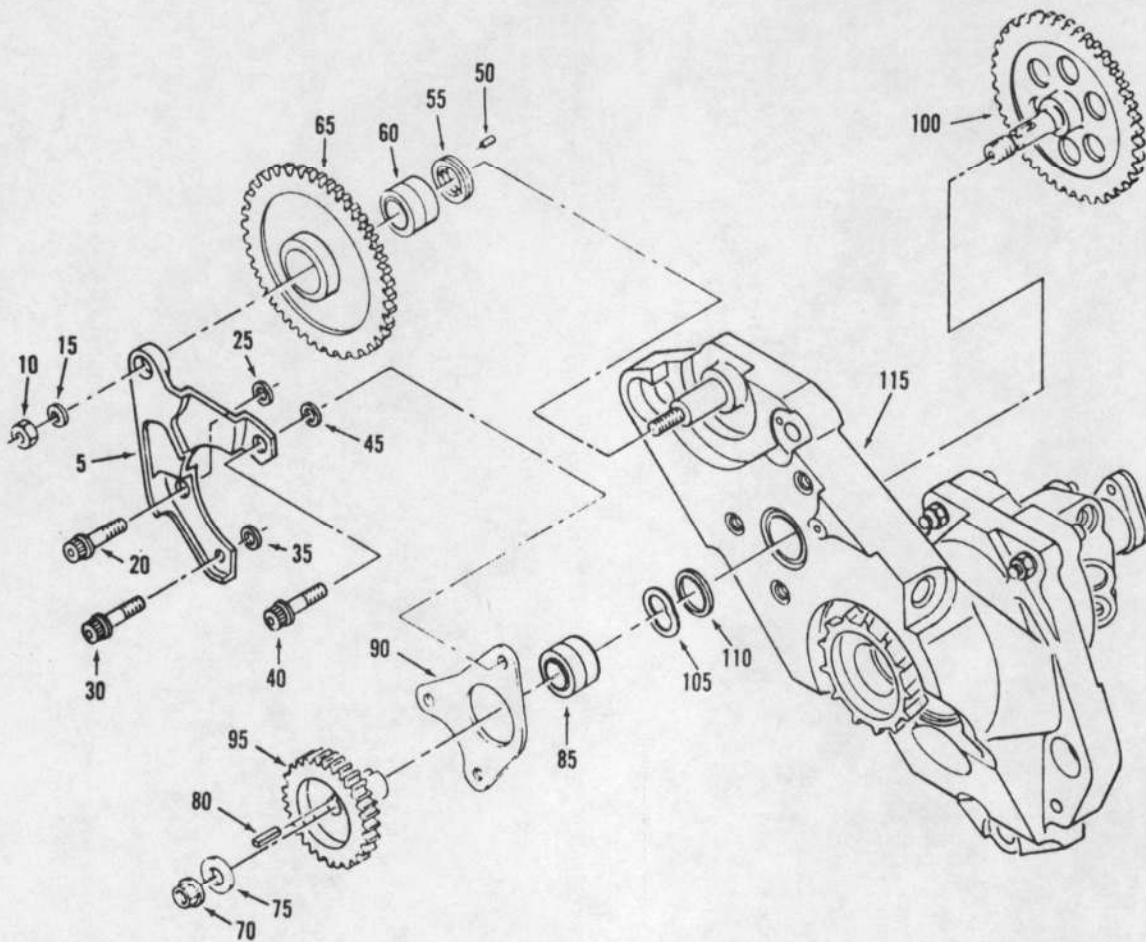
APPENDIX D
ANNEXE D

The support brackets for both right and left idler gears (Item 5, Appendix D) on the torque sensor assemblies and the gears themselves (Items 95 and 65, Appendix D) had curved imprints on the forward faces (Photos 3 and 4, Appendix F). The gears could be aligned so that the marks were concentric, and there was no indication of smearing.
