**FINAL REPORT**  
**OF**  
**DC - 10**  
**HL 7328**

# FINAL REPORT OF DC - 10

## AIRCRAFT ACCIDENT FINAL REPORT

KOREAN AIR MCDONNELL DOUGLAS DC-10-30 KOREAN REGISTRATION  
HL-7328 CRASHED NEARBY TRIPOLI INTERNATIONAL AIRPORT SOUTH  
-EAST OF RUNWAY 27 ON JULY 27TH 1989.

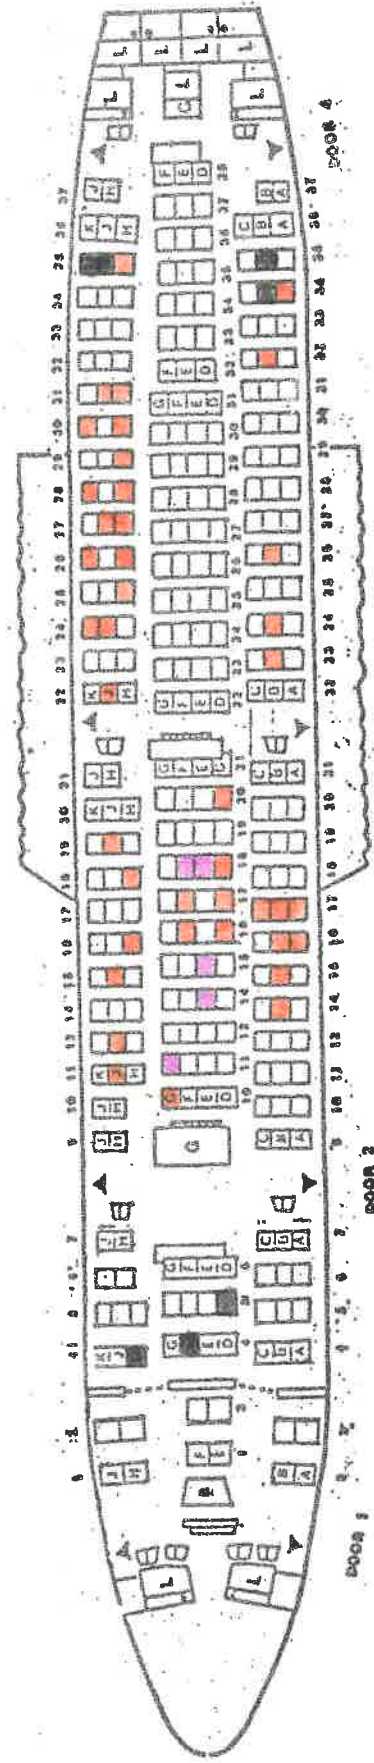
HL7328 CABIN INTERIOR ARRANGEMENT

- KOREAN VICTIMS BY FIRE ضحايا كوريين بسبب الحريق
- KOREAN VICTIMS BY SHOCK ضحايا كوريين بسبب الصدمة
- OTHER VICTIMS BY FIRE ضحايا آخرون بسبب الحريق
