**REPORT ON THE ACCIDENT
B707 - REG. 5N-VRG AT OSTEND
AIRPORT ON 14TH NOVEMBER 1998**

REPORT

Engine Inspection Report IAT B707 Engine Separation, Brussels, Belgium, 14 November 1998

SUBJECT: B707 - INVESTIGATION ON SEPARATED ENGINE

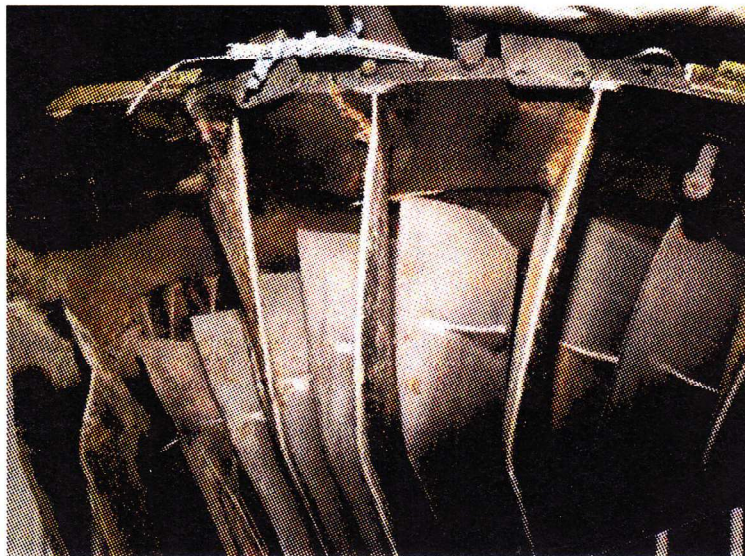
The R-1 fan blade rear tip section was examined by mirror and no evidence of fatigue was found. The tip fracture section about the 2/3 chord could not be examined because lack of space.

The R-1 fan case, the 1st vanes, R-2 fan, and fan exit guide vane did not show any evidence of fan blade liberation witness marks. The OD of the crushed side of the fan case, centered at 3:00 o'clock viewed from rear, did not show evidence of a piece of fan blade impact from the inside outward.

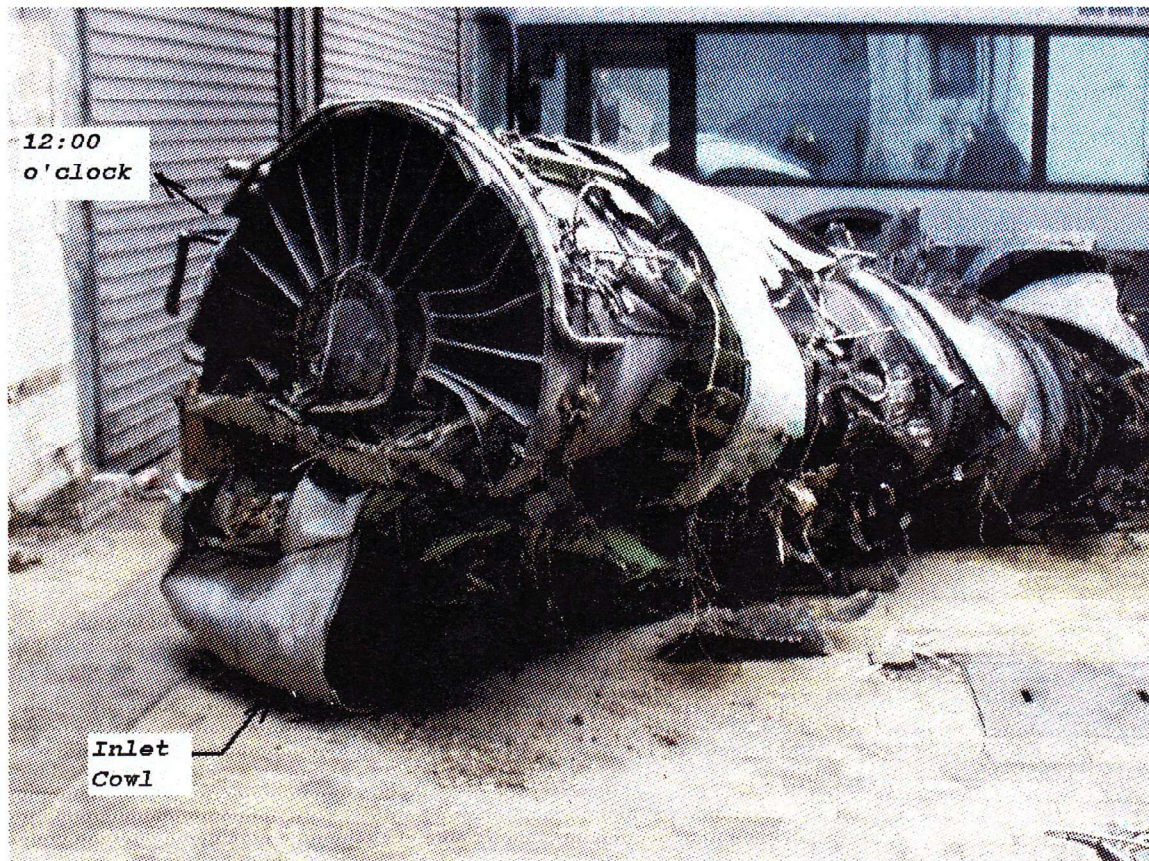
LOW PRESSURE COMPRESSOR (LPC)

The R-1 fan case, the 1st vanes, R-2 fan, and fan exit guide vane did not show any evidence of fan blade liberation witness marks.

No signs of disk rupture through examined case.
