AVIATION OCCURRENCE REPORT

**BRADLEY AIR SERVICES LTD.
BRITISH AEROSPACE HS 748-2B C-GFFA
CHENEY, ONTARIO
15 SEPTEMBER 1988**

REPORT NUMBER 88H0011

18 June 1991

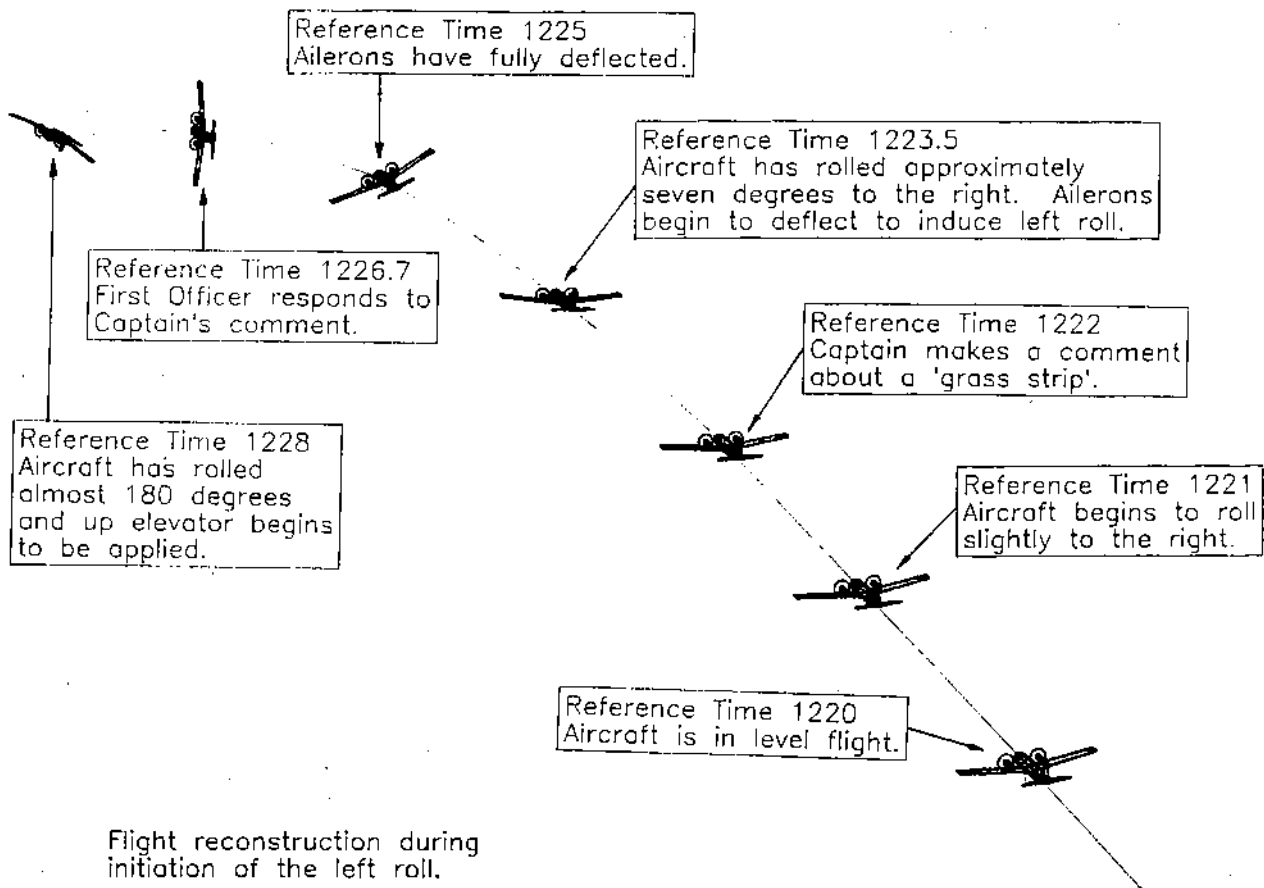
DIAGRAM OF ACCIDENT MANOEUVRE

The aircraft was in cruise flight at 3,000 feet in visual flight conditions while on an instrument flight rules flight to Ottawa International Airport from Montreal/Dorval Airport. Coincident with a remark by the captain pointing out a ground feature, the aircraft commenced a full aileron deflection roll to the left; the aircraft rolled 465 degrees and descended to impact with a final speed of approximately 290 knots. In the last stages of the accident manoeuvre, a maximum vertical acceleration of approximately 4.7 g was recorded. Both crew members on board were killed, and the aircraft was destroyed.
