Aviation Investigation Report AIR-26-02

Midair Collision over the Potomac River PSA Airlines Flight 5342, Mitsubishi Heavy Industries (MHI) RJ Aviation CL-600-2C10 (CRJ700), and US Army Priority Air Transport Flight 25, Sikorsky UH-60L

Washington, DC
January 29, 2025

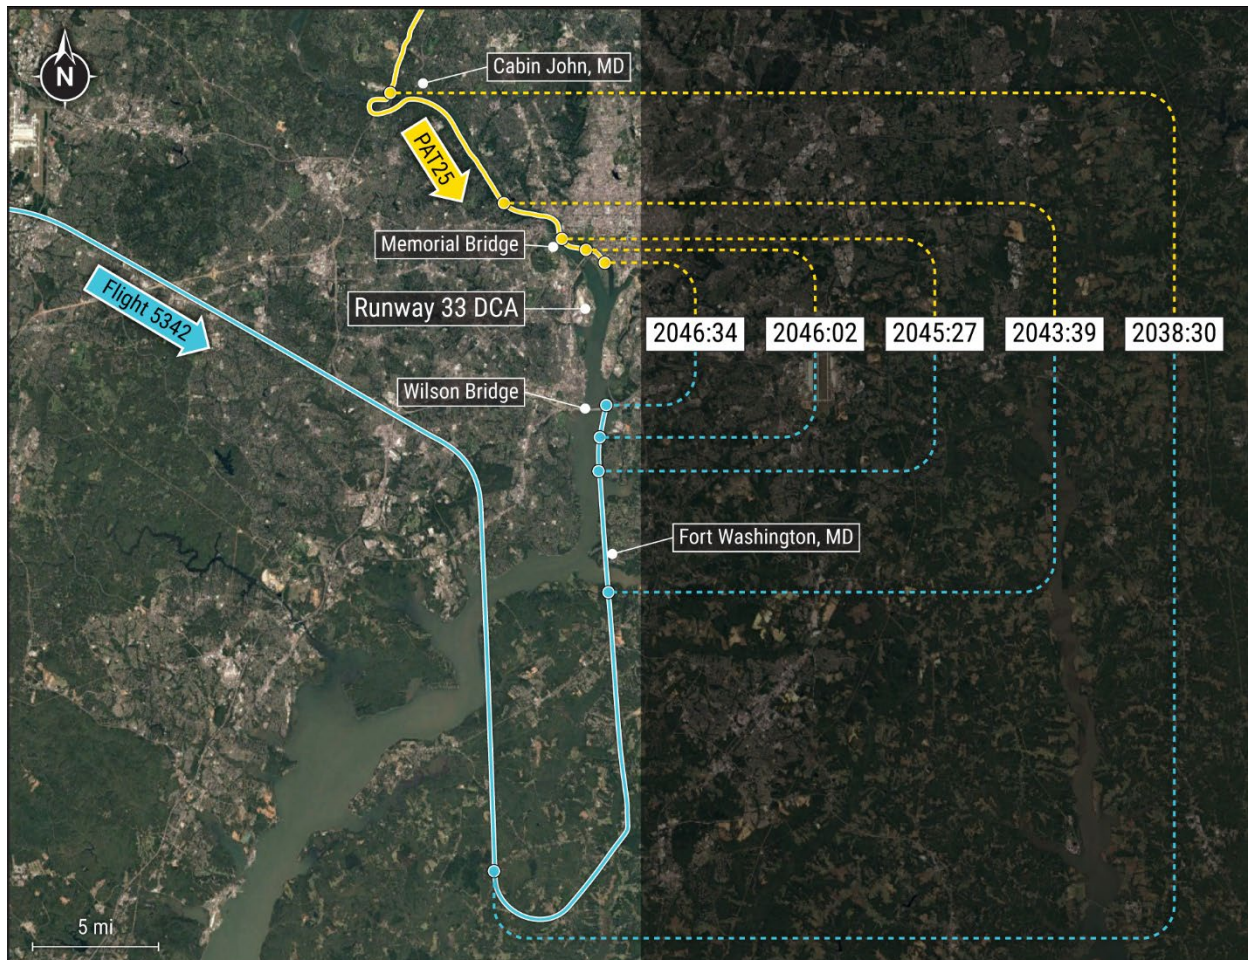
Figure 1. Locations and flight paths of flight 5342 and PAT25 showing aircraft positions from 2038:30 to 2046:34.

About 2038:30 (or 9:29 before the collision), while descending from 1,400 ft mean sea level (msl), the helicopter reached Cabin John, Maryland, where Helicopter Route 1 began. The pilot initially turned west before the IP advised that they had turned the wrong direction. The helicopter subsequently circled toward the east while continuing its descent, joined Route 1, and continued south along the Potomac River at 800 ft msl (see figure 1).

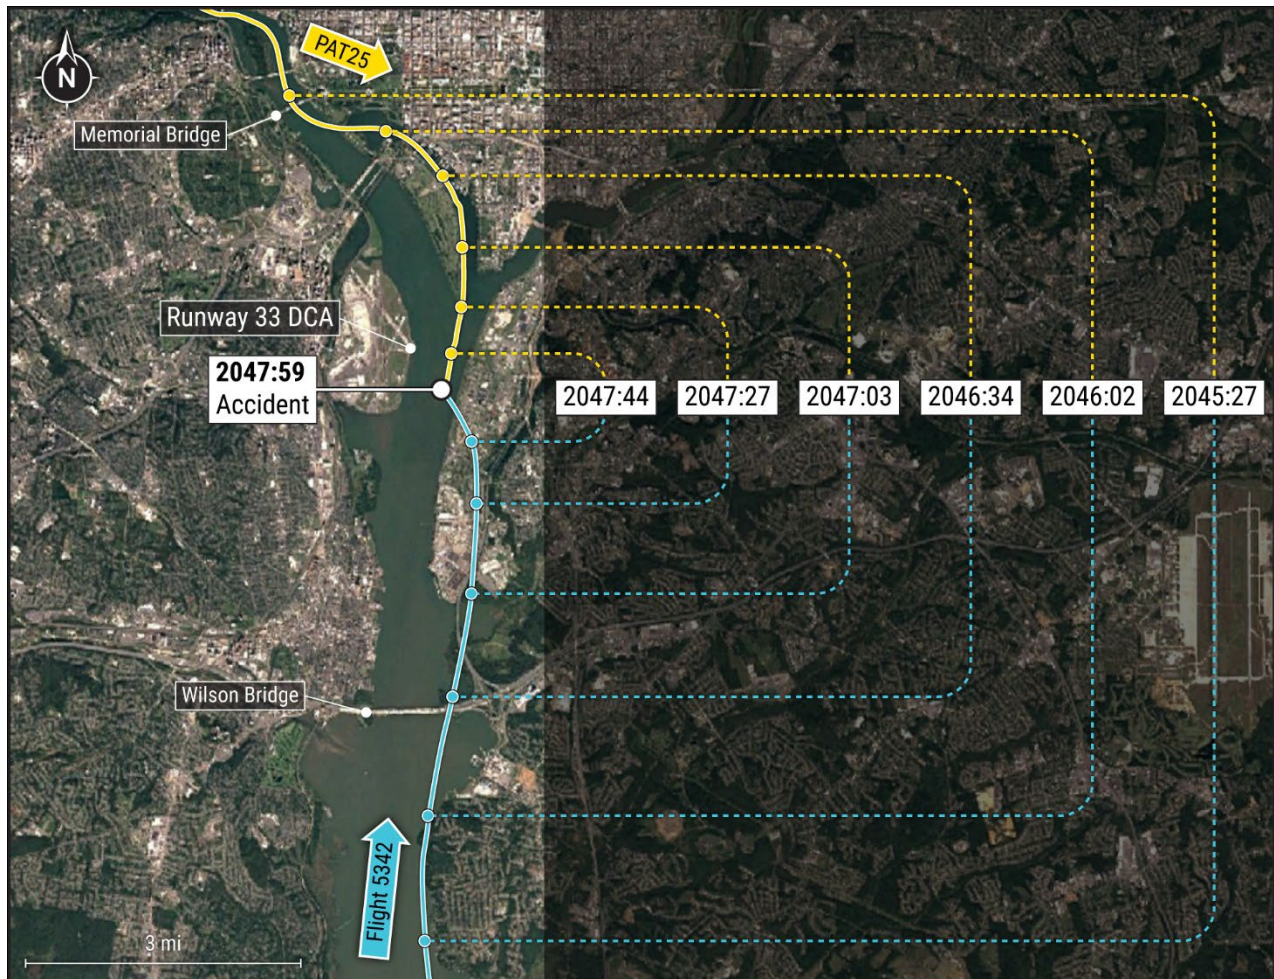
Figure 2. Locations of flight 5342 and PAT25 from 2045:27 through 2047:59.

According to radar data, the controller received a conflict alert beginning at 2047:33 (or 26 seconds before the collision).¹⁷ At 2047:39 (see figure 2), the controller contacted the helicopter, stating, “PAT two five do you have the C-R-J in sight?” The conflict alert was audible in the background of this transmission.¹⁸ The controller’s query to PAT25, with the conflict alert audible in the background, was audible on the airplane’s CVR. Data from the airplane’s FDR and CVR also indicated that, about this time, at a radio altitude of 448 ft, the crew received a traffic alert and collision avoidance system (TCAS) traffic advisory (TA), which included the aural annunciation, “Traffic. Traffic.” Information recorded on the FDR did not indicate if the TA on the TCAS display provided the crew with information on the bearing, or

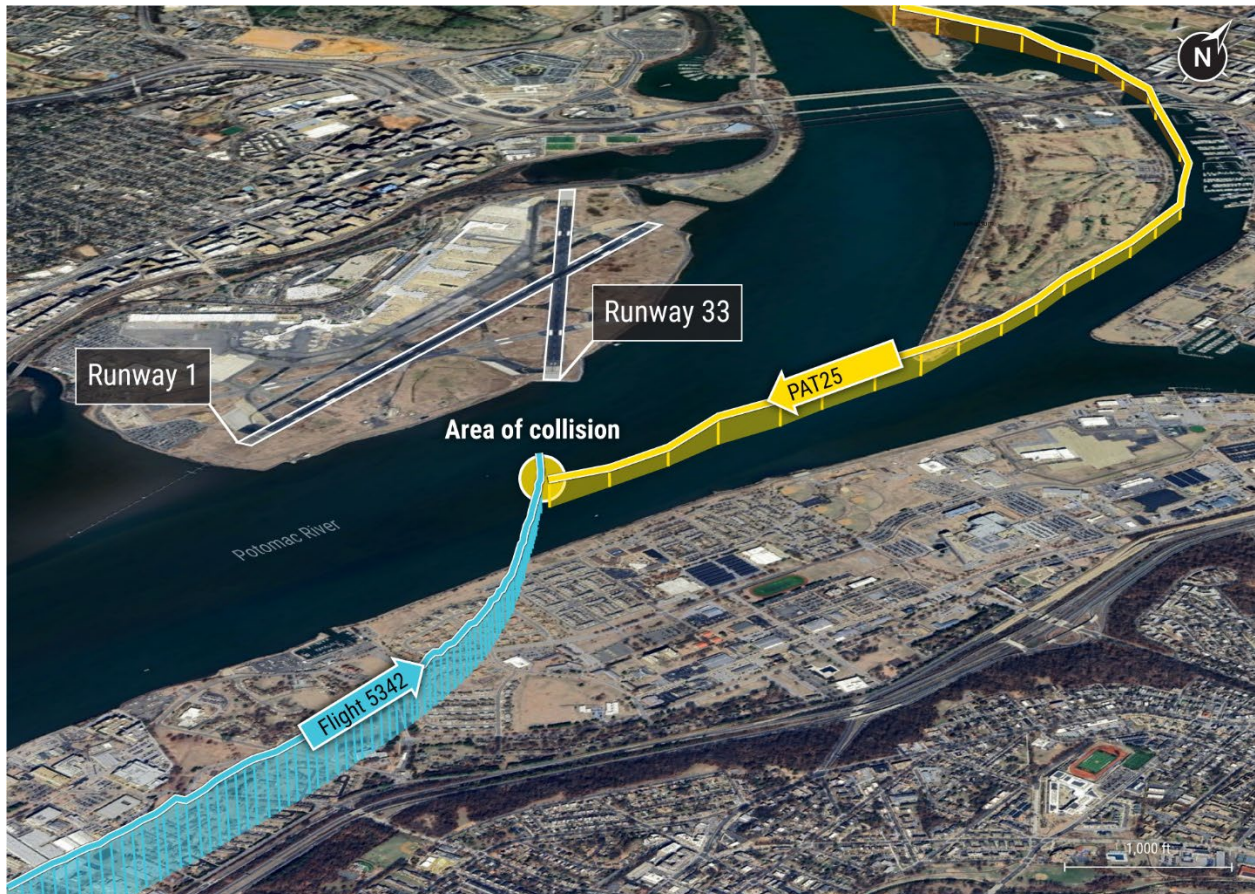
Figure 3. Oblique aerial illustration of the Automatic Dependent Surveillance–Broadcast flight track for flight 5342 (yellow line) and the composite data-derived flight path for PAT25 (blue line) converging near DCA.

position, of the conflicting traffic. The CVR indicated that the crew did not verbally acknowledge the TA, nor did they discuss looking for the traffic. The aircraft were about 1 nm apart with a closure rate of about 200 knots. Figure 3 shows the final portions of the flightpaths of both aircraft as they converged.

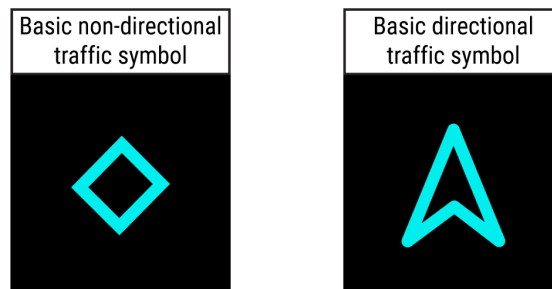
Figure 12. Comparison of basic non-directional and directional traffic symbols. (Source: RTCA DO-317C)

ADS-B In CDTI systems that adhere to ATAS standards display the same traffic information elements as ACAS but also display directional traffic symbols, which is not currently a requirement for TCAS and ACAS Xa products (see figure 12). An important distinction between TCAS and ADS-B is that ADS-B Out equipped aircraft can also transmit additional data besides the aircraft position, including horizontal velocity vector and vertical speed (rate of climb).

TCAS, however, is limited by the fact that it cannot measure bearing, or the relative angle of the target aircraft, precisely enough to determine the direction of the target’s travel. TCAS targets are displayed as symmetrical symbols that do not contain directionality information. To determine the direction these targets are moving, a pilot has to monitor the TCAS display to observe how the target’s position on the display changes over time. Because the primary purpose of TCAS is to assist the pilot in visually acquiring traffic identified by a TA, its use in providing pilots with a complete picture of the behavior of surrounding traffic is limited.

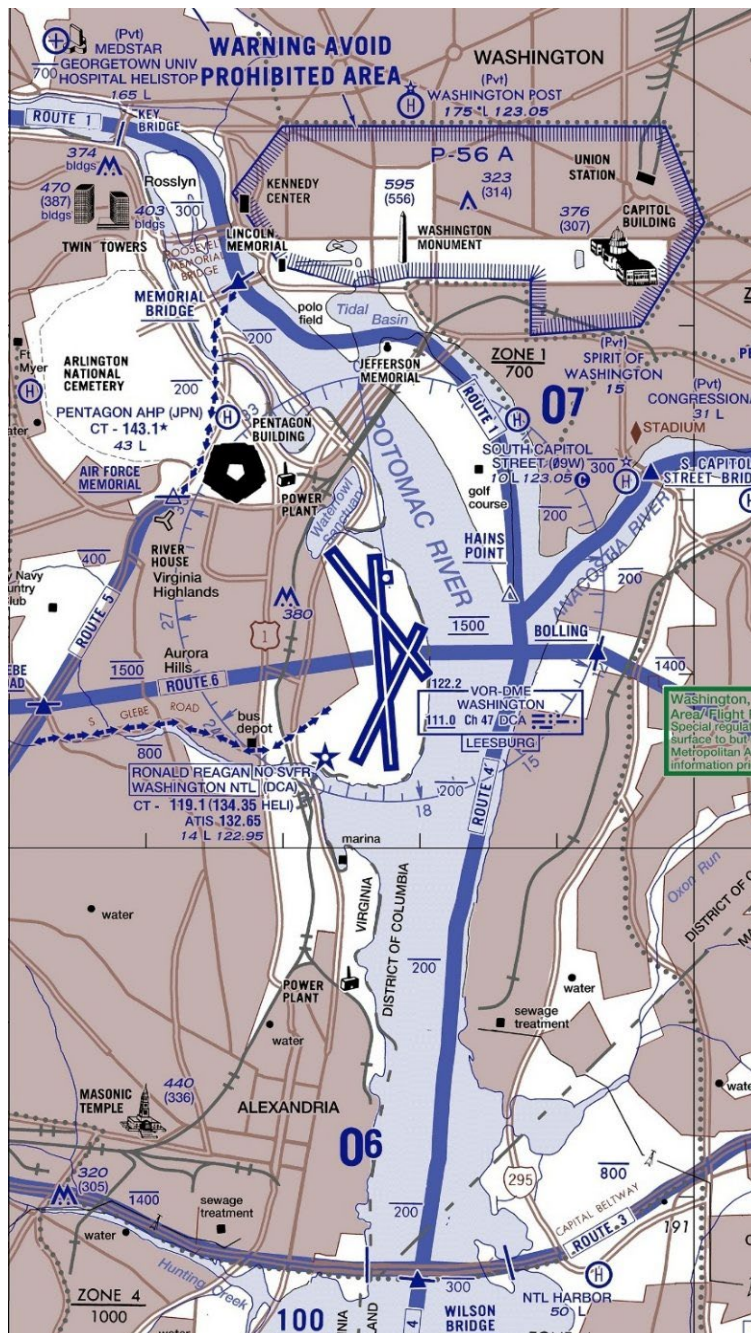
Figure 13. Excerpt of FAA Baltimore-Washington Helicopter Route Chart, current at the time of the accident, showing the area surrounding DCA. (Source: FAA.)

The DCA Class B airspace contains a high volume of helicopter activity from numerous operators, including local and state law enforcement, military, government, and medical transport. The helicopter routes for the Washington, DC, area are contained on the Baltimore-Washington Helicopter Route Chart; figure 13 shows an excerpt from the chart in effect at the time of the accident depicting the area immediately surrounding DCA.

PAT25's route on the night of the accident included Route 1, which began at Cabin John, Maryland (not shown in figure 13), and followed the western shore of the Potomac River southeast toward Washington, DC. After crossing Key Bridge when flying south, the route followed the eastern shore of the Potomac with the Kennedy Center and Lincoln Memorial to the east and Roosevelt Island to the west, then

Route 1 then continued south of the Washington Monument, crossing West Potomac Park and the Tidal Basin before following the Washington Channel along East Potomac Park. Hains Point, the southernmost tip of East Potomac Park and located at the confluence of the Potomac and Anacostia rivers, was identified as a non-compulsory reporting point and the area where Route 4 began and intercepted Route 1, which continued northeast up the Anacostia River. Route 4 continued south toward the Woodrow Wilson Bridge along the Potomac River's eastern shore, with DCA to the west. DCA approach and departure paths for fixed-wing traffic were not shown on the chart.

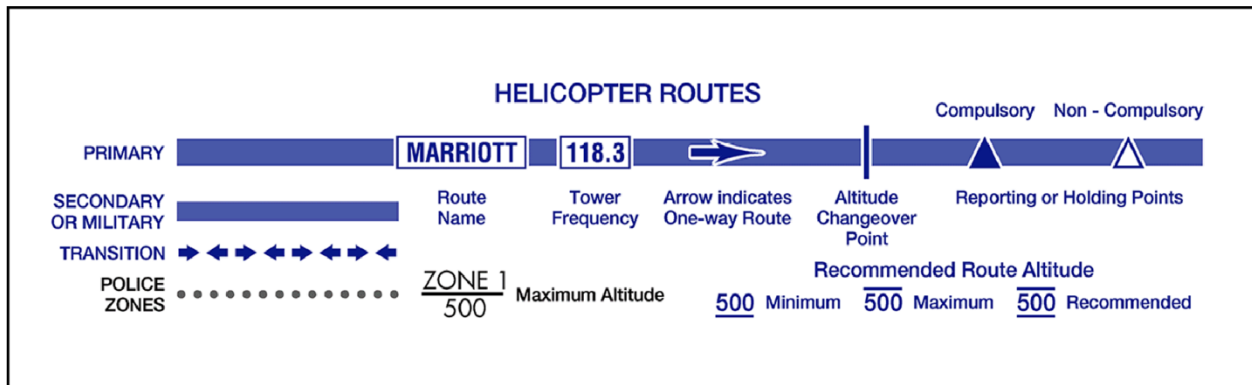
Figure 14. Helicopter route chart excerpt showing altitude information. (Source: FAA)

The chart legend contained additional information regarding the symbology depicted on the chart. The information provided regarding route altitudes was labeled "Recommended Altitudes," and was depicted with a bar below the listed altitude indicating a minimum recommended altitude, a bar above indicating a maximum recommended altitude, and bars both above and below indicating a specific recommended altitude, as shown in figure 14.

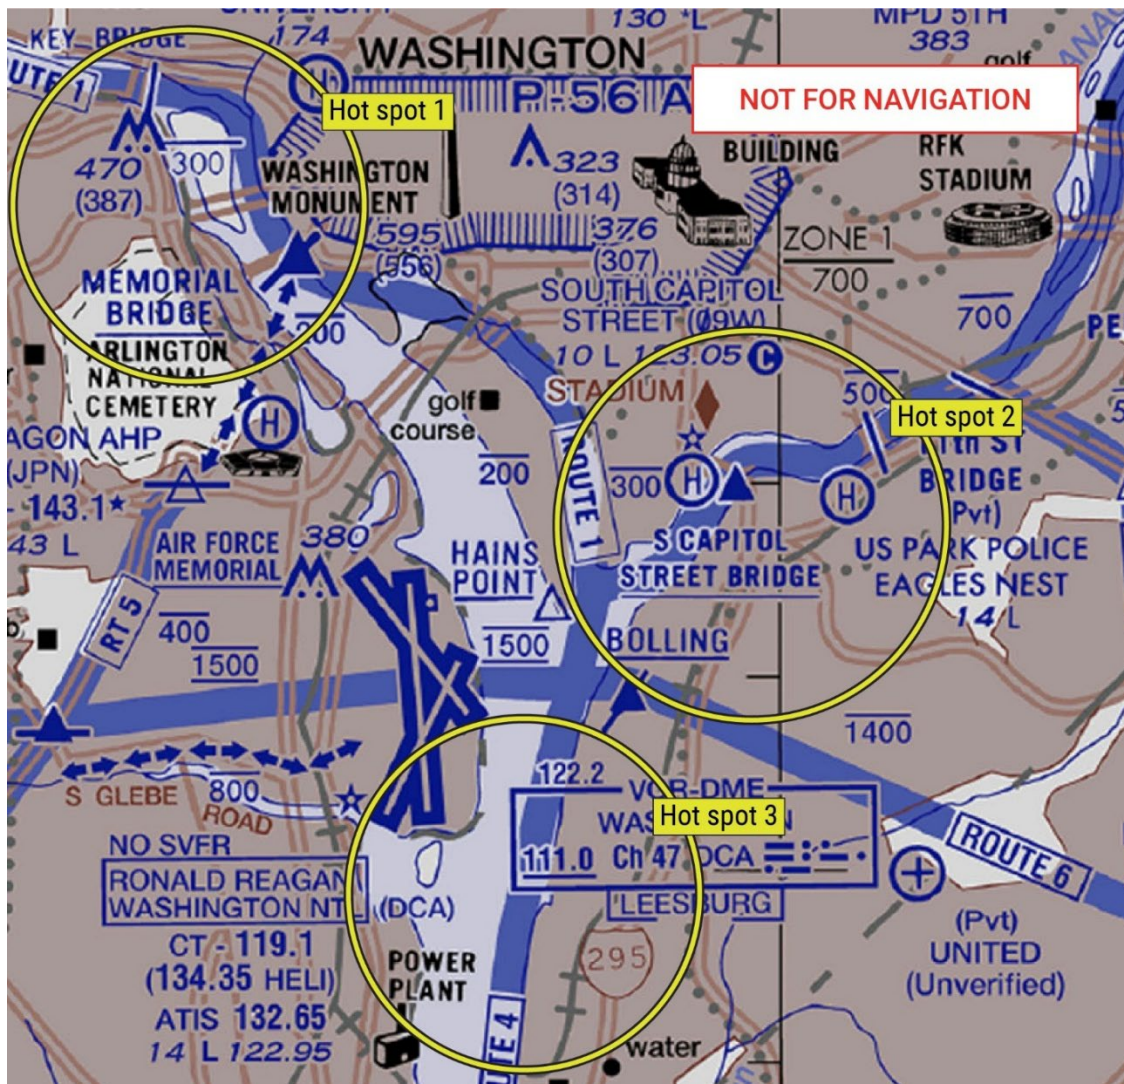
Figure 16. Helicopter route chart excerpt with proposed hotspots circled.

In addition to these suggested changes, the proposal included the addition of three “hotspots” to the helicopter route chart, which were areas that the HWG had identified as posing an increased risk of midair collision based on review of Preliminary Aviation Risk Identification and Assessment (ARIA) Reports (PARs).^{58,59} The intent of the proposed hotspots was to increase pilot and controller awareness and vigilance in those areas. The proposed hotspots included the area of Route 4 and the runway 33 final approach path (where both the 2013 NMAC and this accident occurred), Route 1 in the vicinity of South Capitol Street, and Route 1 near the Memorial Bridge (see figure 16).

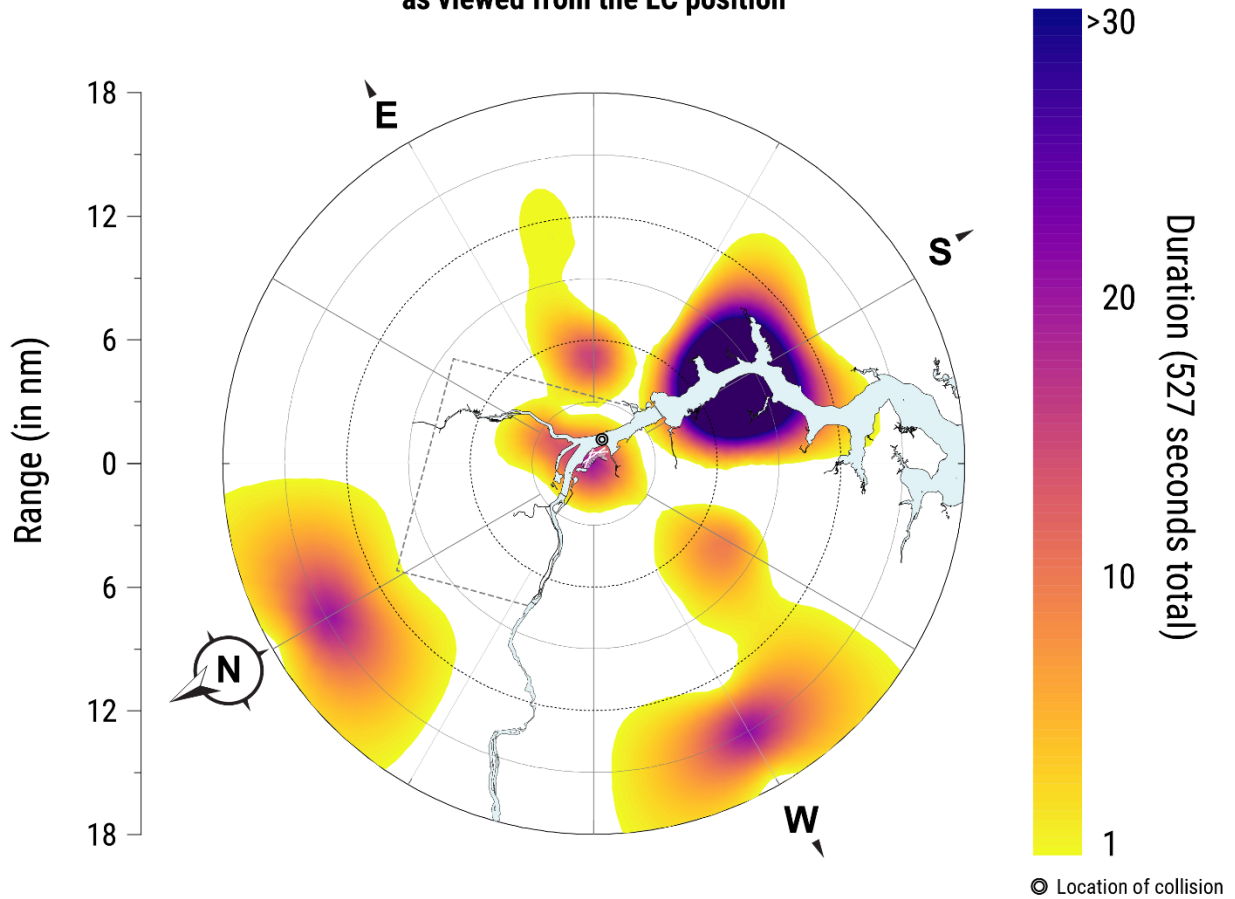
Figure 21. Heatmap of the direction, distance, and duration of the LC controller's communications with aircraft from 2030 to 2047:59 (impact), as viewed from the LC position.

Of the 17 minutes and 59 seconds before the collision, the LC controller was engaged in radio communications with aircraft—either speaking or receiving—for 8 minutes and 46 seconds, or about 49% of the time. A complementary heatmap focusing on the 2 minutes before the collision is presented in figure 22; during this period, the LC controller was attending to radio communications with aircraft for 72 seconds, or 60%, of the time.

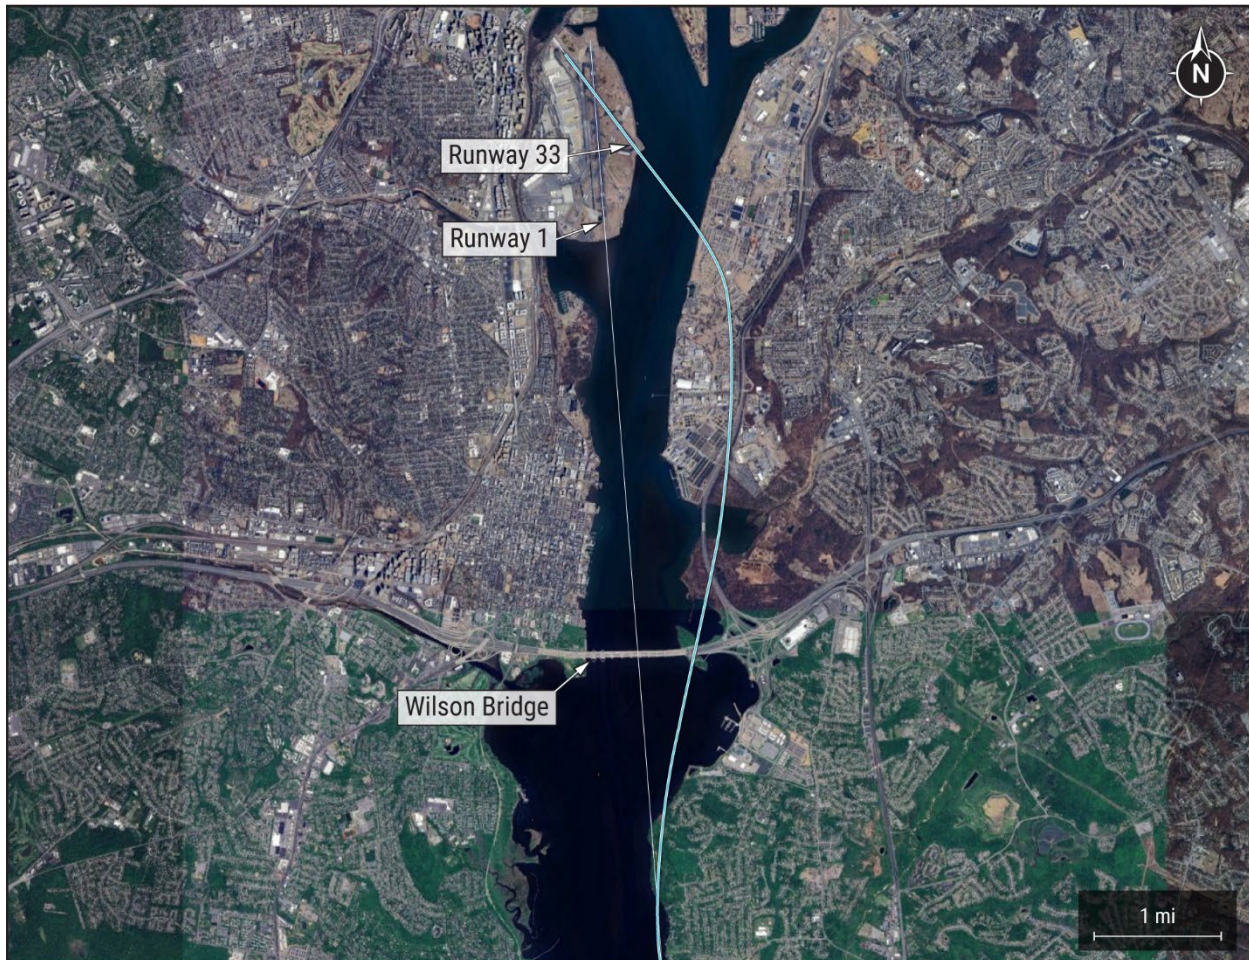
Figure 23. Circling approach to runway 33, annotated with an extended centerline from runway 1.

The change to runway 33 from runway 1 required flight crews to turn away from the runway 1 final approach course and circle to the final approach course for runway 33, then continue their descent and land (see figure 23).⁸⁰ Flight crews were under no obligation to accept a circling approach to runway 33, and due to its shorter length, larger or heavier aircraft with longer landing distances were often unable to use it.

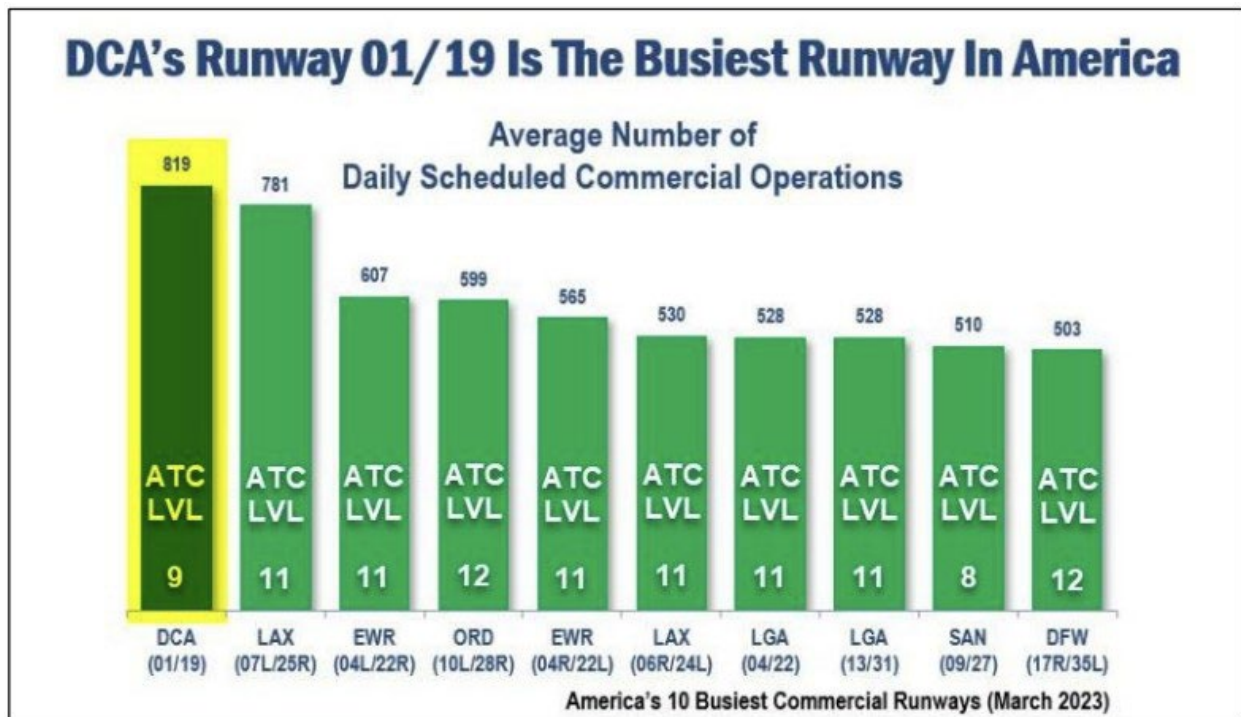
Figure 25. Graph showing average number of daily scheduled commercial aircraft operations on the nation's busiest runways and the ATC facility level associated with each airport.

In June 2023, the Metropolitan Washington Airports Authority (MWAA) newsletter, "On Good Authority," reported on efforts to increase the number of flights at DCA, increasing already heavy congestion on the "busiest runway in America." The article included the graphic shown in figure 25, with additional annotations showing the facility level of the ATCT of each airport. DCA runway 1/19 was shown with an average of 819 daily operations. Of the ten busiest runways depicted on the chart, all but DCA and SAN were classified as level 11 or 12 ATCT facilities.

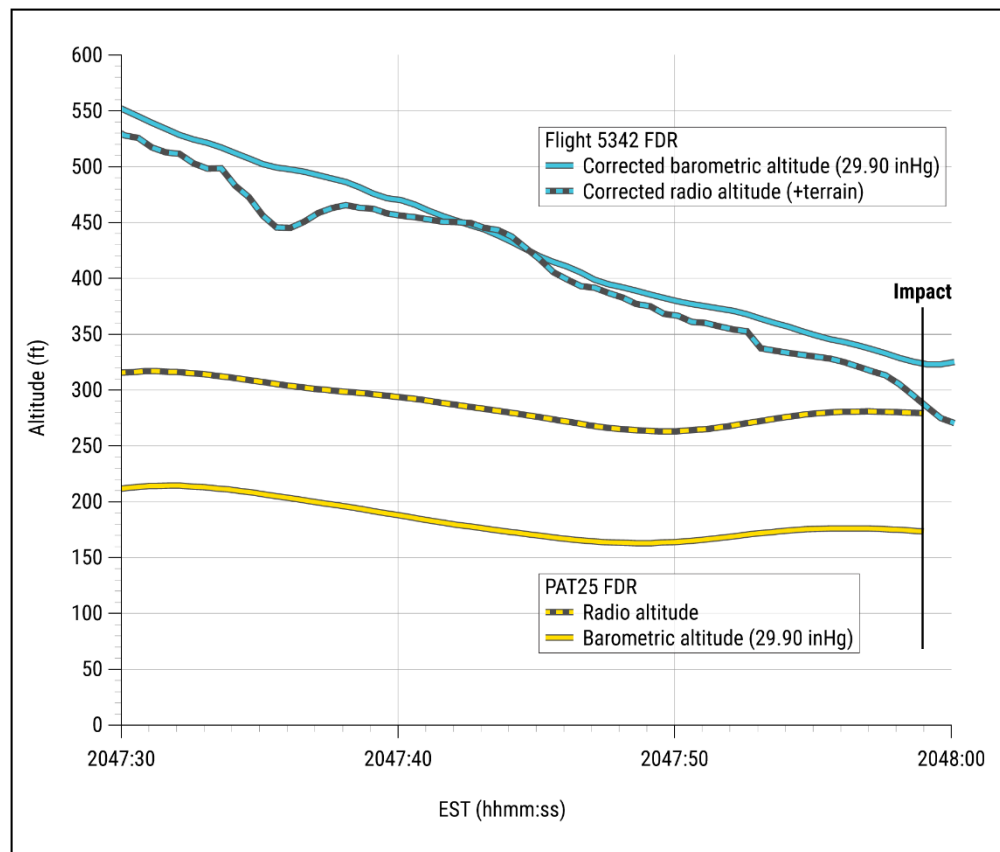
Figure 41. FDR-corrected radio and barometric altitudes for the airplane and helicopter for the flights' final 30 seconds.

The collision occurred at an altitude of 278 ft msl. At the time of the impact, the FDR data for each aircraft showed that their respective radio altitudes were within 10 ft, consistent with the helicopter impacting the underside of the airplane, as confirmed by the wreckage examination. The helicopter's barometric altitude, however, was about 100 ft lower than the other recorded altitudes, as shown in figure 41.

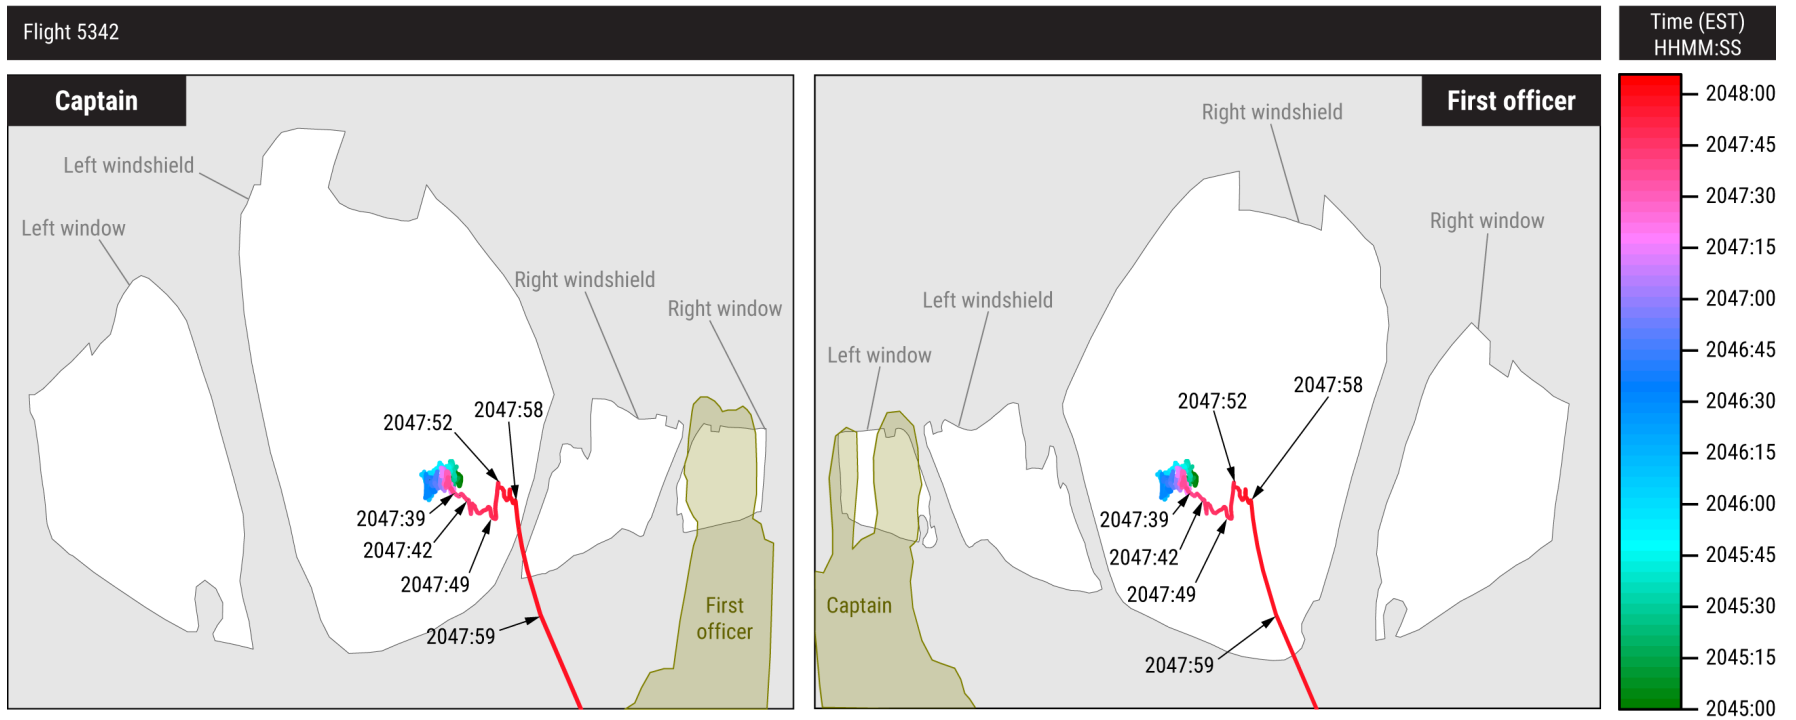
Laser scans of an exemplar CRJ were used to determine how the structure of the airplane would have affected the pilots' view outside. Figure 44 shows the view from the left (captain's) and right (FO's) seats with the structure of the airplane shown in gray and the outlines of the pilot in the opposite seat shown in olive yellow. The shapes are distorted so that the view out all four windows can be shown together. The colored line shows where in the window the helicopter would have been visible to the captain and FO during the final 3 minutes of the flight. From 2045 to 2047:58, the helicopter would have been in the lower right corner of the left windshield for the captain and in the lower third of the right windshield for the FO.

Figure 44. Viewing angles of PAT25 from the captain's (left) and FO's (right) seats of flight 5342, looking straight ahead.

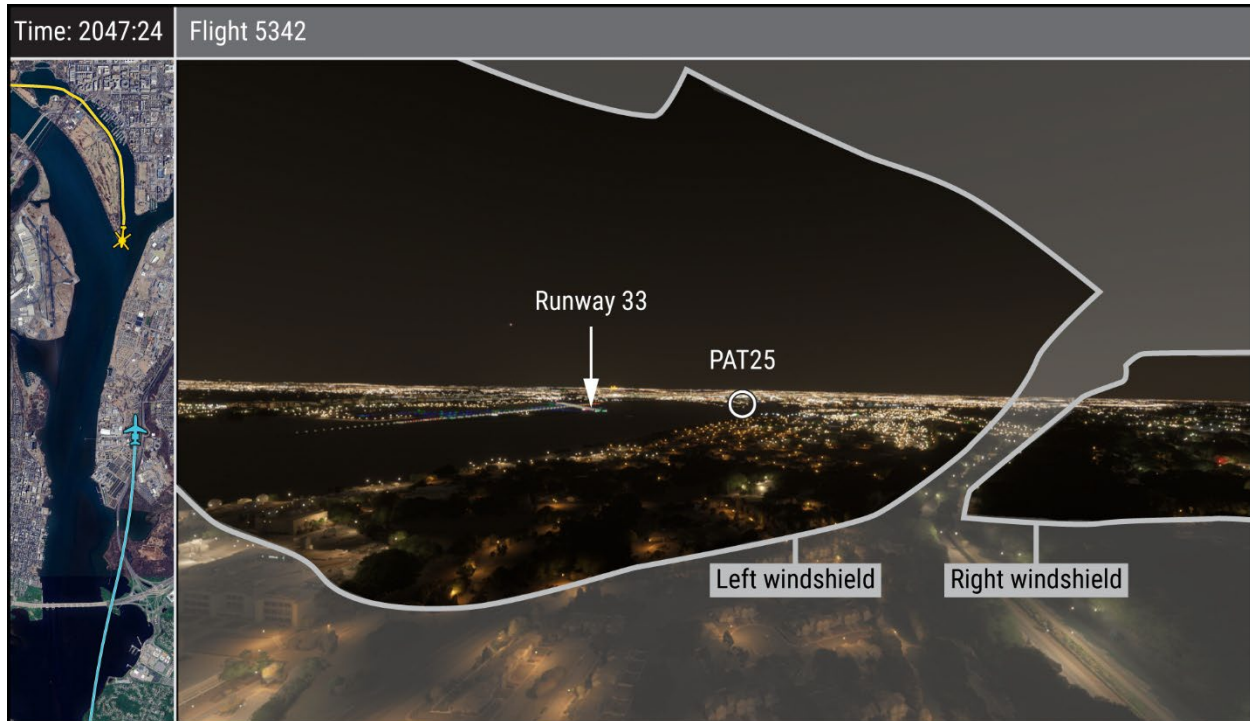
However, during most of the time it was in view, the helicopter would have appeared in the airplane's windscreen as a small object spanning less than 1° of azimuth and elevation.¹⁰⁶ Figure 45 shows a simulated view from the left (captain's) seat of flight 5342; simulated views from the right (FO's) seat are not presented because the background views would be similar.

Figure 45. Simulated view from the left seat of flight 5342 at 2047:24 (35.3 seconds before the collision), looking straight ahead.

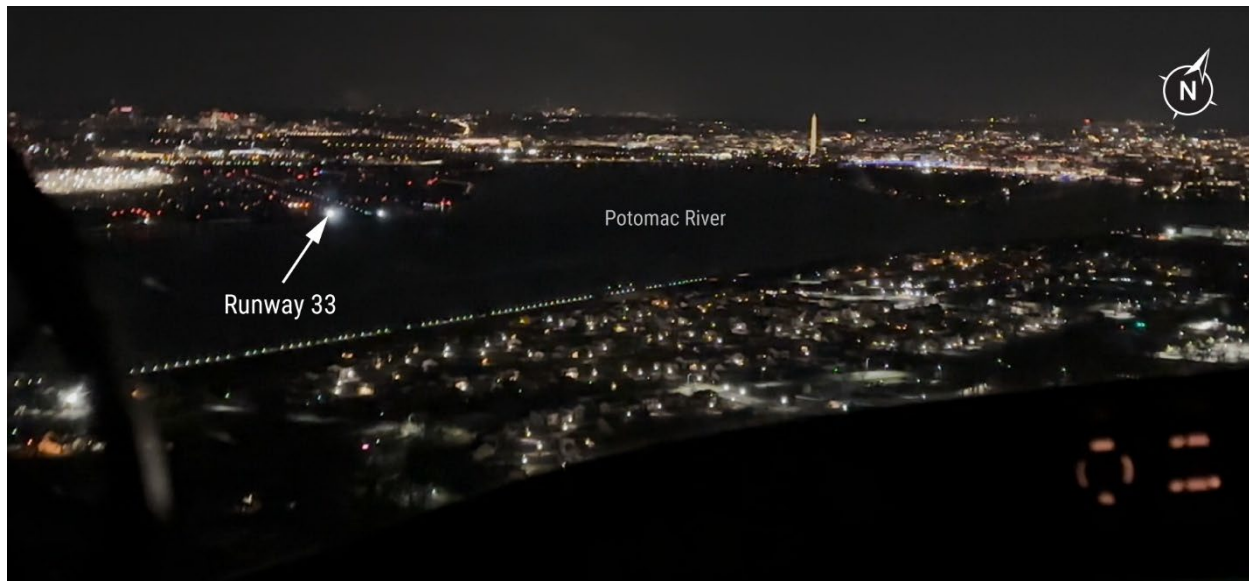
Until about 10 seconds before the collision, the helicopter would have been difficult to visually detect and identify against the cultural lighting of Washington, DC. Figure 46, a frame from a video recorded on an Apple iPhone inside the cockpit of a CRJ turning for final approach to runway 33 during an NTSB night observation flight (discussed in section 1.11.4.4), shows the extent of this cultural lighting. In the simulation, the helicopter emerged from the city lights and appeared against the dark background of the Potomac River about 2047:49. Between 2047:54 and 2047:58, the helicopter's fuselage would have grown significantly in the pilots' fields of view, and

Figure 46. Cultural lighting around Washington, DC, as captured in a video frame recorded on an Apple iPhone inside the cockpit of a CRJ turning for final approach to runway 33 during an NTSB night observation flight.

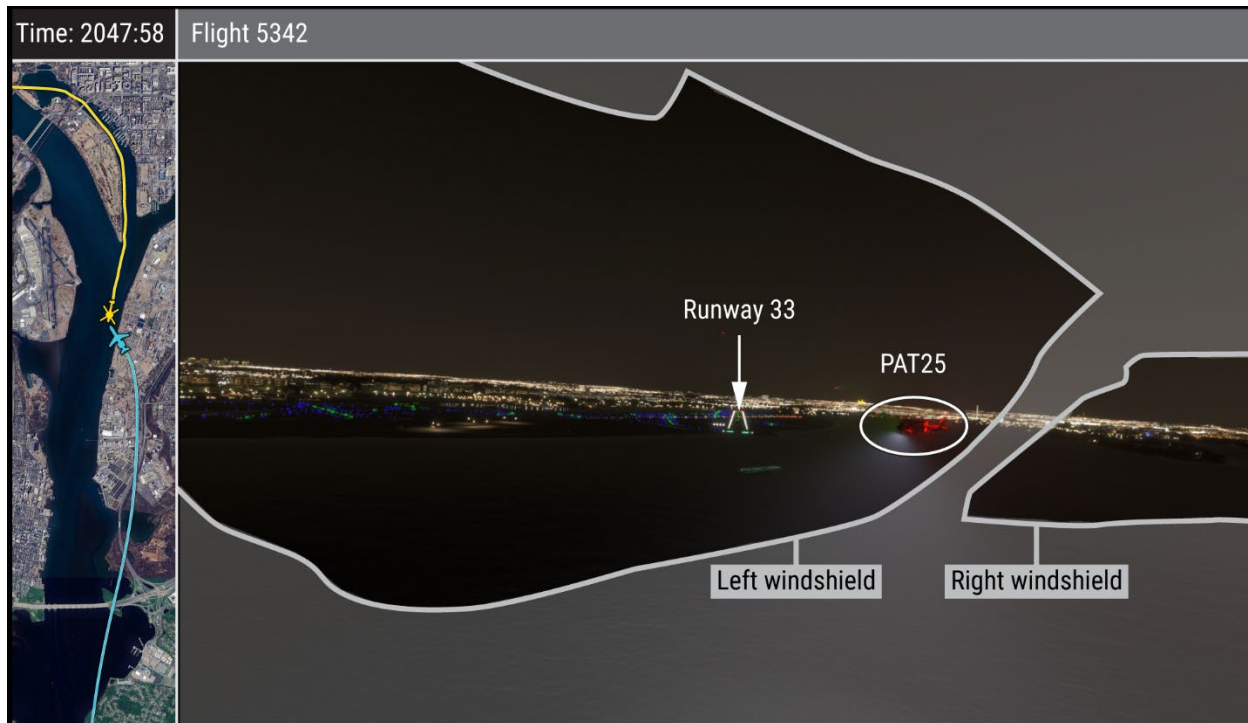
at 2047:58 (1.3 seconds before the collision), the helicopter was apparent in the simulation, as shown in figure 47.¹⁰⁷

Figure 47. Simulated view from flight 5342's left (captain's) seat at 2047:58 (1.3 seconds before collision), looking straight ahead.

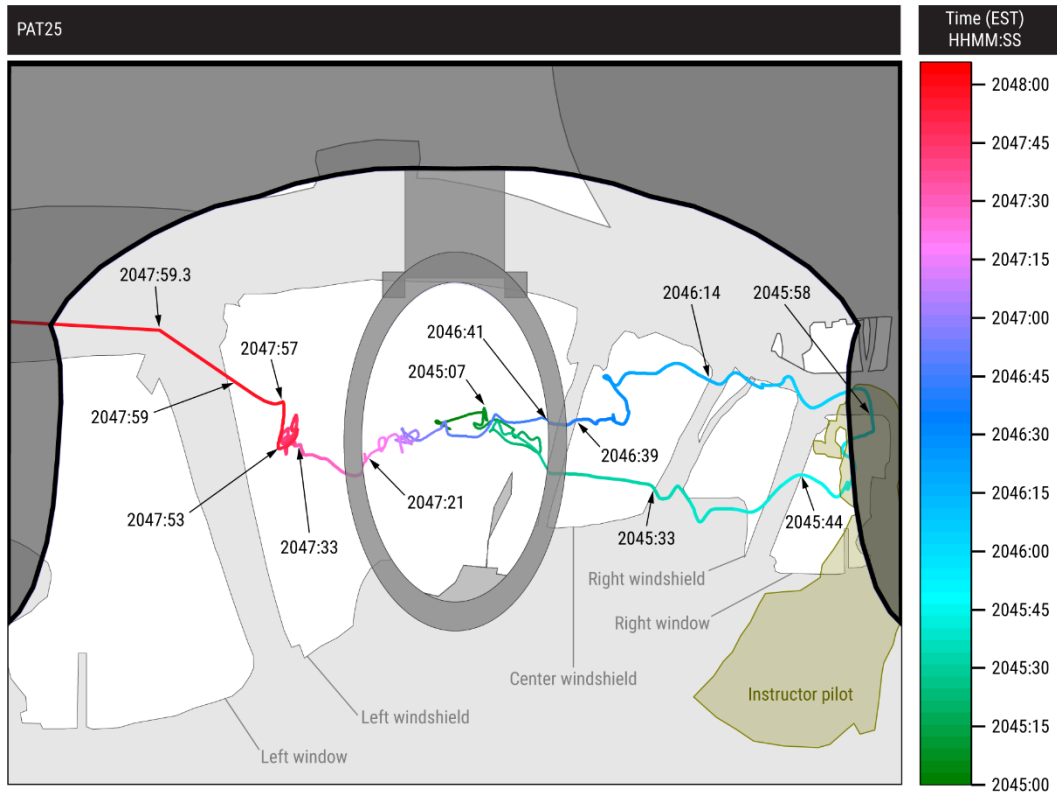
Figure 50 shows the airplane's location for the last 3 minutes of the flight from the perspective of the pilot in the left seat. After about 2046:42 (1 minute 16 seconds before the collision), the airplane would have appeared unobstructed in the left windshield.

Figure 50. Viewing angles of the airplane from the position of the helicopter pilot (left seat), looking straight ahead.

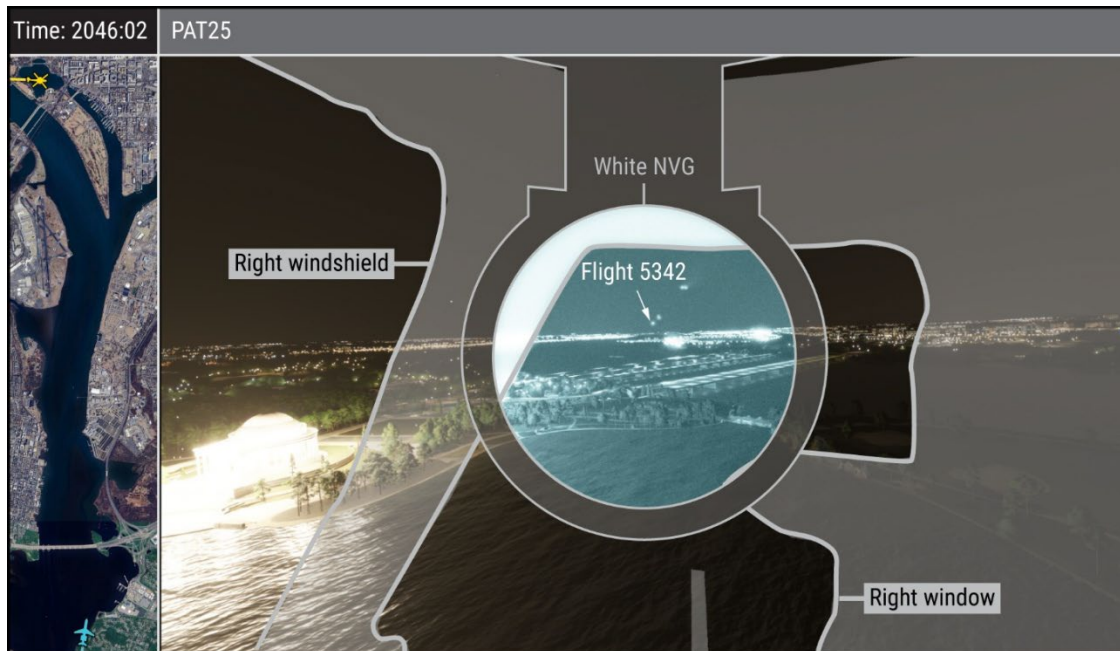
At the time of the controller's first traffic advisory to PAT25 (2 minutes 57 seconds before the collision) the airplane was in a position that would have required the IP to rotate his head to the right and look out the right cockpit window to visually acquire it, as shown in figure 51. From the pilot's view on the left side of the cockpit, the airplane would have been obscured by the IP and aircraft structure.

Figure 51. Simulated view from the right seat of the helicopter at 2046:02 (2 minutes 57 seconds before the collision), about the time of the initial traffic advisory, as seen looking 80° to the right.

The airplane, which was about 6.5 nm away at this time, would have appeared to the PAT25 IP as a dot of light surrounded by a soft “halo” when viewed through NVGs, and would have been one point of light among the several other airplanes on approach to DCA. Outside of the 40° field of view of the NVGs, the airplane and other traffic inbound to DCA would have appeared as points of light in the periphery of the IP’s vision. Figure 52 shows an unaided view of the cultural lighting surrounding Washington, DC, recorded from a GoPro camera in a UH-60L cockpit during an NTSB night observation flight.

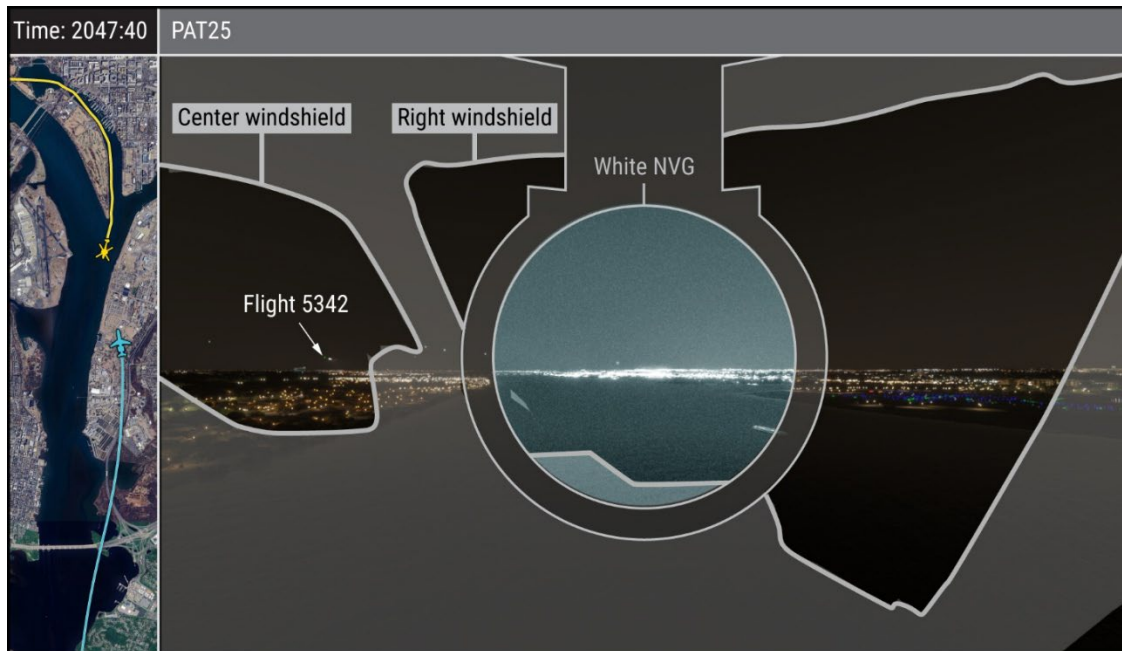
After 2047:26, about 33 seconds before the collision, the airplane would have passed to the left of the IP's field of view provided by the NVGs when focused straight ahead; therefore, to visually acquire the airplane, the IP would have had to turn his head to the left and look out the center windshield. Figure 53 shows the simulated view from the IP's position about 19 seconds before the collision. Figure 54 shows the simulated view from the pilot's position about 19 seconds before the collision. From the pilot's perspective, the airplane would have appeared in the left windshield, and would have remained in the pilot's left windshield until just before the collision occurred.

Figure 53. Simulated view from the right (IP's) seat of the helicopter, looking straight ahead, at 2047:40 (19 seconds before the collision) about the time ATC asked if the helicopter had the CRJ in sight.

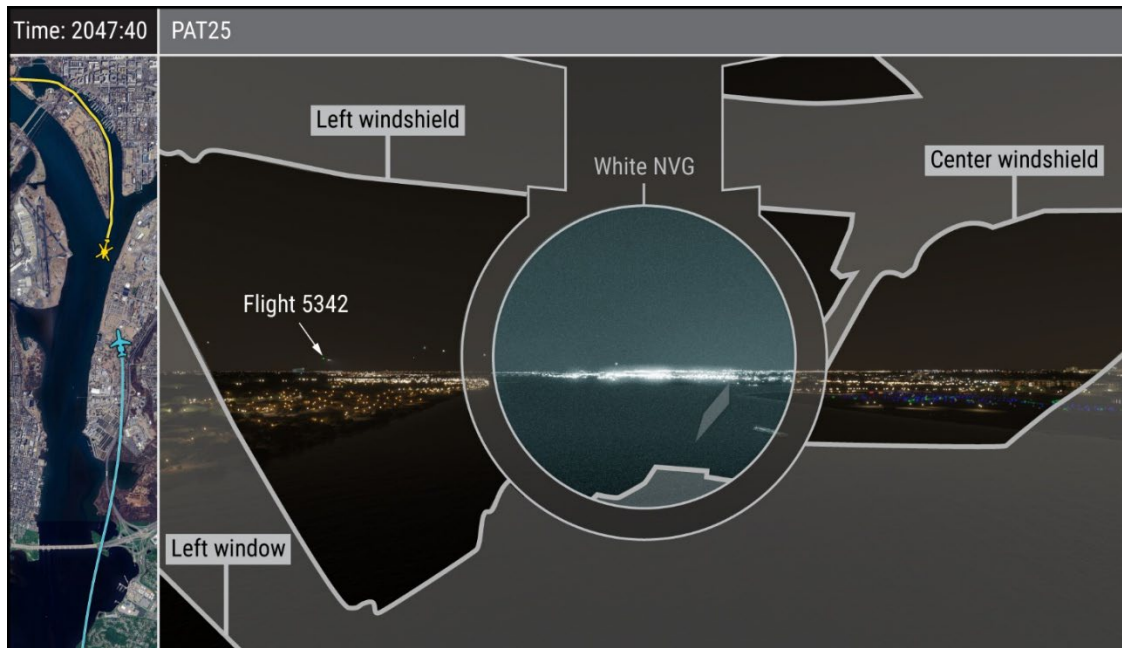
Figure 54. Simulated view from the left (pilot's) seat of the helicopter, looking straight ahead, at 2047:40 (19 seconds before the collision) about the time ATC asked if the helicopter had the CRJ in sight.

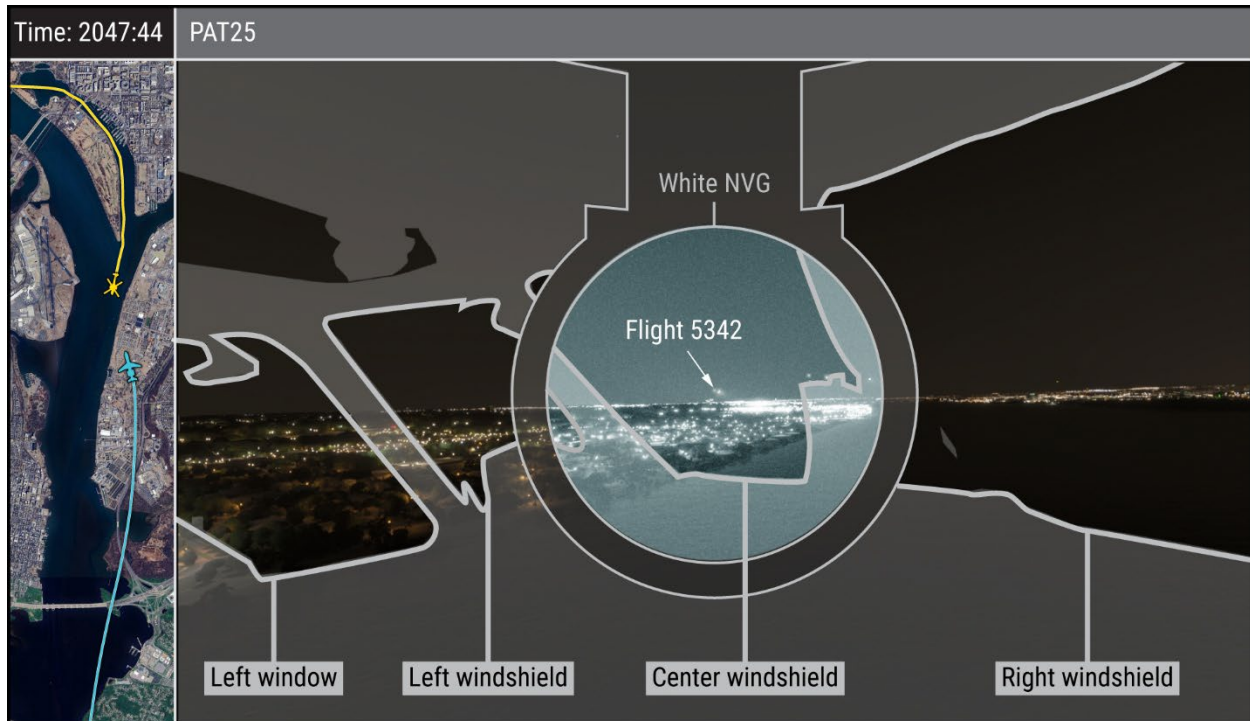
From about 2047:44, about 15 seconds before the collision, the airplane appeared in the simulation above the cultural lighting on the ground, but close to the horizon and just above a brightly-lit hotel in the area of the National Harbor southeast of DCA, as shown in figure 55.

Figure 55. Simulated view from the right (IP's) seat of the helicopter, looking 38° to the left, at 2047:44 (15 seconds before the collision) depicting flight 5342's position just above the horizon through white phosphor NVGs.
