Aviation Investigation Report AIR-26-02

Midair Collision over the Potomac River PSA Airlines Flight 5342, Mitsubishi Heavy Industries (MHI) RJ Aviation CL-600-2C10 (CRJ700), and US Army Priority Air Transport Flight 25, Sikorsky UH-60L

Washington, DC
January 29, 2025

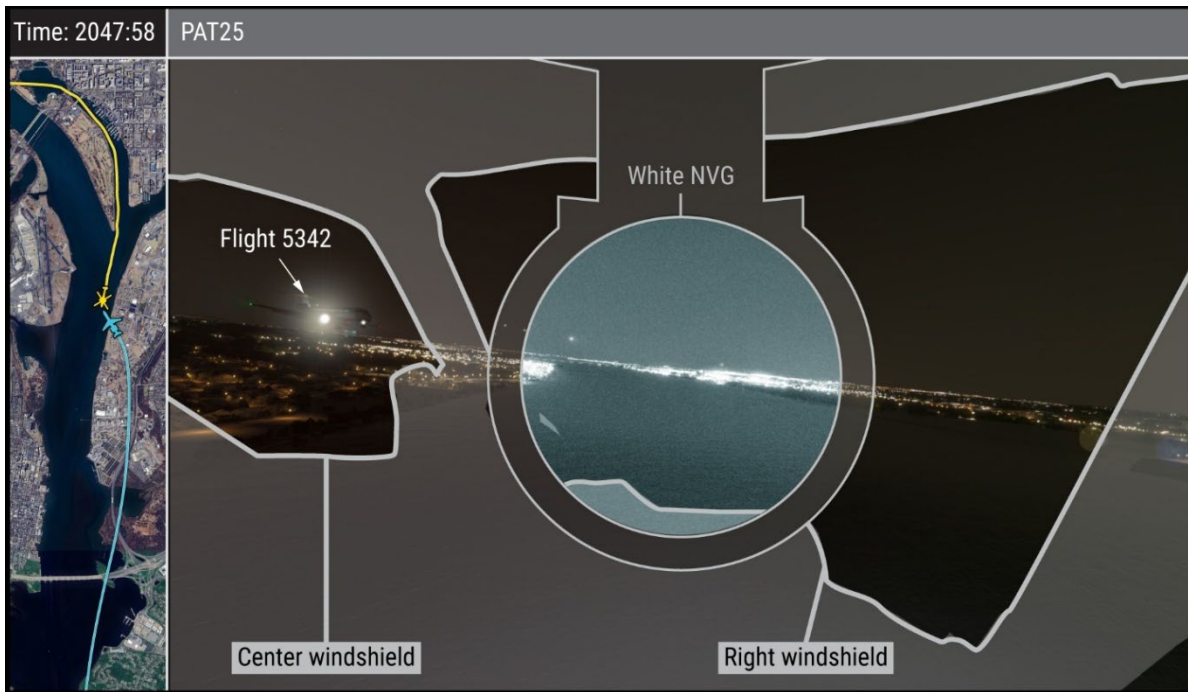
Just before the collision, the airplane would have suddenly increased in size in the helicopter's windscreen, as shown in figure 56, which depicts the IP's perspective from the right seat. Figure 57 depicts the view from the pilot's perspective in the left seat at 2047:58.

Figure 56. Simulated view from the right (IP's) seat of the helicopter at 2047:58 (1 second before the collision), looking straight ahead.

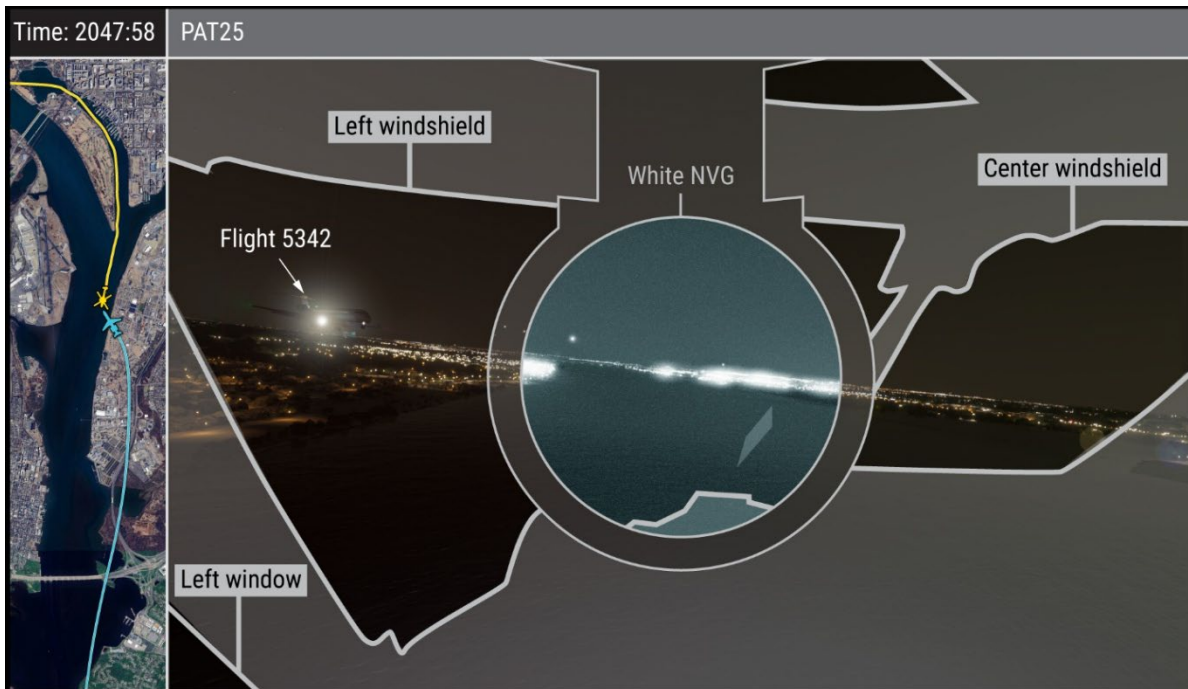
Figure 57. Simulated view from the left (pilot's) seat of the helicopter at 2047:58 (1 second before the collision), looking straight ahead.

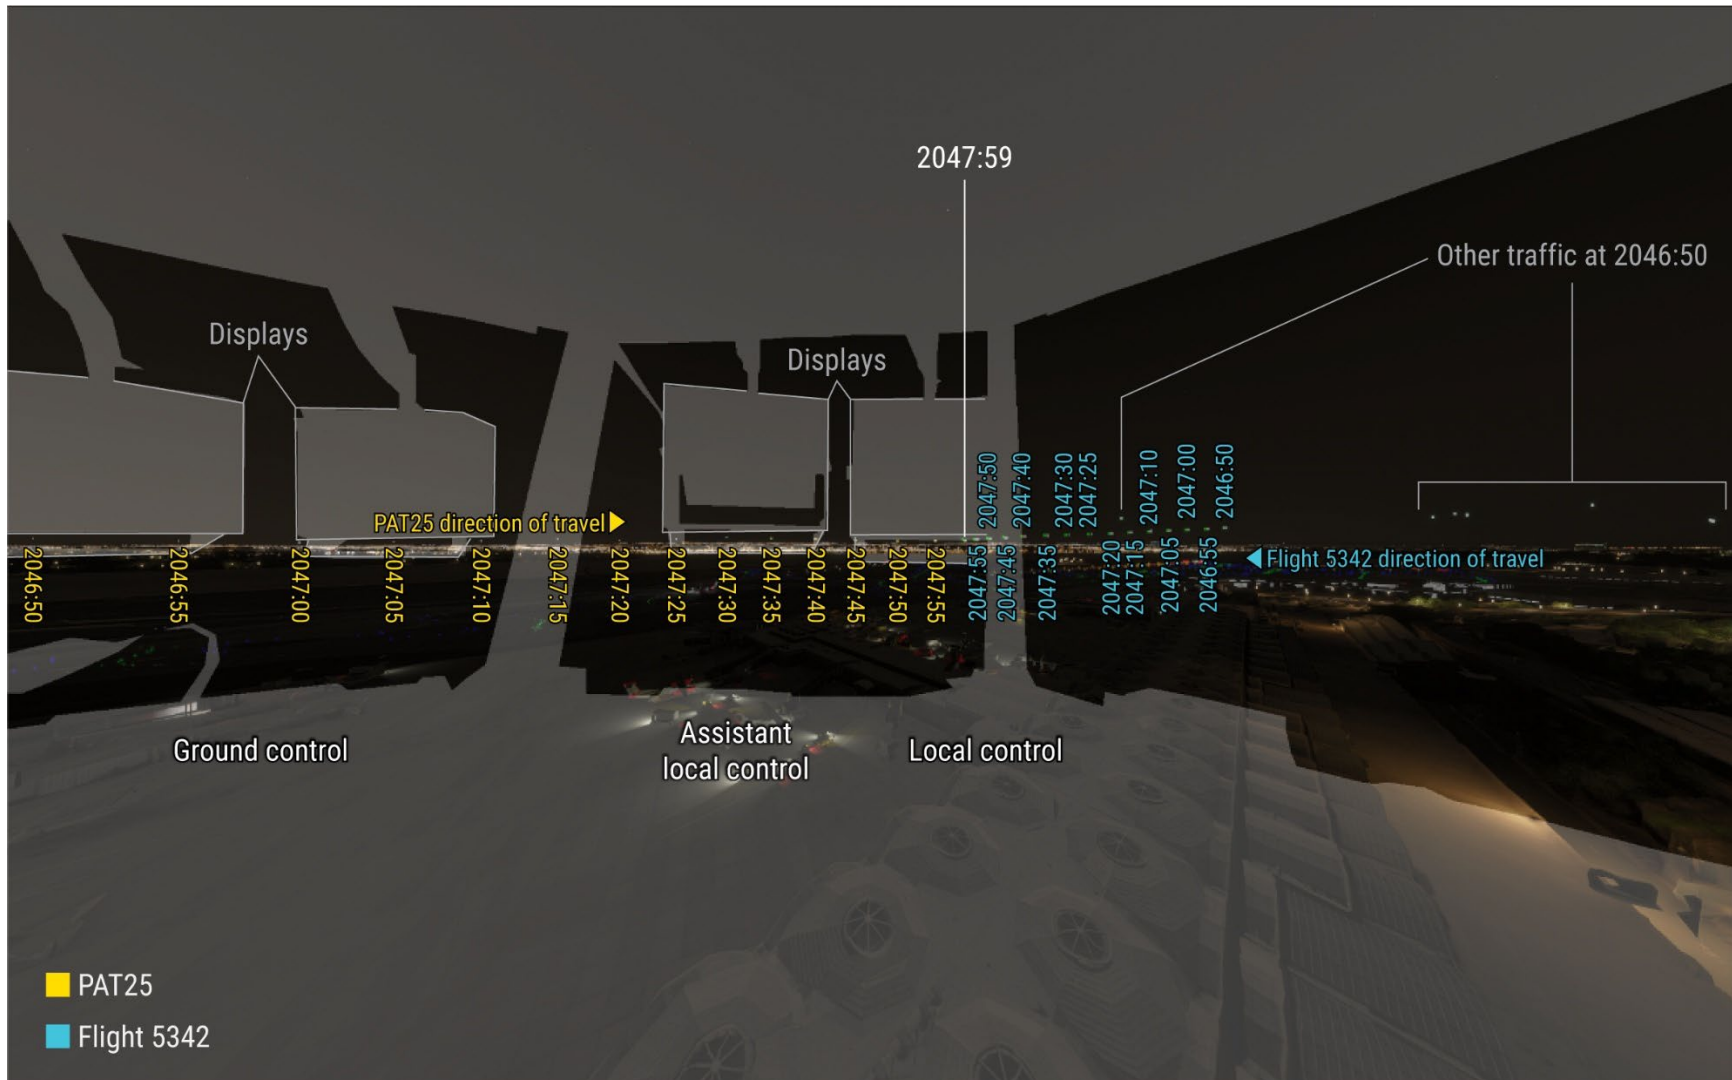
Laser scans of the DCA ATCT cab were used to define the geometry of the cab's windows and the locations of several screens near the top of the windows. These scans were used to generate a simulation of the view from the LC controller's seat, including any obstructions to vision. Figure 60 depicts the simulated tracks of each aircraft as viewed through the tower cab from the LC controller's perspective, with the cab structure and interior equipment (which would have obscured his view) depicted in gray. Figure 61 presents a plot of the viewing angles of flight 5342 and PAT25 from the LC controller's workstation. These images assume a stationary position, and do not account for uncertainty in the LC controller's actual position or the freedom he had to move around. Figure 62 presents a photograph taken from the LC position during an NTSB observation.

Figure 60. Simulation of the views from the ATC tower cab of the helicopter and airplane during the approximate minute before the accident, with aircraft positions at the labeled times.

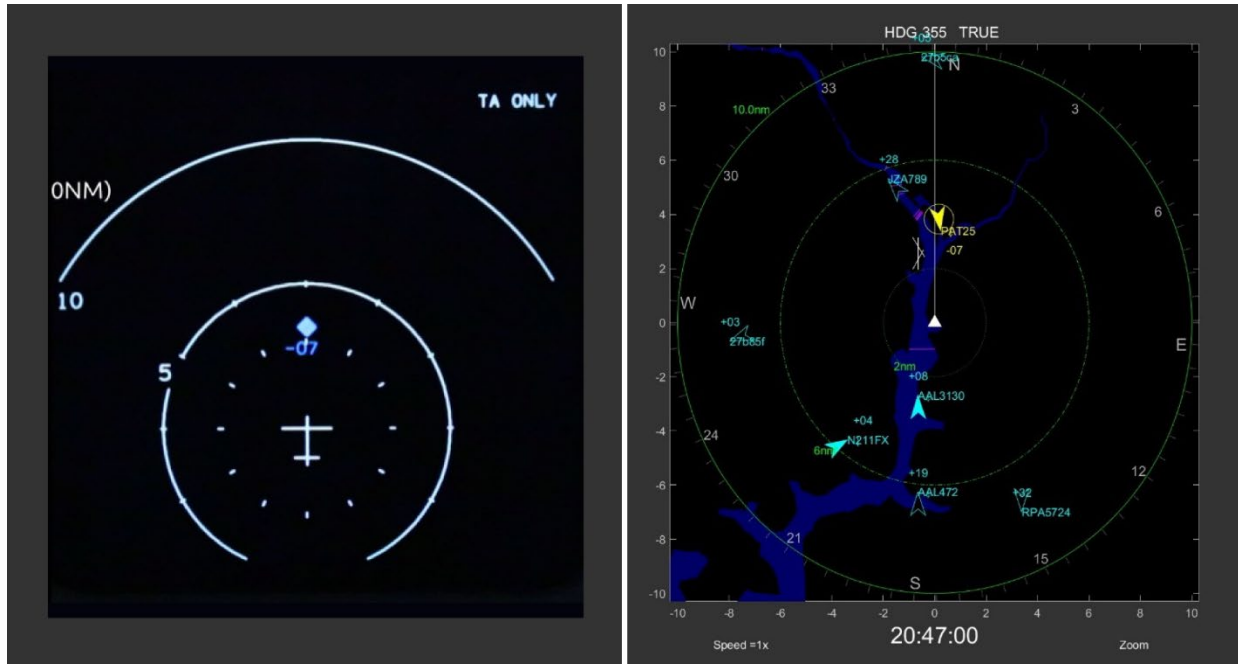
Figure 63 shows a simulated TCAS display (left), similar to the actual display presented to the pilots of flight 5342, and a simulated CDTI display (right) consistent with what the pilots would have observed at 2047:00 (59 seconds before the collision), had the airplane been equipped with an ADS-B based CDTI. The ADS-B based CDTI would have provided the first alert regarding PAT25 at this time, which was 40 seconds before the crew received the TCAS TA. The CDTI would have provided a second aural alert regarding PAT25 about 35 seconds before the collision and 16 seconds before the crew received the TCAS TA. Figure 64 presents a

Figure 63. Simulated view of TCAS display at 2047:00 (59 seconds before the collision) from flight 5342's cockpit (left), compared with a simulated ADS-B In-based CDTI display using ATAS symbology and alerting criteria (right), which the airplane was not equipped with.

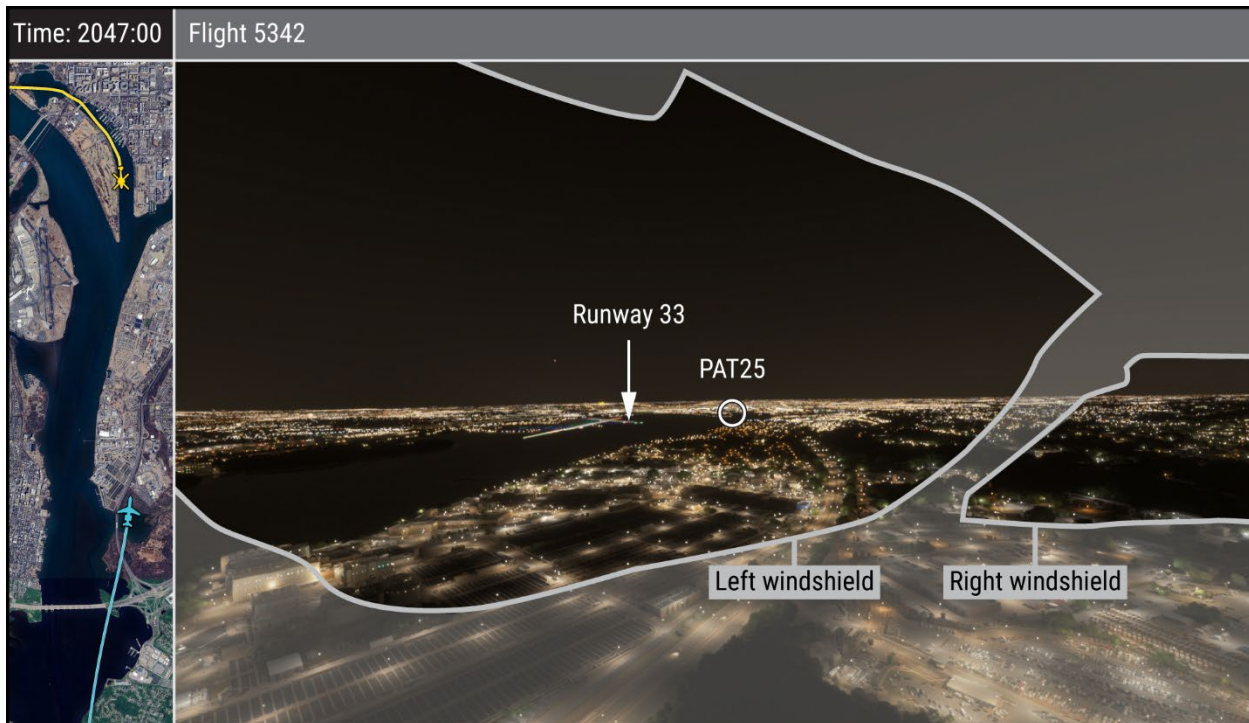
Figure 64. Simulated view from the left (captain's) seat of flight 5342 at 2047:00 (59 seconds before the collision), looking straight ahead.

Note: Had the airplane been equipped with an ADS-B based CDTI, it would have provided the crew of flight 5342 with the first alert regarding PAT25 at this time (2047:00, or 59 seconds before the collision). However, because the airplane was equipped instead with TCAS, the crew only received its first TA alert 40 seconds later, at 2047:40 (or 19 seconds before the collision).

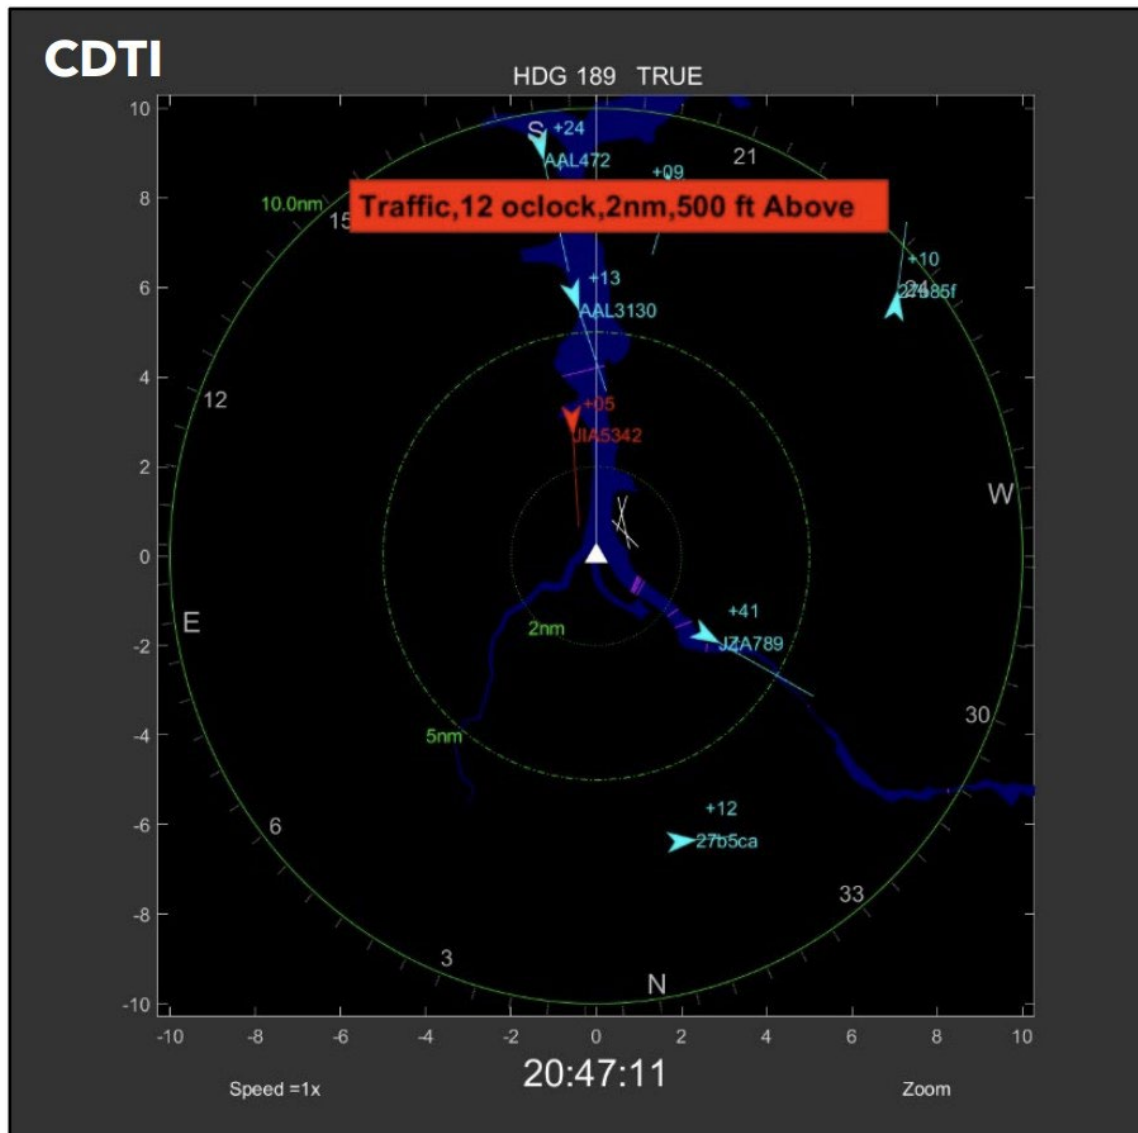
The ForeFlight CDTI display onboard the helicopter could have generated a visual and aural alert concerning the airplane at 2047:11, or 48 seconds before the collision, as shown in figure 65. The aural alert would have comprised the annunciation, "Traffic, 12 o'clock, 2 miles, 500 ft above." At this time, the helicopter was only 9 ft above the 250-ft aural alerting threshold. Figure 66 presents a simulated view from the IP's (right) seat of PAT25 at 2047:11, when the Foreflight CDTI that was onboard the helicopter could have provided a visual and aural alert concerning flight 5342.

Figure 65. Simulated ForeFlight display and visible text alert (shown in red box) at 20:47:11 (48 seconds before the collision).

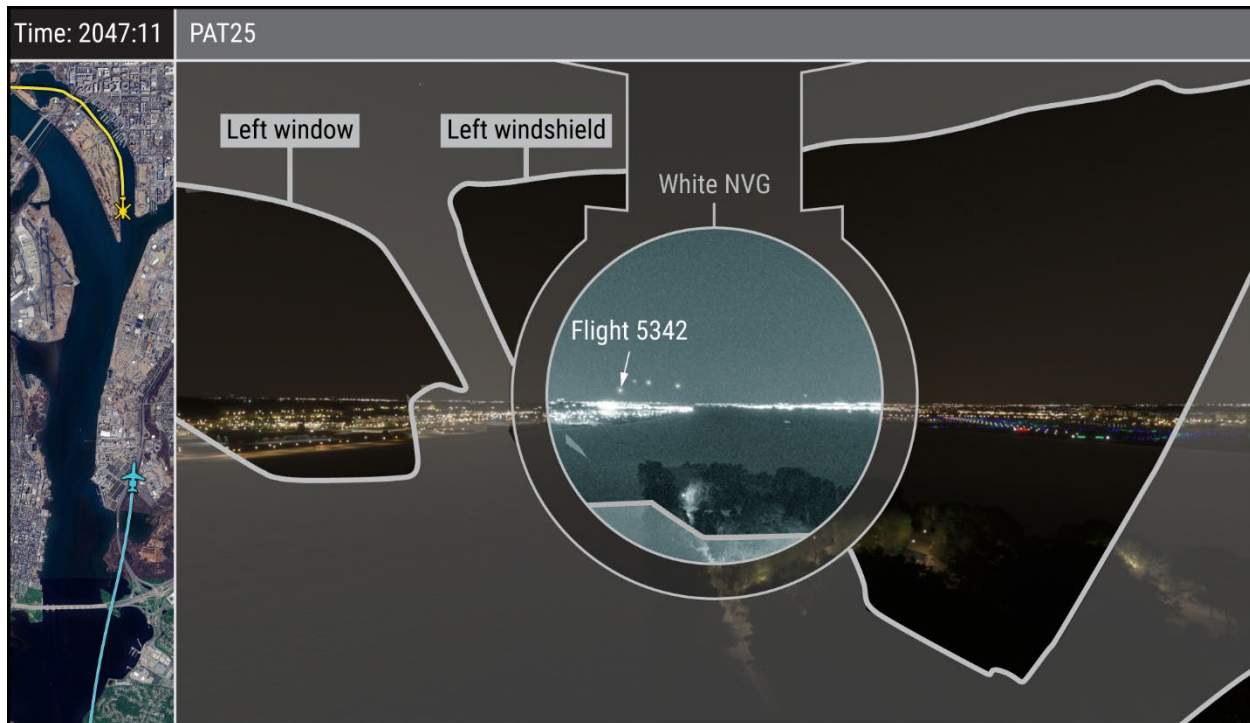
Figure 66. Simulated view from the right (IP's) seat of PAT25 at 2047:11 (48 seconds before the collision), as seen looking straight ahead.

Note: At this moment, the Foreflight CDTI running on the helicopter flight crew's tablets would have displayed the visible text alert shown in the red box in figure 65, and the application would have annunciated an aural alert, "Traffic, 12 o'clock, 2 miles, 500 ft above," which would have been audible to the flight crew, had the flight crew's helmets been equipped to receive audio from the tablets—which they were not. Additionally, Army pilots do not visually monitor the tablets while flying low level on DC helicopter routes because, according to postaccident interviews, the flying task was too demanding.

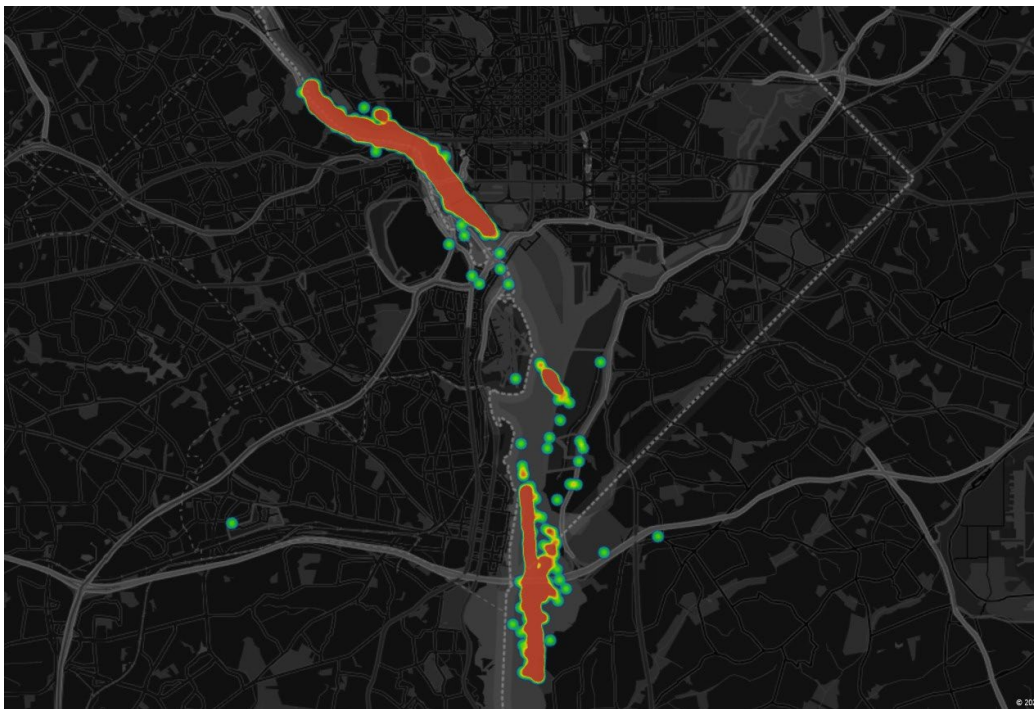
PDARS was also used to examine encounters at various proximities between fixed-wing airplanes and helicopters. For arriving and departing airplanes and helicopters flying on Routes 1 or 4 over the period January 2018 to February 2025, there were 4,067 encounters (65.6 encounters per month) in which separation was less than or equal to 1,000 ft and 348 encounters (5.6 encounters per month) in which separation was less than or equal to 500 ft. Figure 70 shows a heat map produced

Figure 70. Heat map produced using PDARS data depicting frequency of encounters between arriving and departing airplanes and helicopters flying on Routes 1 or 4 at altitudes from 500-1000 ft, from January 2018 to February 2025. (Source: FAA)

Note: Red denotes areas with the greatest frequency of encounters, and green indicates areas where encounters occur relatively less frequently.

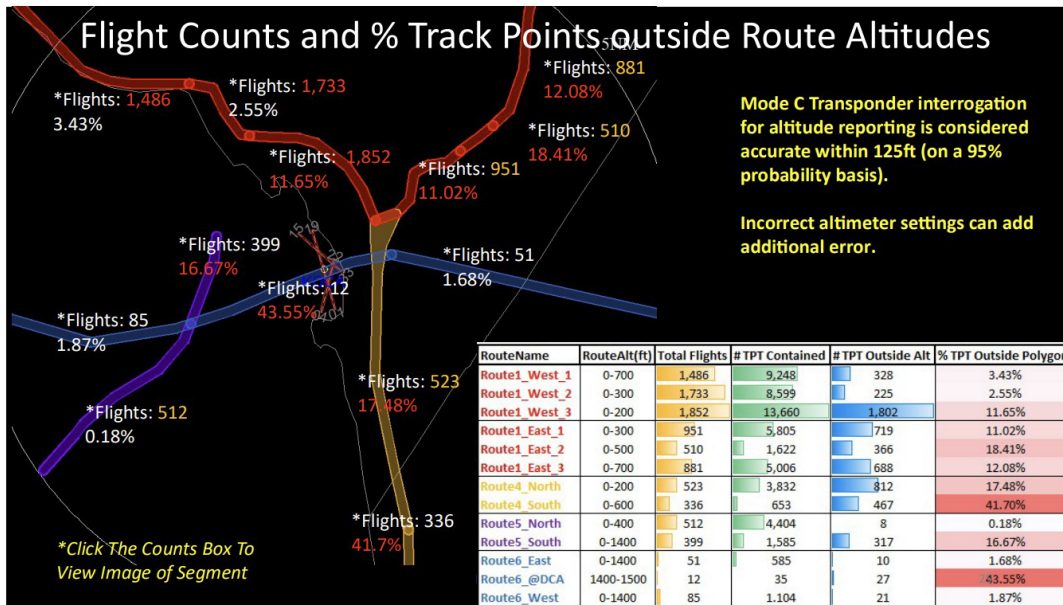
Figure 71. Results of analysis of Potomac TRACON data processed by PDARS for various segments of the Washington, DC, area helicopter routes. (Source: FAA)

A separate PDARS analysis for the 13-month period of January 1, 2024, through January 30, 2025, identified 13,866 helicopter flights on the DC helicopter routes within 5 nm of DCA, of which 10,990 helicopter flights (79.2%) were military flights. "Track points" and flights that flew above route altitudes were calculated for 13 segments on four helicopter routes.¹⁵⁰ The percentage of track points estimated to be above published route altitudes ranged from 0% to 44% for the 13 segments, as shown in figure 71. For the northern segment of Route 4, which included the area of the collision, 17% of all track points exceeded altitude limits. Further analysis found that of the 523 flights that transited this route segment, 260 flights (49%) had at least 1 track point within this segment above route altitude limitations.

Note: The number of helicopter track points within and outside of published route altitudes are shown.

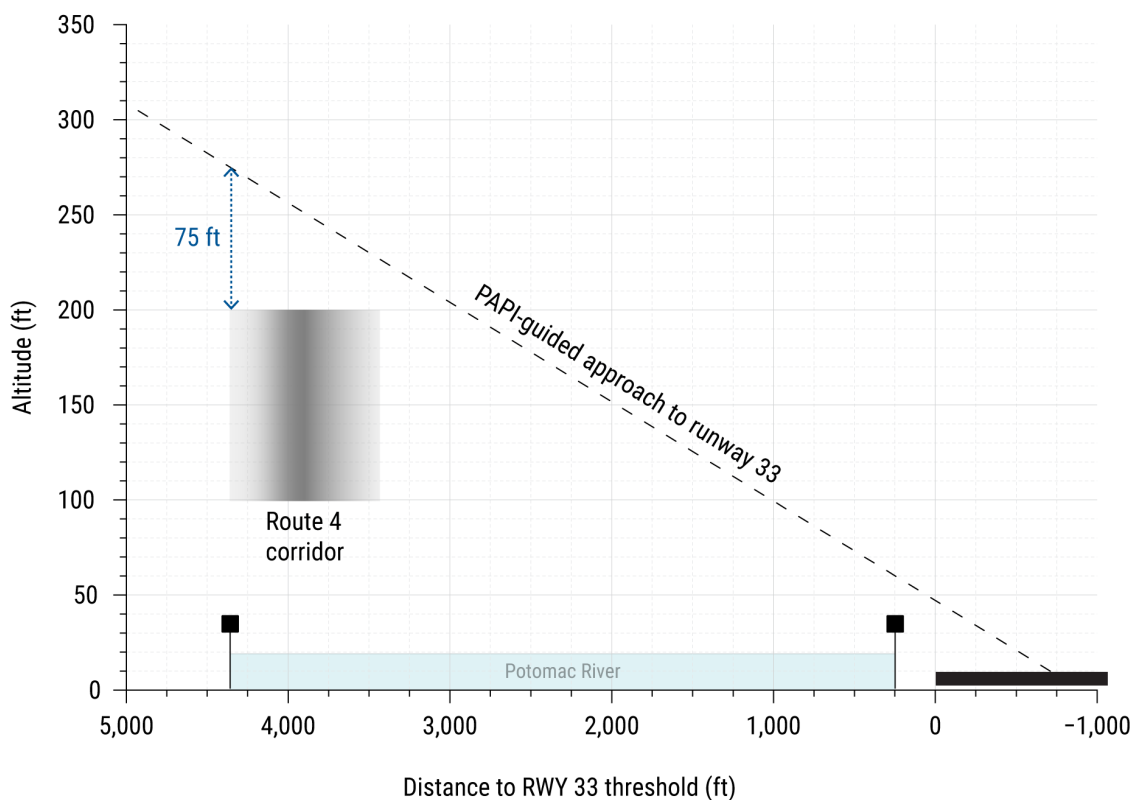
Figure 72. Cross section showing the notional separation between Route 4 and a PAPI-guided visual approach to runway 33, according to FAA charts and aerial photogrammetry analysis.

Figure 72 presents a cross section of the airspace that extends from the runway 33 centerline, spanning the Potomac River from the runway 33 threshold markings to the river’s east bank. The figure shows the separation distance that would exist between a helicopter on Route 4 and an airplane descending on a 3° visual glidepath (the angle provided by runway 33’s PAPI system).

Because helicopter routes established by the FAA have no lateral boundaries and the Baltimore-Washington Helicopter Route Chart includes no warning for helicopters to operate a defined distance from the shoreline, the shaded region represents an approximation of the area in which helicopters could be flown. At an altitude of 200 ft, a helicopter operating over the eastern shoreline of the Potomac River would have about 75 ft of vertical separation from an airplane approaching

In the urgent safety recommendation report, the NTSB concluded that the separation distances between helicopter traffic operating on Route 4 and aircraft landing on runway 33 as they existed at the time of the accident were insufficient and posed an intolerable risk to aviation safety by increasing the chances of a midair collision. Safety Recommendation A-25-1 asked the FAA to prohibit operations on Helicopter Route 4 between Hains Point and the Wilson Bridge when runways 15 and 33 were being used for departures and arrivals, respectively, at DCA.

The NTSB also concluded that it was critical for public safety helicopter operators to have an alternate route available for operating in and around Washington, DC, without increasing controller workload, and in Safety Recommendation A-25-2 asked the FAA to designate an alternative helicopter route that could be used to facilitate travel between Hains Point and the Wilson Bridge when that segment of Route 4 was closed.
