Fuel starvation and collision with terrain involving Britten-Norman Islander BN2A-20, YJ-AT2

6 km east-south-east of Port Vila International Airport, Vanuatu on 15 July 2024

Aviation Occurrence Investigation

AA-2024-008 (CAAV investigation number: 136272/AIG/A2.5)

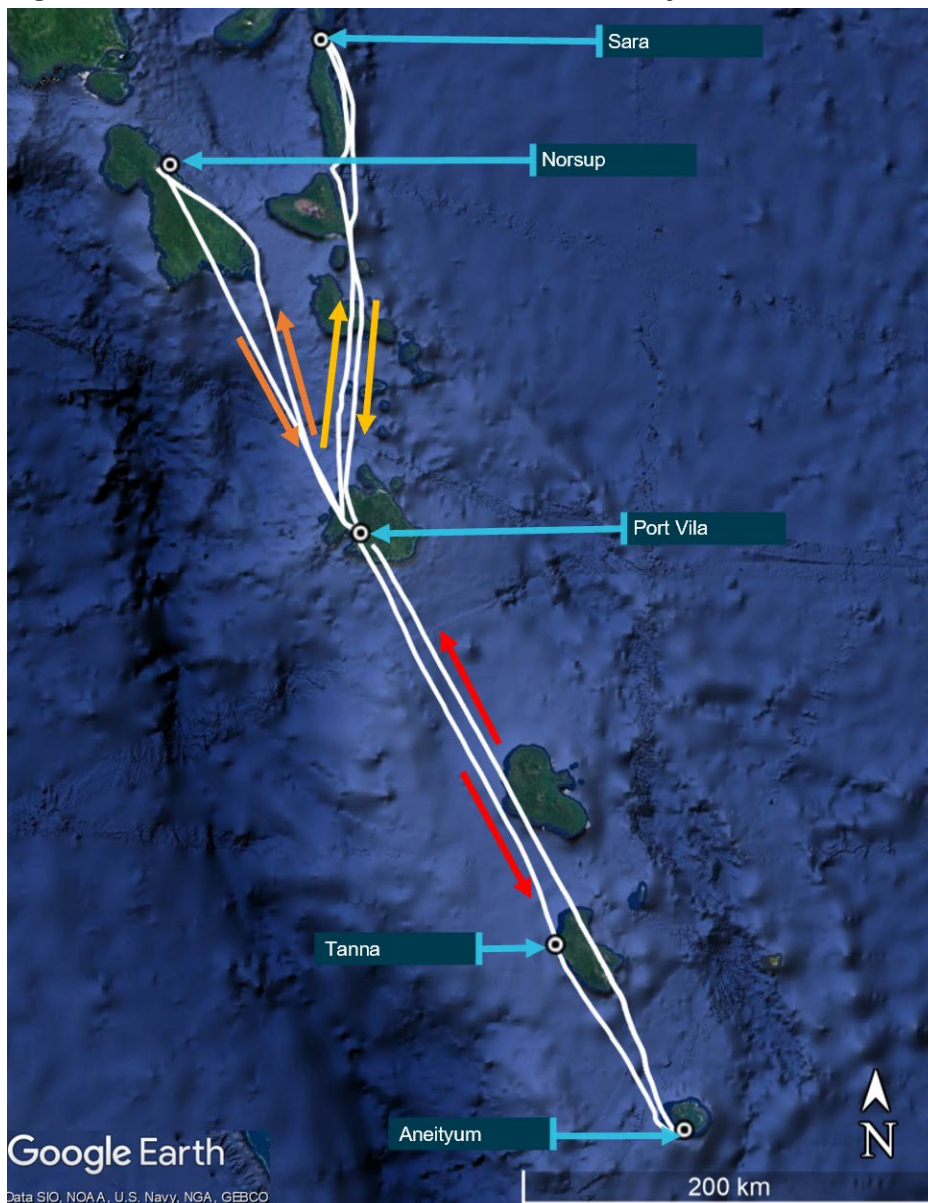
Figure 1: Recorded GPS tracks for YJ-AT2 on 15 July 2024

On 15 July 2024, the pilot of a Britten-Norman Islander BN2A-20 aircraft, registered YJ-AT2 and operated by Air Taxi Vanuatu, was preparing to conduct passenger-carrying charter flights under the visual flight rules.¹ The pilot arrived at the Air Taxi Vanuatu office at Port Vila International Airport at about 0530 Vanuatu Time.² Three return flights had been assigned to the pilot that day – 2 north and north-north-west from Port Vila and one to the south-south-east (Figure 1).

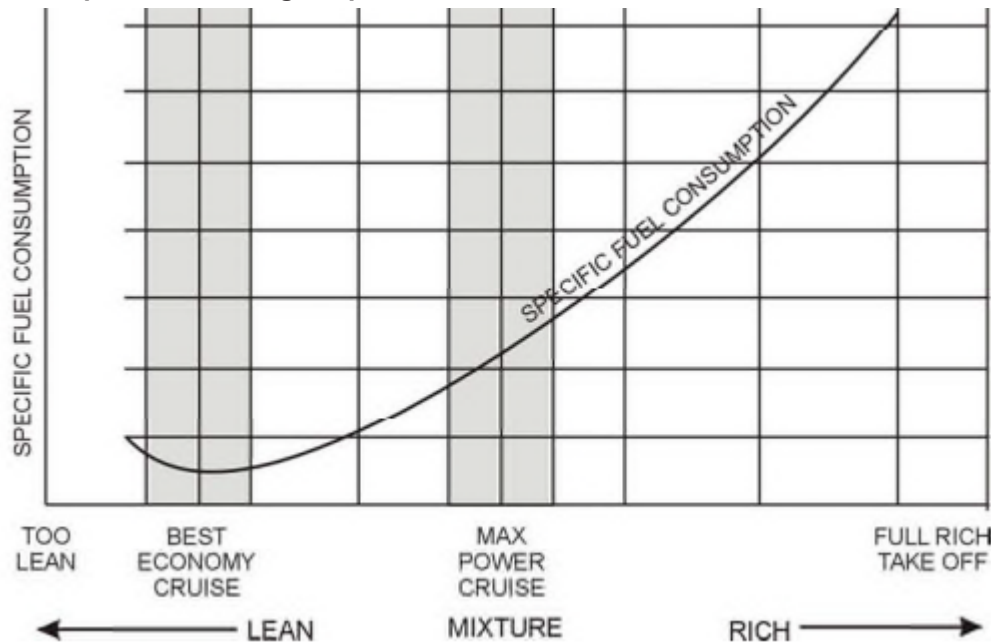
Figure 6: Extract of Lycoming Operator’s Manual Figure 3-1, showing specific fuel consumption with change in power and mixture

The manual included a diagram showing the representative effect of leaning on cylinder head temperature, EGT, engine power and specific fuel consumption. Figure 6 is an extract of that diagram, showing a significant increase in fuel consumption from lean to a fully rich mixture.
