AAIS Case Reference: 13/2010

AIR ACCIDENT INVESTIGATION REPORT

**Uncontained Cargo Fire Leading to Loss of Control
Inflight and Uncontrolled Descent Into Terrain**

Boeing 747-44AF
N571UP
Dubai
United Arab Emirates
03 September 2010

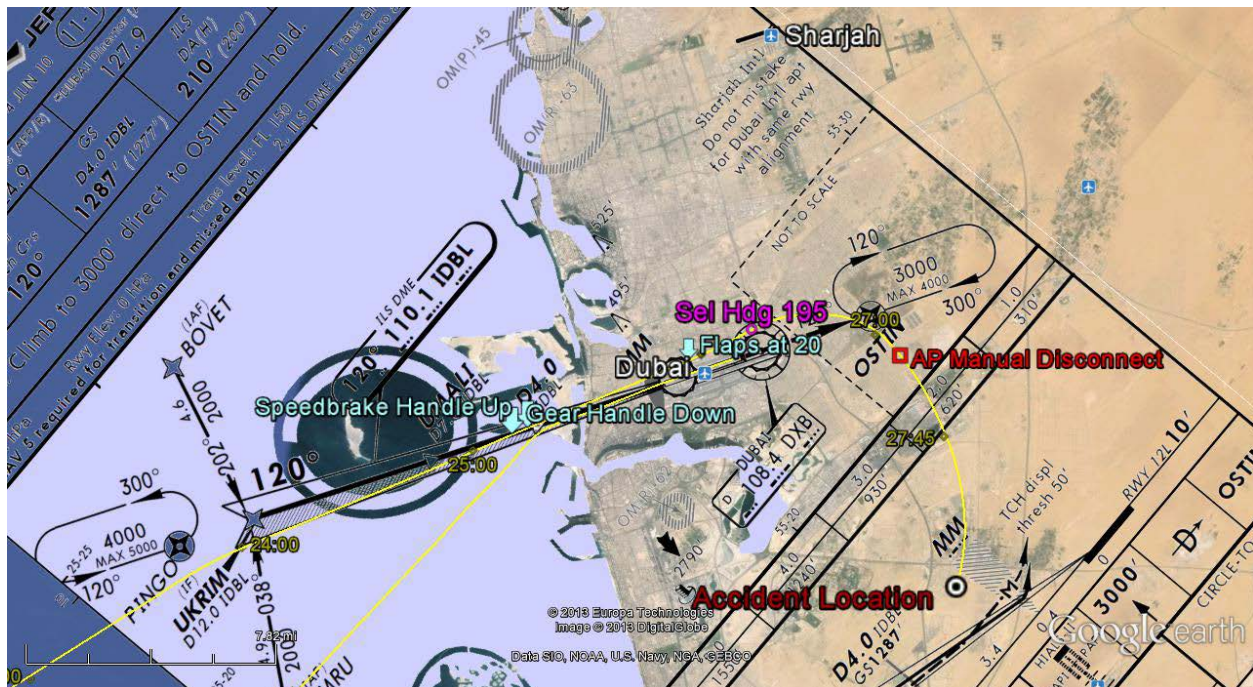
Figure 3 DXB Overview and Track [Yellow]/SHJ location and required heading for SHJ RWY 31 localizer interception

The relay aircraft advised that SHJ was at 095° from the current position at 10 nm. The PF acknowledged the heading change to 095° for SHJ.

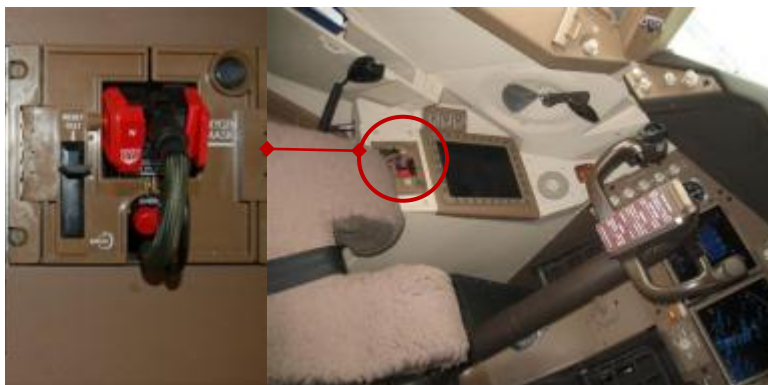
Figure 12 Captains Mask Stowage Location

- i Between the oxygen supply cylinders and the high pressure regulator
- ii At the Captain's mask stowage box manifold, and
- iii At the inlet to the Captain's oxygen mask.

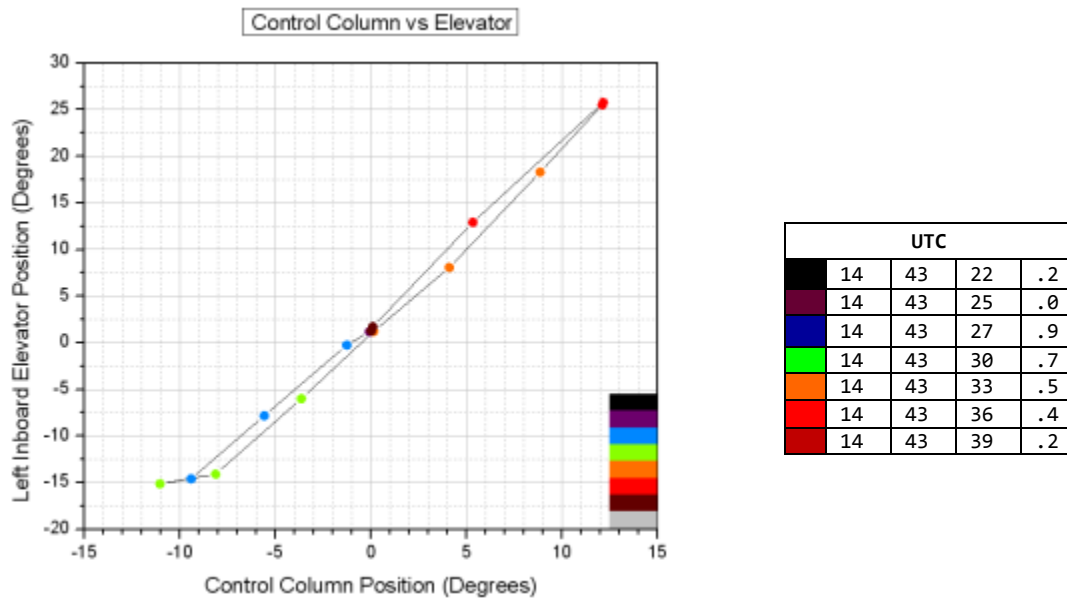
Figure 17 - Control column movement to elevator deflection

Control column movement to elevator deflection during the controls check prior to takeoff is normal as there is a linear correlation between the control column movement and the corresponding elevator trailing edge movement.

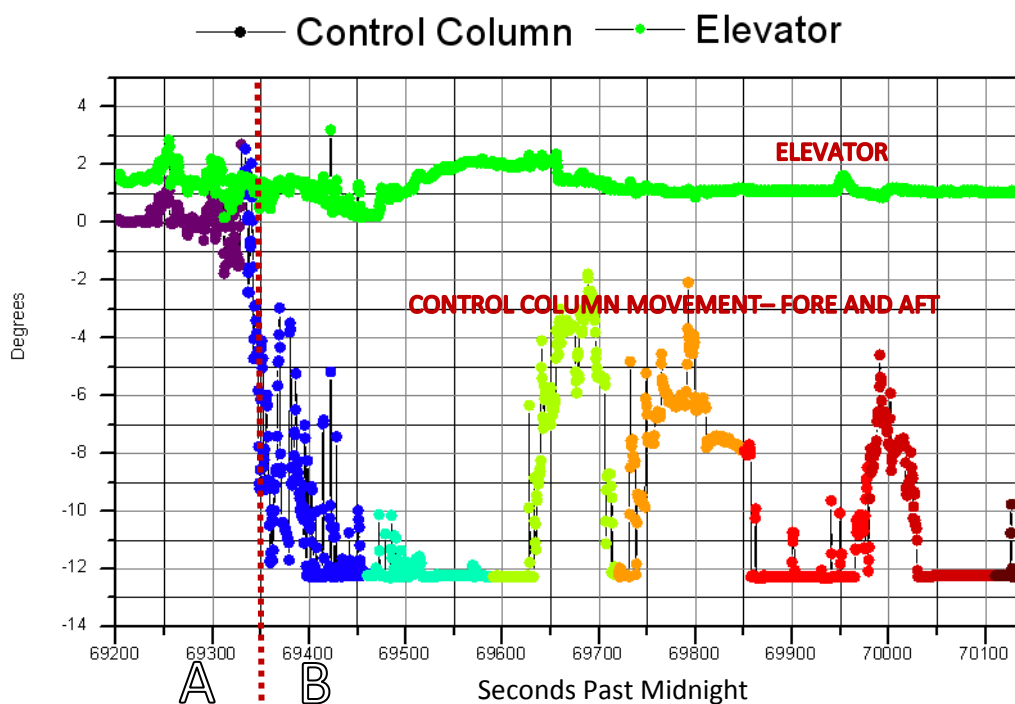
Figure 18 control synchronization/desynchronisation

A: Uniform Control Synchronization: Pre Main Deck Fire Warning

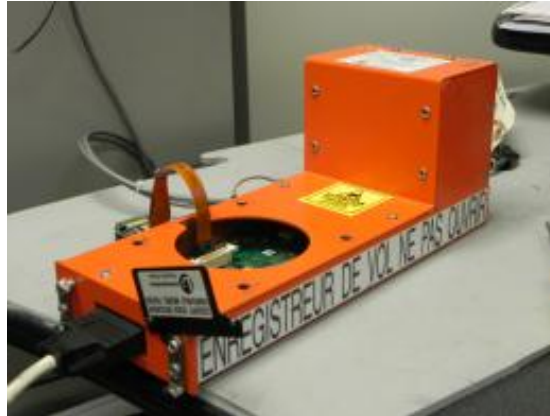
Picture 4 – The FDR Memory Connected to the Surrogate Recorder

The memory was removed from the unit and readout by using a surrogate recorder. Data were downloaded normally and all data was successfully recovered.

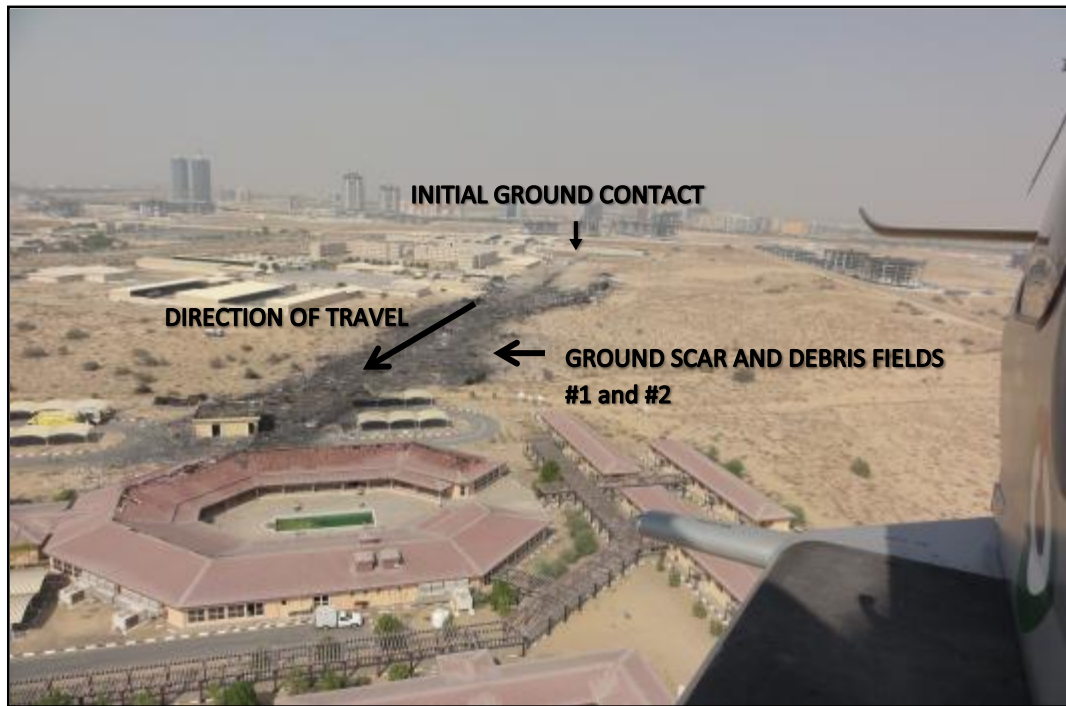
Photo 1 View looking over Nad Al Sheba military base towards the residential area of Silicon Oasis, Dubai

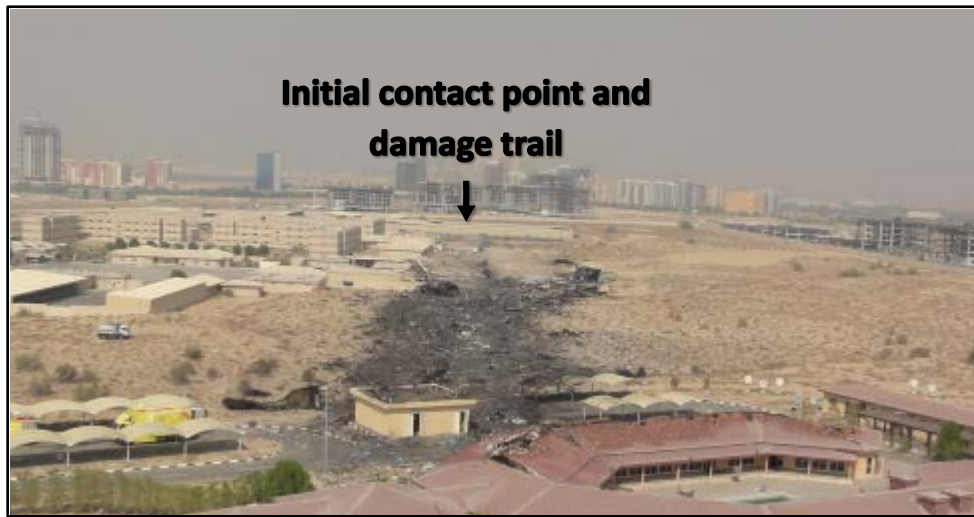
The accident aircraft impacted the ground inside the confines of Nad Al Sheba military base nine nautical miles south of Dubai, United Arab Emirates. During the impact, the aircraft destroyed an unknown number of buildings and trucks. There was an extensive post-crash fire which consumed the bulk of the aircraft and remaining cargo.

Photo 2 Overall view of the debris field, looking back towards the initial impact location

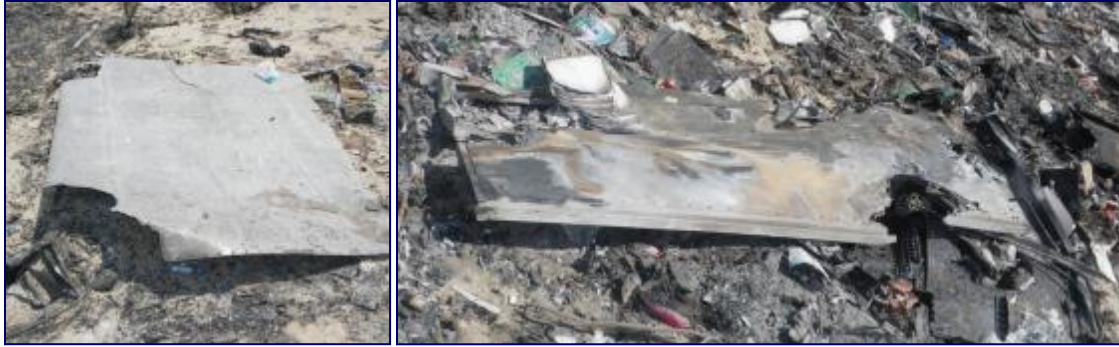
The cargo containers and pallets were all destroyed by the impact forces and post-crash fire. The few recognizable parts of the containers and pallets were base plates and a few doors. All of the pieces identified as being parts of containers and pallets were examined for recognizable in-flight fire damage. Due to the severe post-crash fire damage to these components, no particular in-flight fire characteristics were observed. The contents of the cargo containers were spread throughout the debris field, both inside and outside the post-crash fire zone. Details about the cargo contents, as declared by the shippers and contained within the cargo manifest, can be found in the cargo group's factual report.

Photo 3 Cargo container base plate [LH] and cargo door [RH]

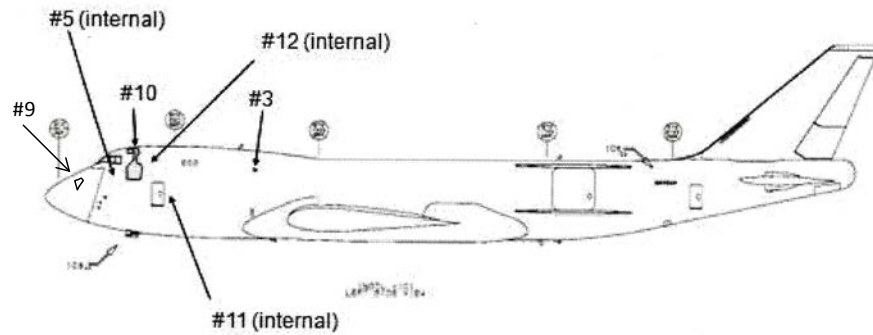
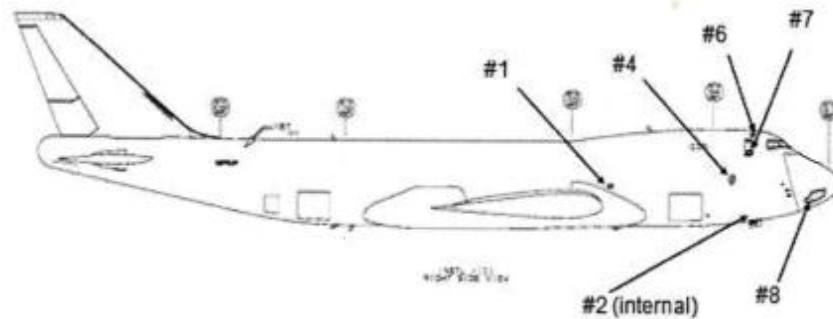
The on-scene wreckage examination focused on items found on the border and outside of the main post crash fire zone. These items were aircraft structure with thermal damage and soot patterns believed to be consistent with damage occurring prior to the aircraft's impact and not artefacts of the post-crash fire. The locations from where these items originated on the aircraft are shown in the following two diagrams of the aircraft's outline. Each of the identified items is numbered on the two diagrams including whether the item was internal aircraft component or external.

Left hand side outline of accident aircraft depicting locations of identified items

Right hand side of accident aircraft depicting locations of identified items

#1: Fuselage observation window	#7: Hinge casting
#2: Cover from power distribution center	#8: Part of nose door (lower)
#3: Fuselage skin	#9: Part of nose door (upper)
#4: Fuselage skin & structure	#10: Portion of structure and fuselage skin
#5: Structure with pulley attached	#11: Stair to flight deck

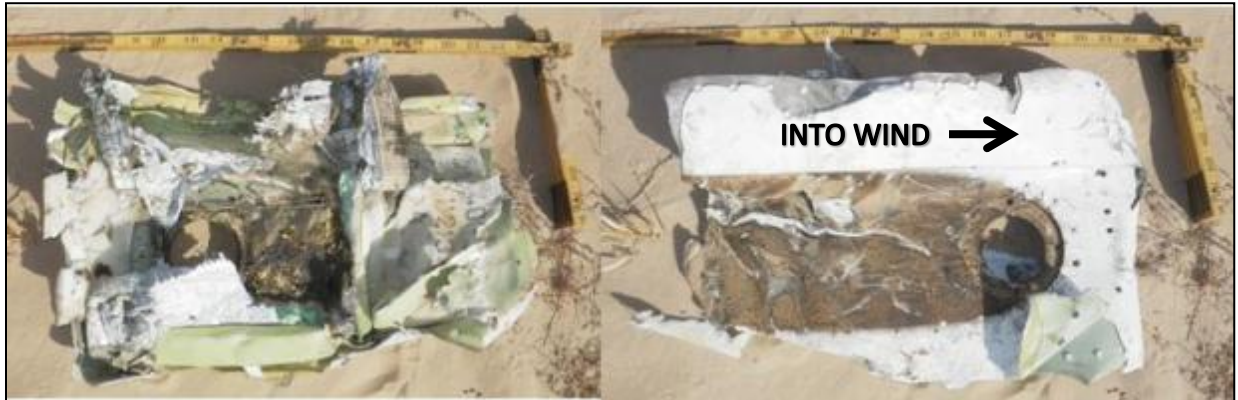
The portion of fuselage skin contained the cut-out for the flight deck's smoke evacuation shutter. The actual smoke shutter had separated from this portion of the fuselage. A very thick soot trail almost resembling tar extended from the cut-out location aft to the end of the recovered portion of fuselage.

Photo 10 Fuselage skin piece with smoke shutter cut-out (interior on the left, exterior on the right)

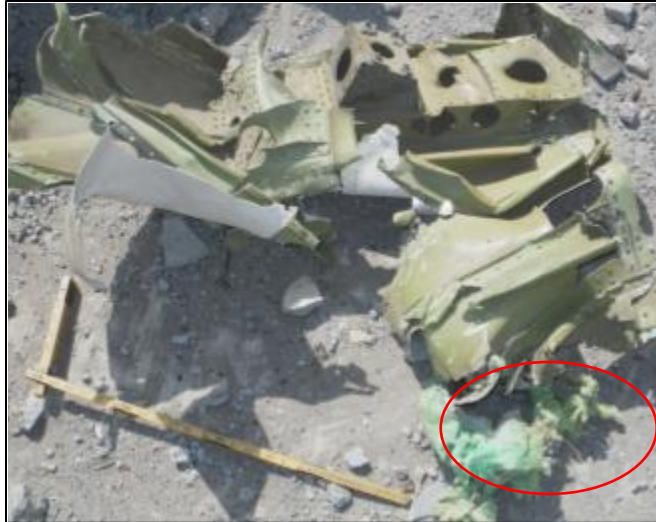
Photo 14 Portion of nose door (upper)

This portion of nose door was from the upper portion of the door on the left hand side approximately between stations 160 to 200. This piece exhibited some localized discoloration of primer shown circled above.

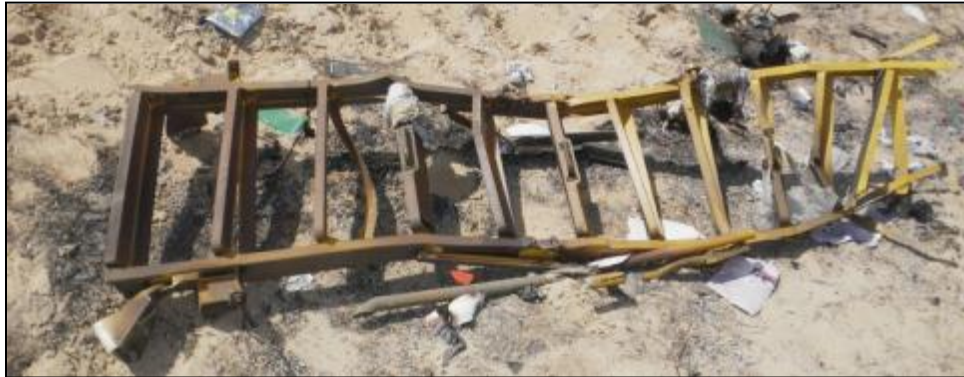
The stairs to the flight deck extend from the floor of the main cargo deck up to the upper deck. The stairs have sooting at the top portion of the stairs which then tapers off towards the bottom. This soot graduation is consistent with a stratified smoke layer existing within the main cargo deck.

The demarcation of sooting on the stairs suggests a smoke layer extending to the height shown by the dotted line in photo 17 below.

Photo 16 Stairs to the flight deck

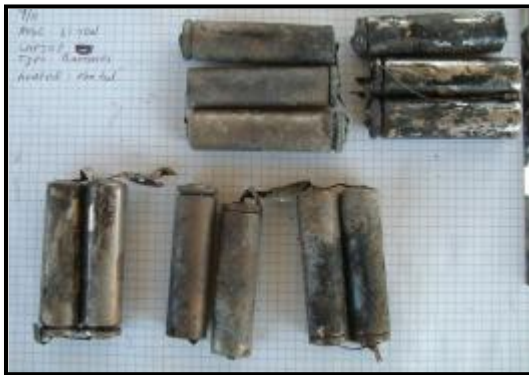
Additional battery pack remains [LH]/D-Cell size lithium primary batteries. Photo shows fire damaged and undamaged batteries [RH]

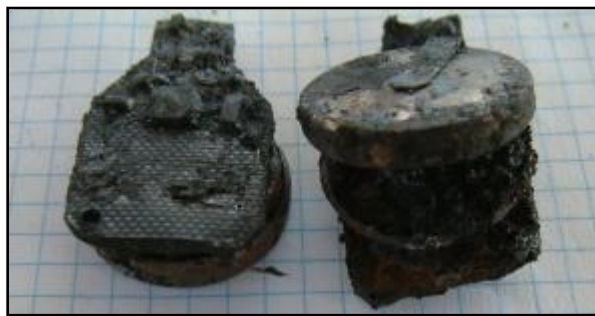
Lithium primary button sized flat cell batteries (watch style) with small circuit board

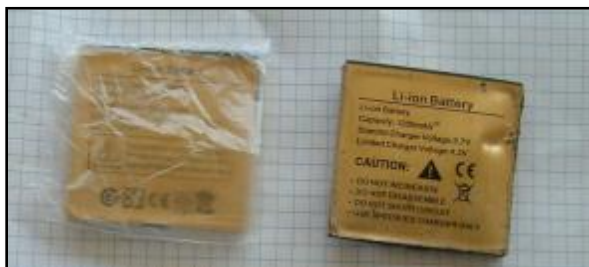
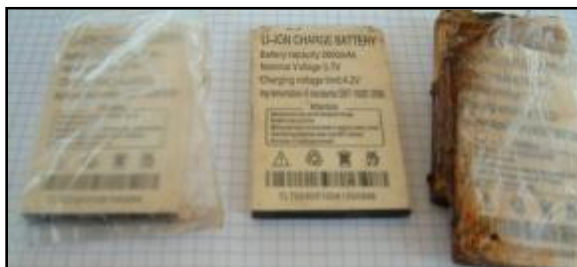
Lithium-ion, mobile phone type battery

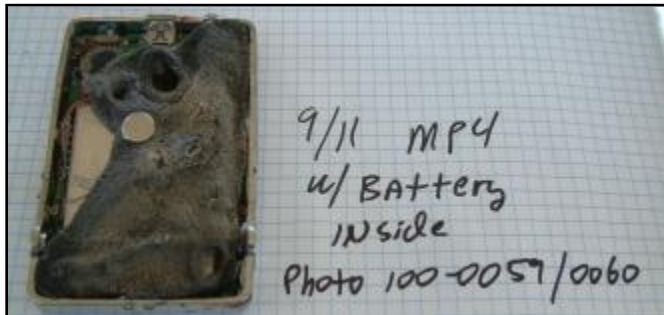
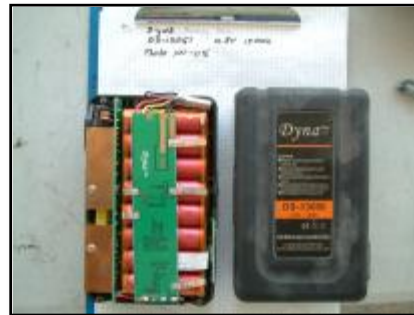
Personal electronic device with battery inside [LH]/Lithium-ion battery pack [RH]

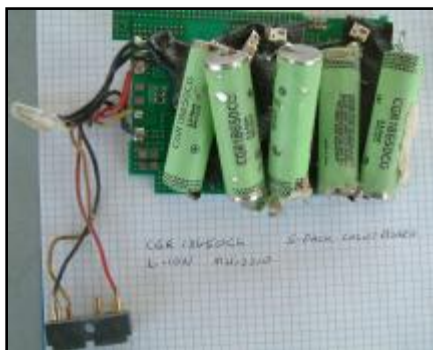
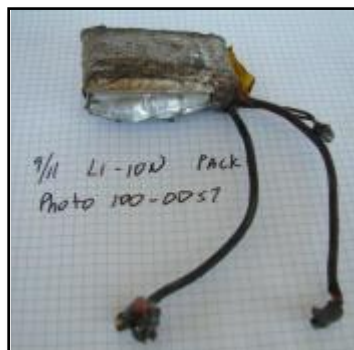
Lithium-ion battery packs - LH and RH

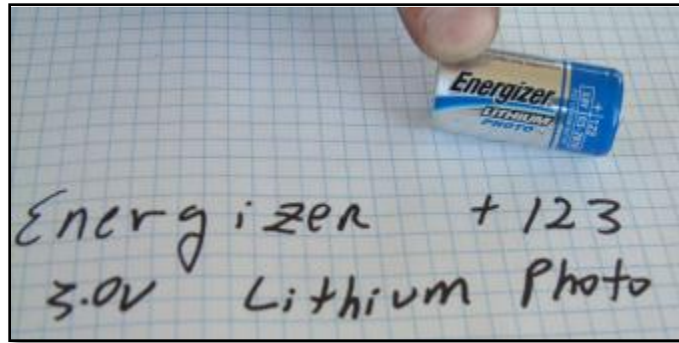
Lithium primary (CR123 type) battery

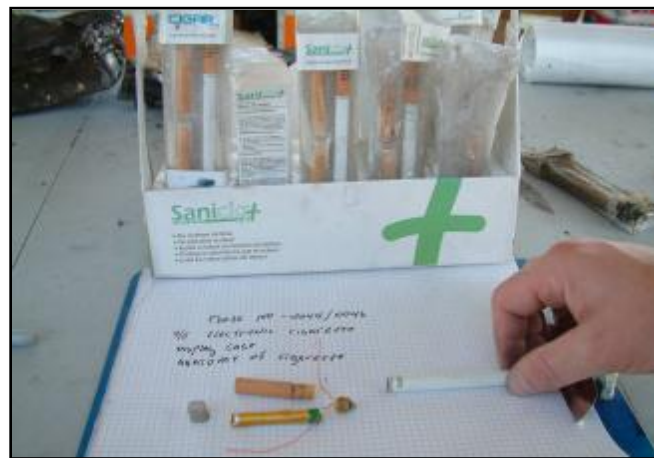
Electronic cigarettes containing lithium primary batteries⁵⁵

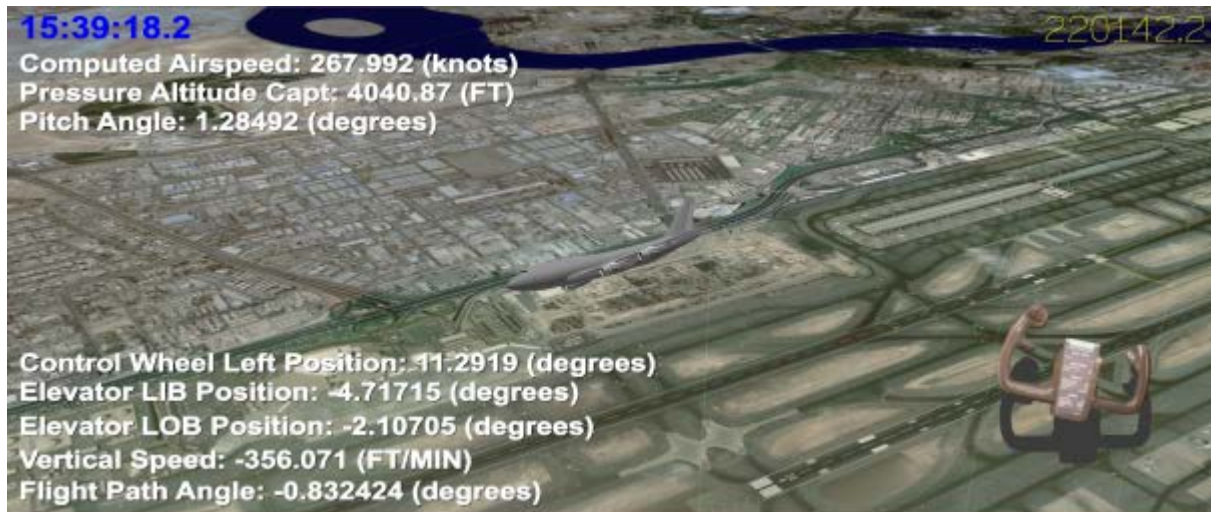
Figure 42 DXB RWY 12L Over Flight

- 15:38:45 - Heading bug to 110 deg
- 15:38:50 - Flaps 20
- 15:38:59 - Speed Select 360
- 15:39:00 - Heading bug to 115 deg
- 15:39:07 - Heading bug to 195 deg
- 15:39:12 - (Comms ATC) - PF acknowledges a heading of 095 for Sharjah airport
 - › The PF after being cleared to Sharjah Airport (SHJ), selected a different heading than cleared, the MCP input is 195 deg for an undetermined reason.
- 15:39:19 - GPWS: Bank Angle

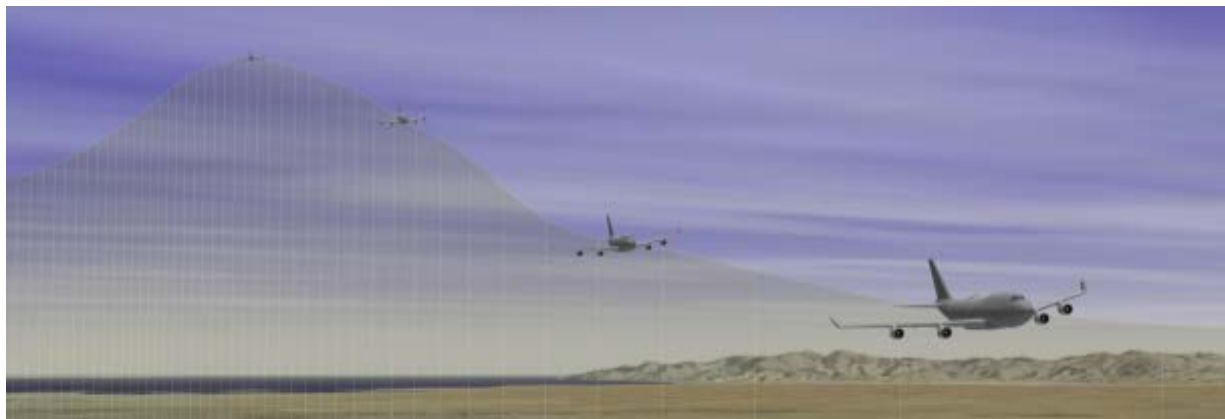
Figure 45 Profile: Descent and Pitch Oscillations

The PF made a series of inputs into the elevators which had a limited effect on the descent profile; the descent is arrested temporarily. There then followed a series of rapid pitch oscillations. These were not phugoid oscillations, but commanded responses where the elevator effectiveness decreased rapidly as the airspeed decayed and the elevators could not compensate for the reduced thrust moment from the engines to maintain level flight in a steady state. This was due to the de-synchronisation of the control column inputs and the elevators reduced trailing edge travel.

Had the aircraft remained on this heading and descent profile it would have intercepted the terrain at or near a large urban development, Silicone Oasis.

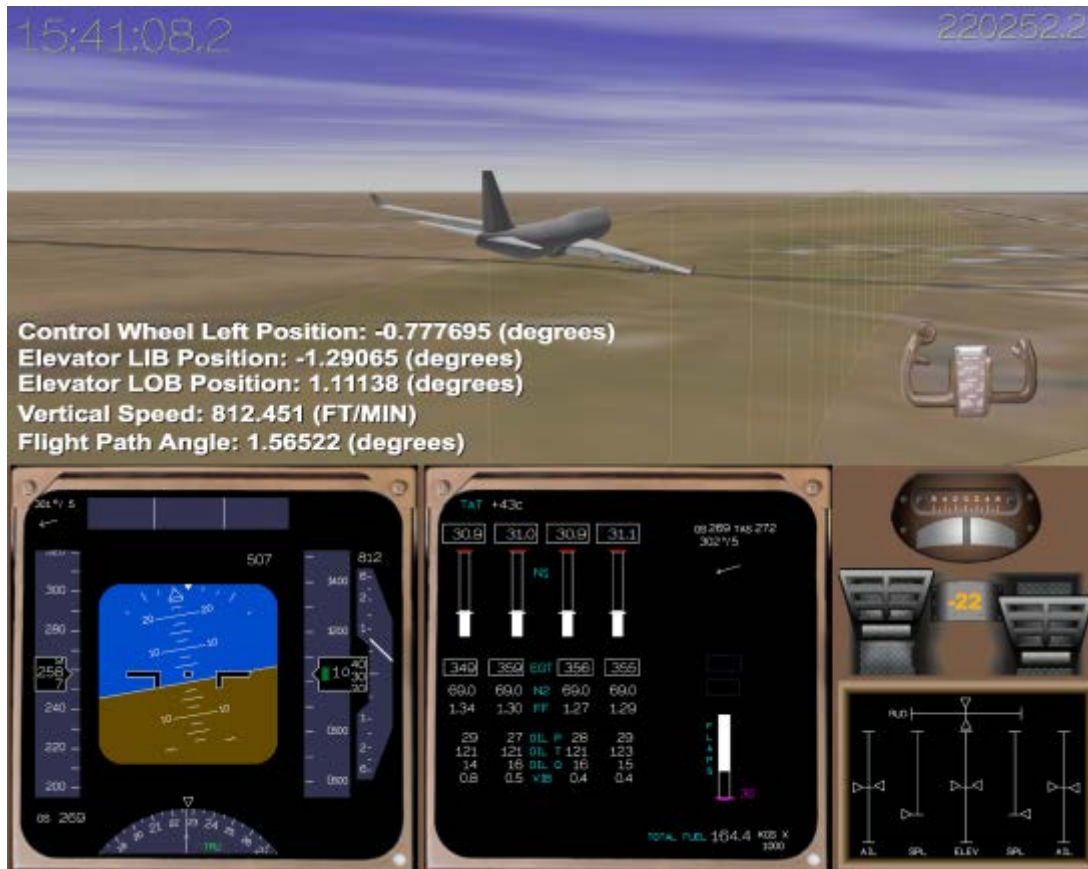
Figure 46 Temporary Arrested Descent

Between 15:41:05 and 15:41:15, approximately ten seconds, the descent is temporarily arrested with a peak positive rate of climb of approximately 800 feet per minute.

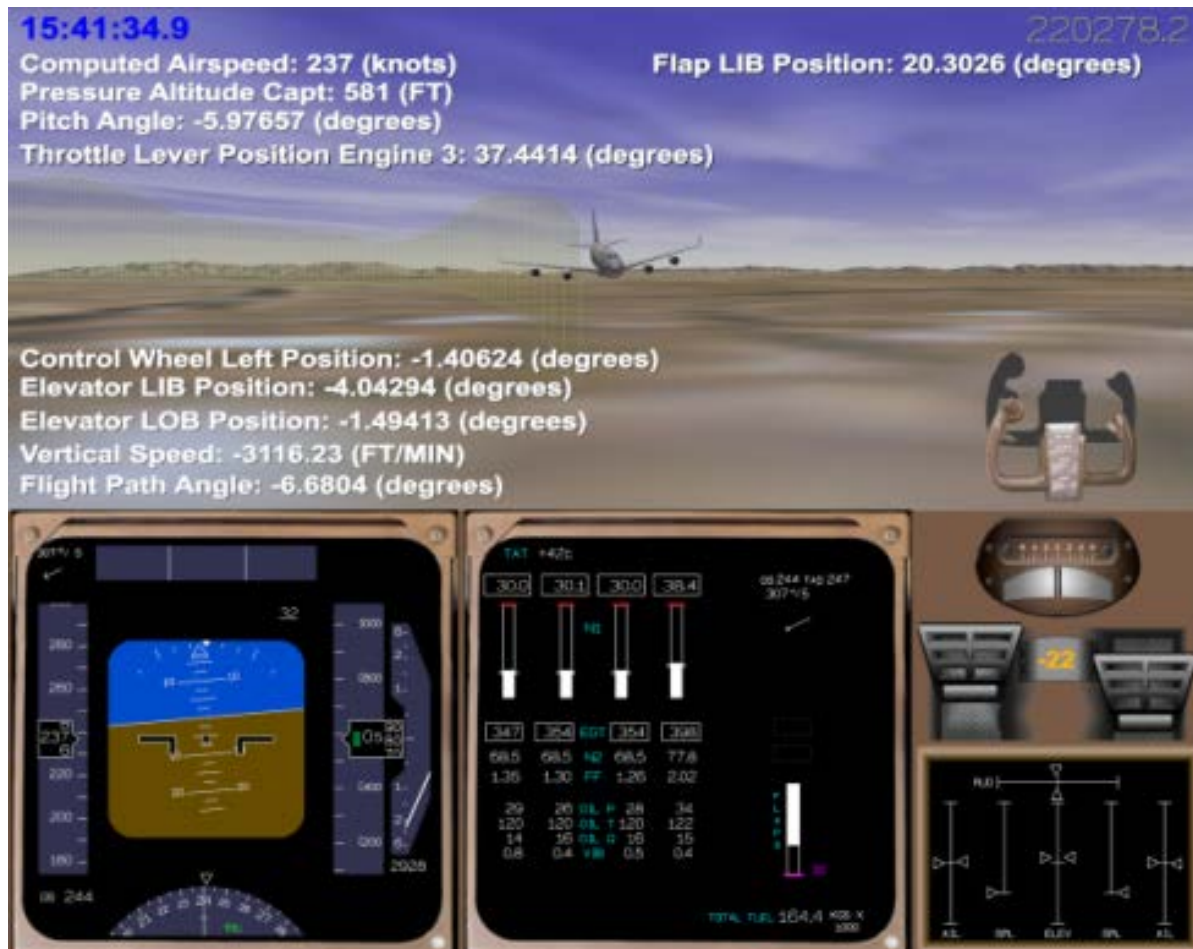
Figure 47 - 15:41:30 UTC - LOC-I/Loss Of Control In Flight/Data Ends

The collision with the terrain is now inevitable.

15:41:34 - LOC- I/UCFIT: Loss of Control In-flight/Uncontrolled Flight into Terrain/Data Ends.

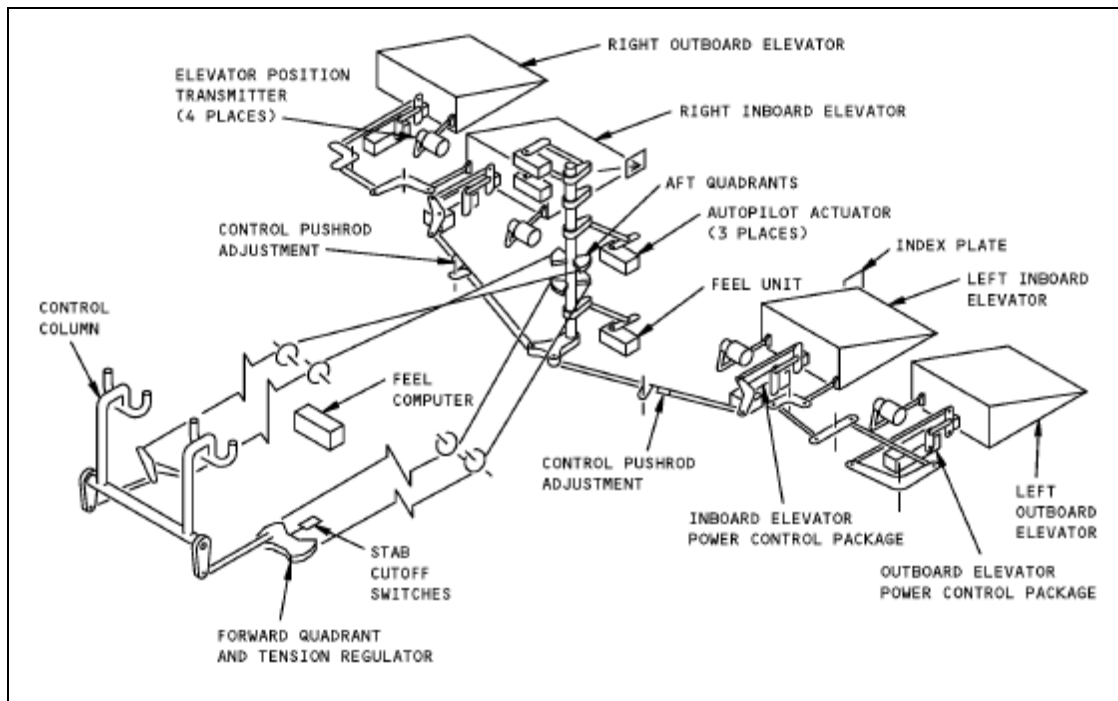
Figure 48 Elevator control system schematic from the Aircraft Maintenance Manual

The uncontained cargo fire severely damaged the control cables, the truss frame supporting the cables and the cable tension.

The cable tension reduction is the cause of the de-synchronisation, this affected the control function between what the PF commanded and the movement of the elevators. Other flight controls were also affected, the pitch control effectiveness is a contributory causal factor to the accident.

All of these indications are consistent with a decrease in elevator control cable tension.

The elevator control system schematic is shown in Section 1. The cable that connects the forward and aft quadrants requires tension for the column movements to translate into elevator movements.

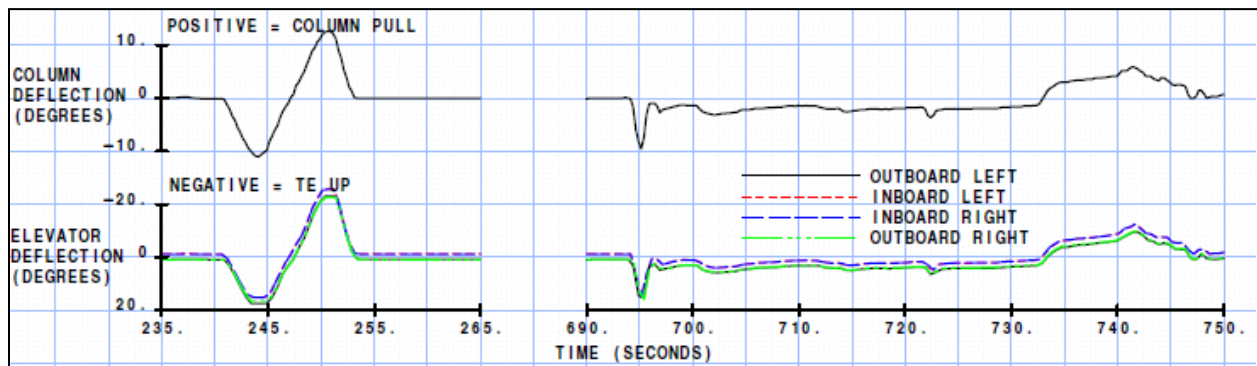
Figure 49 Column sweep and take-off rotation

Column sweep and take-off rotation display the normal relationship between column and elevator. If the tension is below the allowable tolerance, the column and elevator will no longer be consistent.

Following the initial fire warnings the column moved nose-down with no corresponding change in elevator deflection (left plot Fig. 49 above).

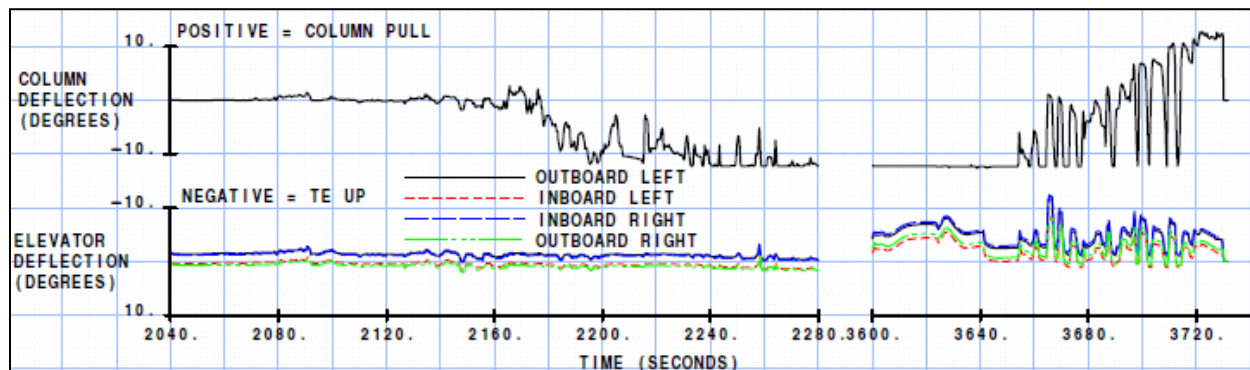
Figure 50 Column to Elevator deflections following the initial fire warnings and just prior to end of data.

The elevator was deflecting with the column inputs but not with the relative magnitude seen in the figure below. This indicates that there was some column cable tension but not enough to maintain normal column to elevator gearing.

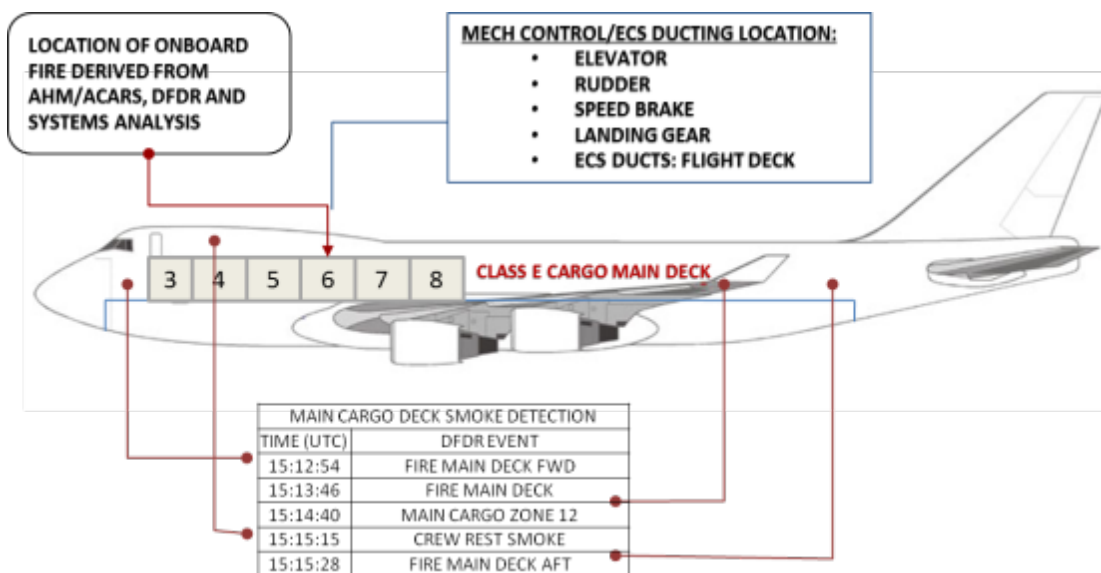
Figure 56 AHM/ACARS Derived Fire Warnings

Below is a interpretation of the ACARS messages from the AHM data received from the accident flight.

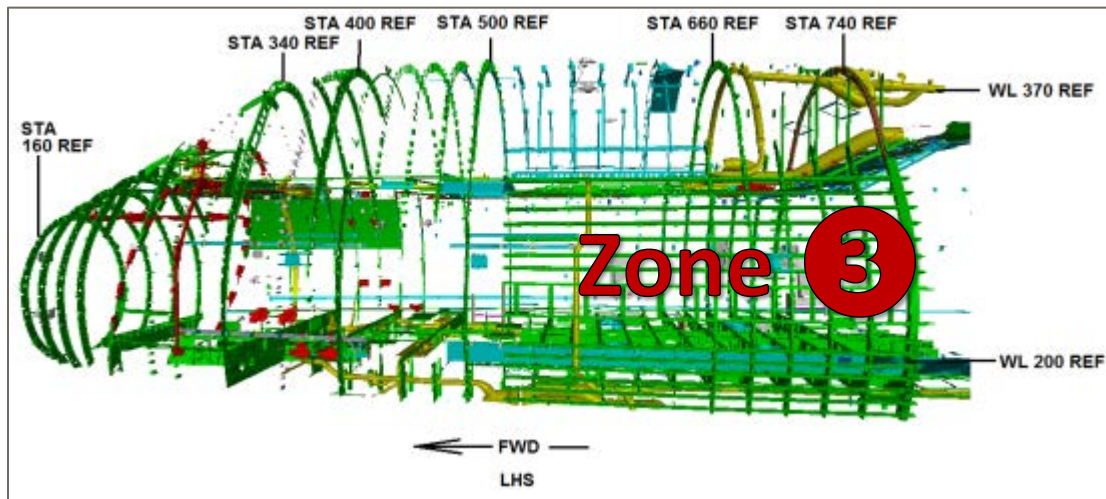
Figure 57- Cutaway Forward Fuselage and Main Deck Cargo Compartment

Conclusion: Based on the ACAR/AHM analysis the cargo fire occurred in Fire Zone 3 at 15:13 UTC

Zone 3 is approximately defined by the volume between STA 580 and STA 700, where the ceiling begins sloping up at the cargo liner transition point. This immediately below the LH and RH truss assemblies supporting the flight control cables

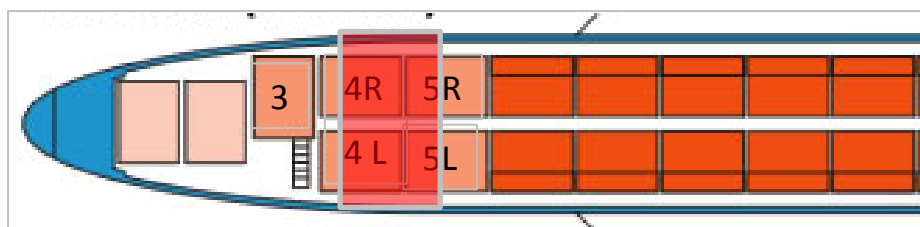
Figure 58 - Pallet Locations/Fire location

As shown in the diagram above, smoke zone 3 encompasses the area occupied by the forward portion of ULD no.'s 5L and 5R, as well as most of ULD no.'s 4L and 4R on the main deck.

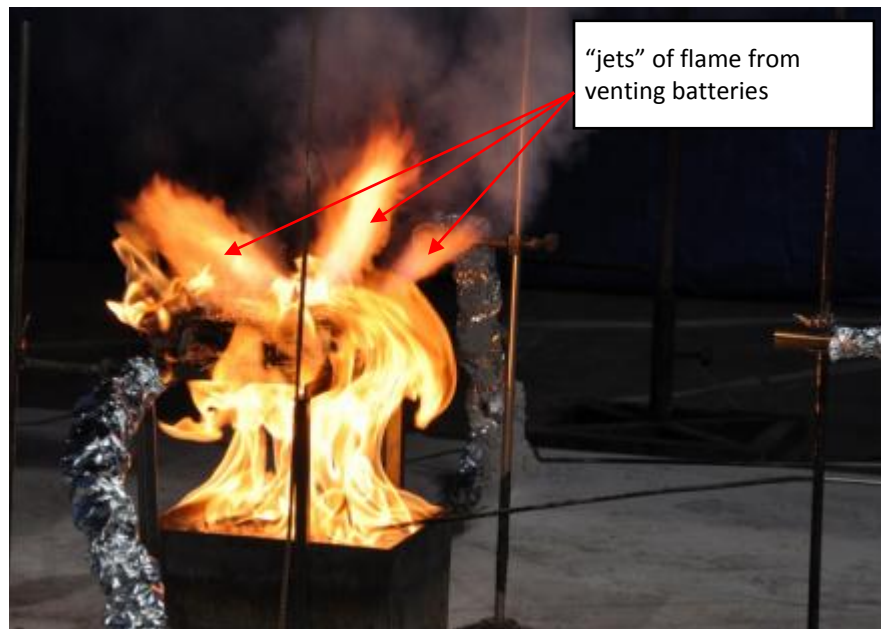
Figure 84: Box of lithium-ion batteries burning over propane burner exhibiting battery venting and electrolyte combustion

Due to the violent nature of the battery case venting and combustion of the electrolyte, some of the batteries (or battery components) were liberated from the charred packaging and propelled several feet, landing onto the floor. Some of these projectiles continued to burn upon landing.

In the intermediate scale tests conducted using single boxes containing 100 batteries each, exposed to a 30kW propane burner, the batteries increased the fire's energy release rate by approximately 90kW at the peak burning rate. This increase, based on the data from the small scale tests, was equivalent to seven battery cells failing simultaneously. During the test, while the batteries were venting, some of the burning batteries became projectiles, landing a few feet away from their original position.

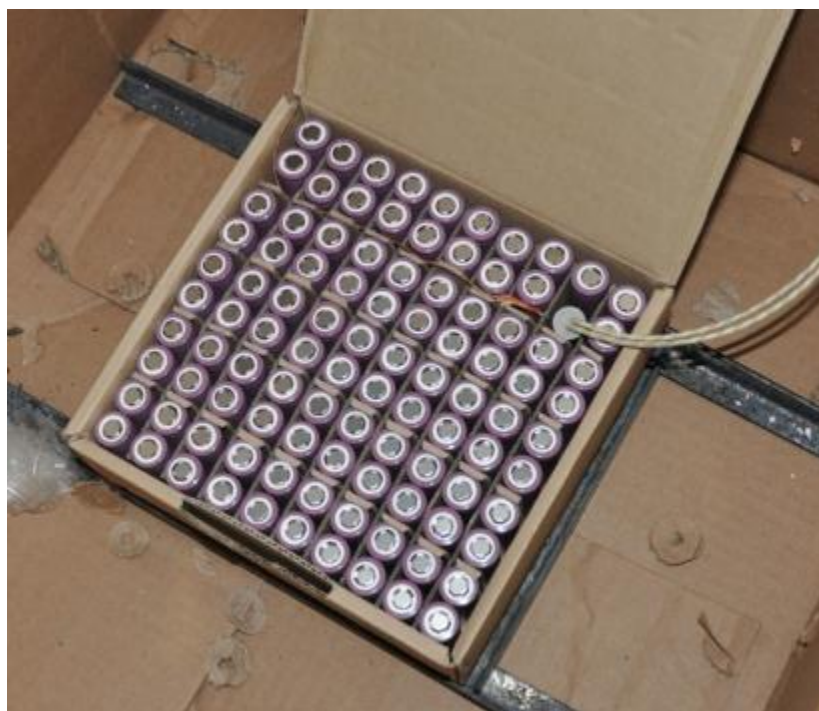
Figure 86: Box of batteries with cartridge heater in place (circled in red)

To simulate the case of batteries being the cause of the fire and self-igniting, a 250-watt cartridge heater was used to simulate a battery going into thermal runaway. One cell in the corner of the box of 100 batteries was replaced by the cartridge heater (figure 12). In addition to the batteries, the fire load for each of the two tests included 18 cardboard boxes each containing 2.5 lb of shredded paper inside, arranged in a 3 x 3 array two levels high (figure 13). Each cardboard box was an 18" cube. The box of batteries was placed inside the cardboard box (and covered with 2.5lb of shredded paper) at the center of the top level of boxes in the array. The additional fire load was used to observe the battery thermal runaway spread to the rest of the combustibles and to determine if the presence of batteries in the fire load had any measureable effect. For reference, two control tests were conducted using 18 boxes and no batteries. Those fires were initiated by an electric match inside the cardboard box at the center of the top level of boxes in the array, just as in the tests that included the box of batteries.

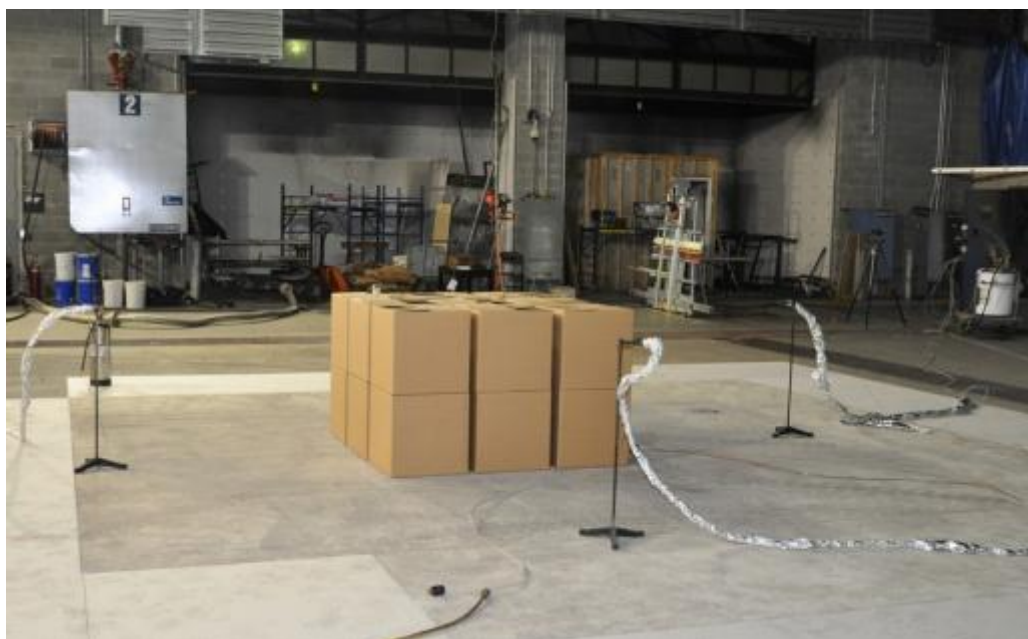
Figure 87: Test setup for tests involving 18 cardboard boxes and one box of batteries

In this test series (Battery#3), just as in the test with the box of batteries over the propane burner (Battery#2), radiant heat flux measurements and plume temperatures were recorded along with the oxygen consumption calorimetry. The test was run in duplicate. During the first iteration (test I), it appeared that the batteries vented without ignition of the expelled electrolyte until the very end, where it is unclear if the batteries or cartridge heater finally ignited the rest of the fire load. During the second iteration (test II), the vented electrolyte ignited early on in the test and actually caused a small explosion within the cardboard box in which the box of batteries was placed. The fire rapidly spread to the rest of the fire load and consumed it, leaving the batteries still venting and burning after all the boxes were consumed. The difference between the two tests was that for the first one, the box of batteries was placed in between the center boxes of the lower and upper layers of

boxes, and in the second test, the box of batteries was placed inside the center box of the upper layer.

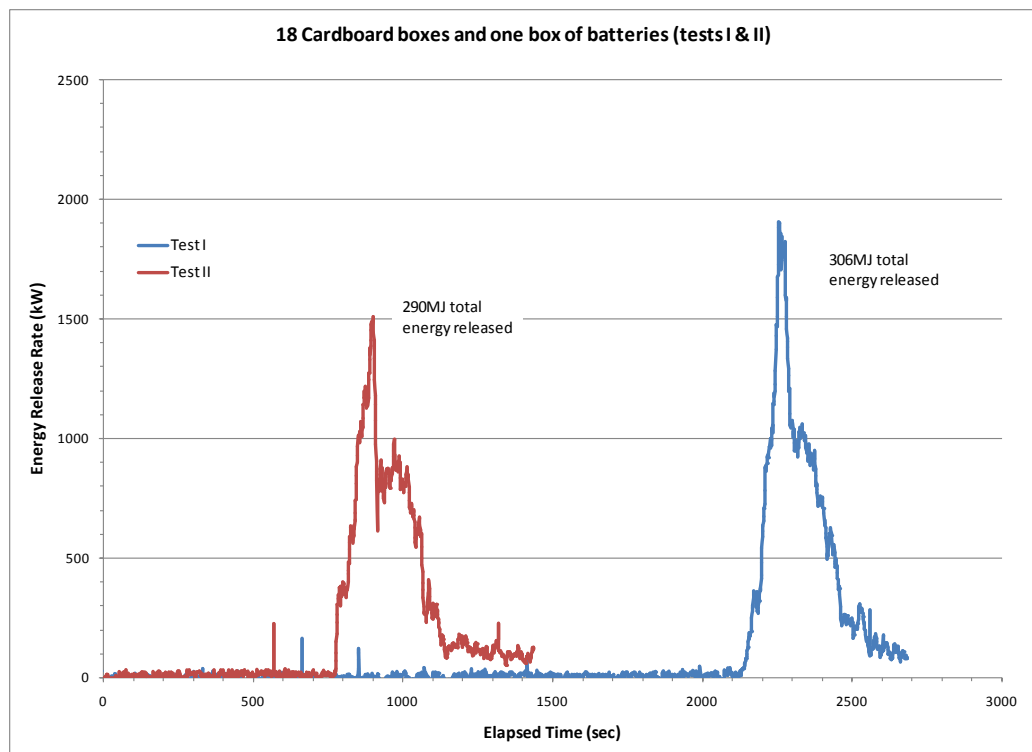
Figure 88: Energy release rate from tests involving cardboard boxes and batteries

The graph of the energy release rates of both of the two tests involving cardboard boxes and batteries is shown in figure 14. On average, the tests involving the cardboard boxes and batteries had a peak energy release rate of 1.7 MW and a total energy of 298 MJ. The tests to which these results are to be compared to involved only cardboard boxes and no batteries. The results of these tests are shown in figure 15. On average, the tests involving just the cardboard boxes had a peak energy release rate of 1.6 MW and a total energy of 288 MJ. The tests involving the batteries did not exhibit any perceptible differences in the overall characteristics of the fires. Peak energy release rates were very similar and well within the variable nature of fire tests. The overall burning time of all the tests was also similar and was approximately 400 seconds. The average total energy of the tests which included the box of batteries was 10 MJ greater than the average of those tests that did not include the box of batteries. That difference is very close to the energy contribution of the box of batteries calculated from the propane burner tests. Temperatures measured in the fire plume of all these tests were also consistent regardless of the presence of batteries and peaked at $1000\text{ }^{\circ}\text{C} \pm 100\text{ }^{\circ}\text{C}$. The measured radiant heat flux also did not exhibit any significantly different results for the tests that included the batteries. The test reports from the BATFE containing all the test results for the battery tests with the propane burner and the battery tests with the array of cardboard boxes can be found in appendixes B and C respectively.

In the intermediate scale tests conducted using single boxes containing 100 batteries each and an additional fire load of 18 cardboard boxes containing shredded paper, the batteries were found to be capable of spreading the fire to adjacent combustible materials. Upon causing ignition, the presence of batteries in the fire load did not appear to have an influence on the characteristics of the fire. Ignition of vented battery electrolyte caused an explosion, which resulted in the opening of the closure flaps of a cardboard box in which the box of batteries was placed. This explosion, which opened the box, allowed oxygen to enter, facilitating the combustion process.

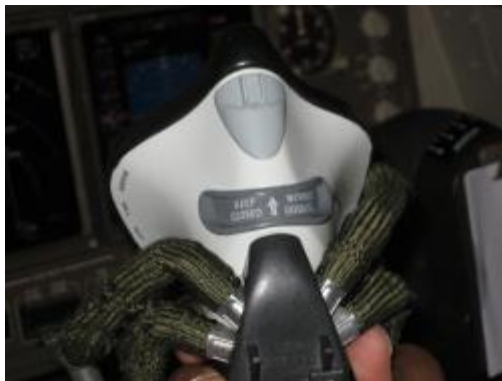
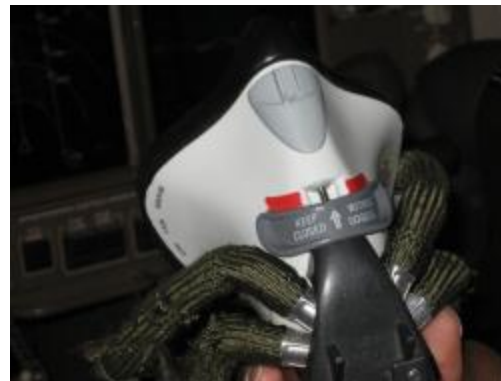
Figure 101: Smoke vent valve selector (closed) Figure 102: Smoke vent valve selector (open)

The pilots involved in the exercise indicated that with the smoke goggles donned, it was difficult to find the switch to clear the goggles of smoke (see figures 9 and 10) and one stated “it was “awkward”.

The pilots did not believe they would have thought to clear the goggles if they had not practiced it before the scenario. Pilot #1 stated that it was a misconception that the goggles should fit snugly. He said they were designed to be loose so that the goggles could be cleared of smoke. The instructor informed the crew that they should have completed the smoke fire and fumes checklist prior to completing the smoke removal checklist. Asked who would be in charge of communicating with ATC, both pilots indicated that the PM would do this.

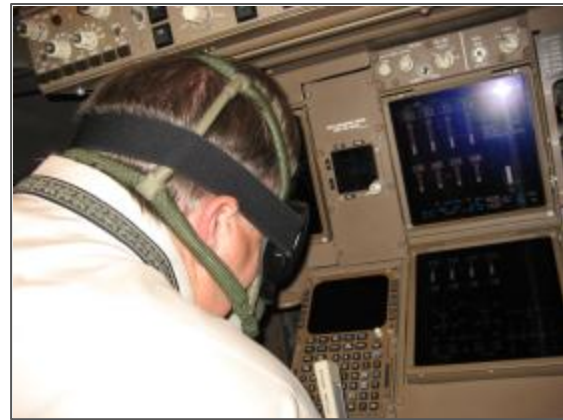
Pilot #2 indicated that with the smoke goggles donned, he could not see the standby compass. He said the image was distorted and he would have gotten his flashlight to improve visibility of the compass. Figures 11 and 12 show how close a pilot could get to the instrument panel with the oxygen mask and goggles donned.

Figure 103: Closest position to the MCP

Figure 104: Closest position to the FMS

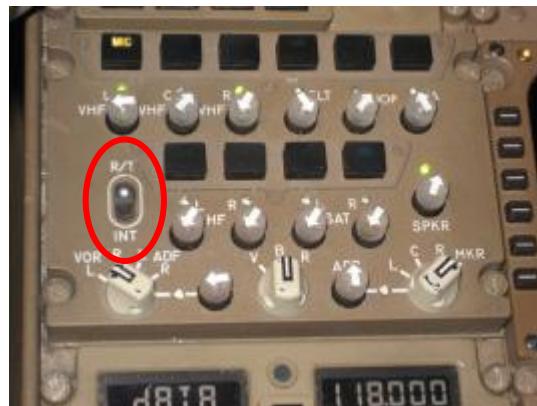
Figure 105: “Push to Talk” switch

Pilot #1 stated that not having a live mic could be an issue. He said if he did not hit the lower rocker (the “push to talk” switch on the audio panel; see figure 13), pilot #2 could not hear him. It was difficult to do this when holding the checklist.
