AAIS Case Reference: 13/2010

AIR ACCIDENT INVESTIGATION REPORT

**Uncontained Cargo Fire Leading to Loss of Control
Inflight and Uncontrolled Descent Into Terrain**

Boeing 747-44AF
N571UP
Dubai
United Arab Emirates
03 September 2010

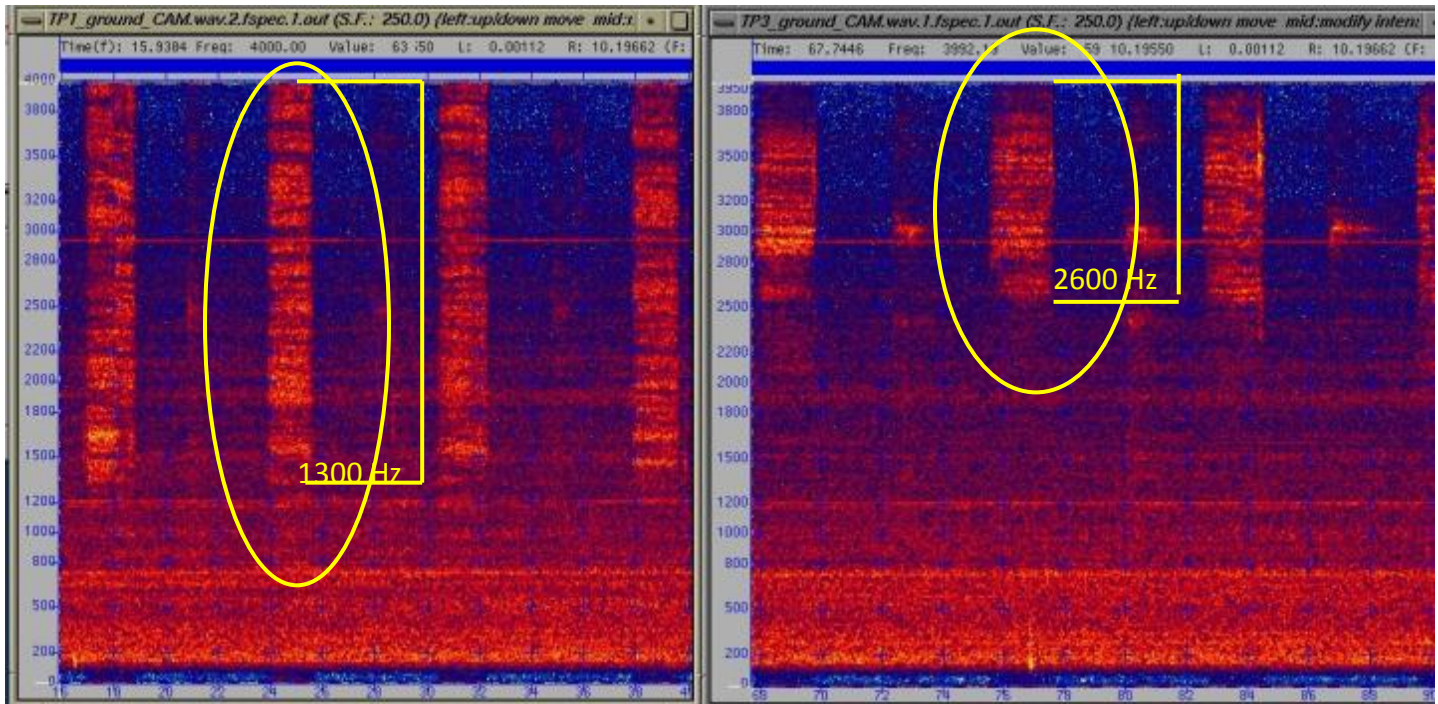
Figure 108 – Spectrogram of CAM - Test points 1 and 3, on Ground

The left side of Figure 107 shows the sounds during TP1 (mask in Normal mode). One of the inspiratory noises is circled in yellow. This chart shows a relatively equal distribution of sound energy over a range from about 1300 Hz to 4000 Hz. In contrast, the right side of Figure 107 shows the audio from TP3 (100%) mode, where the majority of energy is spread over a range from about 2600 Hz to 4000Hz. This is consistent with the auditory review of the recording which indicated that 100% mode sounded as though it had a higher pitch. This spectrogram shows that the 100% mode actually has less sound energy in the lower frequency range, which causes it to sound as though it has higher pitch when compared to the Normal Mode.

In flight, this characteristic is much more difficult to discern, due to the background ambient noise in the cockpit. The area highlighted in Figure 108 shows the background noise during flight is too loud to see the lower frequency range of the inspiratory noise. As a result, this characteristic was not suitable to differentiate between mask modes.

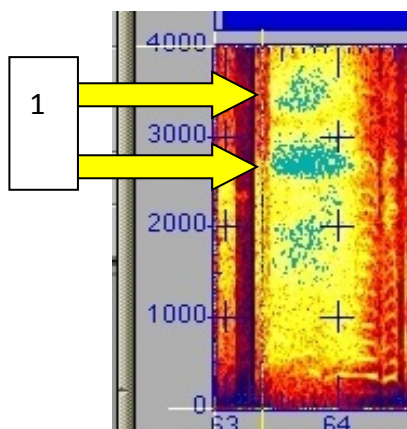
Figure 110 – Spectrogram of Inspiratory Noise from Mask Microphone Audio

The auditory review of the mask microphone audio revealed that the breath noises did not sound significantly different between the two mask modes. However, the sound spectrum analysis found a unique characteristic in the audio that differentiates one mask mode from the other. Figure 109 shows a spectrogram of the inspiratory noise from a single breath, as recorded from the oxygen mask microphone.

The audio from the mask microphones exhibits characteristic “bands” of energy during inspiratory breaths (light blue regions labeled 1 and 2 in Figure 109). These bands are a concentration of relatively higher sound energy within certain frequency ranges. The height of the bands (range of frequency) and total number of bands seems to vary, and may be affected by the overall loudness of the breath sound itself. However, two of these bands are present in all segments of audio that were examined (labeled 1 and 2 in Figure 109). The unique characteristic is the “center” frequency of Band 2. The band height (total frequency range) can vary, but the center of the band appears to be unique to the mask mode. In

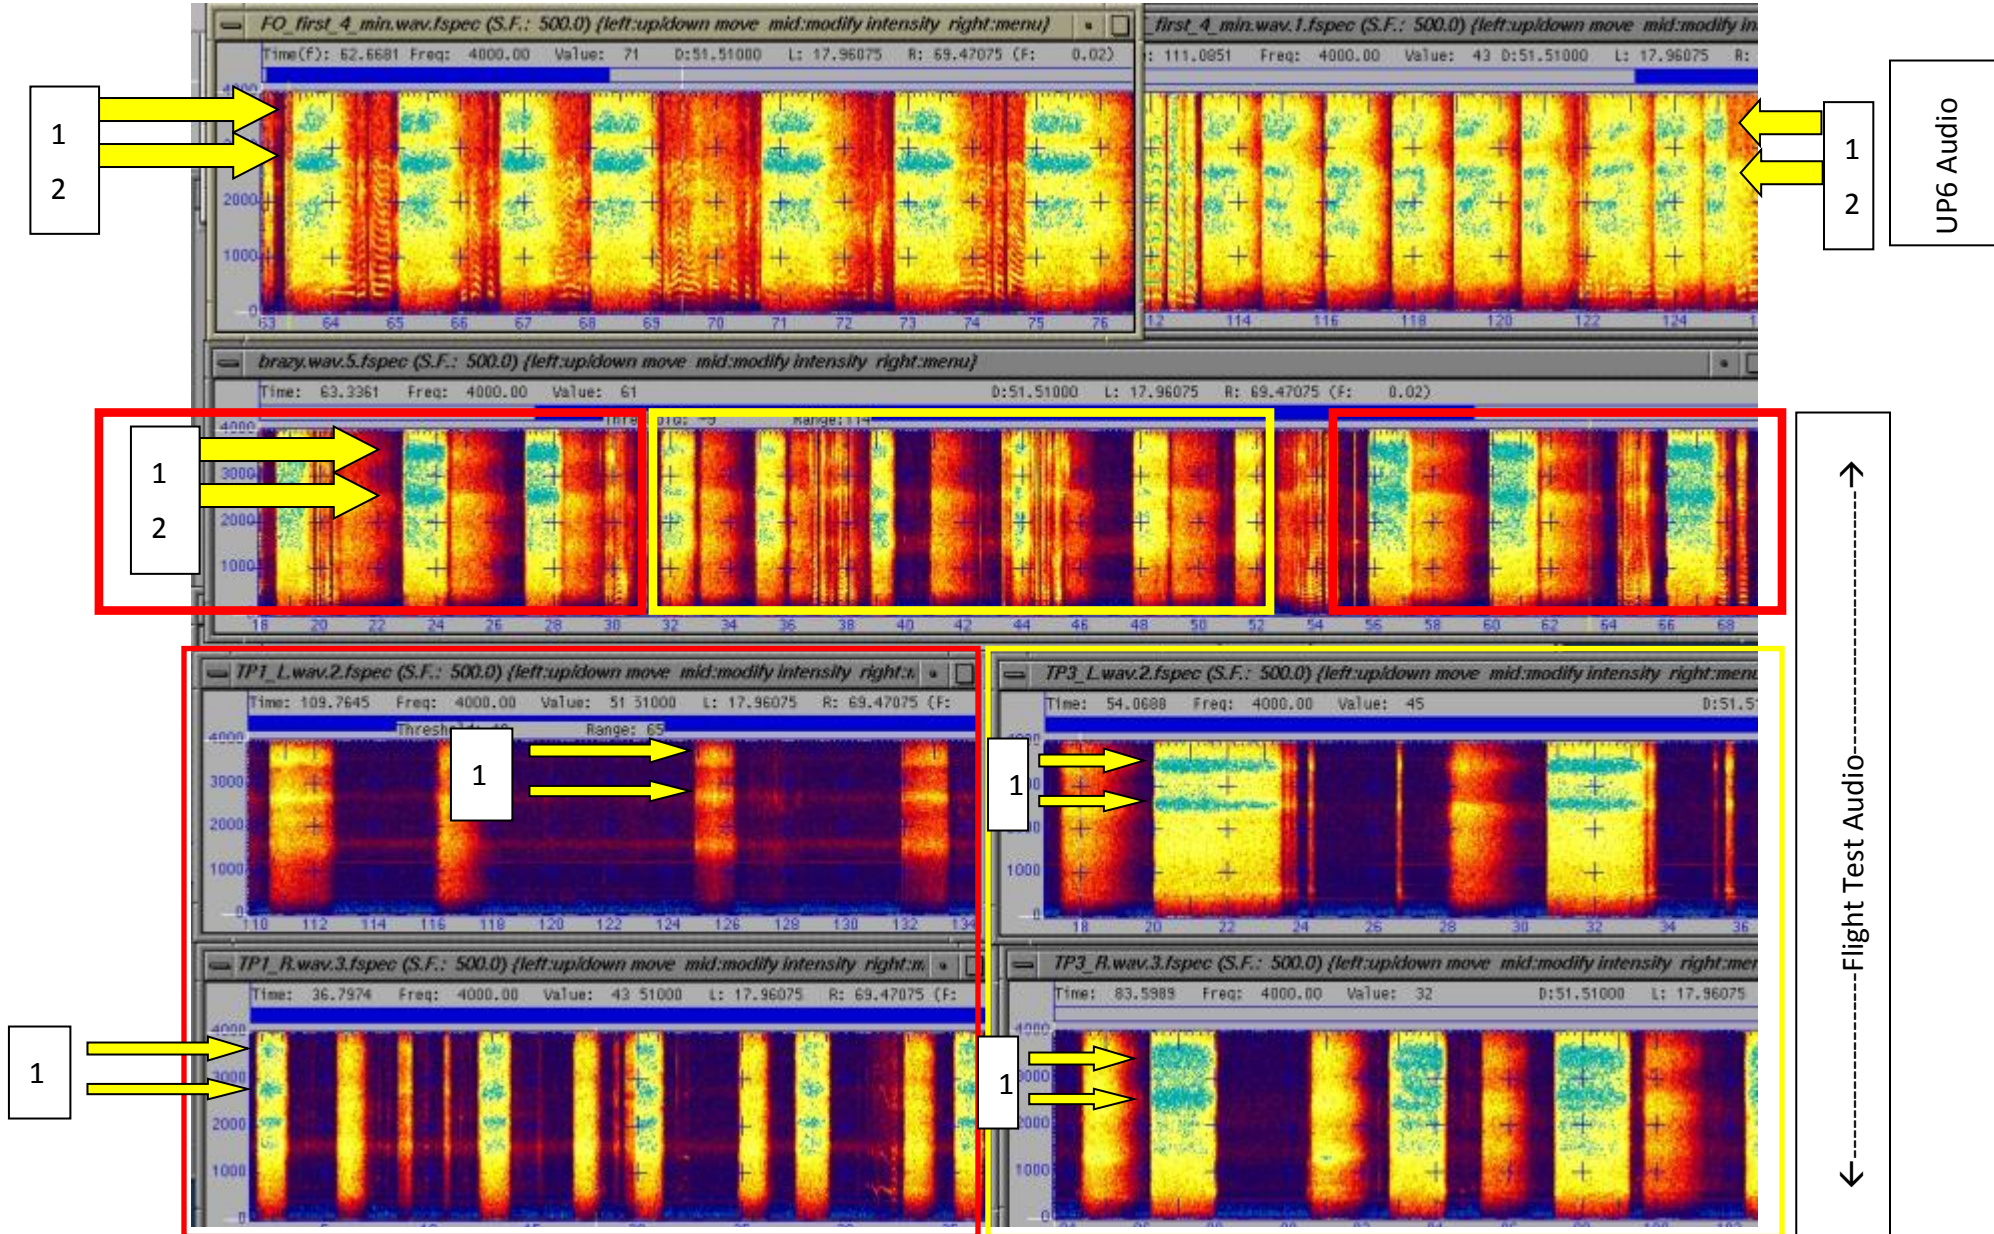
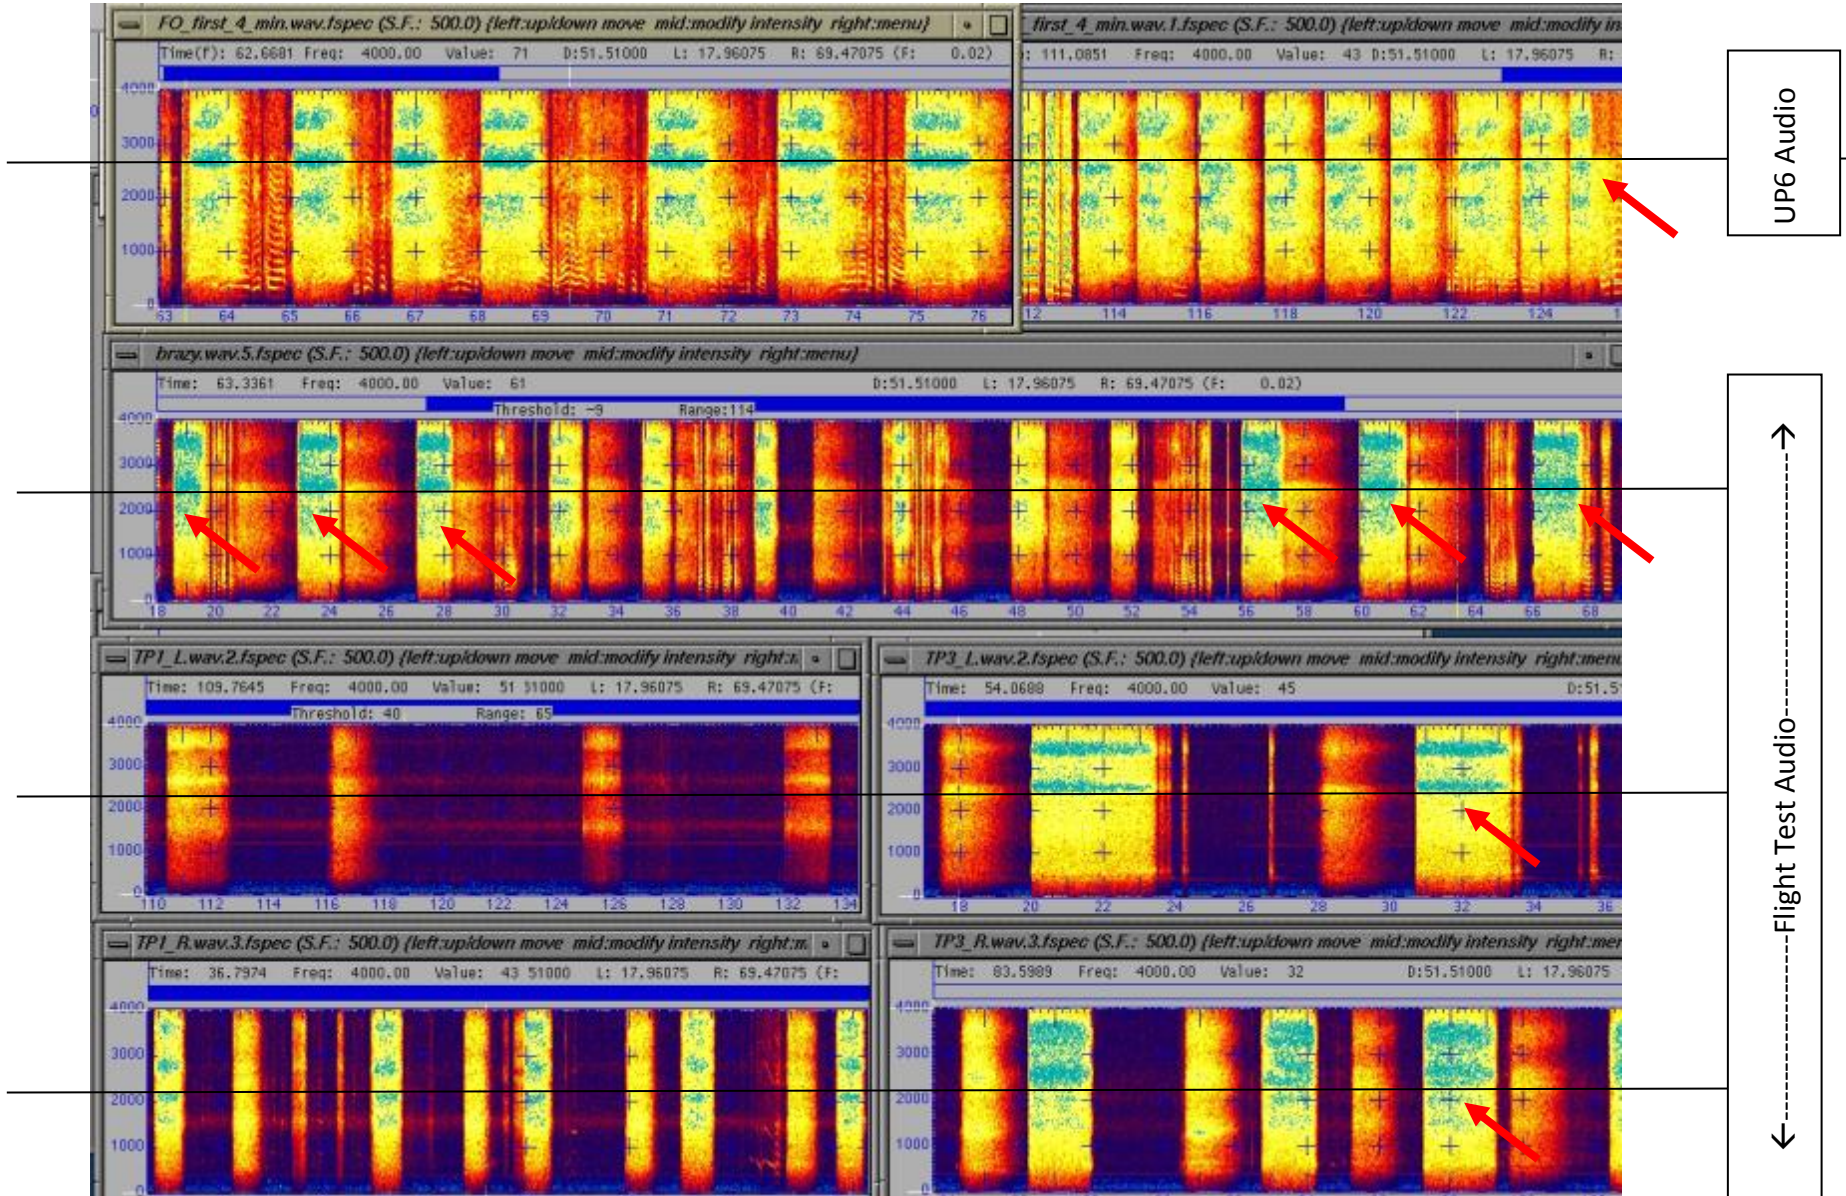
The audio from the accident airplane is at the top of **Error! Reference source not found.**. The left hand side shows the audio from the First Officer's mask microphone, with the center of band 2 at approximately 2700 Hz which is consistent with the Normal mode. The right side shows the audio from the Captain's mask microphone, with the center of band 2 at about 2560 Hz, consistent with the 100% mode.

This “frequency shift” of the centerline of band 2 according to mask mode is consistent throughout all of the audio from the test flight, which varied among 3 separate masks and 4 separate pilots, both in flight and on the ground.

In the accident recording, the centerline frequency of band 2 for the First Officer’s audio is consistent with the flight test data for the Normal mask mode, throughout the recording. Segments of audio were examined at the time the mask was donned, at time the cabin altitude reached its peak (approximately 25,000 feet)¹³³, and at the end of the recording. The Captain’s audio was consistent with flight test data for the 100% mask mode at the time the mask was donned, at the time of the last breath sounds and at several other randomly selected times in between.

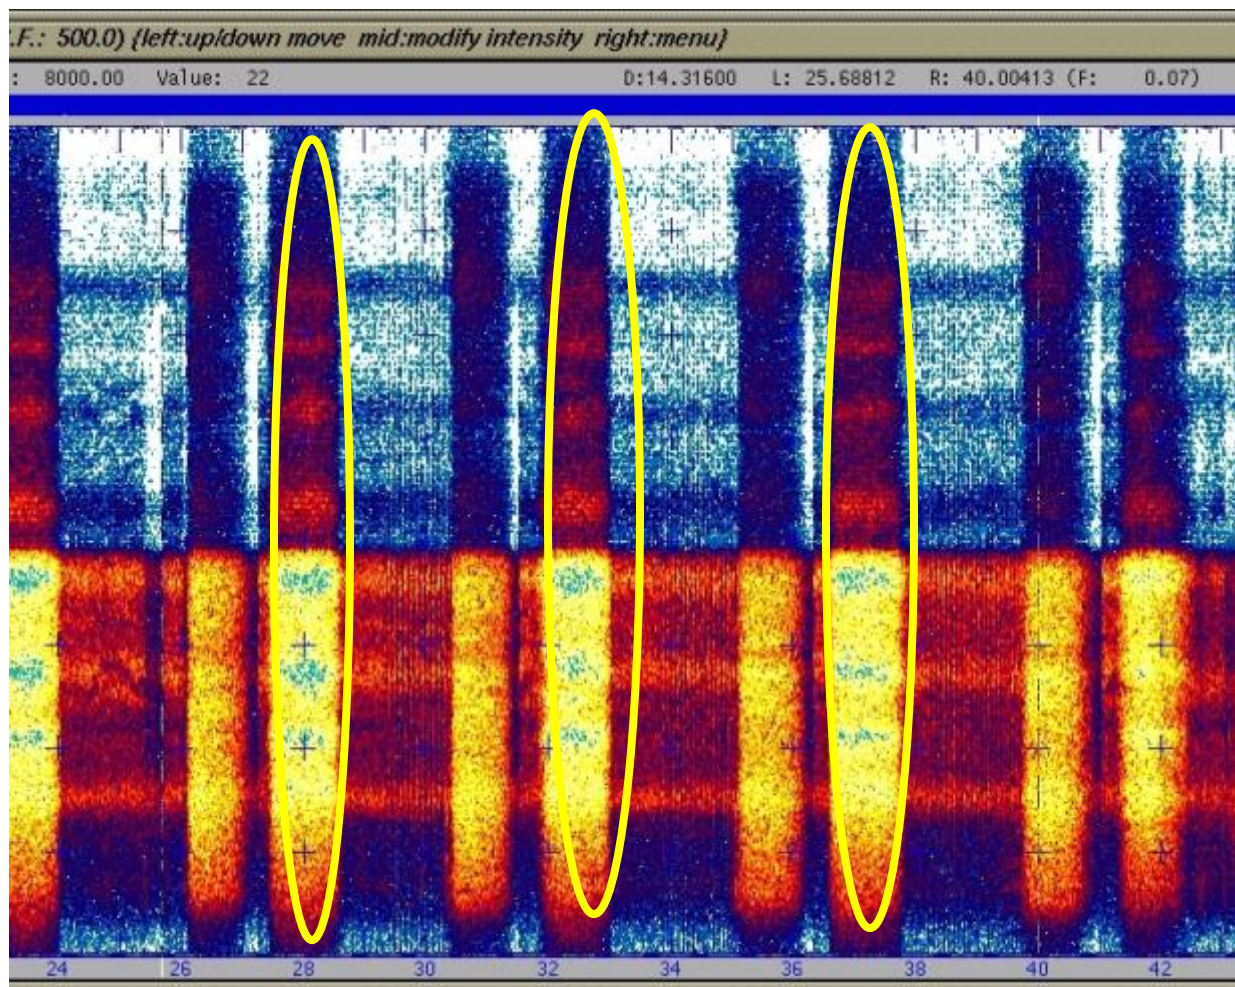
Figure 111 - Emergency Setting = On

During the testing in the NTSB laboratory as well as the flight test, a characteristic was noted which appears to be consistent with the emergency setting set to “on”. This characteristic can be heard audibly as well as seen in a spectrogram. It is a “chattering sound” that occurs between breaths. This characteristic is not continuous and only occurs occasionally, however it occurred at some point during every test when the emergency setting was on, and did not occur in any tests when the setting was off. None of the audio on the accident recording contained this characteristic. The “chattering” is visible as the series of thin dark vertical lines highlighted in Figure 110.
