KNKT 09.12.28.04

**Aircraft Serious Incident Investigation Report**

**PT. Merpati Nusantara Airline  
Fokker F 28–MK100 ; PK – MJD  
El Tari Airport, Kupang, East Nusa Tenggara  
Republic of Indonesia**

**02 December 2009**

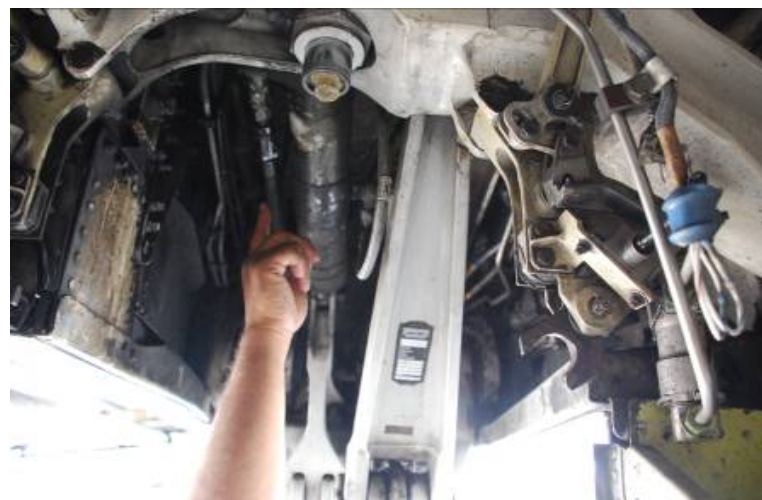
**Figure 8: Restrictor Valve and Actuator position**

Considering that during the evacuation of the aircraft, the connector to the restrictor check valve was loosened, this allow hydraulic fluid released from the actuator and the left main landing gear moved to down position by gravity. Therefore, the investigation was focused to the restrictor check valve of the left main landing gear actuator.

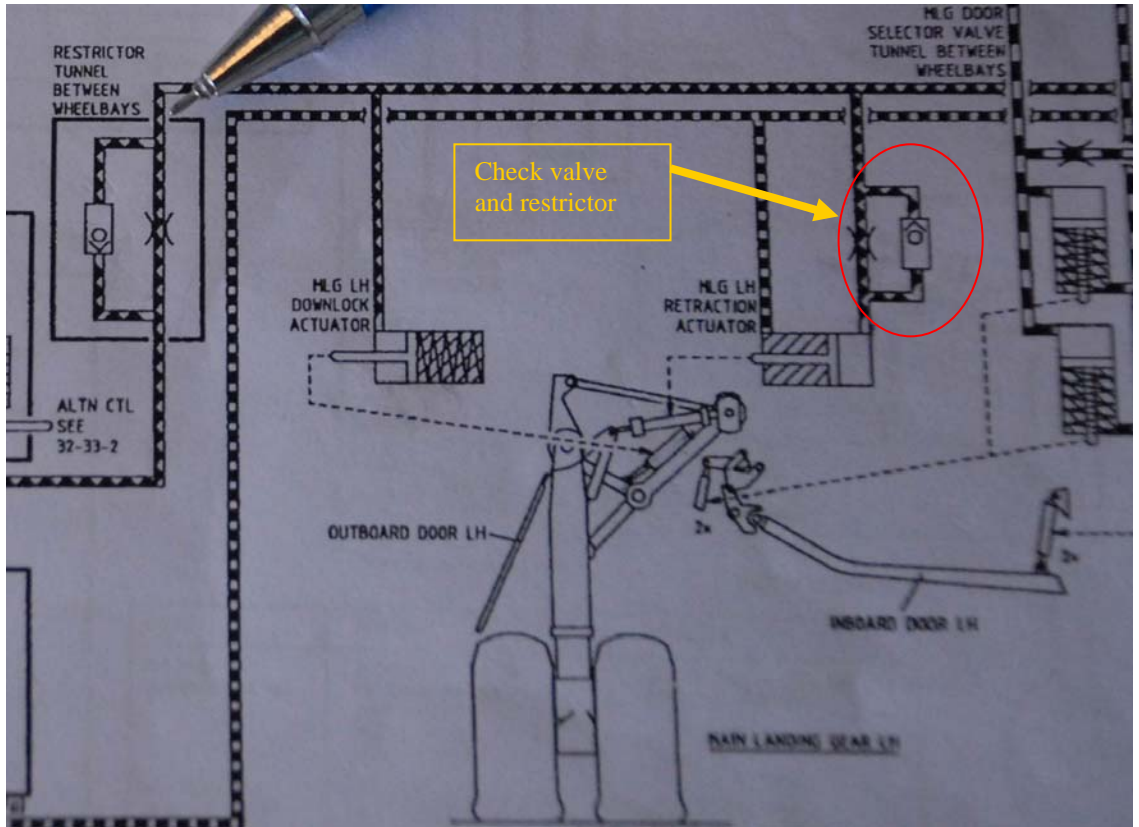
Figure 9: Schematic of hydraulic diagram of the return line (down position)

The restrictor check valves are installed in hydraulic line, the check valve will open when the landing gear is selected to up position the hydraulic fluid will flow through the check valve and the restrictor (see Figure 9). When selected to down position the hydraulic will flow through the restrictor only, this is to reduce the hydraulic flow and slowing down the landing gear movement.

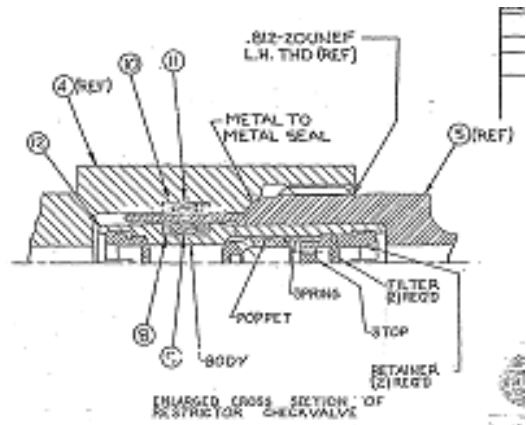
Figure 11: Cross section of restrictor check valve

The O-ring debris was found in the chamber between the orifice and the stopper next to the intact screen filter.

The damage of the screen filter on the up line (Figure 12) indicated that the O-ring debris were blocked it. Subsequently during the landing gear up position, the applied pressure of 3000 psi pushed the debris and caused the screen filter damage. Those debris were continued to enter to the chamber between the orifice and the stopper next to the following screen filter, through the opening of the check valve. This stopper was preventing the damage of the intact screen from the blockage (Figure 14).
