ATSB TRANSPORT SAFETY BULLETIN
Aviation Level 5 Investigations AB-2010-061
Final

Level 5 Factual Investigations: July 2010 to September 2010

**Level 5 factual investigations:
1 July 2010 to 30 September 2010**

AO-2009-024: VH-NXM, Runway lighting failure

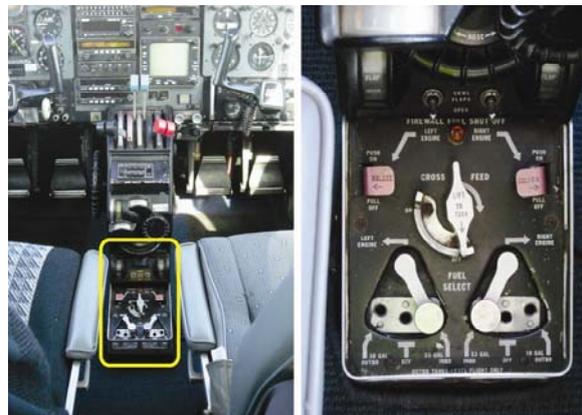
Figure 1: Central fuel control panel and fuel selectors in VH-ZMK

pedestal (Figure 1). They comprised the fuel tank selectors (one for each side), fuel shutoffs, and crossfeed controls. During normal operation, each engine was supplied with fuel from its own respective fuel system: the fuel controls on the right control the fuel from the right cells to the right engine and the controls on the left control the fuel from the left fuel cells to the left engine. The crossfeed system was not used for normal operation. For emergencies, fuel from one system can supply the opposite engine through the crossfeed system.

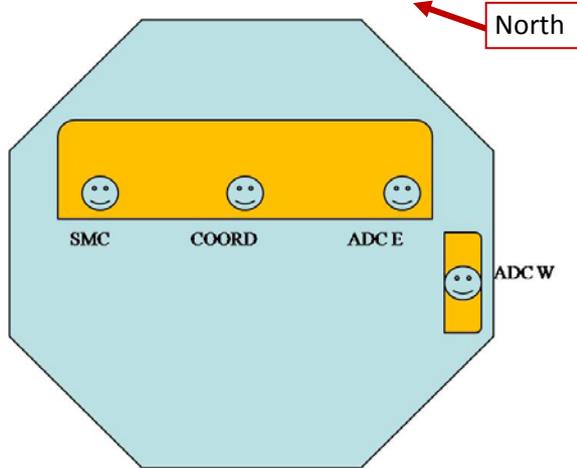
Figure 2: Control tower layout

The control tower was manned by four control positions; surface movement controller (SMC), coordinator (Coord), aerodrome controller east (ADCE), and aerodrome controller west (ADCW) (Figure 2). The position from where the ADCW worked was not a part of the original design of the tower and was introduced in 1982.

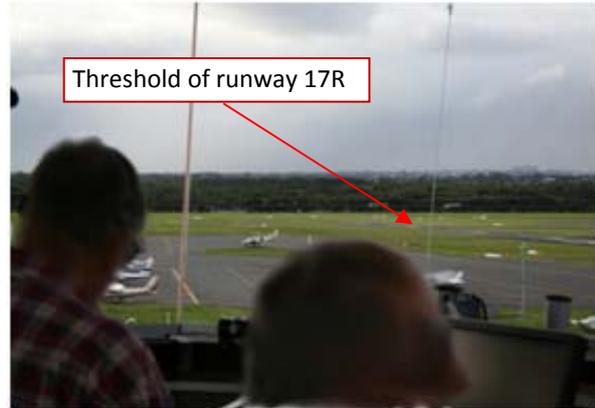
Figure 3: View from the ADCW position

As a consequence of the tower layout, the ADCW was required to look over the main tower console and past other controllers to see the threshold of 17R (Figure 3).
